CLINTON RESERVOIR DAM

INVENTORY No. NY 212

PHASE I INSPECTION REPORT
NATIONAL DAM SAFETY PROGRAM

JULY 1981

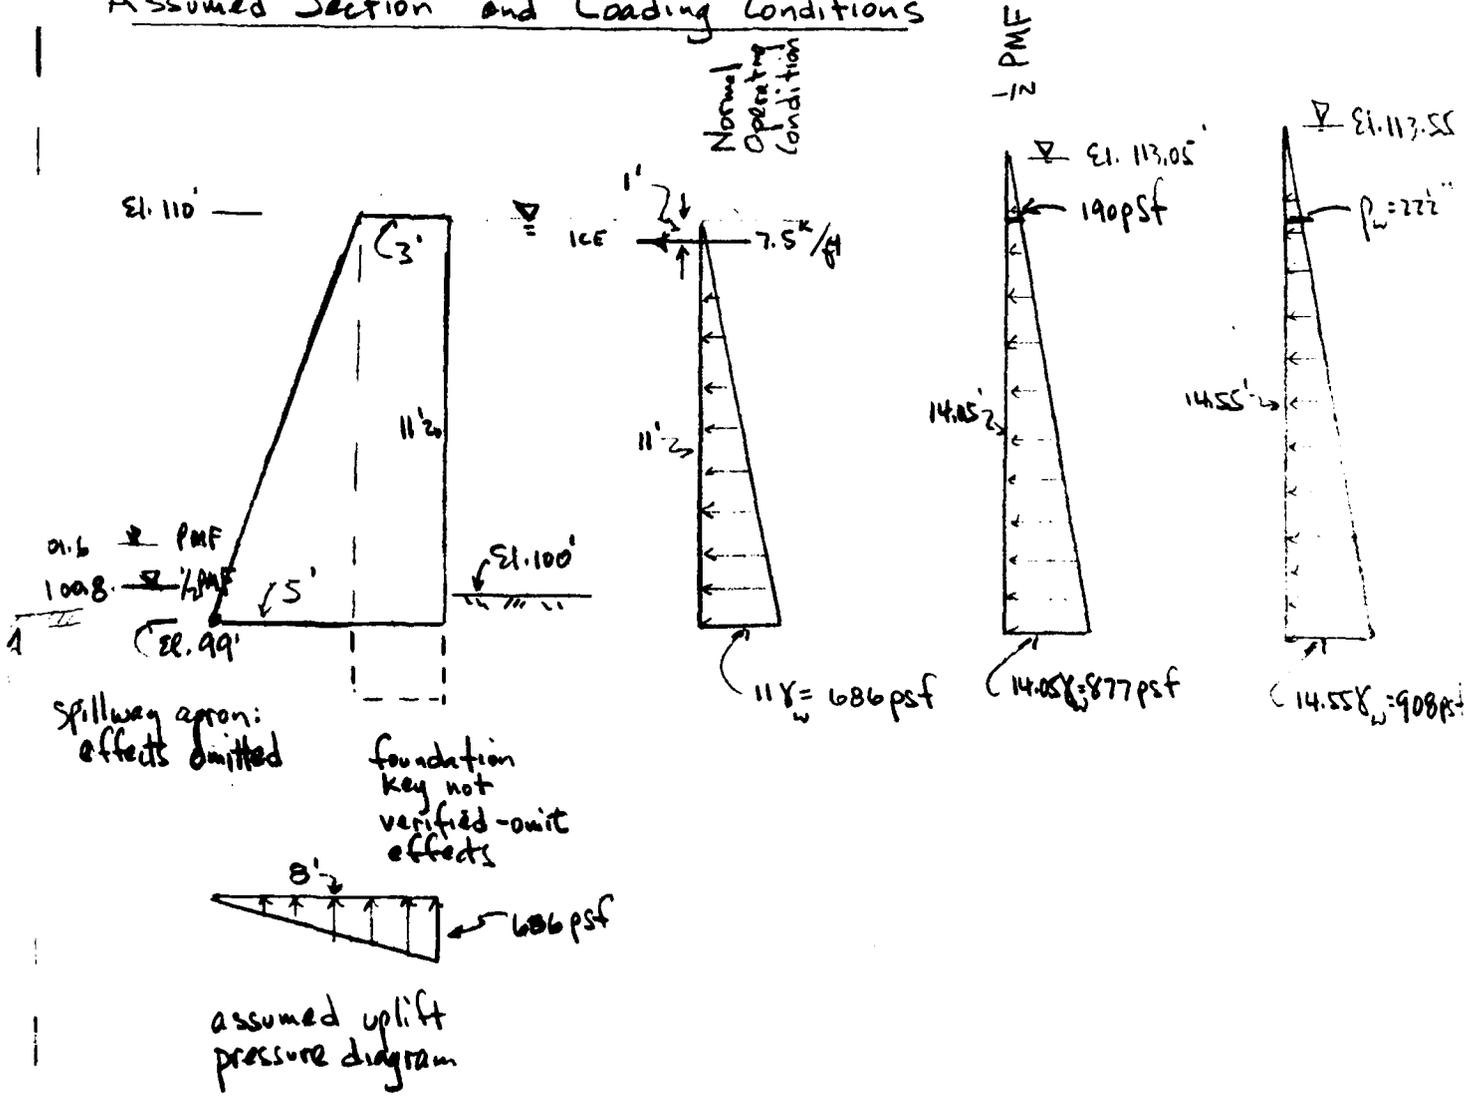
Assumed Section and Loading Conditions

Weight of dam = $.150 \text{ kcf} \left(\frac{3+8}{2} \times 11 \right) = 9.07 \text{ k/ft of length}$

M_{toc} due to weight of dam = $.150 \left[\left(\frac{1}{2} \times 11 \times 5 \times \frac{2}{3} \times 5 \right) + (3 \times 11) \left(\frac{3}{2} + 5 \right) \right] = 45.9 \text{ k ft}$
