**KLONDIKE LAKE DAM  
ST. CHARLES COUNTY, MISSOURI  
MO 30019**

**PHASE 1 INSPECTION REPORT  
NATIONAL DAM SAFETY PROGRAM**

KLONDIKE LAKE DAM - MISSOURI INVENTORY NO. 30019

AUGUST 1980

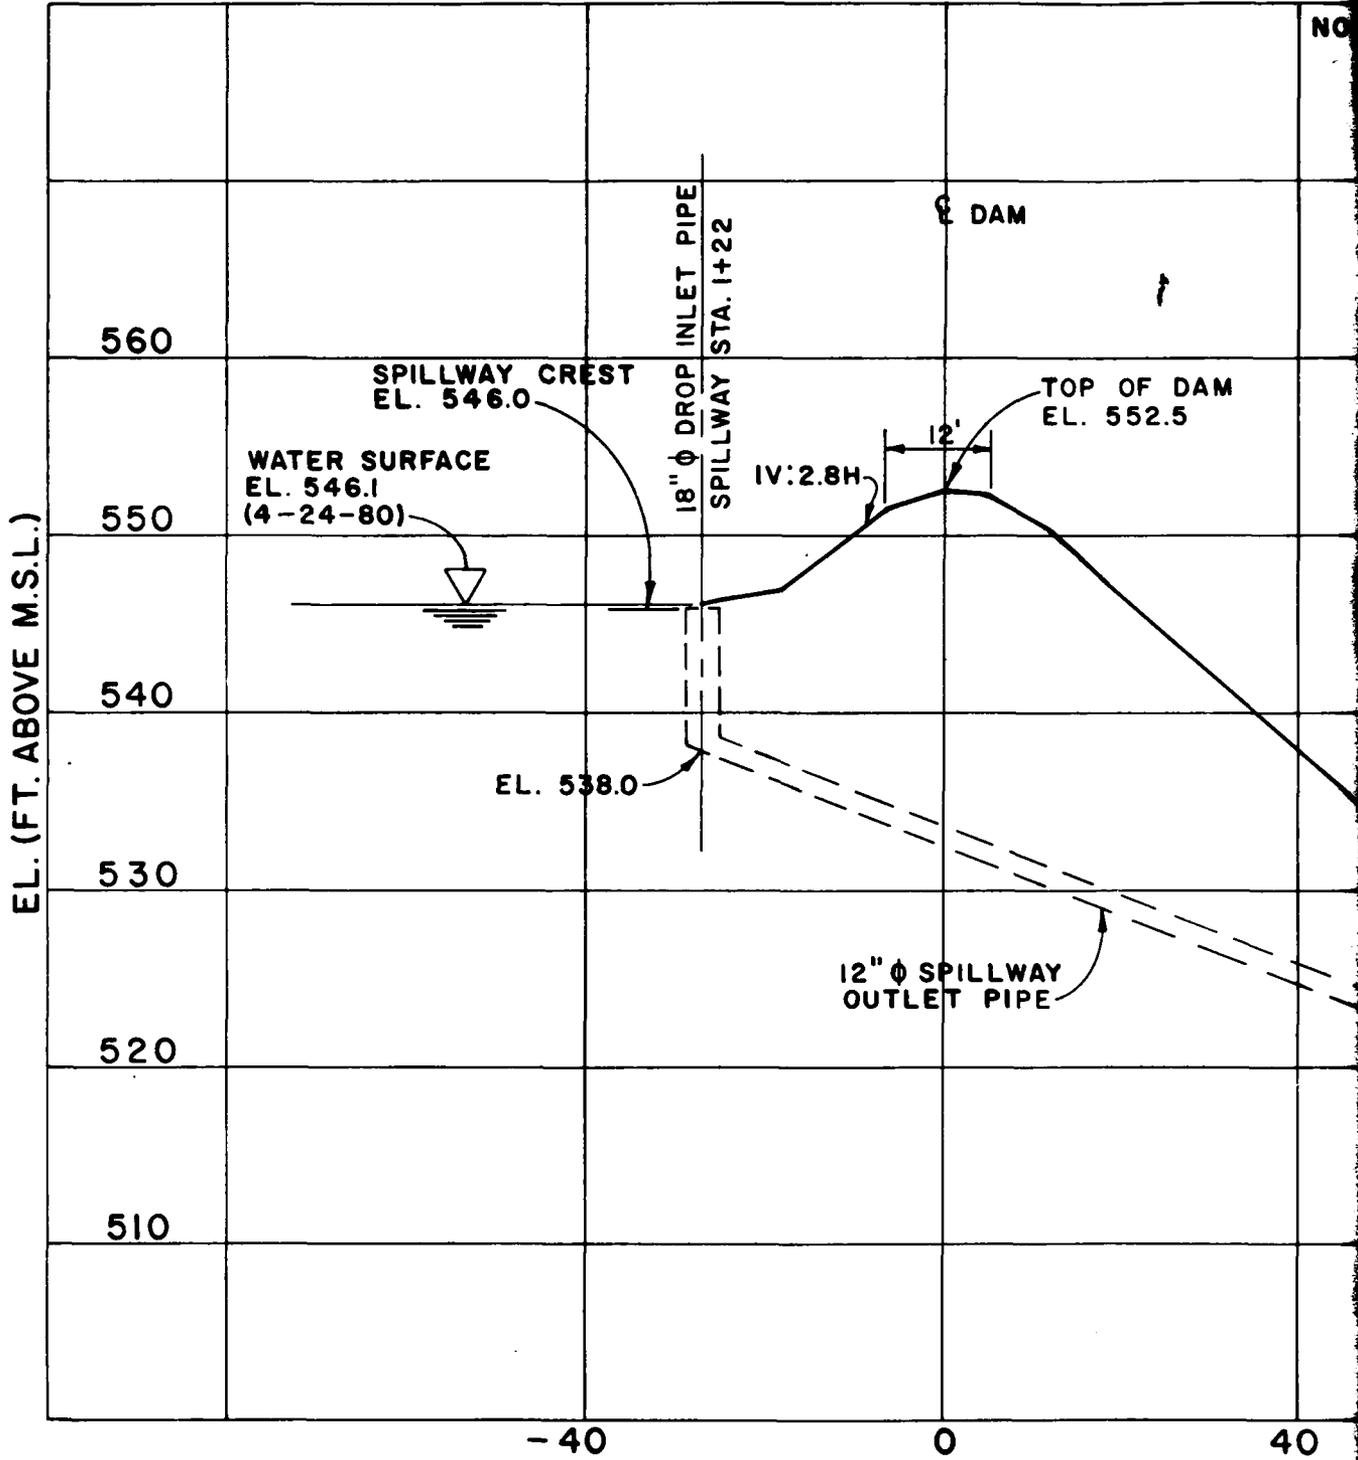
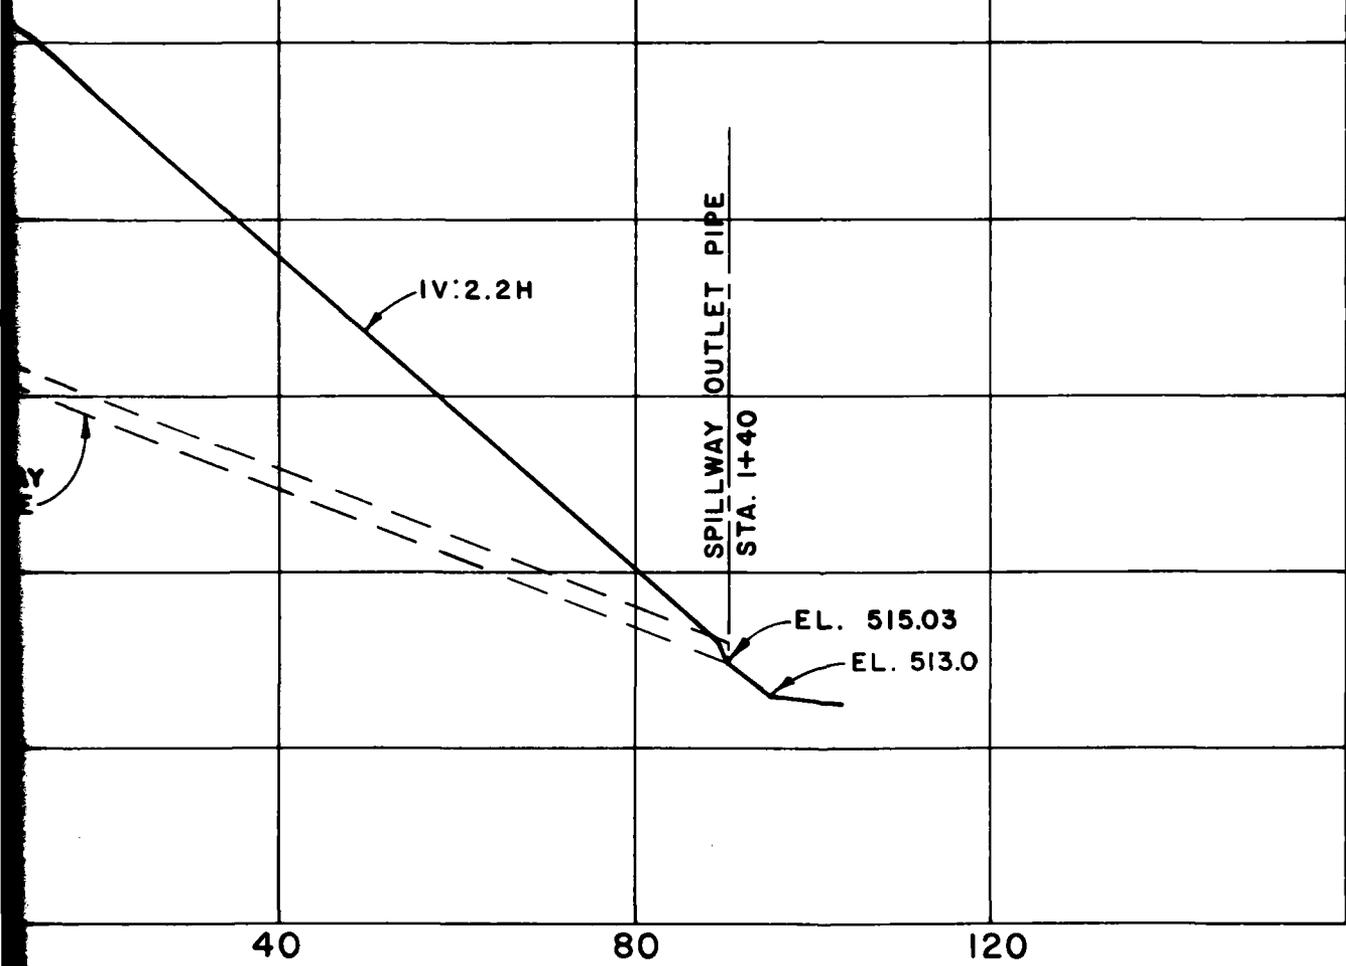
PLATE 4

**DAM CROSS-SECTION STA. 1**  
 SCALE: 1"=10' V., 1"=20' H.

NOTE: SPILLWAY PIPE PROFILE SUPERIMPOSED ON DAM SECTION.  
ACTUAL LOCATION OF OUTLET PIPE AS NOTED.
