STATE OF MISSOURI
BRANSON DAM
BRANSON COUNTY, MISSOURI
1958

PHASE 1 INSPECTION REPORT NATIONAL DAM SAFETY INSPECTION

17. DISTRIBUTION STATEMENT (of the abstract entered in Block 20, if different from Report) 6 National Dam Safety Program. Buick Mine Tailings Dam (MO 30162), White River Basin, Reynolds County, Missouri. Phase I Inspection Report.

BUICK MINE TAILINGS DAM

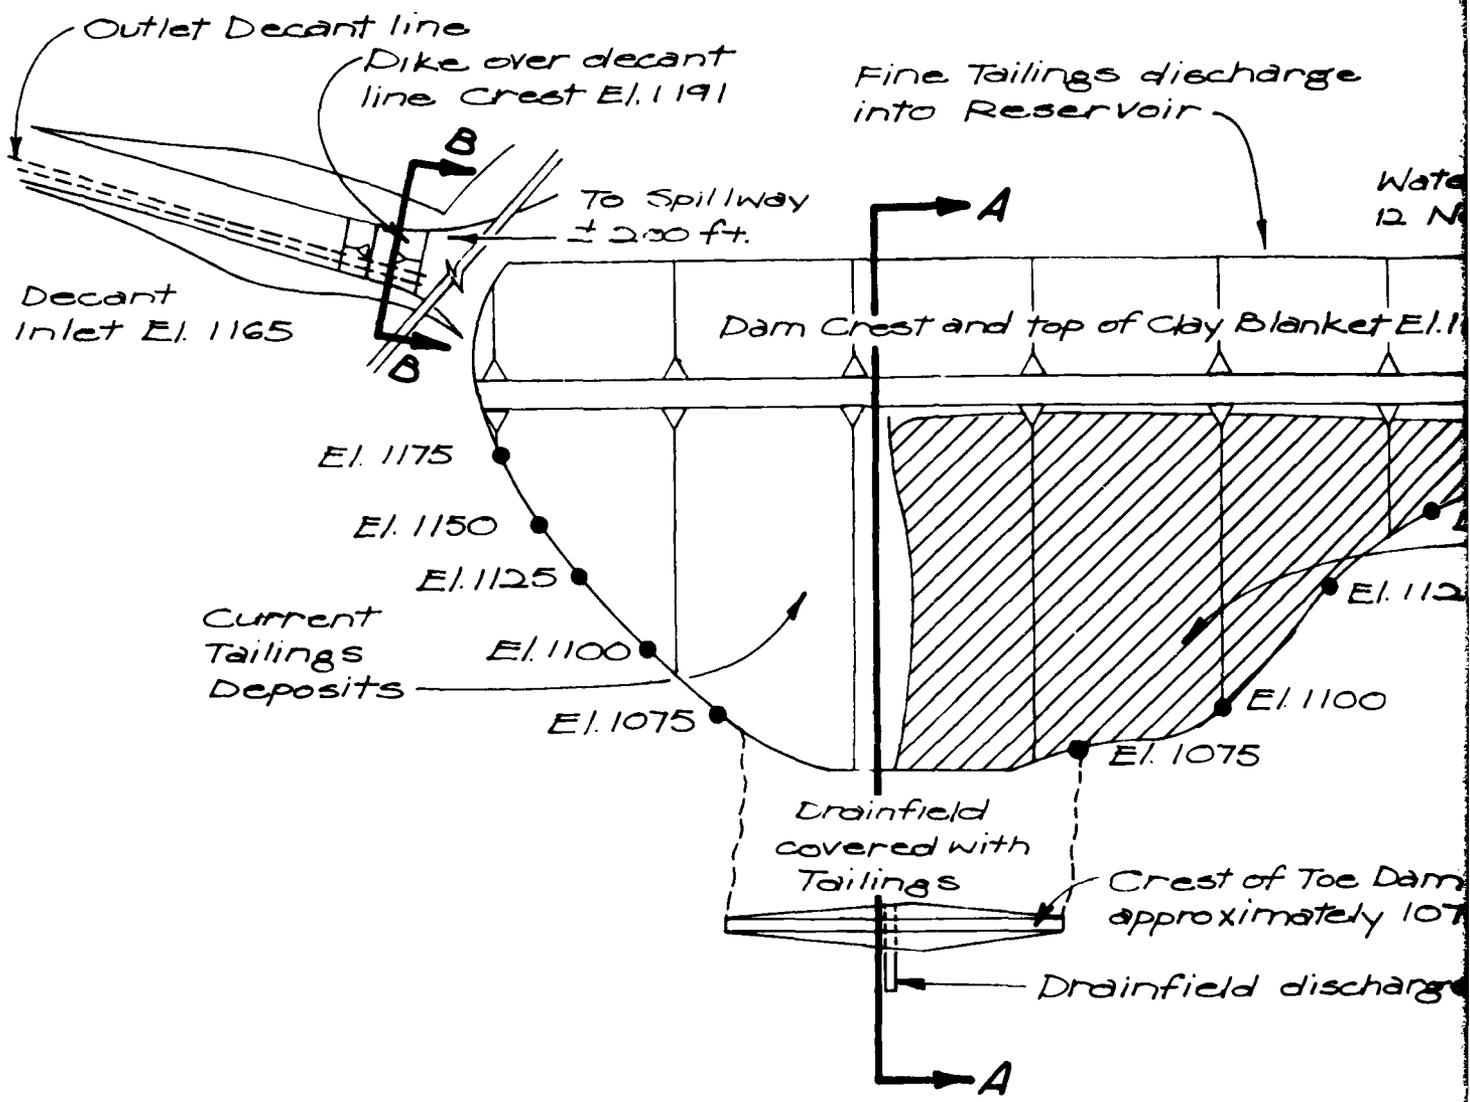
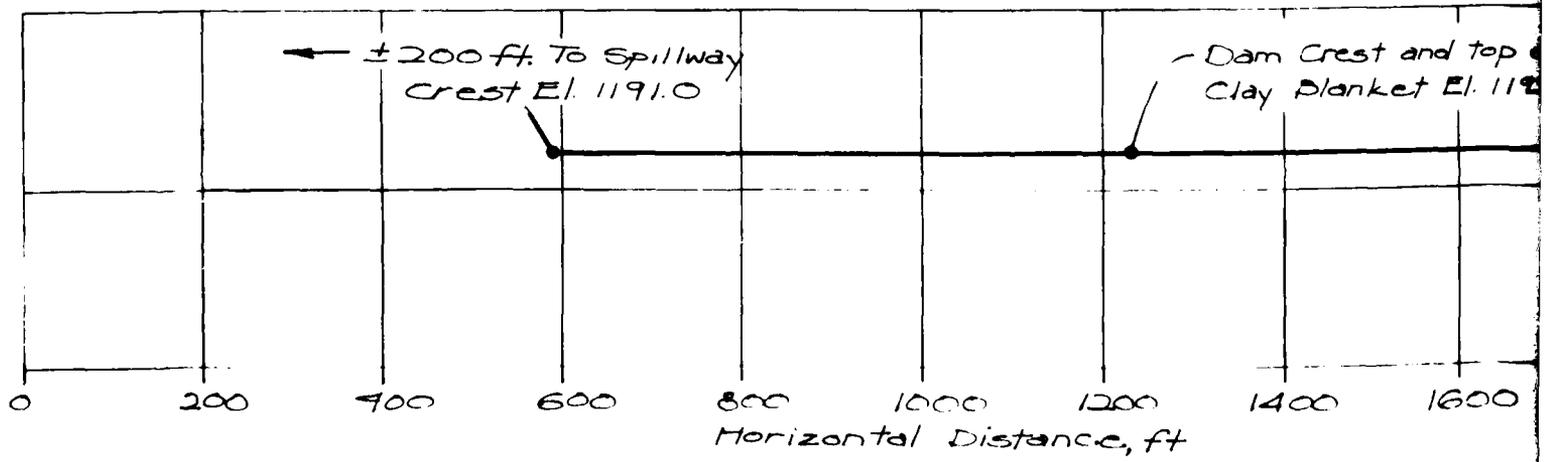
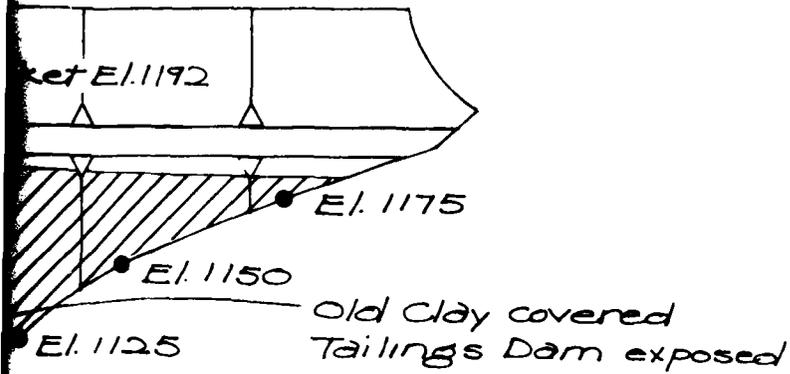
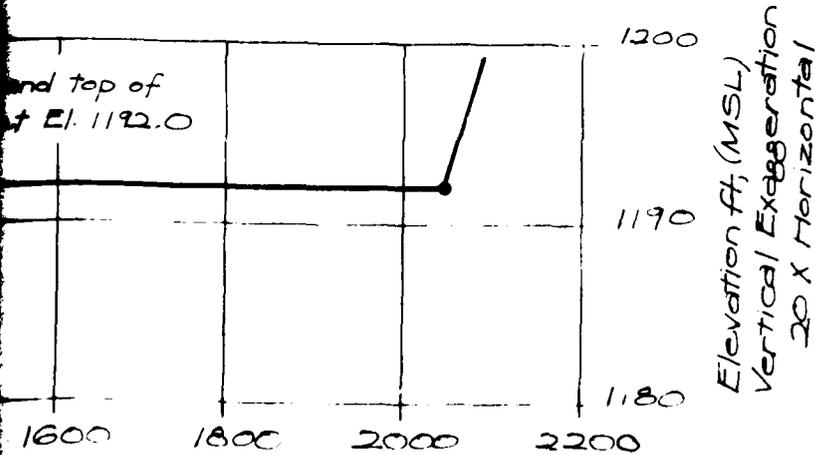
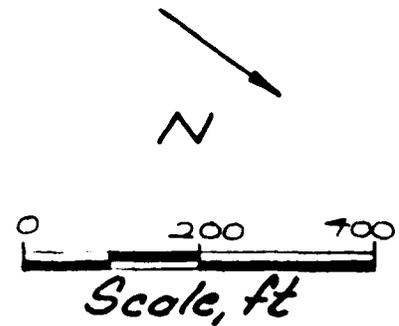
MO 30162 Fig. 3-A

Note:
Permanent Spillway, to be located on the south-east bank of impoundment, not yet constructed at time of inspection.
