PHASE I INSPECTION REPORT  
NATIONAL DAM SAFETY INSPECTION

**DESOTO MINING COMPANY  
PIT AND PLANT "A" DAM  
Washington County, Missouri  
Missouri Inventory No. 30468**

**Phase I Inspection Report**

Name of Dam	Desoto Pit and Plant "A" Dam
State Located	Missouri
County Located	Washington
Stream	Turkey Creek
Date of Inspection	5 June 1980

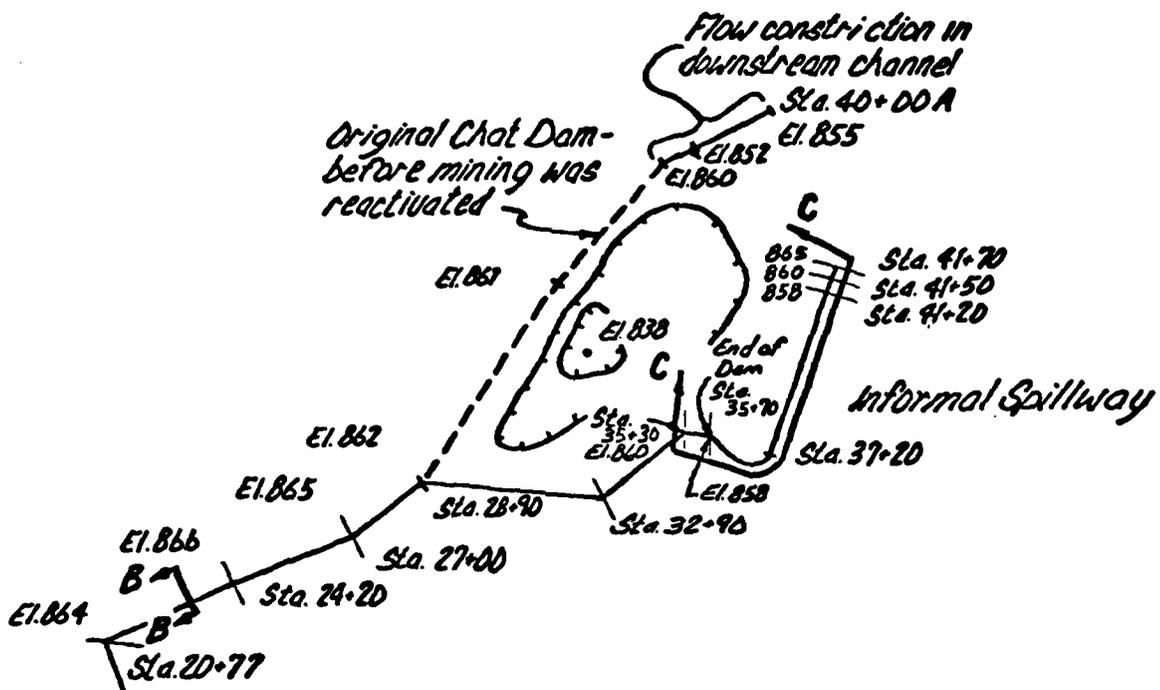
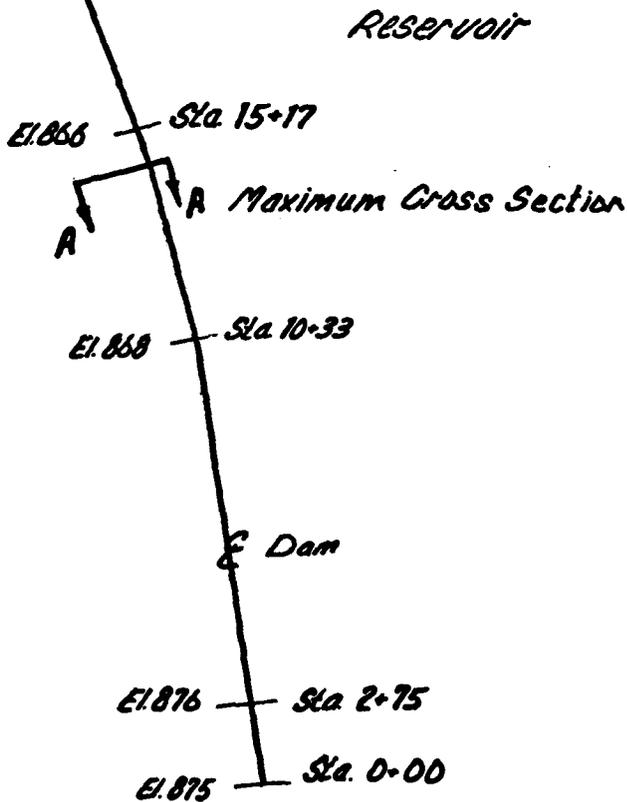
<b>PLAN OF DAM CREST</b>	
<b>DESOTO MINING CO PIT &amp; PLANT 'A'</b>	
<b>MO. 30468</b>	<b>FIG 3A</b>

3. Spillway. There is no formal designed spillway at this facility. The term "informal spillway" has been assigned to the low area to the south of the south end of the dam (see Figs. 3a and 3b). This overflow area has a moderate to high erosion potential as the stoney clay residual soil is only vegetated by grass, brush and small trees. This soil has been observed to be highly erodible when stripped of vegetation and exposed to high flow velocities.

4. Downstream channel. The channel downstream of the informal spillway flows through a mined-out depression to the east (bottom elevation 838). An extension of the original chat dam (constructed before disturbance by mining) extends to the southwest of Sta 28+90 (see Fig. 3a). This chat embankment constricts flow in the channel and will be eroded during high outflows. After passing the flow constriction, the outflow passes through areas of previous mining operations that have been vegetated by nature to varying degree. The vegetation in these areas indicate overflow may become retarded during flooding. Further downstream, the channel becomes an intermittent stream passing through mixed areas of forest and pasture.
