BEL-AIR LAKE DAM

NDI I.D. PA-0066

PHASE I INSPECTION REPORT
NATIONAL DAM INSPECTION PROGRAM

D'APPOLONIA CONSULTING ENGINEERS

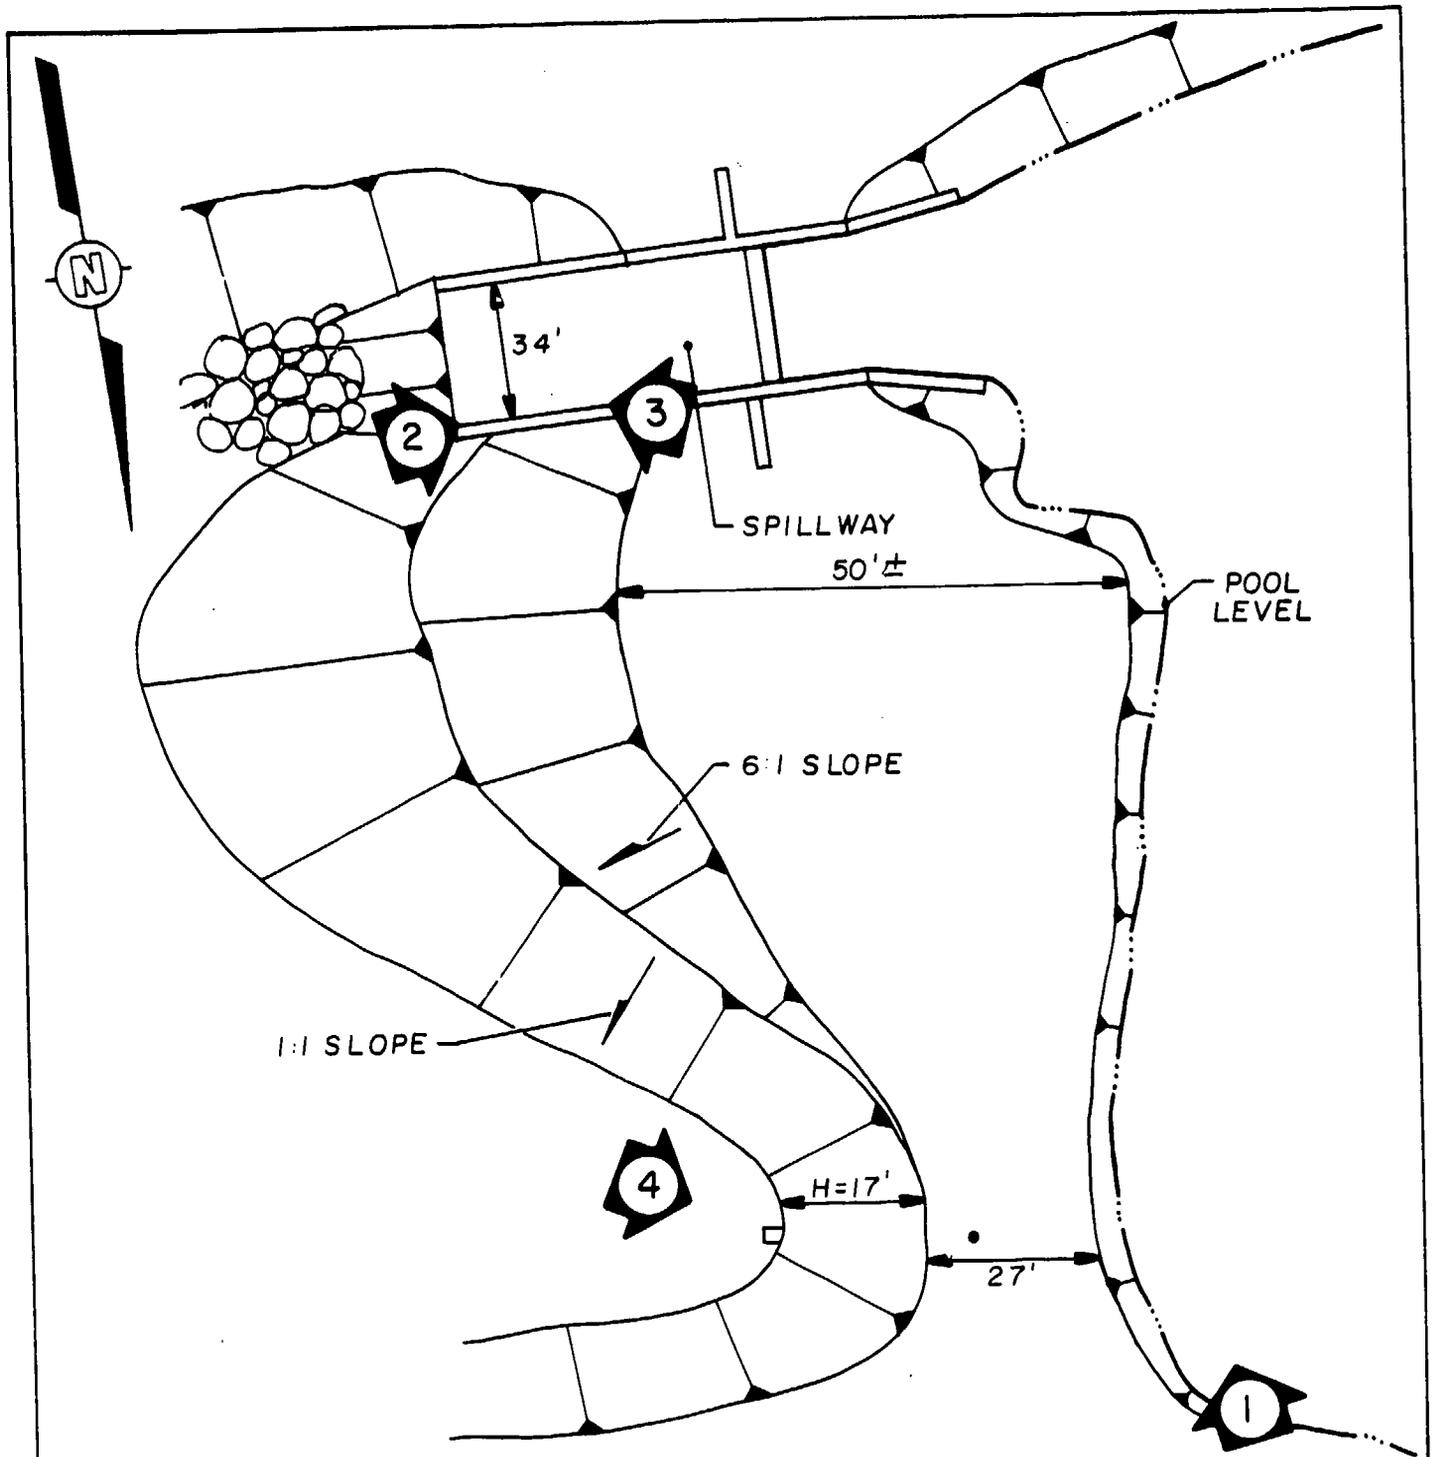
<u>PHOTOGRAPH NO.</u>	<u>DESCRIPTION</u>
1	Dam crest and upstream slope (looking south).
2	Spillway crest and approach channel.
3	Spillway discharge channel (note channel erosion below the plunge pool).
4	Seepage area near the toe of the dam.
5	Houses near Route 29 (approximately 1.5 miles downstream from the dam).
6	One store and two houses in the Village of Lawsville (approximately 1.5 miles downstream from the dam).
