SUCCESS LAKE DAM

CT 00079

PHASE I INSPECTION REPORT

NATIONAL DAM INSPECTION PROGRAM

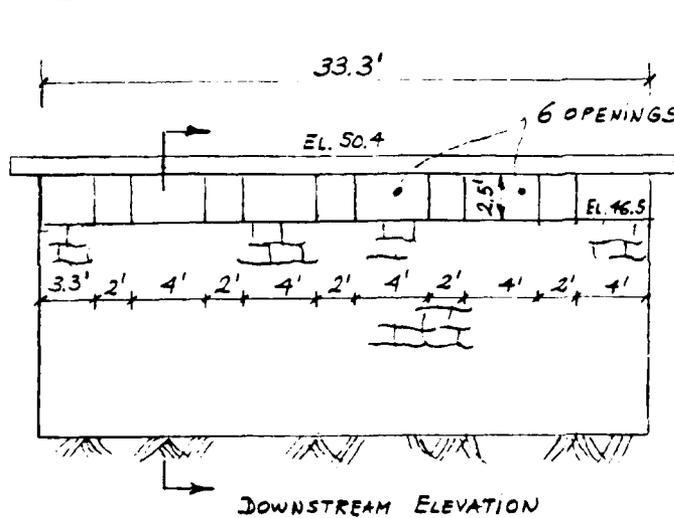
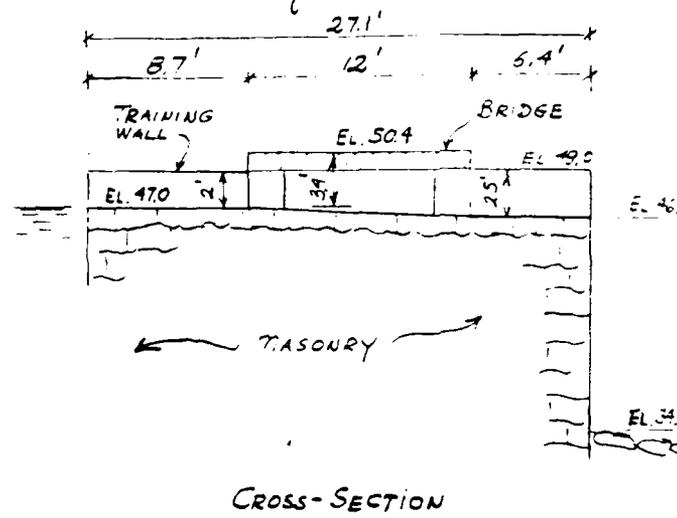
THE 33.3-FT-WIDE AND 27.1-FT-LONG SPILLWAY HAS A CONCRETE ROAD BRIDGE WITH 6 OPENINGS THE FIVE OF WHICH HAVE A WIDTH OF 4 FT AND THE ONE OPENING ON THE RIGHT SIDE IS A 3.3-FT WIDE. THE HEIGHT OF THE OPENINGS IS 2 FT ON THE UPSTREAM BRIDGE EDGE AND 2.5 FT ON THE DOWNSTREAM EDGE.

THE TOTAL LENGTH OF THE OPENINGS IS 23.3 FT ( $L_o$ ) AND THE TOTAL AREA OF THE OPENINGS ON THE UPSTREAM SIDE IS 46.6 SQ. FT ( $A_o$ ).
