CONNECTICUT COASTAL  
BRANFORD, CONNECTICUT

**BRANFORD SUPPLY PONDS DAM  
CT 00116**

**PHASE 1 INSPECTION REPORT  
NATIONAL DAM INSPECTION PROGRAM**

APRIL 1981

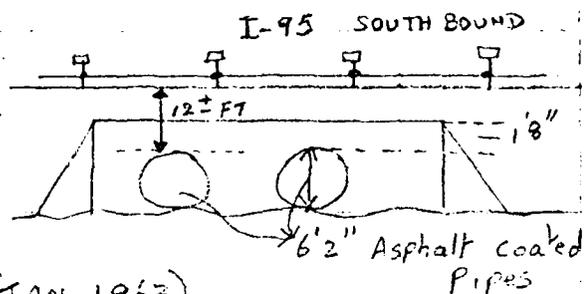
IMMEDIATELY BELOW SECTION BB, I-95 HIGHWAY CULVERT EXISTS WITH TWO 6'2" DIAMETER ASPHALT COATED PIPES WITH CONCRETE HEADWALLS. PER U S BUREAU OF PUBLIC ROADS (JAN, 1963) NDMOGRAPH FOR  $\frac{H.W.}{D} = \frac{81.6}{74} = 1.1$  FROM SCALE 2

(REV. MAY 1964) DISCHARGE CAPACITY OF EACH PIPE = 260 CFS. ∴ TOTAL DISCHARGE CAPACITY FOR 2 PIPES = 520 CFS WHICH IS INADEQUATE TO CONVEY THE PEAK OUTFLOW OF 4140 CFS FROM THE 1ST REACH.

THUS, THE WATER DEPTH U/S OF THE HWY EMBANKMENT WOULD INCREASE FURTHER. HOWEVER, THE DAMMING EFFECT OF THE EMBANKMENT WOULD NOT INCREASE THE FLOOD DEPTH HIGH ENOUGH SO AS TO CAUSE DAMAGE TO FIRST FLOORS OF THE HOUSES IN THE VICINITY AND THE HIGHWAY EMBANKMENT IS HIGH ENOUGH TO PREVENT OVERTOPPING.

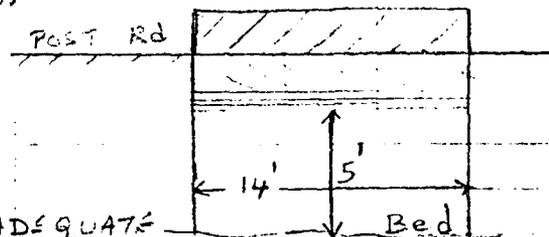
$$\text{FOR } \frac{H}{d} = \frac{7.2}{5} = 1.44$$

THUS, THE CULVERT HAS INADEQUATE CAPACITY FOR THE PEAK INFLOW IN REACH 2 AND THE POST RD COULD BE SUBJECT TO SUBMERGENCE. HOWEVER, DUE TO DAMMING EFFECT, THE INCREASE IN FLOOD DEPTH UPSTREAM IS NOT LIKELY TO BE SIGNIFICANT.
