NAUGATUCK RIVER BASIN
TORRINGTON - GOSHEN, CONNECTICUT

WHIST POND DAM
CT 00102

PHASE I INSPECTION REPORT
NATIONAL DAM INSPECTION PROGRAM

DECEMBER 1980

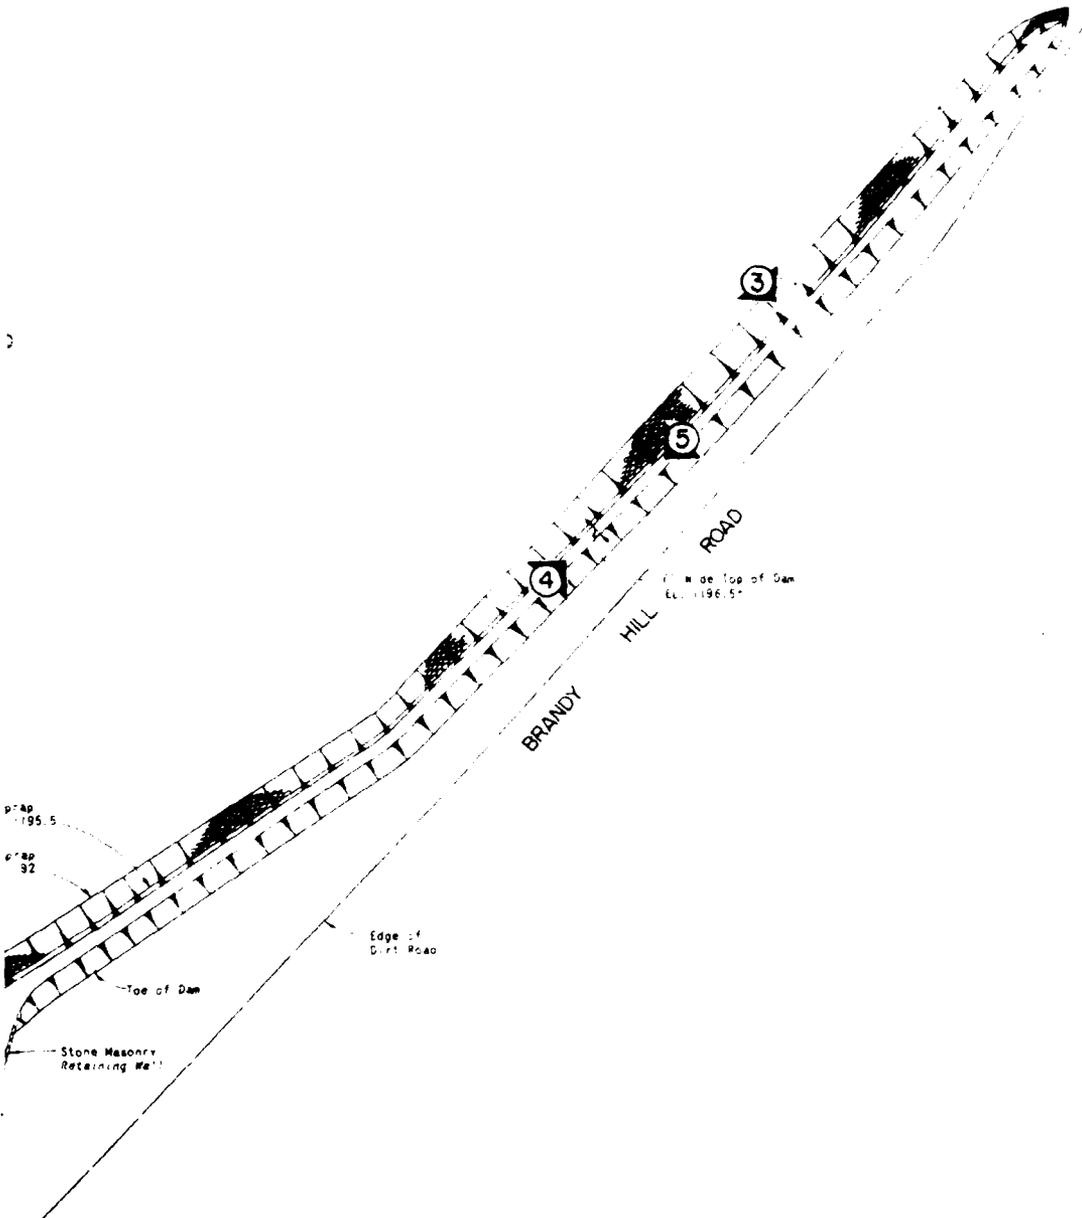
ROALD HESTAD INC. CONSULTING ENGINEERS WATERBURY, CONNECTICUT		U.S. ARMY ENGINEER DISTRICT NEW ENGLAND WATERBURY, CONNECTICUT	
NATIONAL PROGRAM OF INSPECTION OF SMALL DAMS			
PHOTO LOCATION PLAN WHIST POND DAM GOSHEN AND TORRINGTON, CONNECTICUT			
DRAWN JRS	CHECKED RGL	APPROVED RH	SCALE: 1" = 30' DATE: 2/80 PAGE: C-1

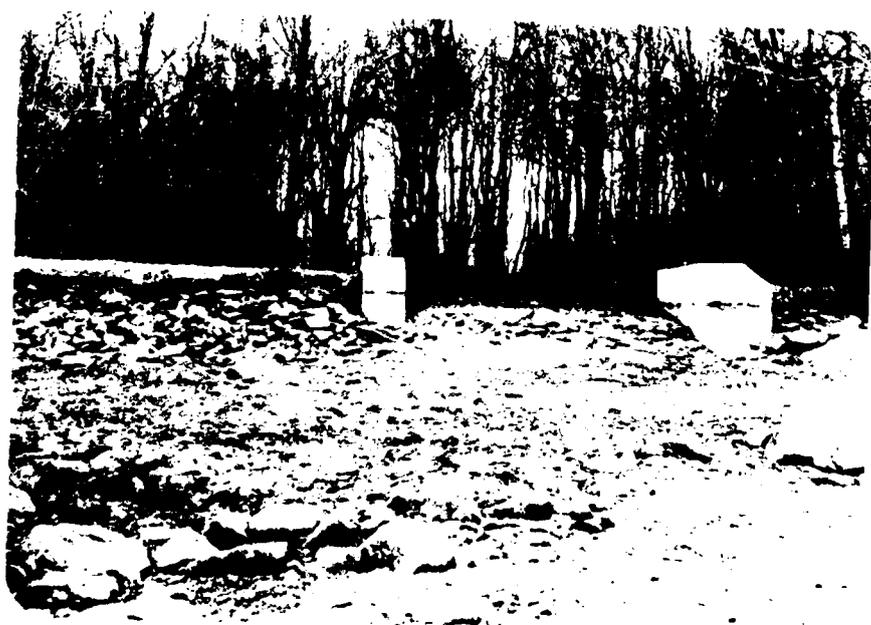
The upstream slope of the dam is protected by a layer of 4 to 12 inch riprap, Photo 2. In several areas the riprap appears to have slumped approximately 12 inches, Photo 3, possibly due to the lack of filter or bedding material between the riprap and the embankment. The slumping is most pronounced near the left end of the dam, Photo 4, where the slumping has cut into the crest.

PHOTO NO. 2
SPILLWAY FROM
UPSTREAM.
