| REPORT DOCUMENTATION PAGE | | READ INSTRUCTIONS BEFORE COMPLETING FORM |
|--|---|---|
| 4. TITLE (and Subtitle) Silver Lake Dam NATIONAL PROGRAM FOR INSPECTION OF NON-FEDERAL DAMS | 5. TYPE OF REPORT & PERIOD COVERED INSPECTION REPORT | |

**CONNECTICUT RIVER BASIN
 BERLIN, CONNECTICUT**

JUNE 1979

SILVER LAKE

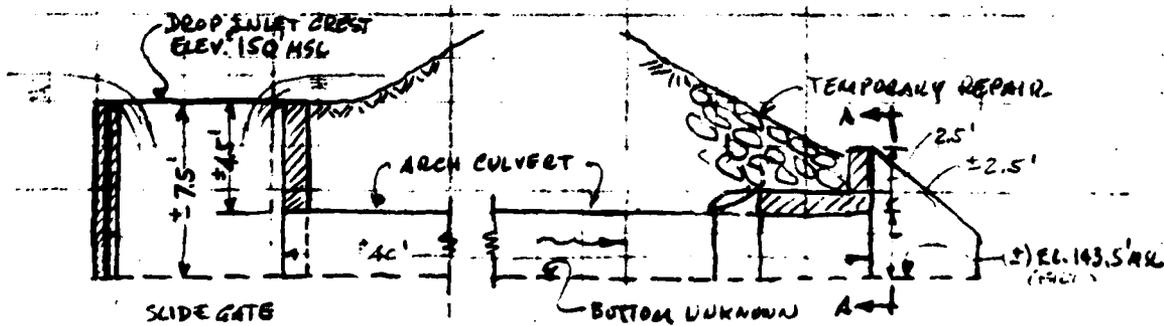
DROP INLET SPILLWAY APPROXIMATE LONGITUDINAL CROSS SECTION

THE OUTLET STRUCTURE OF SILVER LAKE DAM IS A (±) 9.5' X 9.5' SQUARE SHAPED DROP INLET SPILLWAY. THE CREST (ELEV. (±) 150' MSL) IS (±) 1' BROAD. THE BOX (SHAFT) IS (±) 7.5' TO 8' DEEP AND DISCHARGES THRU AN ARCH-CULVERT-TYPE CONDUIT (±) 40' LONG. THE CHORD AT THE BASE OF THE ARCH, AT THE OULET, IS (±) 7' AND THE RISE (±) 2.5'. AT LEAST AT THE OULET, THE CULVERT IS SILTED TO THE CHORD OF THE ARCH AND THEREFORE, THE ACTUAL TYPE, SHAPE AND DEPTH OF THE INVERT OF THE CULVERT (CONDUIT) IS UNKNOWN. HOWEVER, FROM ROUGH MEASUREMENTS AT THE INLET, UNDER OVERFLOWING CONDITIONS, IT IS ESTIMATED THAT THE MAXIMUM HEIGHT OF THE CONDUIT IS (±) 3'. THE 1/2 (LAKE) FACE OF THE INLET BOX INCLUDES A WOODEN SLIDE GATE (±) 2'-10" WIDE AND, PRESUMABLY, (±) AS HIGH AS THE SHAFT. (±) 7'.

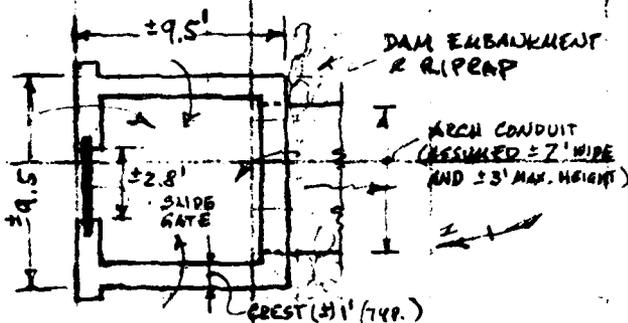
DROP INLET SPILLWAY
 PLAN

THE HEIGHT BETWEEN THE DROP INLET CREST (ELEV. (+) 150.0' MSL) AND THE TOP OF THE DAM (ELEV. (+) 154.5' MSL) IS $H = 4.5'$. A 3' HIGH PIPE RAILING SURROUNDS THE INLET.
