CONNECTICUT RIVER BASIN
CHESTER, CONNECTICUT

JENNINGS POND DAM
CT 00396

PHASE I INSPECTION REPORT
NATIONAL DAM INSPECTION PROGRAM

FEBRUARY, 1981

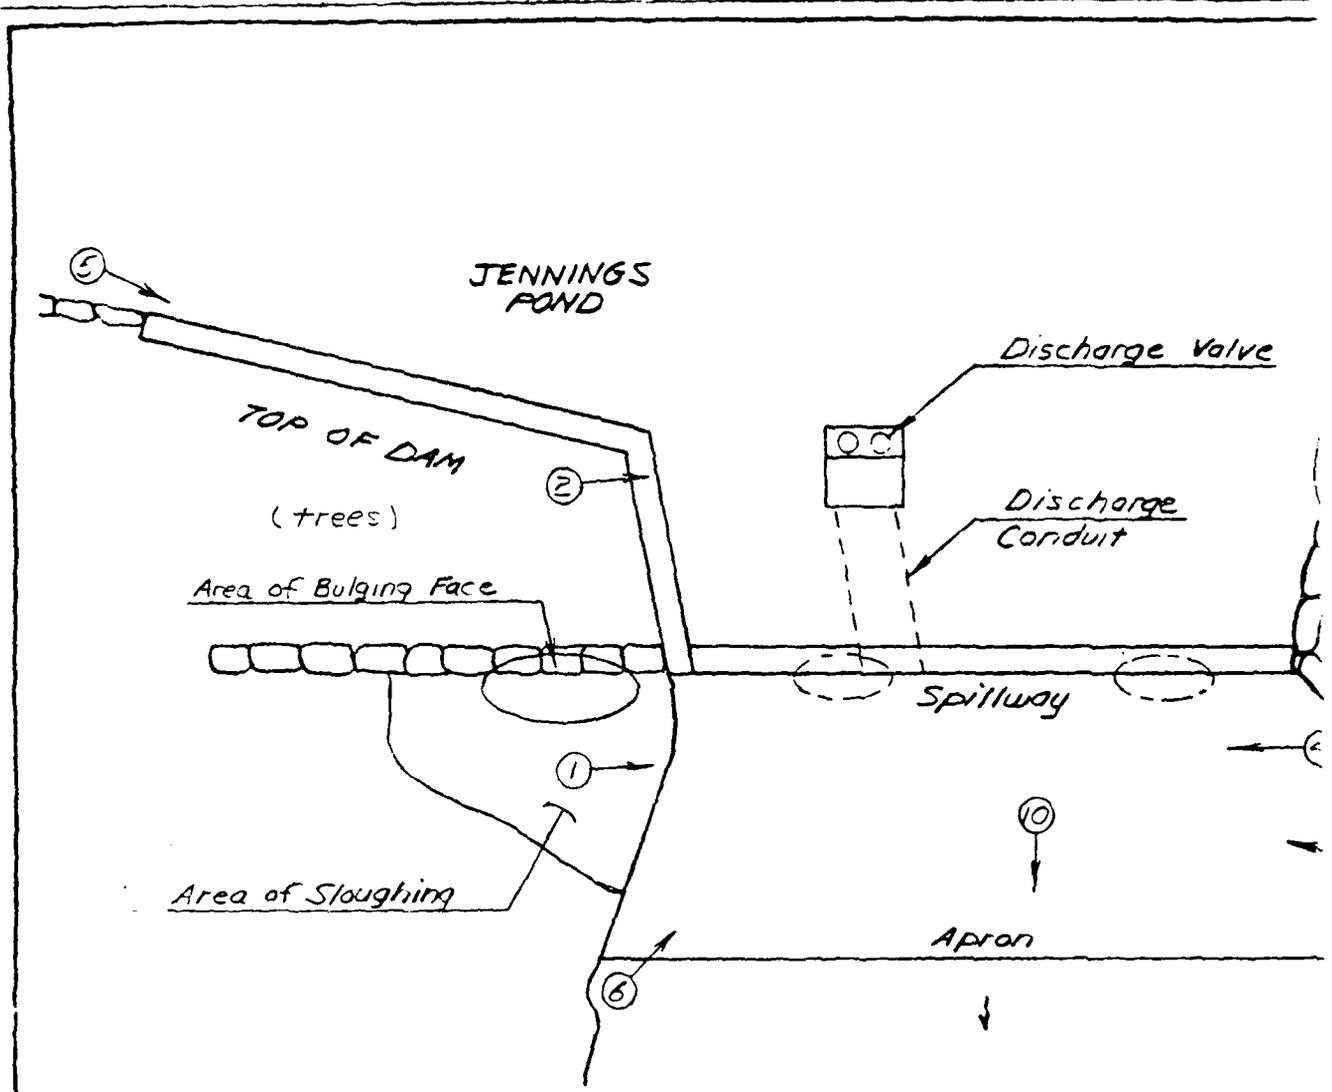
The upstream face of the dam has a stone masonry retaining wall that is generally in fair condition (Photos 2 and 3) and one location the wall is falling into the pond (See Photo Location Plan - Plate 3). The channel embankment adjacent to the dam is eroding and sloughing into the channel (Photo 4). Also at this location, the downstream face of the dam is bulging.

○
Denotes Seepage
