Due to the extent of downstream development that would be affected in the event the dam were to fail, Mill Pond Dam is classified as having a "high" hazard potential in accordance with Corps of Engineers guidelines.

The dam is in poor condition, based on a visual examination of the structure. Several major deficiencies were noted, although there was no evidence of major settlement, overall lateral movement or other signs of impending structural failure, or other conditions which would warrant urgent remedial action.

1. Overview of Mill Pond (Myrtle Street) Dam

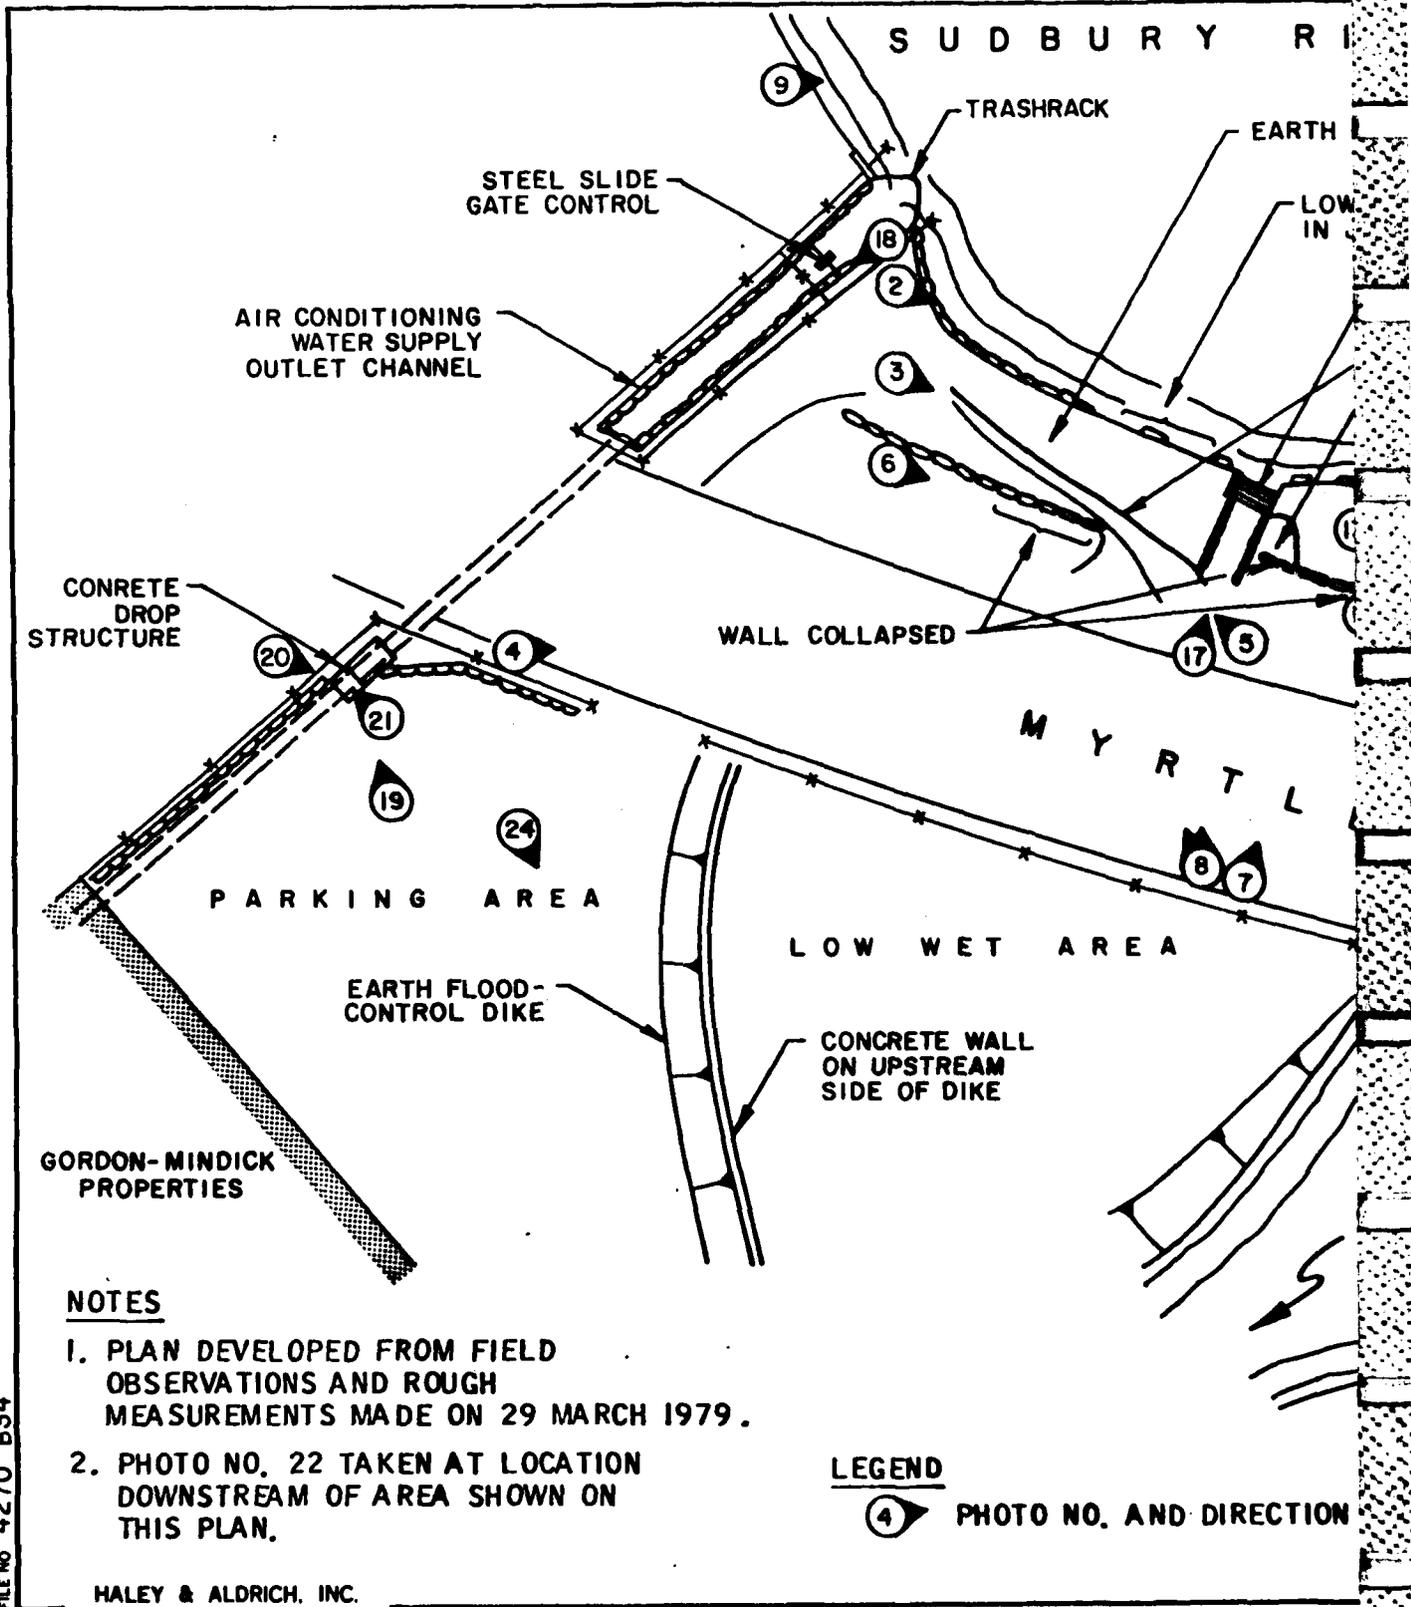
C-1

1. PLAN DEVELOPED FROM FIELD OBSERVATIONS AND ROUGH MEASUREMENTS MADE ON 29 MARCH 1979.
2. PHOTO NO. 22 TAKEN AT LOCATION DOWNSTREAM OF AREA SHOWN ON THIS PLAN.

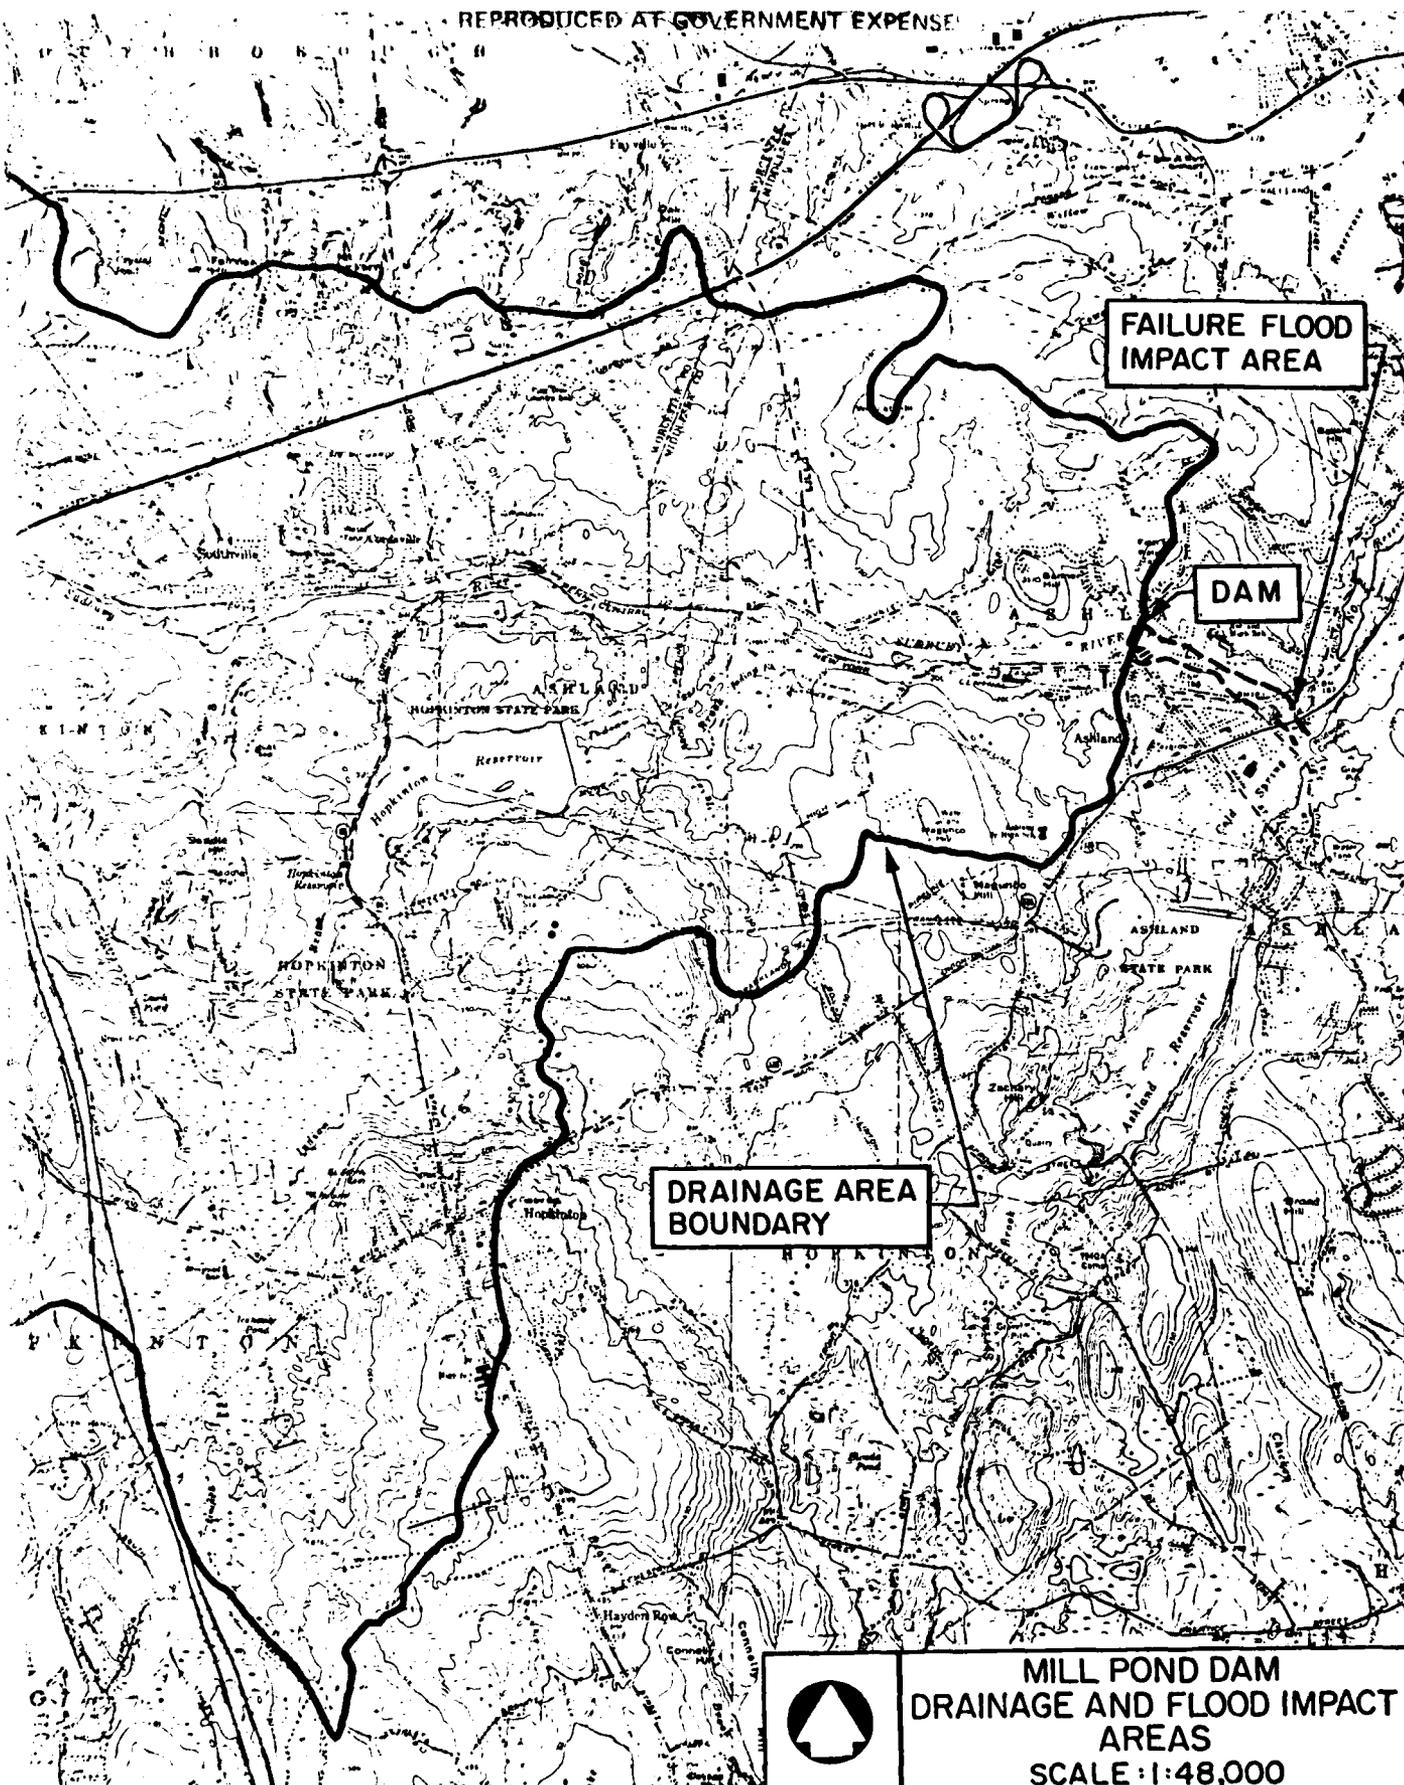
FAILURE FLOOD
IMPACT AREA

In the event of a dam failure potential for loss of lives and excessive residential and industrial damages are expected to occur; therefore the hazard classification for this dam is considered to be HIGH.
