HOUSATONIC RIVER BASIN
WASHINGTON, MASSACHUSETTS

ASHLEY LAKE DAM
MA 00313

PHASE I INSPECTION REPORT
NATIONAL DAM INSPECTION PROGRAM

FEBRUARY 1980

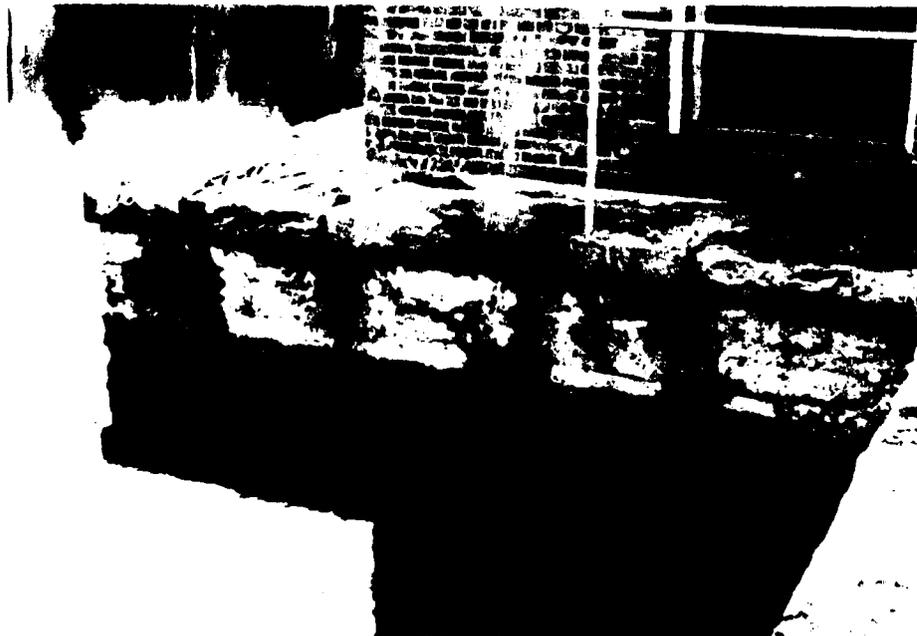
The gate house is a 16 foot by 16 foot brick structure which is located to the right of the spillway. It is in relatively good condition. However, there is extensive spalling at the base of the gate house along the upstream face of the dam. Inside there is a floor board missing but everything else appears to be in good shape. The wheel operated 26 inch sluice gates have been recently operated. There is a 6" x 8" beam with a pulley used to lower and raise the two 3'8" by 4'10" wooden slide gates. The slide gates were fully opened at the time of our inspection. During normal operation one sluice gate is completely closed, one sluice gate is slightly opened and both slide gates are fully opened. Also, there is an 8 inch gate valve which regulates flow from one chamber to the other. There were no visible model numbers on any of the equipment.

Photo 6 - Upstream
face of dam looking
westerly at base of
gate house.

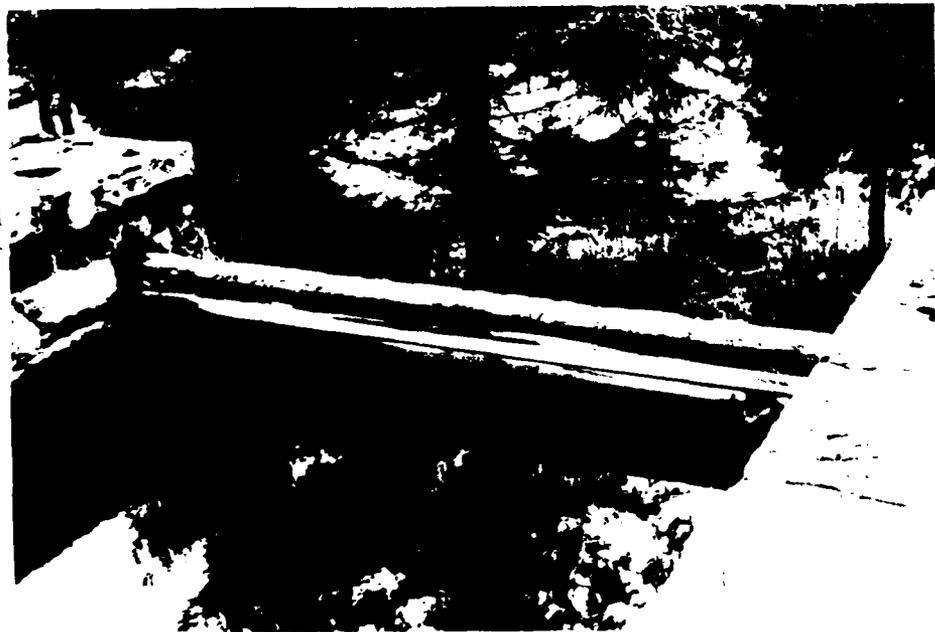
The spillway is in good condition, however, the stone walls along the side of the spillway have grass and weeds growing in the joints. The wall to the left shows some signs of minor seepage from the earthen embankment below the base of the stone section.

Photo 12 - Trees left
of spillway looking
southerly from dis-
charge channel.

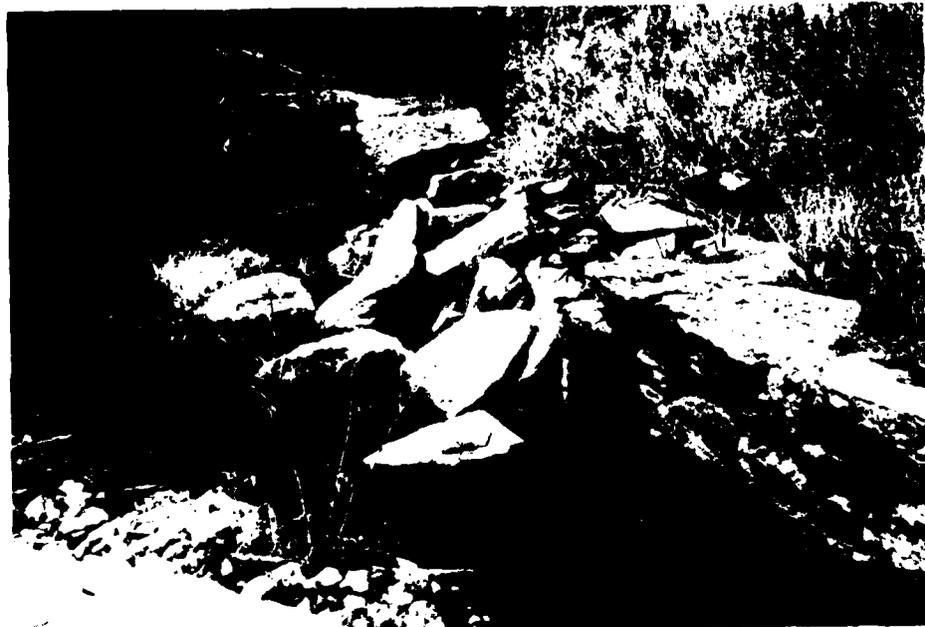
Photo 15 - Apparent
leakage from stone dam.

There are a number of areas that warrant further investigation. The leakage from the downstream face of the dam should be investigated to determine a suitable means of repair. The upstream face of the dam has extensive spalling along its entire length and this condition should be corrected in conjunction with the repair of the leakage on the downstream face of the dam. The area along the toe of the downstream slope of the dam is very wet and the source of this water should be determined. Further hydraulic and hydrologic studies should be carried out to determine the adequacy of spillway capacity; until these studies are completed, the installation of stop logs on the spillway crest should be discontinued.
