20. ABSTRACT (Continue on reverse side if necessary and identify by block number) The dam is an zoned earthfill dam that is about 1560 ft. long and 20 ft. high. The dam is in fair condition. Regular monitoring programs of the groundwater levels should be instituted to monitor the performance of the dam. It is intermediate in size with a hazard potential of high.

ASSABET RIVER DAM

**OVERVIEW
ASSABET RIVER DAM
WESTBOROUGH, MASSACHUSETTS**

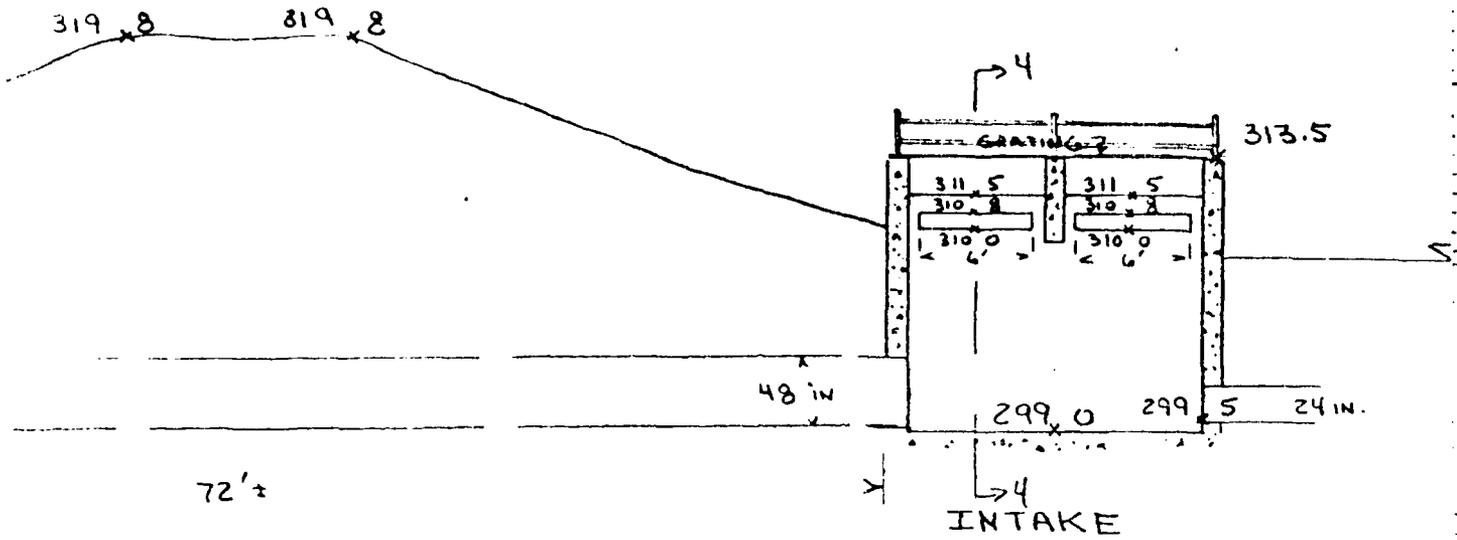
SECTION 3-3
OUTLET
SCALE 1 IN. = 10 FT.

The outlet structure has a baffle wall with an aluminum grating cover. The concrete at the center I-beam connection on the upstream side has minor cracks on both sides of the support, and is in fair condition. The remaining concrete is in good condition with only minimal spalling and staining. Underdrain pipes were not observed during the dam inspection, nor was there any evidence of seepage discharge in the area where they were reported to be located.

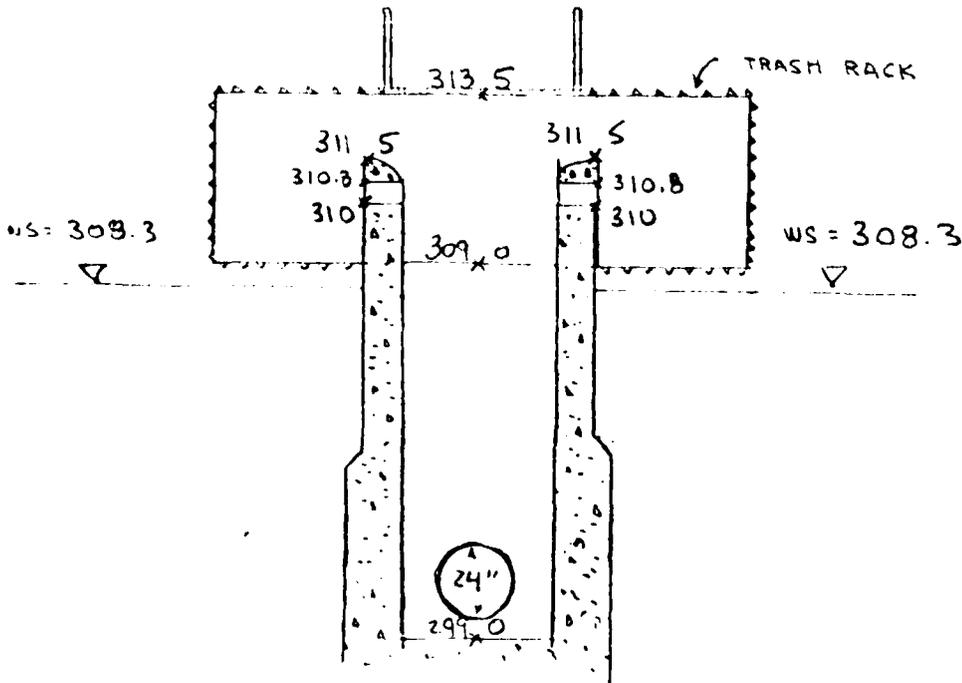
SECTION 4-4

gate is operable and at the time of the inspection was partially open to maintain flow in the Assabet River. It was not operated at the time of the inspection. The concrete on the intake structure was in good condition, although there was some minor pitting and staining on the walls. The trash rack around the intake structure is in fair condition. Some of the bar racks below the waterline show signs of heavy corrosion and several of the bolts are corroded. The riprap protection around the structure is in poor condition and in several areas the riprap is missing.
