①
UNDERWATER FACILITIES
INSPECTIONS
AND
ASSESSMENTS
AT

NAVAL AIR STATION
WHIDBEY ISLAND,
OAK HARBOR, WA

FPO-1-83-(41)

SEPTEMBER 1983

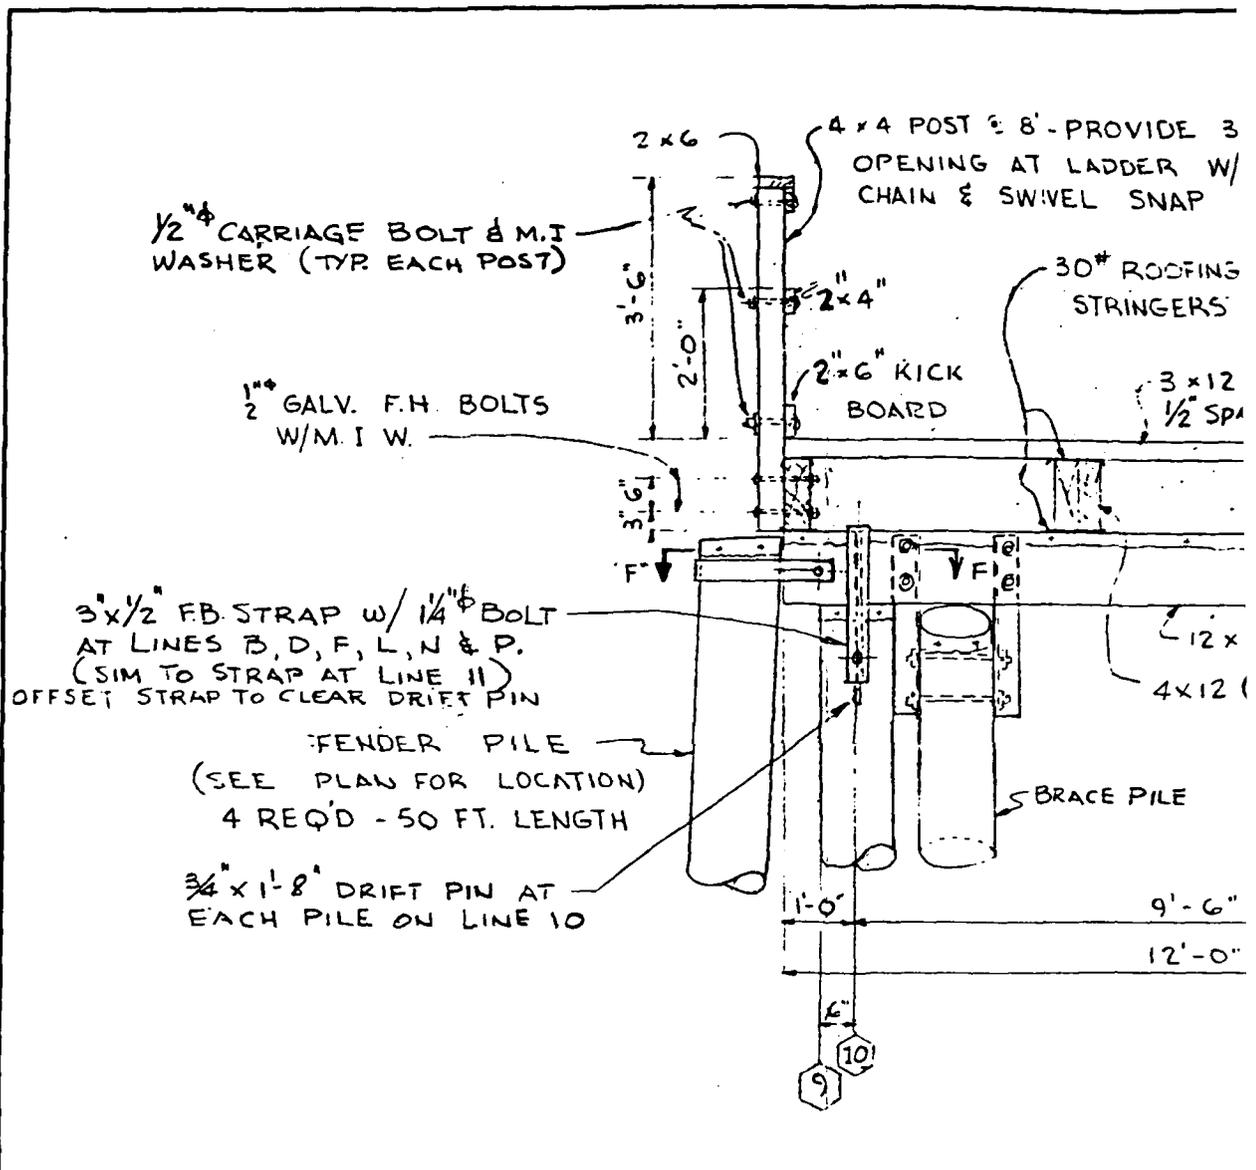
GRAPHIC SCALE	CHILDS ENGINEERING CORPORATION 801 333 WEDFIELD MA	CHESAPEAKE DIVISION NAVAL FACILITIES ENGINEERING COMMAND WASHINGTON D C	
AS SHOWN		NAVAL AIR STATION FUEL PIER	WHIDBEY ISLAND, WA FIG NO 6

The Fuel Pier is generally in good condition. No reduction of pier capacity is recommended. The major structural anomaly is the damage to two (2) piles in the berthing dolphin associated with the pier.

are broken approximately 3' below MLLW. It appears the breaks are the result of impact from a berthing vessel (for location see Figure 6.

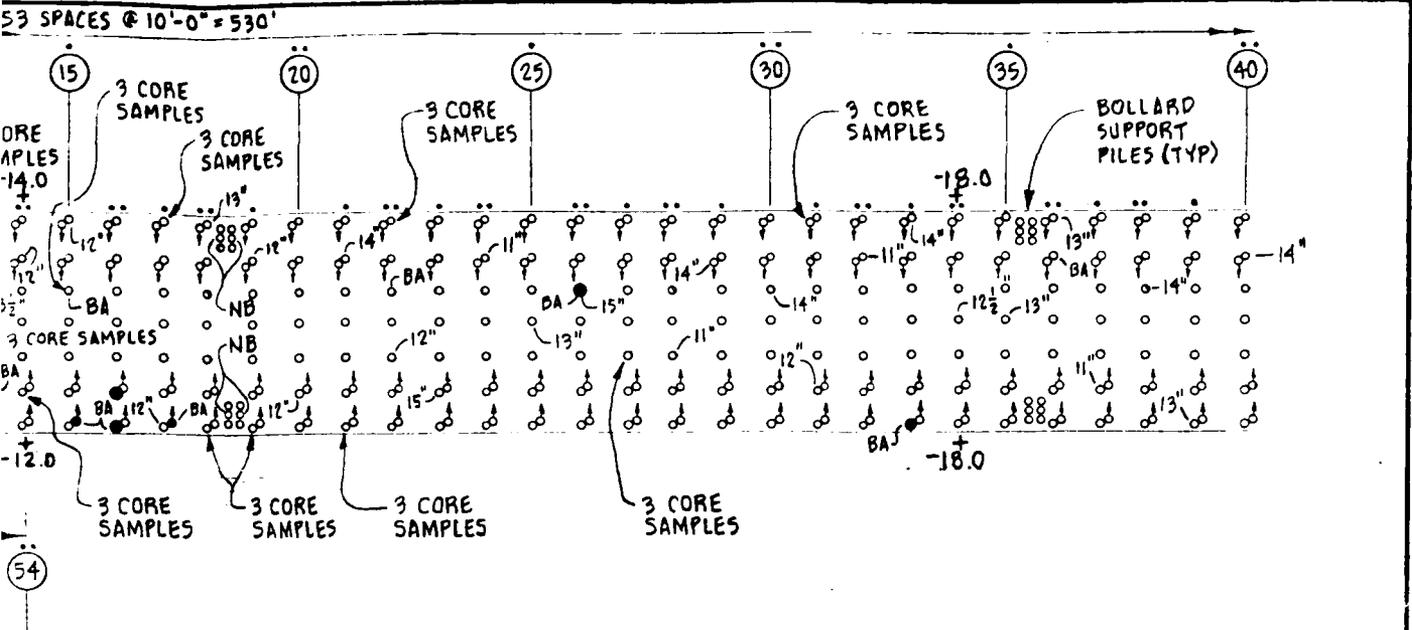
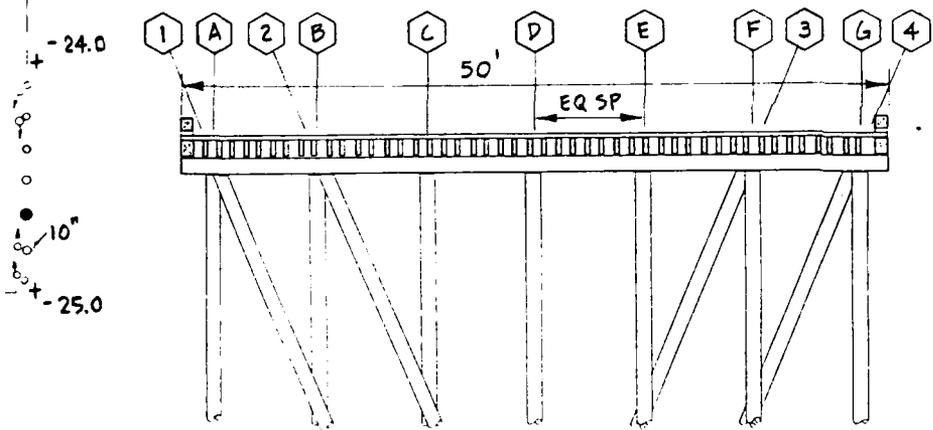
GRAPHIC SCALE	CHILD'S ENGINEERING CORPORATION BOX 333 MILFIELD, MA	CHESAPEAKE DIVISION NAVAL FACILITIES ENGINEERING COMMAND WASHINGTON, D.C.	
		NAVAL AIR STATION MAIN PIER (FINGER PIER)	FIG. NO. 8
AS SHOWN

The Main Pier is in fair condition. Localized structural damage has reduced the pier's live-load capacity.

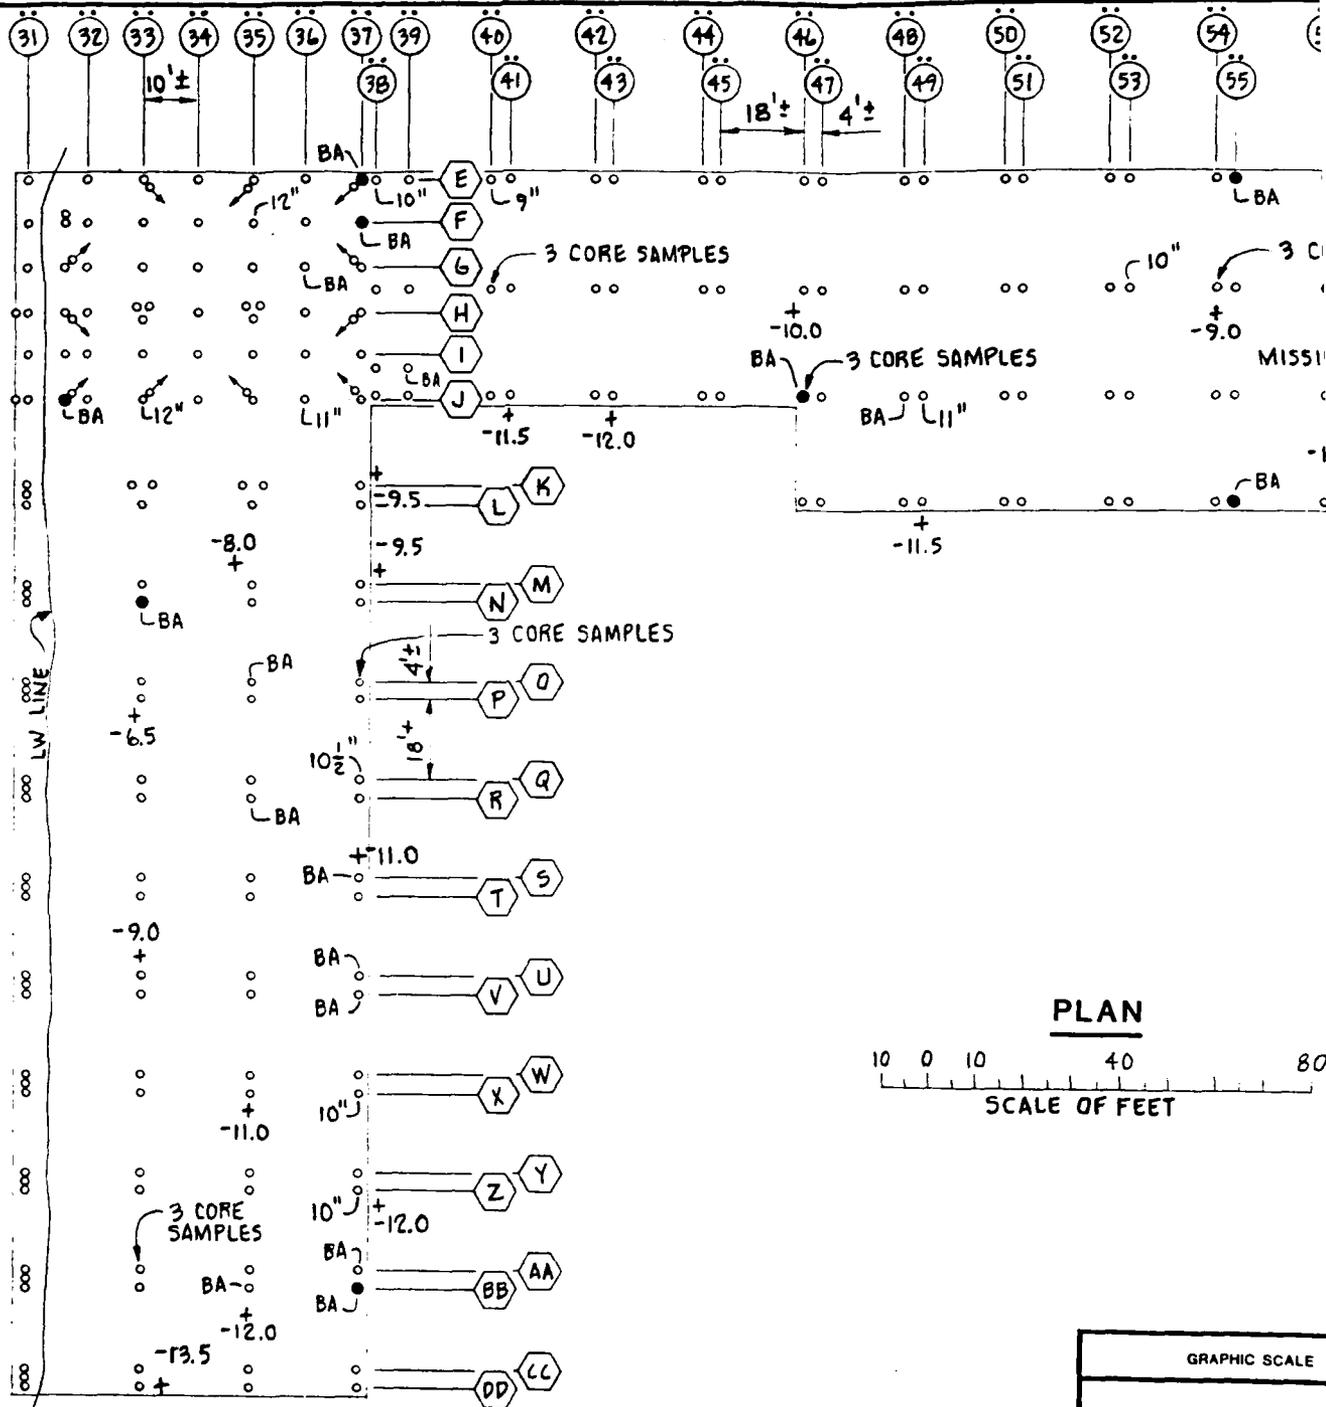
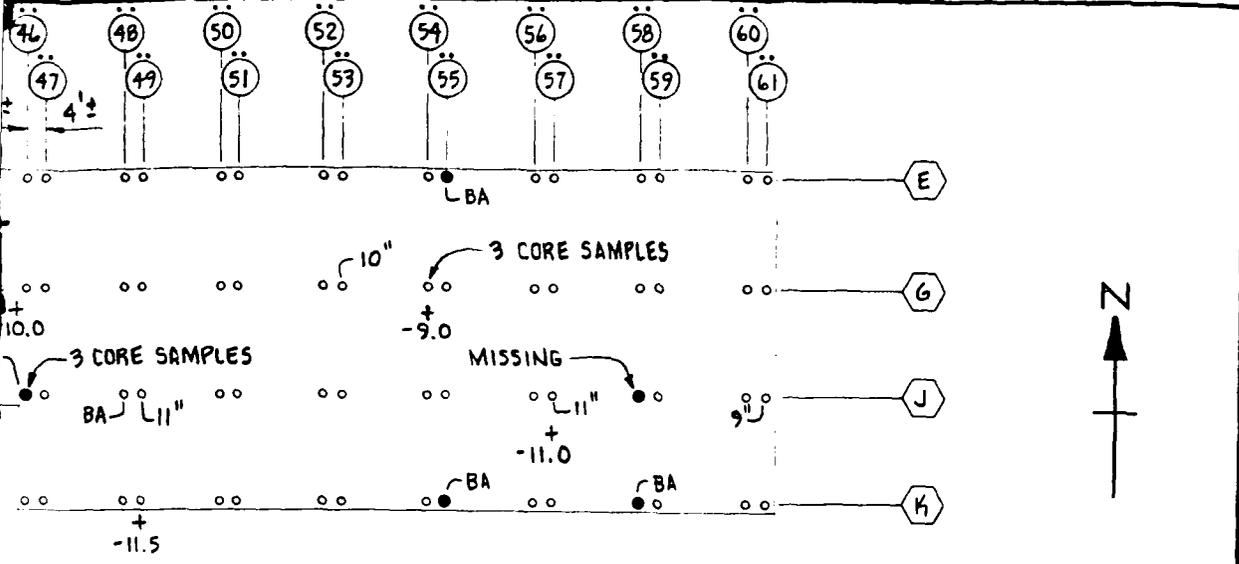
GRAPHIC SCALE	CHILDS ENGINEERING CORPORATION BOX 333 MEDFIELD MA	CHESAPEAKE DIVISION NAVAL FACILITIES ENGINEERING COMMAND WASHINGTON D C	
		NAVAL AIR STATION WHIDBEY ISLAND, WA	FIG NO 9
AS SHOWN		BOAT HOUSE

The Boat House is in fair condition. Marine borer attack has rendered several piles structurally deficient.

The major structural anomaly associated with the piles is marine borer attack. Piles which are severely damaged as a result of borer attack and no longer structurally functional are: (see Photo #9)

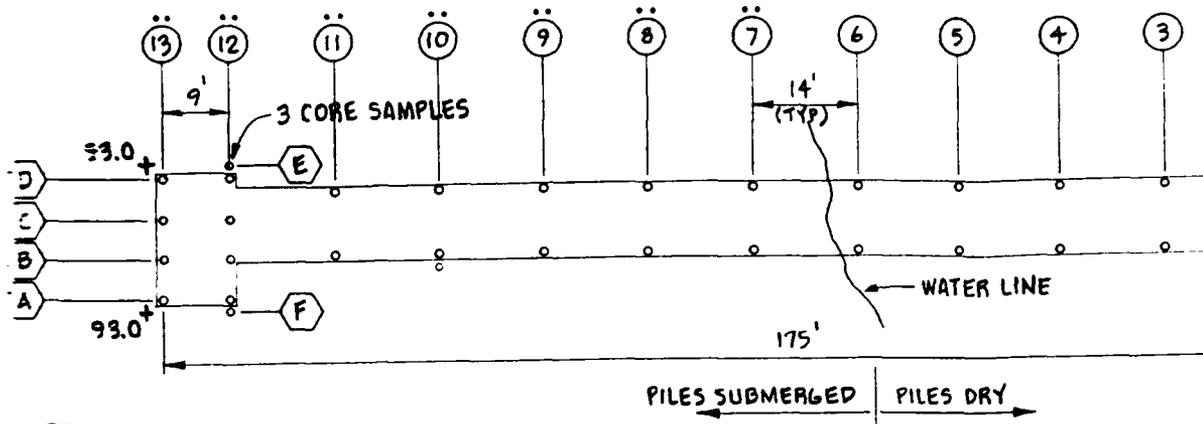
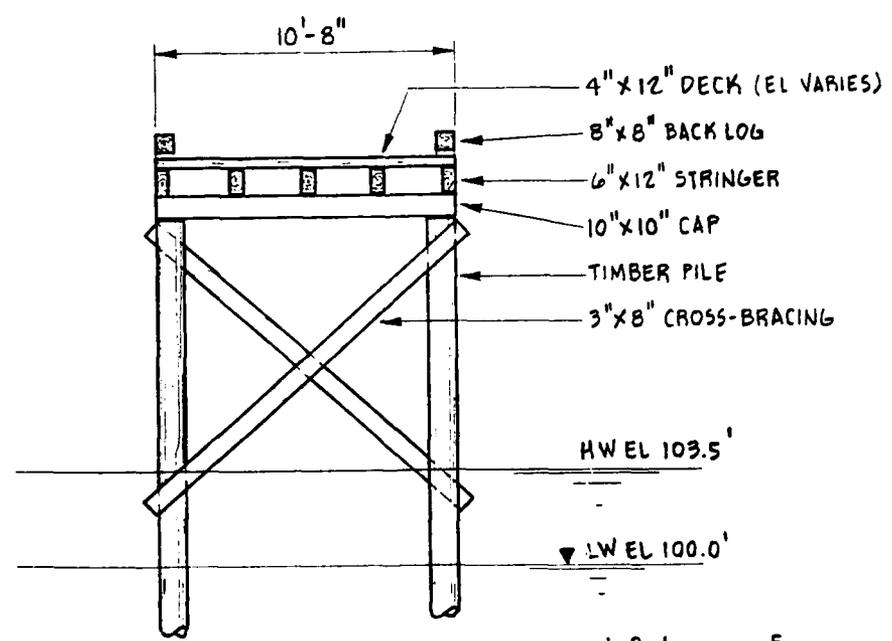
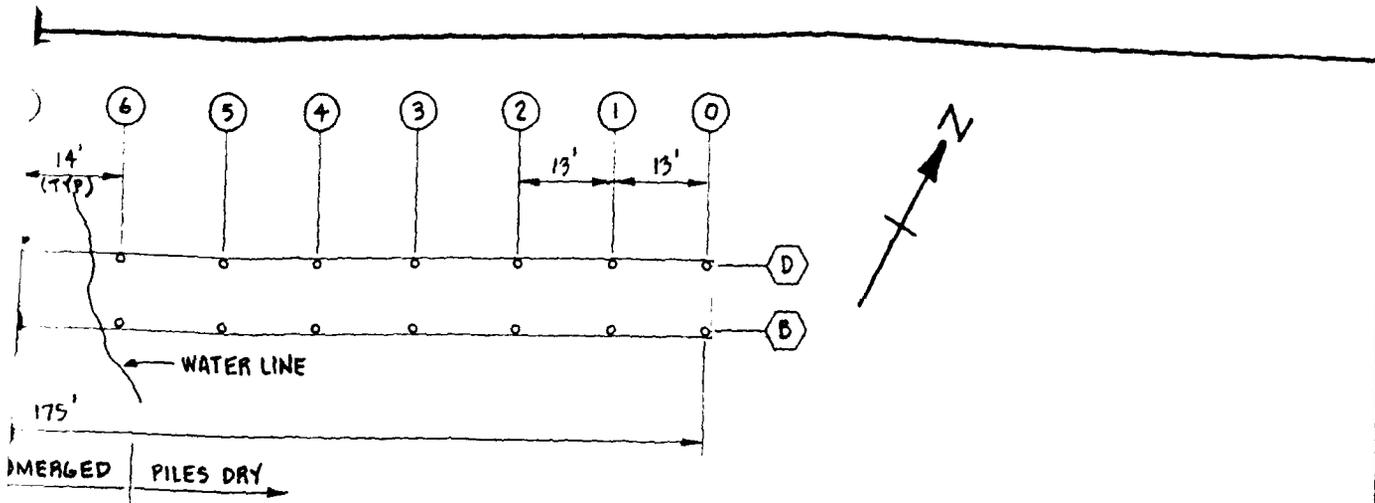
GRAPHIC SCALE	CHILD'S ENGINEERING CORPORATION BOX 333 MEDFIELD, R.I.	CHESAPEAKE DIVISION NAVAL FACILITIES ENGINEERING COMMAND WASHINGTON, D.C.	
AS SHOWN		NAVAL AIR STATION PUMPING STATION PIER	WHIDBEY ISLAND, VA FIG NO 11

The Runway Approach Lights and the Pumping Station Pier facilities are in good condition with no significant structural anomalies noted.
