**NAVAL WEAPONS
STATION
EARLE
FLEET MOORINGS
UNDERWATER
INSPECTION
REPORT**

MAY 1983

OCEAN ENGINEERING
AND CONSTRUCTION PROJECT OFFICE
CHESAPEAKE DIVISION
NAVAL FACILITIES ENGINEERING COMMAND
WASHINGTON, D.C. 20374

FPO-1-83 (16)

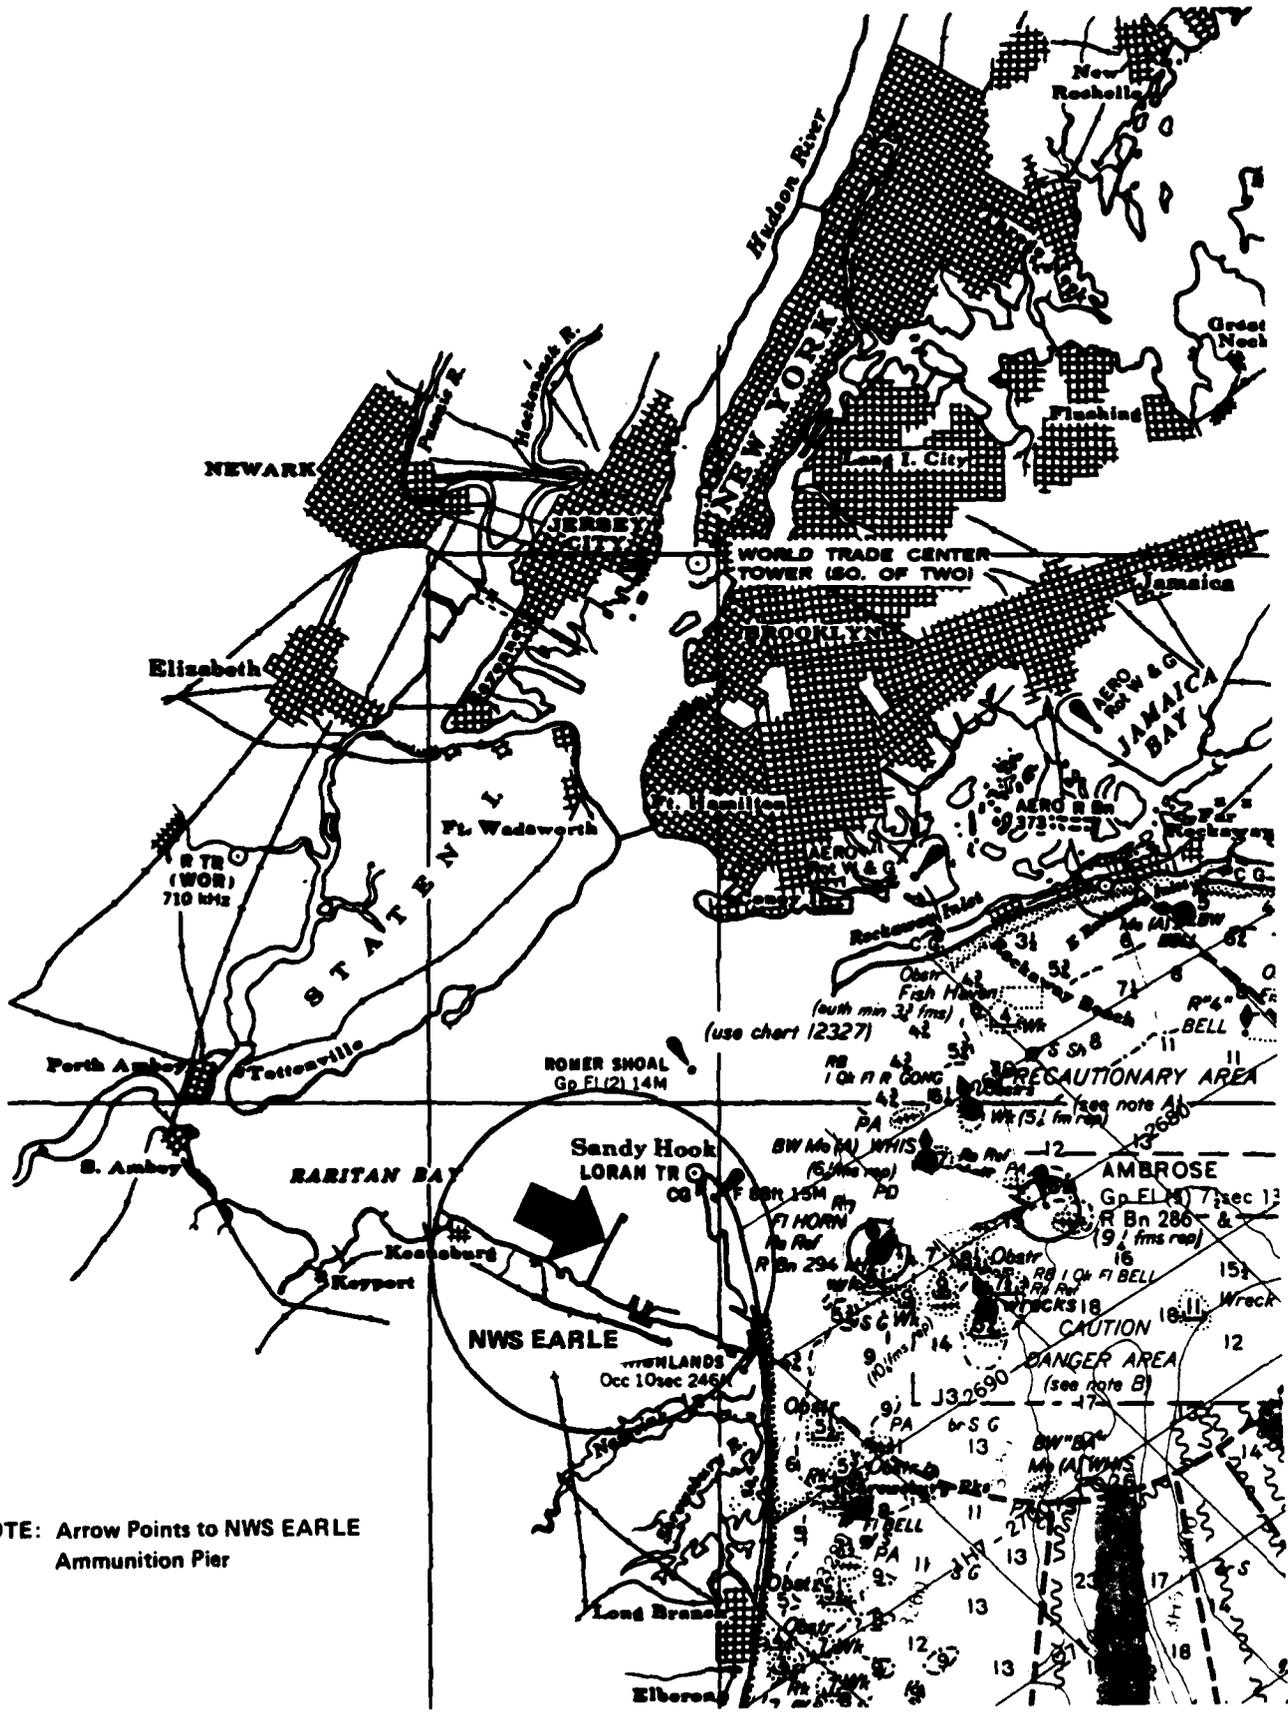
Figure 1. NWS Earle Fleet Mooring Locations

NOTE: Arrow Points to NWS EARLE Ammunition Pier

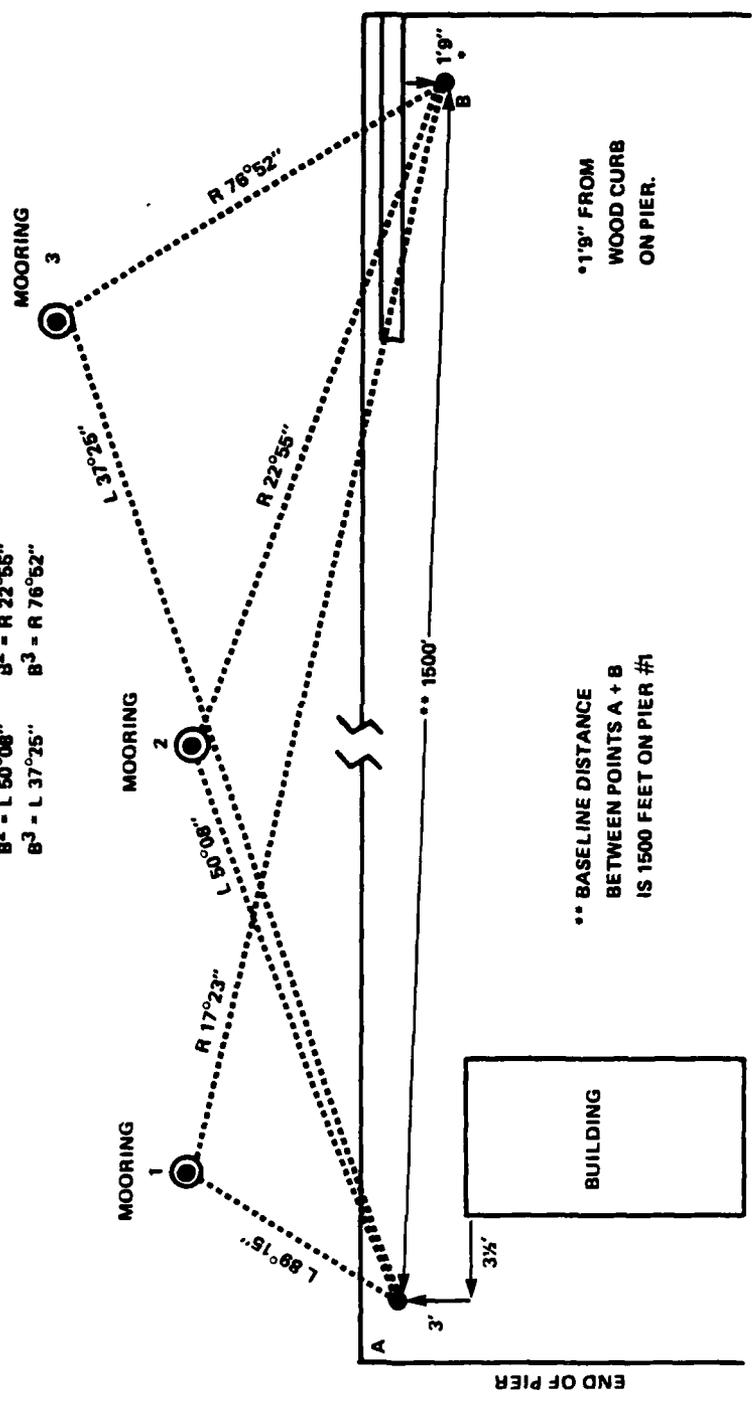
FIGURE 3. NWS EARLE FLEET MOORING POSITIONS

TRANSIT READINGS:

TRANSIT A: TRANSIT B:
 B¹ - L 89°15" B¹ - R 17°23"
 B² - L 50°08" B² - R 22°55"
 B³ - L 37°25" B³ - R 76°52"
