PEARL HARBOR Z-LOOP UPGRADE
PROJECT COMPLETION REPORT

FPO-1-83(34)
OCTOBER 1983

PREPARED BY
ROBERT TAGGART INCORPORATED
FAIRFAX, VIRGINIA

FOR
OCEAN ENGINEERING AND CONSTRUCTION PROJECT OFFICE
CHESAPEAKE DIVISION
NAVAL FACILITIES ENGINEERING COMMAND
WASHINGTON, D. C. 20374

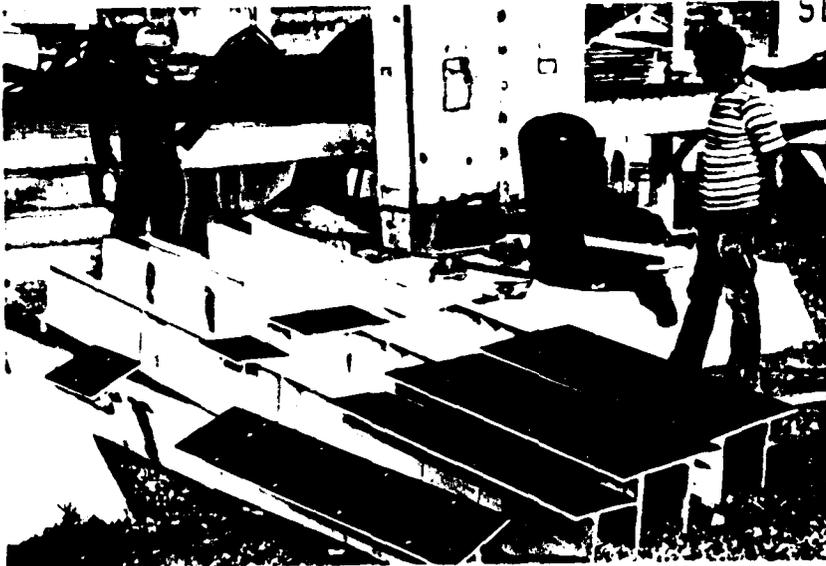
FIGURE 7-11

That afternoon, the CHESNAVFACENGCOM representative, the deperming officer, the deperming engineer, and the facility electrician unstrapped the boxes for internal inspection. All copper surfaces, specified to be silverplated, were green and felt greasy to the touch. The plating operation had not been done correctly, as illustrated in Figure 7-11.

**ORIGINAL SWITCHING MATRIX
SHOWING PLATING AND
SPACING PROBLEMS**

discussed with the design contractor. Resolution was deferred until the arrival of the contractor's representative on 12 January. At that time, it was determined that all copper contact surfaces needed to be cleaned and replated properly.

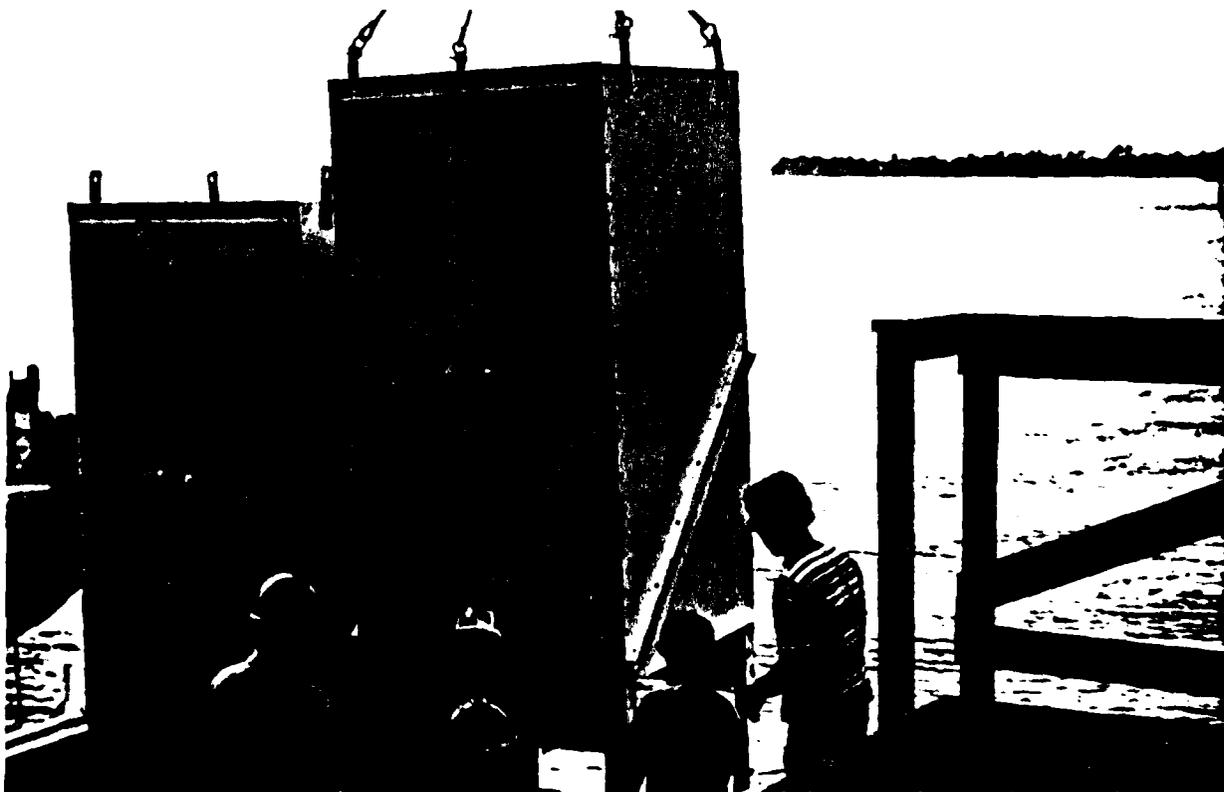
FIGURE 7-14

LOWERING THE SECOND BOX ONTO SUPPORT CHANNELS
