**DAMAGE ASSESSMENT REPORT  
PIER 4  
NAVAL WEAPONS STATION  
CONCORD, CA**

**FPO-1-82-(28) OCTOBER 1982**

**CHILDS ENGINEERING CORPORATION  
MEDFIELD, MASSACHUSETTS 02052**

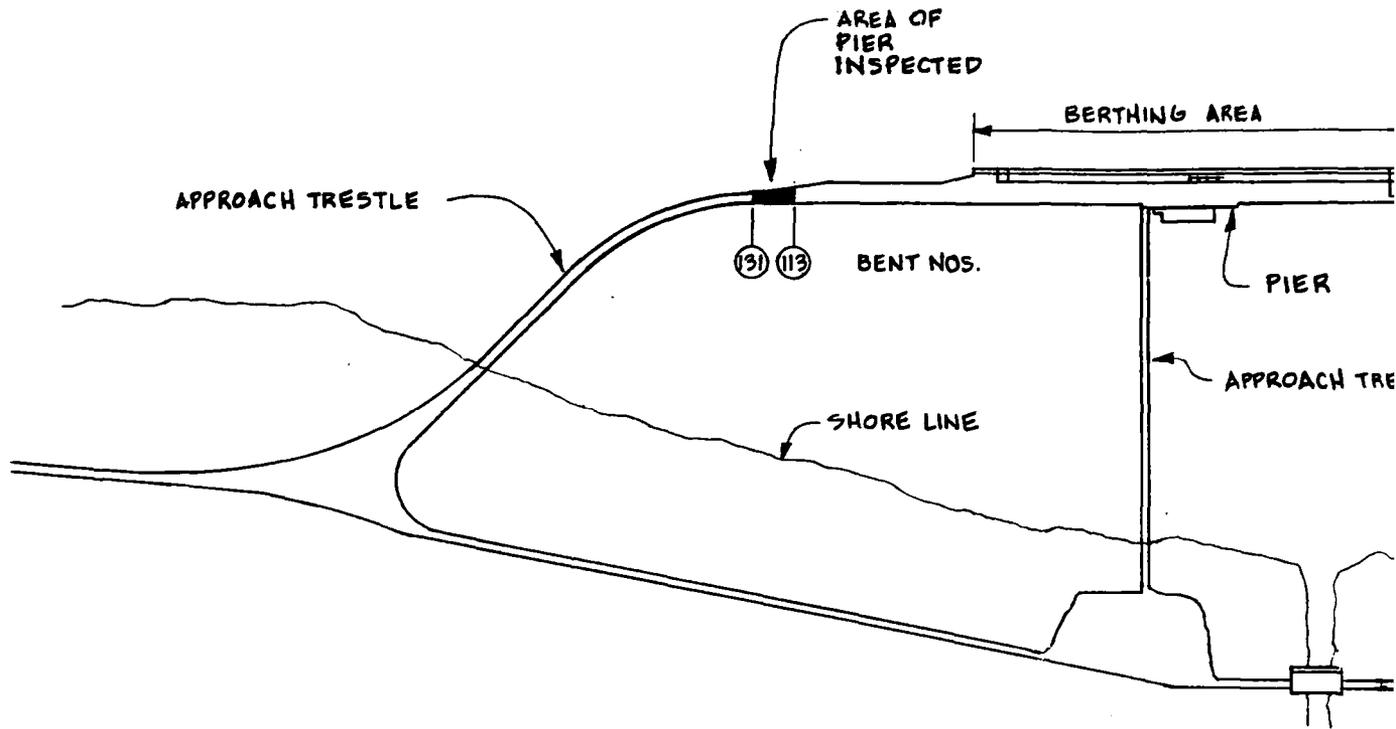
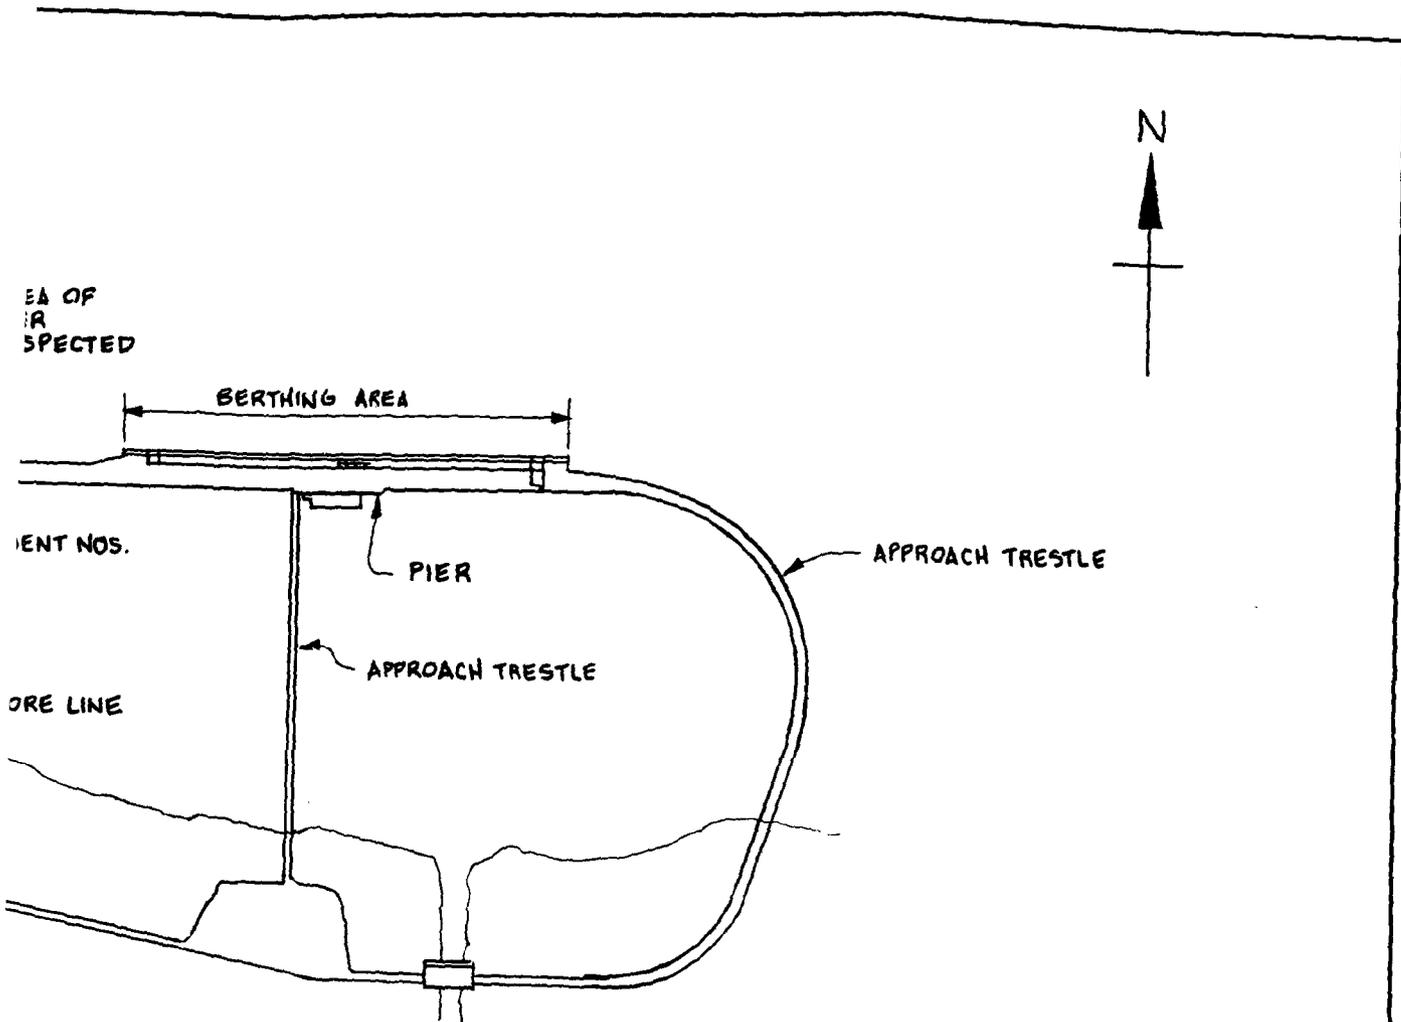
A dive team consisting of two divers and a tender performed the on-site inspection. Each pile in the damaged section of the pier (see Figure 1) was inspected for its full exposed length. Since visibility under water was less than 3", the piles were examined utilizing tactile techniques.

The new section of the pier is of reinforced concrete construction with precast concrete piles supporting a reinforced concrete deck. This inspection was limited to Bents 113 through 131 (see Figure 1), which were damaged as the result of a recent collision. The damaged portion of the pier is of the older timber construction.

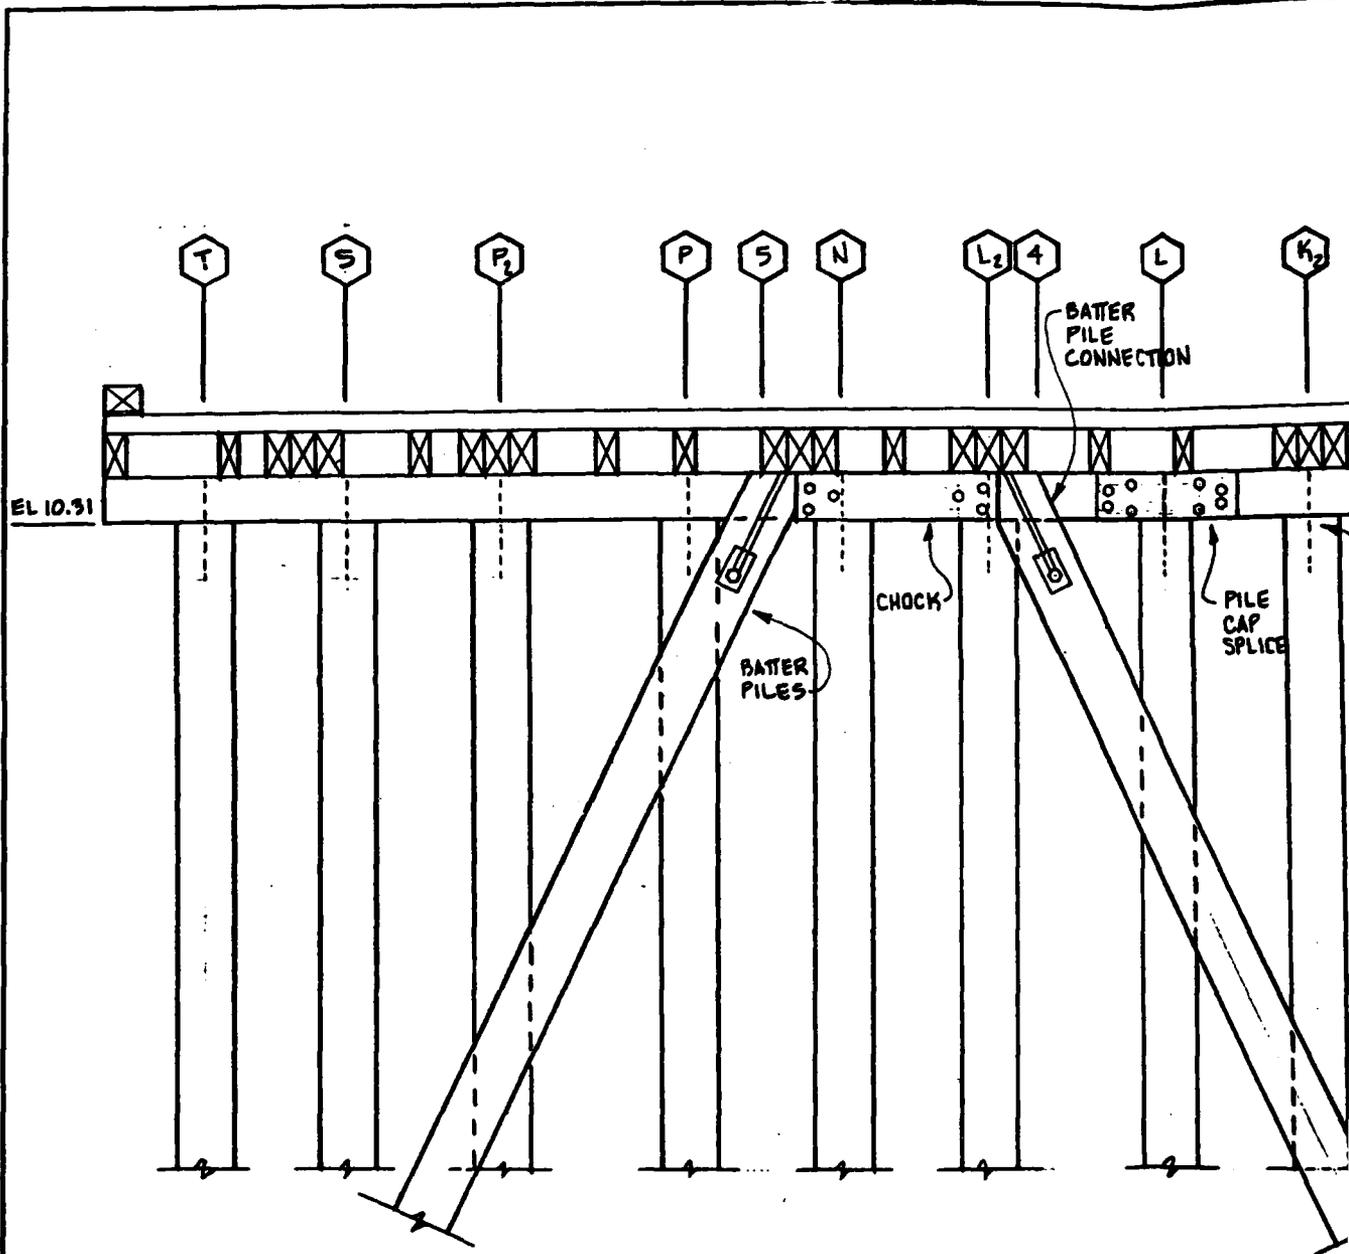
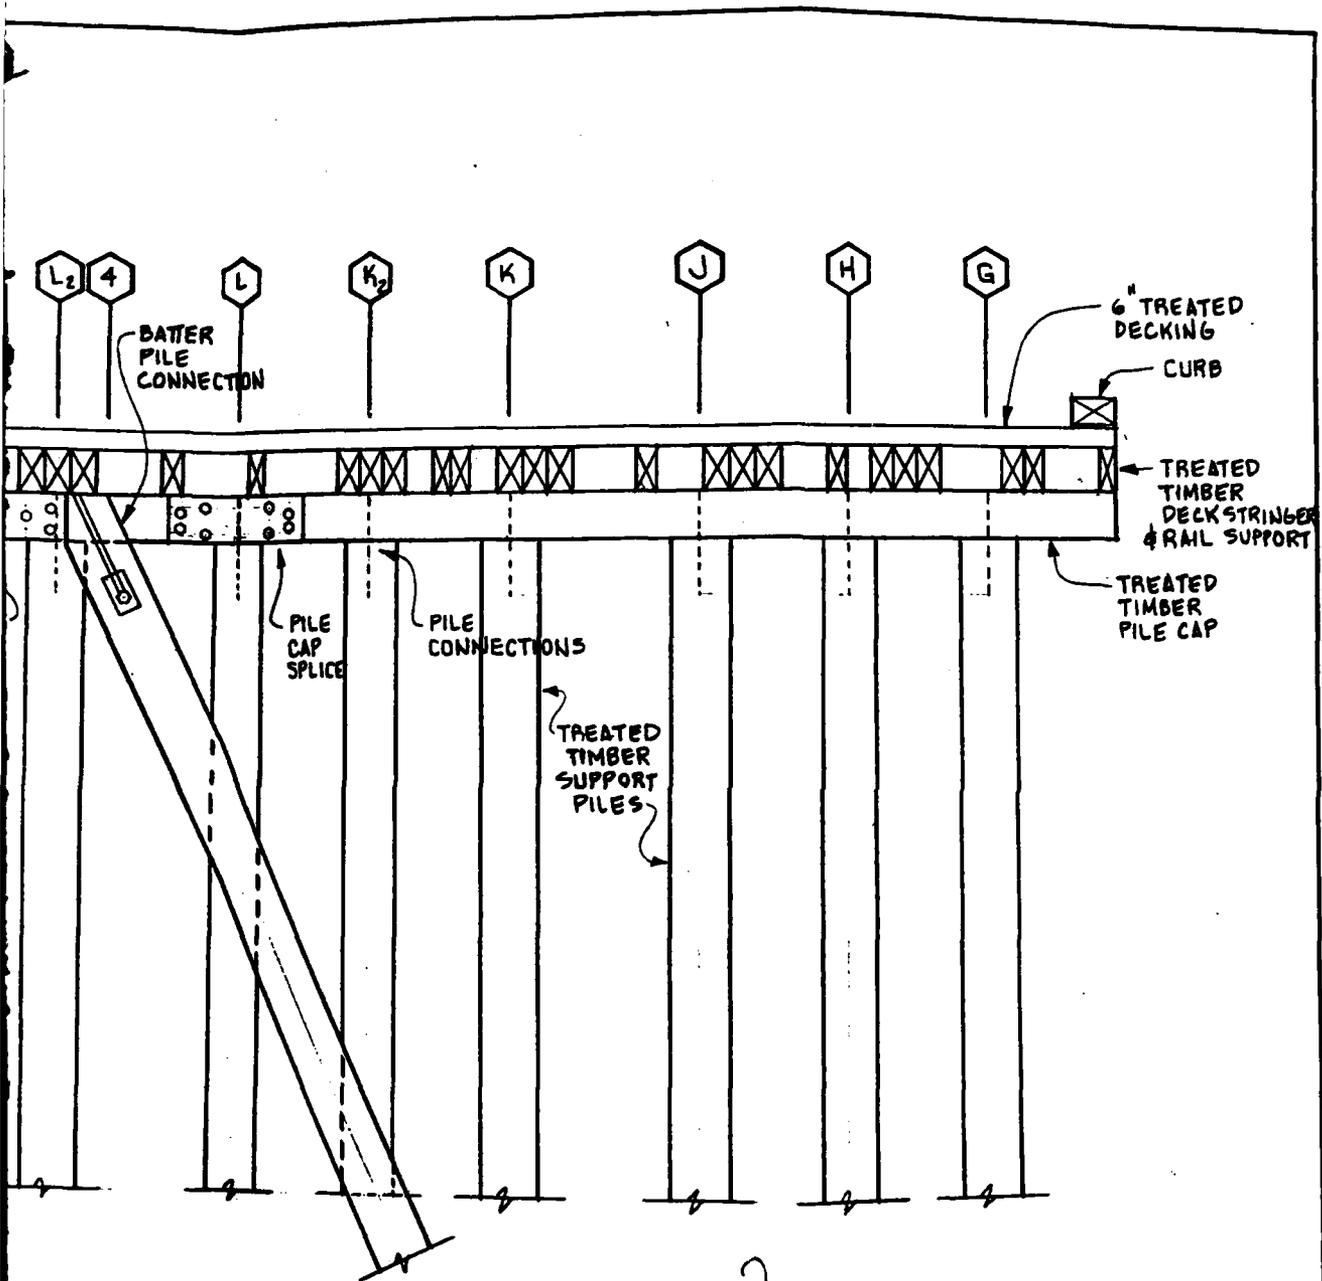
<p>GRAPHIC SCALE</p>	<p>CHILDS ENGINEERING CORPORATION BOX 599 MEDFIELD, MA</p>	<p>CHESAPEAKE DIVISION NAVAL FACILITIES ENGINEERING COMMAND WASHINGTON, D.C.</p>	
		<p>NAVAJ. WEAPONS STATION CONCORD, CA</p>	<p>FIG. NO. 2</p>

The pier was constructed in 1946 and extended in 1973. The original pier section is of timber construction with treated timber piles supporting treated timber pile caps, stringers and decking (see Figure 2).

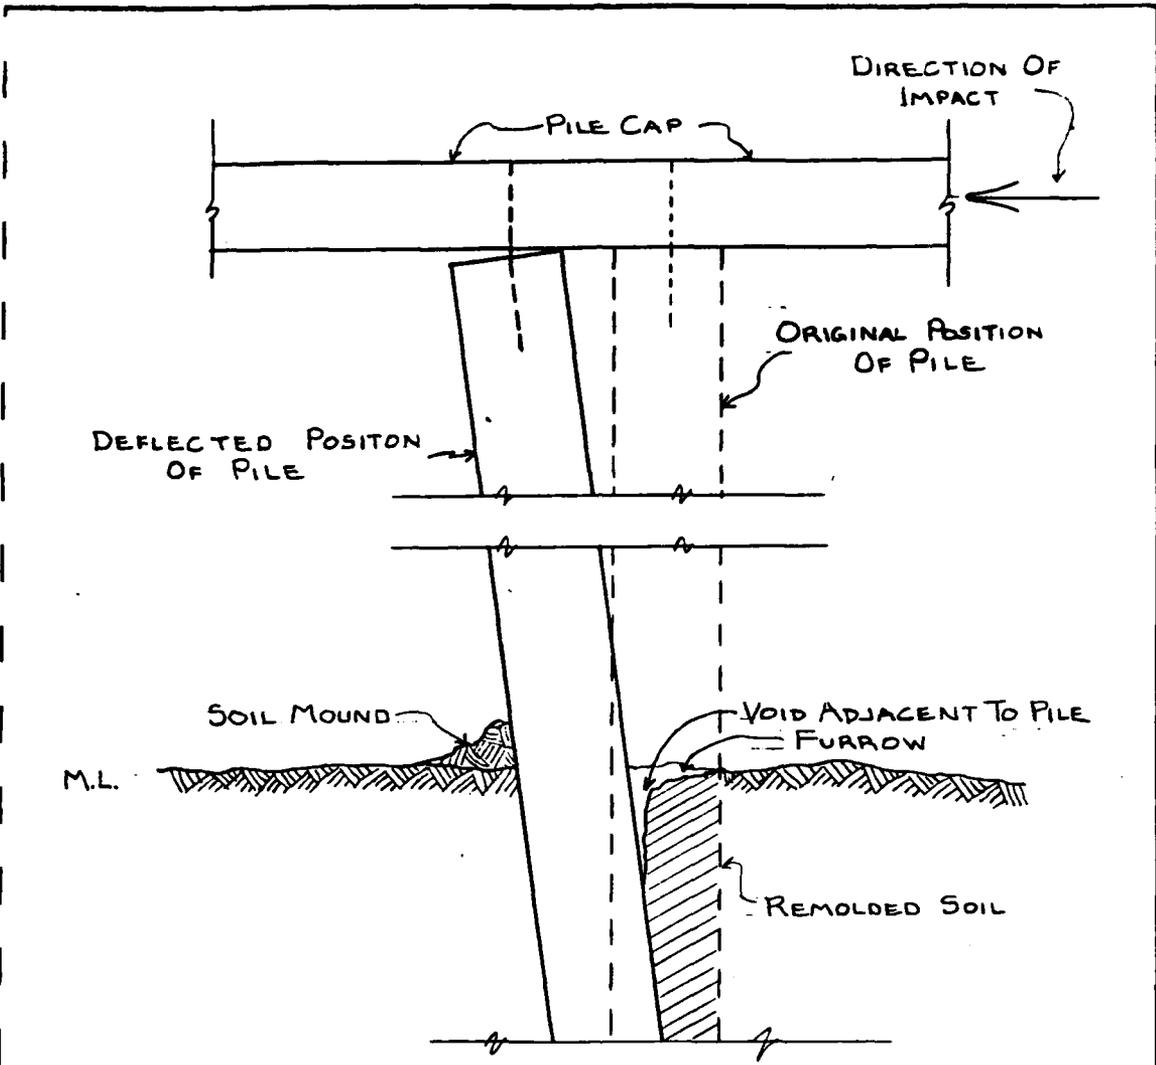
**4**

As a result of the collision, the pier between Bents 116 and 124 has a permanent deflection to the south. The maximum deflection appears to be at Bent 120 and is approximately 12" from original position. The displacement is illustrated in several ways. At the pile to pile cap connection of the vertical piles, there is a distinct rotation of the pile head. This rotation has resulted in a loss of bearing between the pile and pile cap. Typically, the pile head is bearing at the north side and there is a 1/16" to 3/8" gap at the south side (see Figure 4 and Photo 1).

In addition to the pile head rotation, many of the piles are displaced along the length of the pile cap. This displacement is the result of fastener bending (drift pin) or local failure of the pile head timber or pile cap timber (see Figure 4 and Photo 2). In cases where the fasteners have bent, there is no noticeable damage to the pile head or pile cap. Where the fasteners remain straight, either the pile cap or pile head timber, or both, have failed locally. Pile cap failure usually is illustrated by a vertical split through the pile cap which has allowed the fastener to slide. Pile head failure is illustrated by a splitting of the pile head (see Photo #3) which has

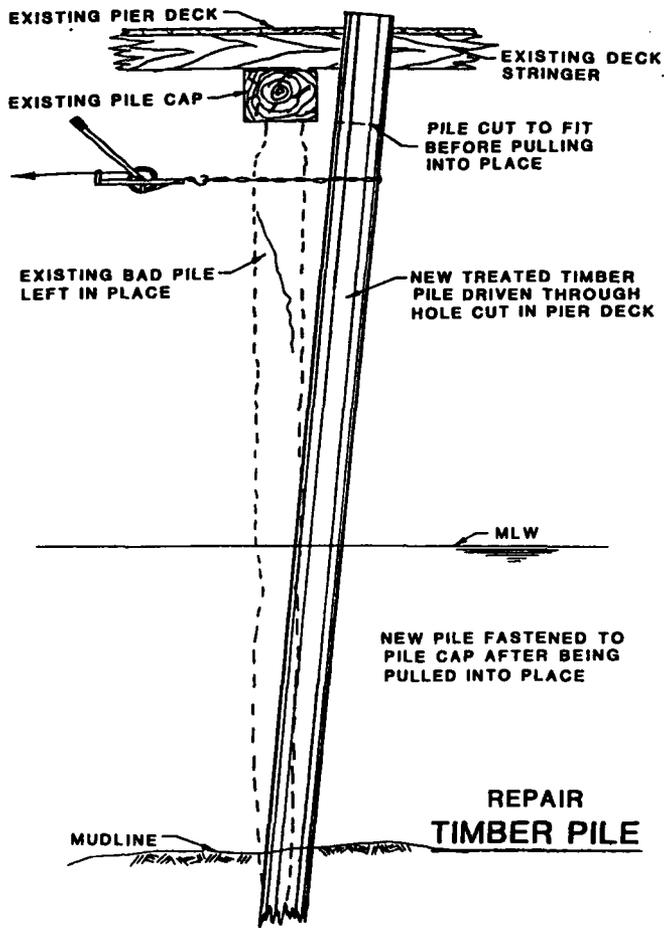
**PILE REPAIR**

Piles which have a permanent deflection in excess of 3" at the head are no longer capable of supporting the design vertical loads without modification. Calculations indicate the imposed bending stress where permanent deflection exceeds 3" plus the vertical loads will yield an excessive combined stress. The vertical piles in Bents 117 through 124 must be replaced or end conditions modified, such that the design loads will not cause excessive stressing (see calculations in Appendix). The two vertical piles which are broken, Pile H Bent 121 and Pile K Bent 122 are not capable of handling any loads.
