REPAIR, EVALUATION, MAINTENANCE, AND
REHABILITATION RESEARCH PROGRAM

TECHNICAL REPORT REMR-C.T-3

GEOTECHNICAL ASPECTS OF ROCK EROSION
IN EMERGENCY SPILLWAY CHANNELS

Christopher P. Cameron, Kerry D. Cato,
Colin C. McAneny, James H. May

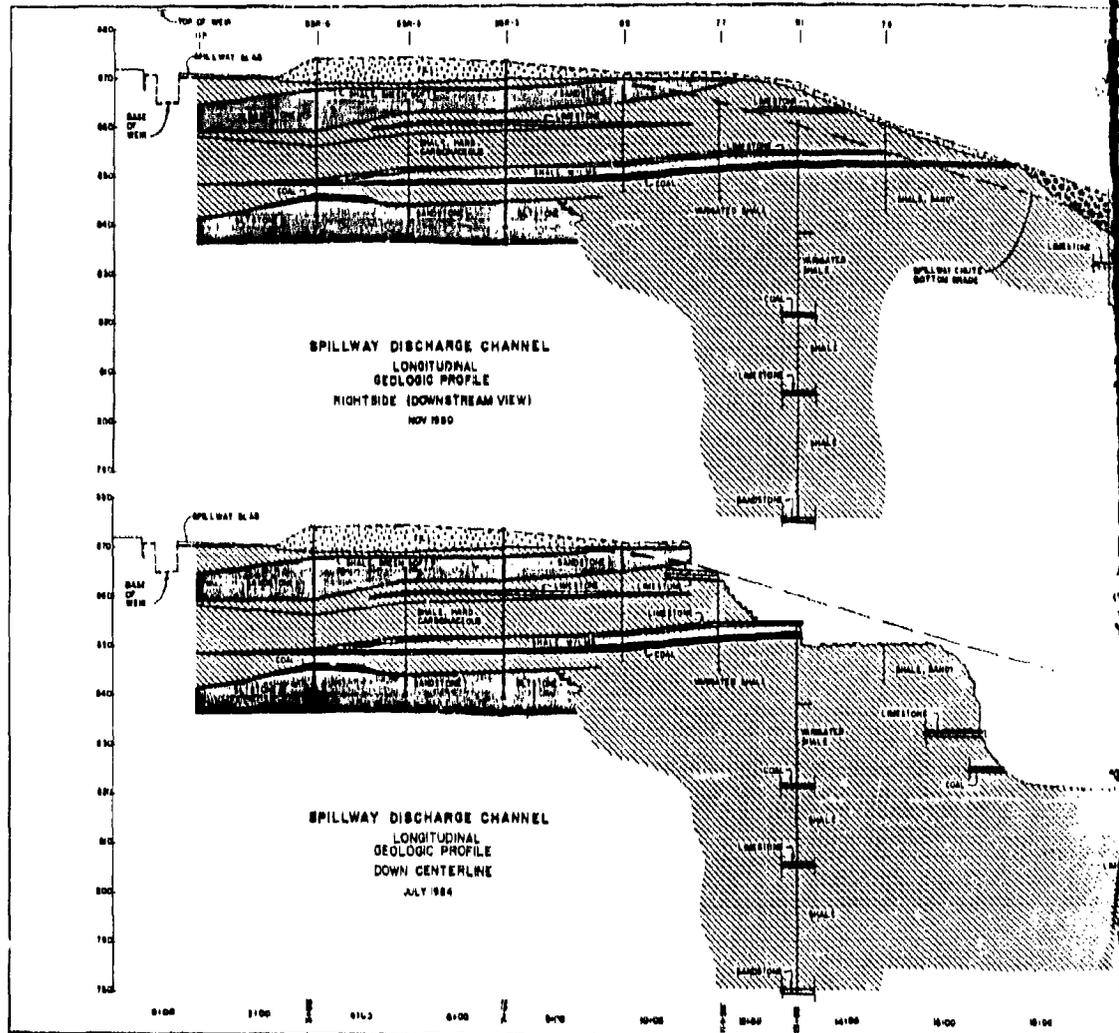
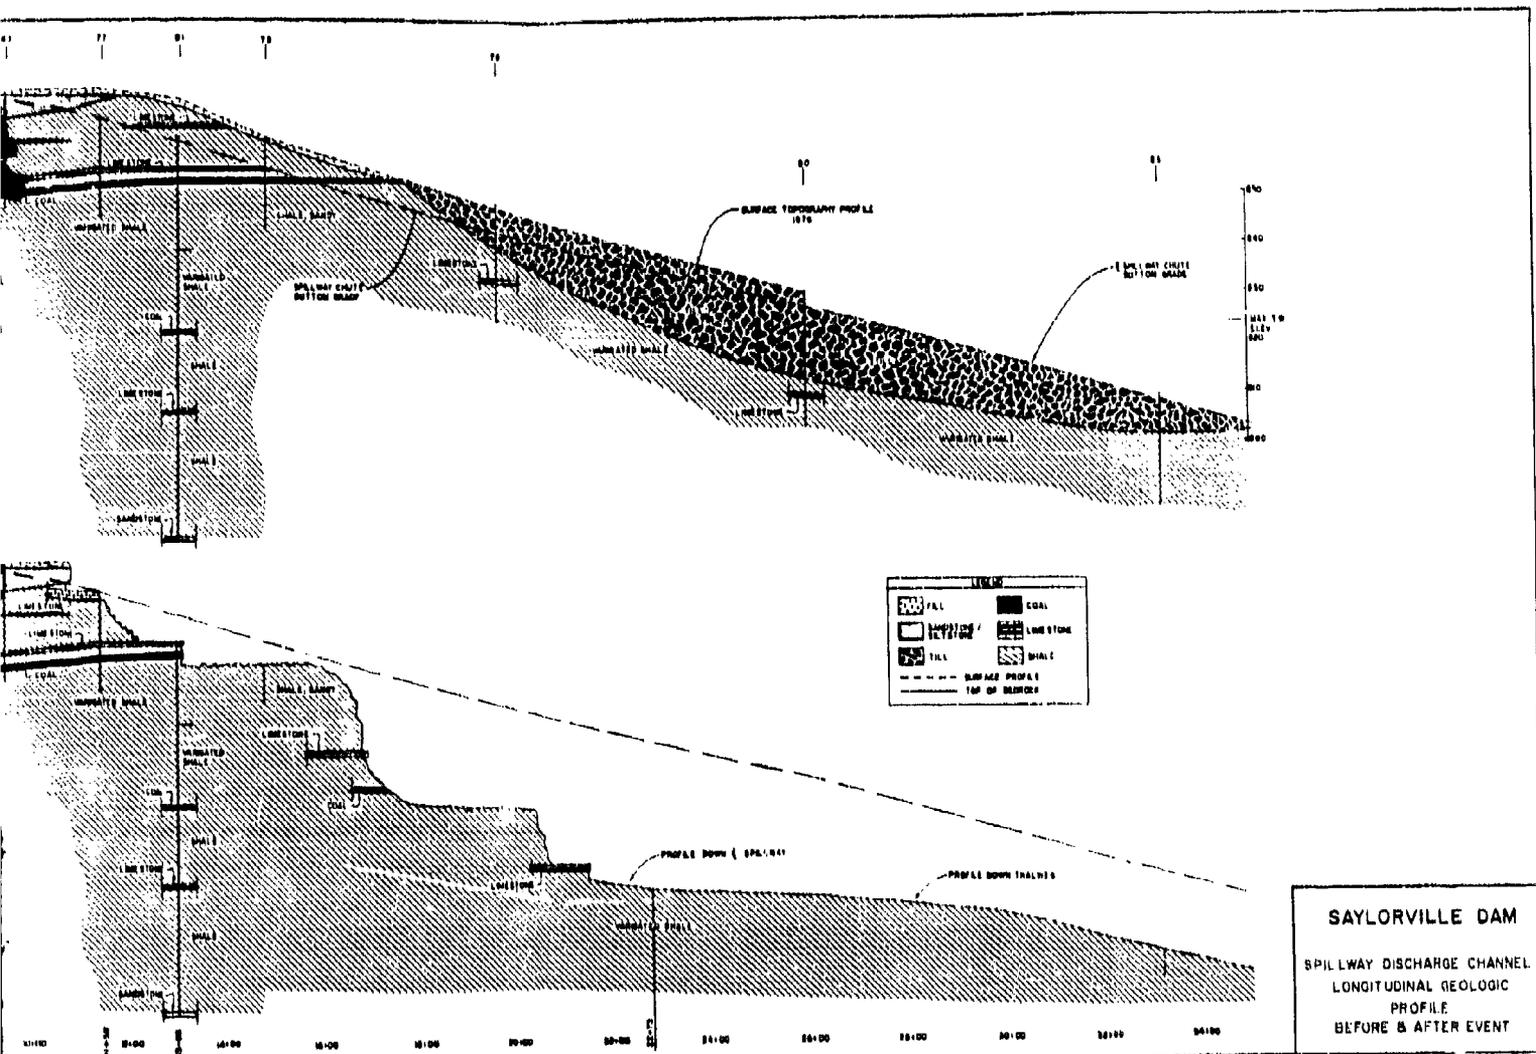
Figure 7. Saylorville emergency spillway discharge
 (down centerline) before and after

Saylorville emergency spillway discharge channel, longitudinal geological profiles (down centerline) before and after initial spillway overflow.

23. Emergency spillway overflow, which peaked at 17,000 cfs on 22 June 1984, produced the rock erosion predicted by the District's studies of 1981-82. District personnel observed the flow and erosion during the event as well as examined the before and after flood longitudinal geologic profiles (see Figure 7), and sections comparing pre-flood and post-flood topography at twelve locations in the channel (Figures 10-12) revealed the following:

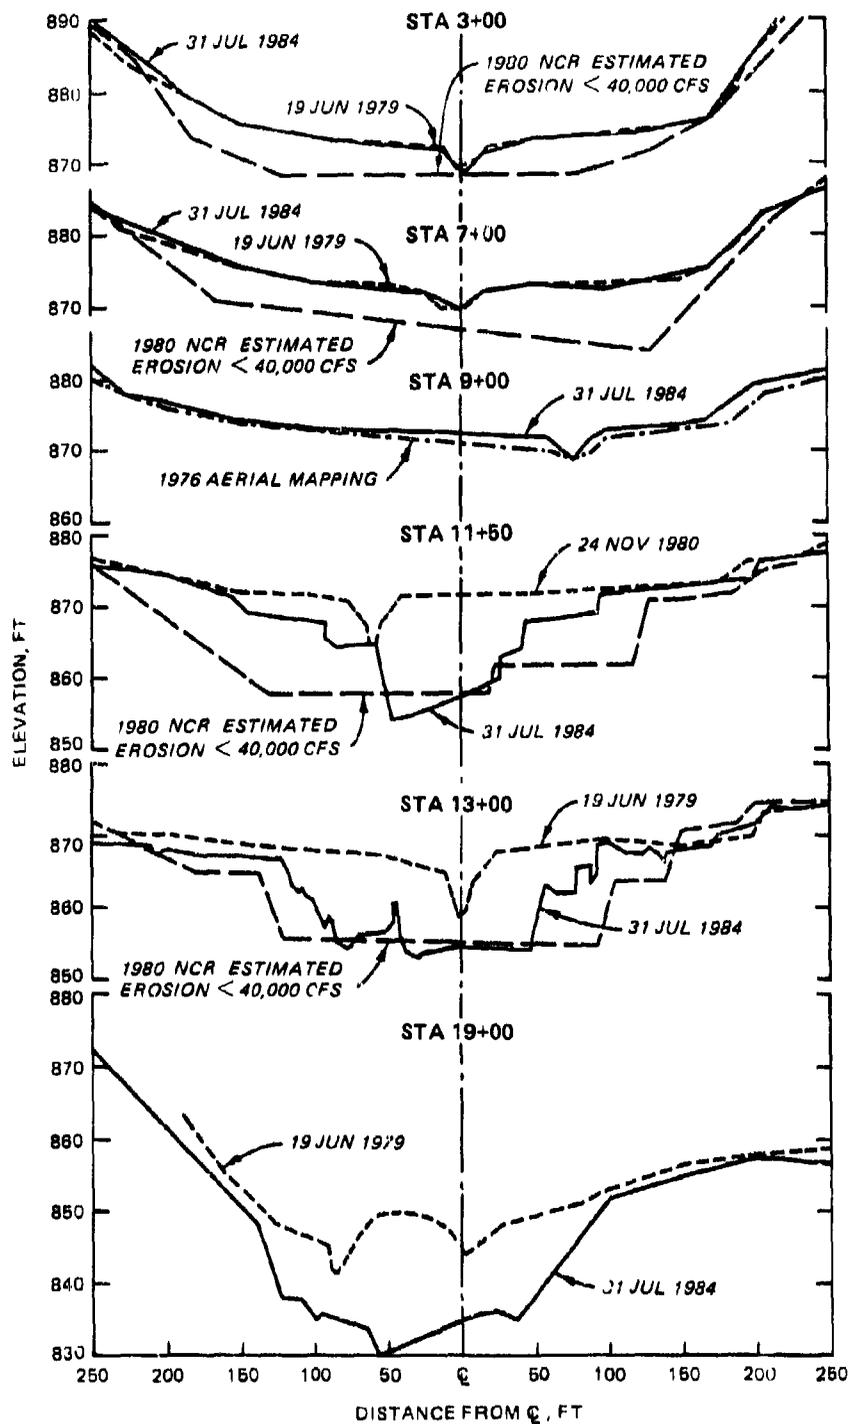
- a. Subcritical, nonerosive flow which only removed part of a thin grass and topsoil veneer over the bedrock was maintained to sta 11+50. District personnel estimated flow velocities in this portion of the channel were in the range of 7 to 10 fps. Stability of this portion of the channel was maintained by the continuous, hard, scour-resistant, medium-bedded sandstone which forms the channel floor to this point.
- b. The stratigraphic pinchout of this sandstone in the vicinity of sta 11+50 probably controlled the position of a gradient change

Figure 10. Saylorville emergency spillway discharge channel, cross sections from sta 3+00 to sta 19+00 showing preflood and postflood topography and the 1980 NCR erosion estimates for overflows less than 40,000 cfs

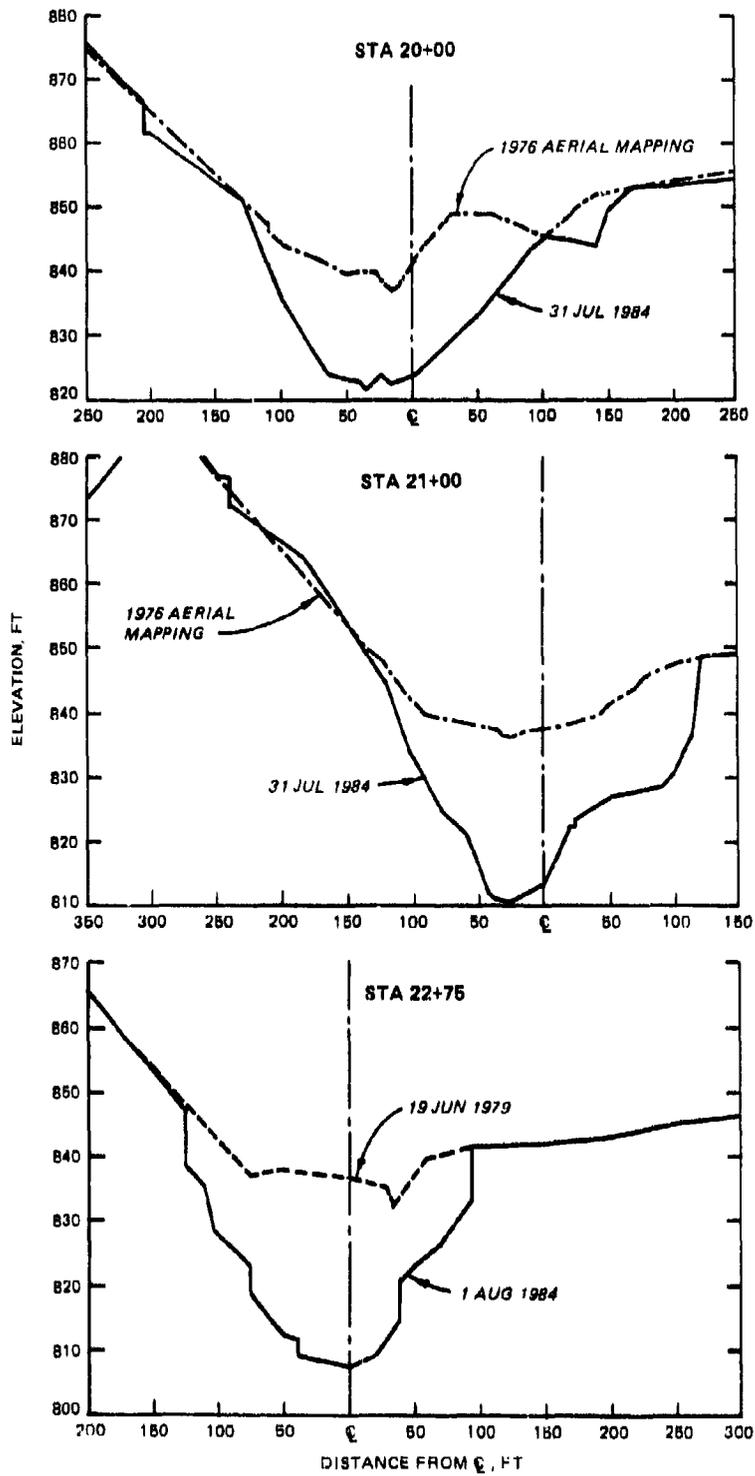
Figure 11. Saylorville emergency spillway discharge channel, cross sections showing preflood and postflood topography

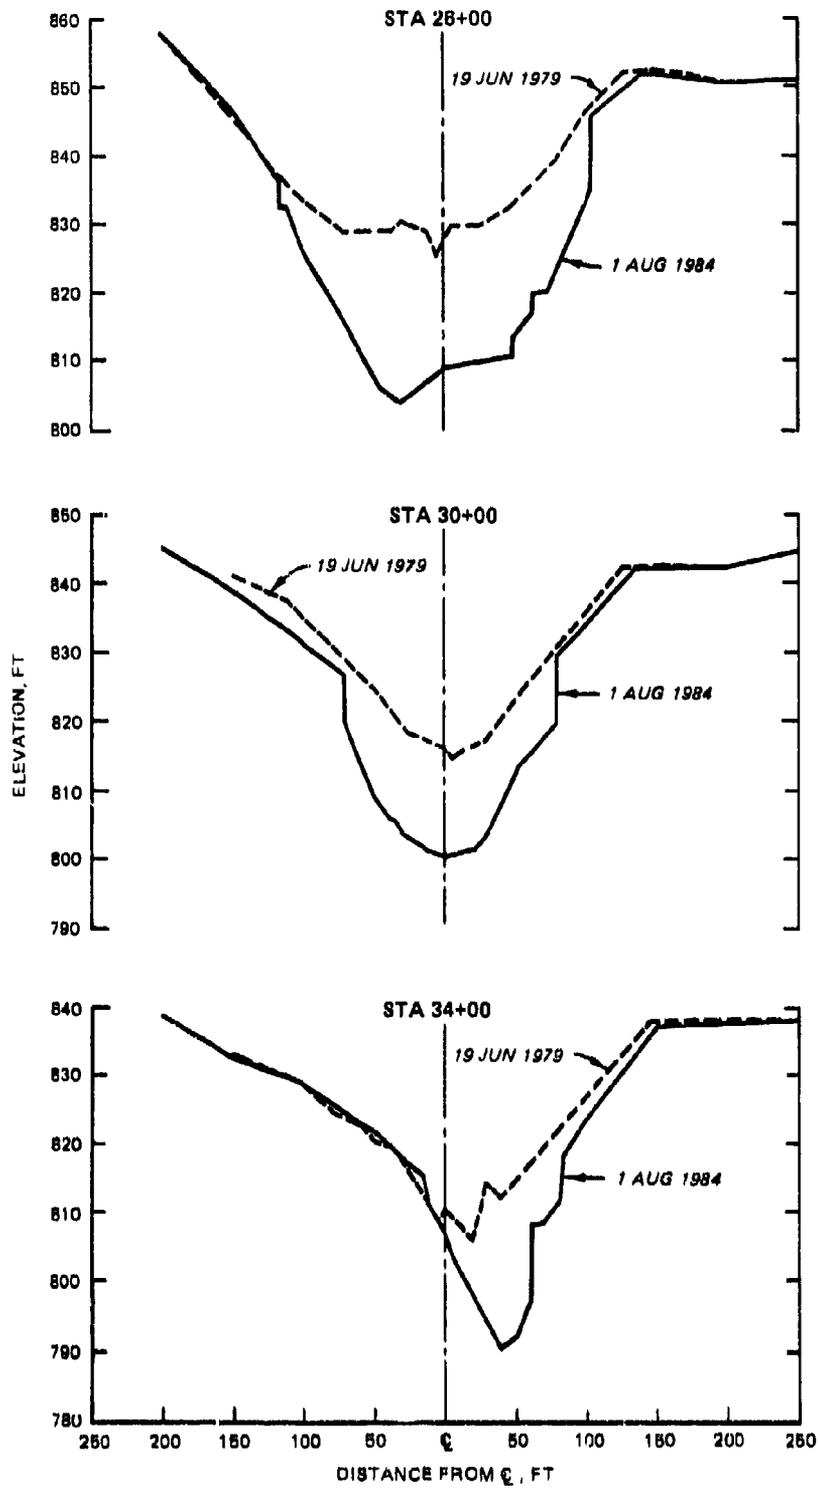
Figure 12. Saylorville emergency spillway discharge channel, cross sections showing preflood and postflood topography

(knickpoint*) in the preflood channel. Downstream from this position, the flow velocity increased and, by the third day, the turbulent white-water flow created falls between sta 10+90 and sta 11+50. Estimates by District personnel of the turbulent flow velocity below the falls area were in the 20- to 25-fps range.

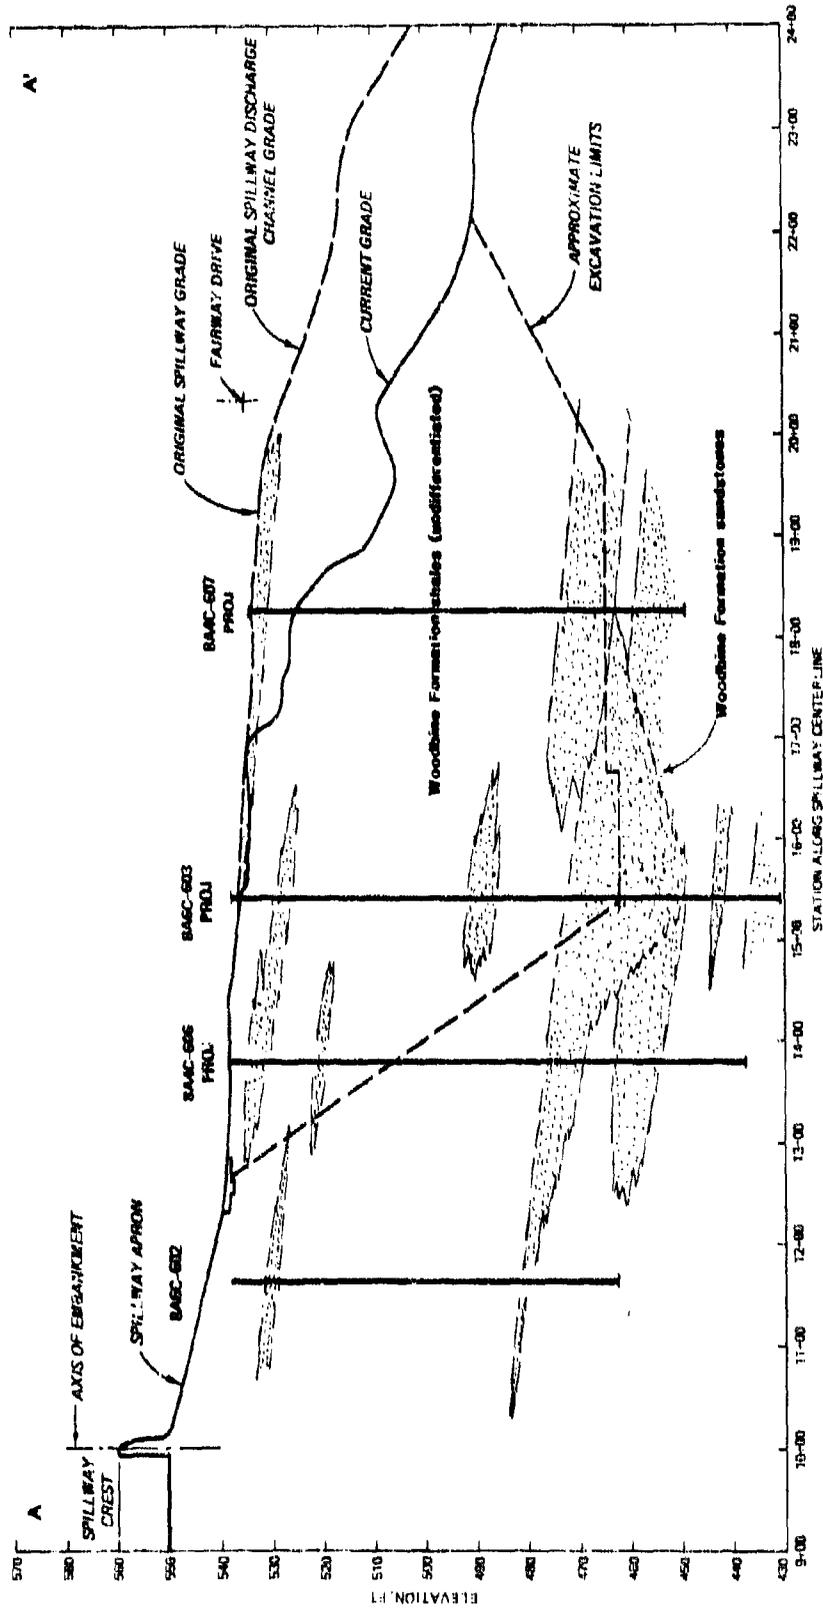
46. Overflow event, 1981. Flood overflows, peaking at 9,100 cfs (approximately 5 percent of the SDF (191,000 cfs)) during the period of 28 October to 21 November 1981, caused severe erosion of the spillway discharge channel from a point about 450 ft downstream from the Apron sill (sta 17+00, Figure 27) to areas nearly a mile downstream from the spillway along the discharge channel. The spillway channel flow destroyed two road crossings and deposited a large amount of silt on the Grapevine City Golf Course. The

Figure 27. Geological profile along Grapevine emergency spillway discharge channel centerline showing the original channel grade as well as that formed by erosion during the 1981 overflow

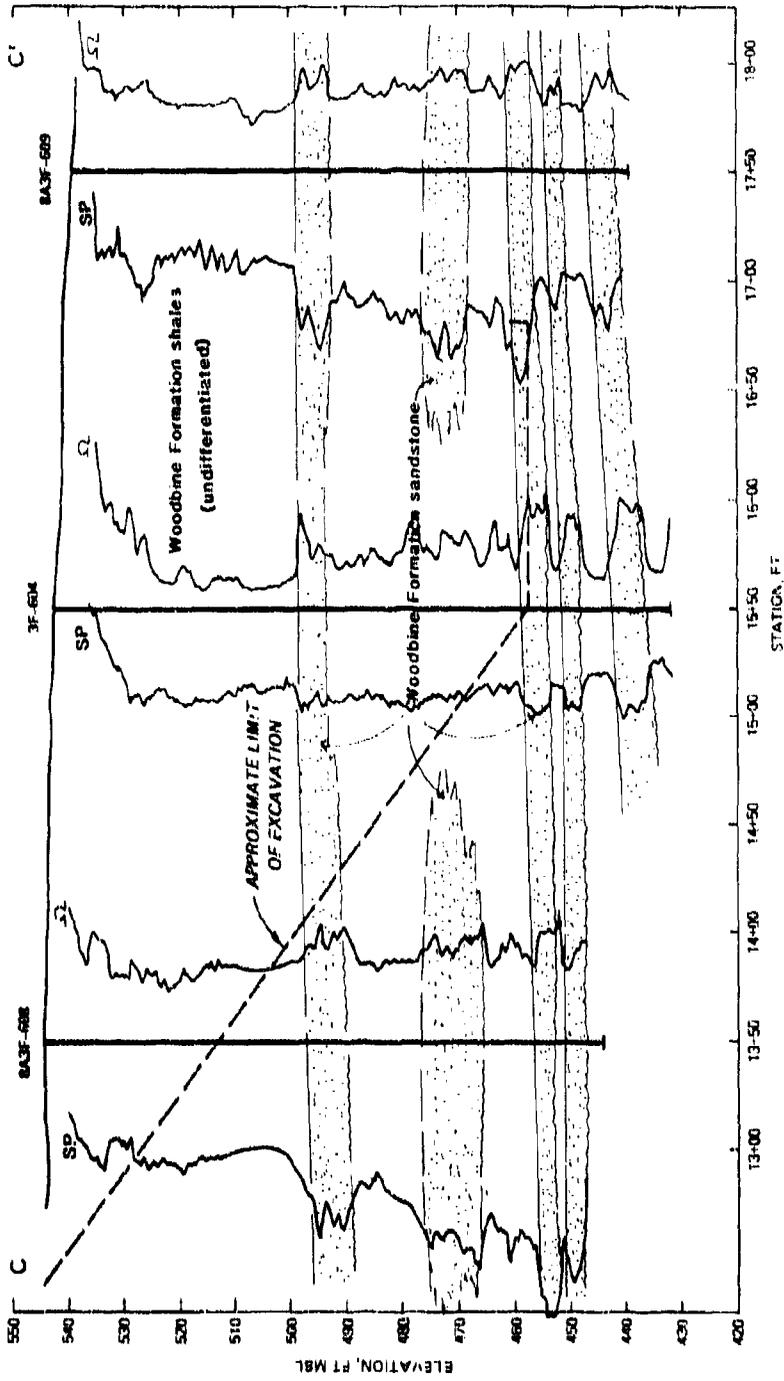
Figure 29. Geological cross section C - C' of the emergency spillway discharge channel at Grapevine Lake is based on borehole electric log interpretations and shows the infrared distribution of Woodbine Formation sandstones and shales

following excerpt from a District report by Alan Marr (SWF Geotechnical Branch) describes the causes of the erosion from a geotechnical point of view:

The obvious factors which caused the severe erosion in the Grapevine Spillway during the November 1981 flood were the heavy discharge and the general erodibility of the Woodbine Formation materials. However, there were other factors which led to the severity of the erosion. These include the presence and location of the FM road embankment in the discharge channel, the high velocities of the discharge, and the inconsistency of the Woodbine Formation materials.

Gradational changes in the lithologic composition of the Woodbine Formation materials typically occur within short distances. The 5-foot thick layer of sandstone comprising the majority of the spillway floor did not extend to the area immediately downstream of the FM roadway embankment. Surface materials below the roadway embankment consisted of loosely compacted clayey sand overburden overlying weathered, soft, sandy shale. The road embankment, acting as a check-dam, caused a 3- to 4-foot head of water to accumulate. Once overtopping of the road embankment occurred, the increasing flow cut rapidly downward through the clayey sand and the underlying soft shale. The road embankment eventually collapsed and the deepening headward erosion began progressing at an accelerated rate. The sandstone layer at the surface of the unprotected discharge channel slowed the headward progression of erosion. However, once the sandstone layer was removed, the underlying sandy shale was readily removed by the churning flow which was then being concentrated into two deepening erosion channels. Discharge through the Grapevine Spillway eventually peaked at 9100 CFS flowing at a velocity of 35-40 feet per second.

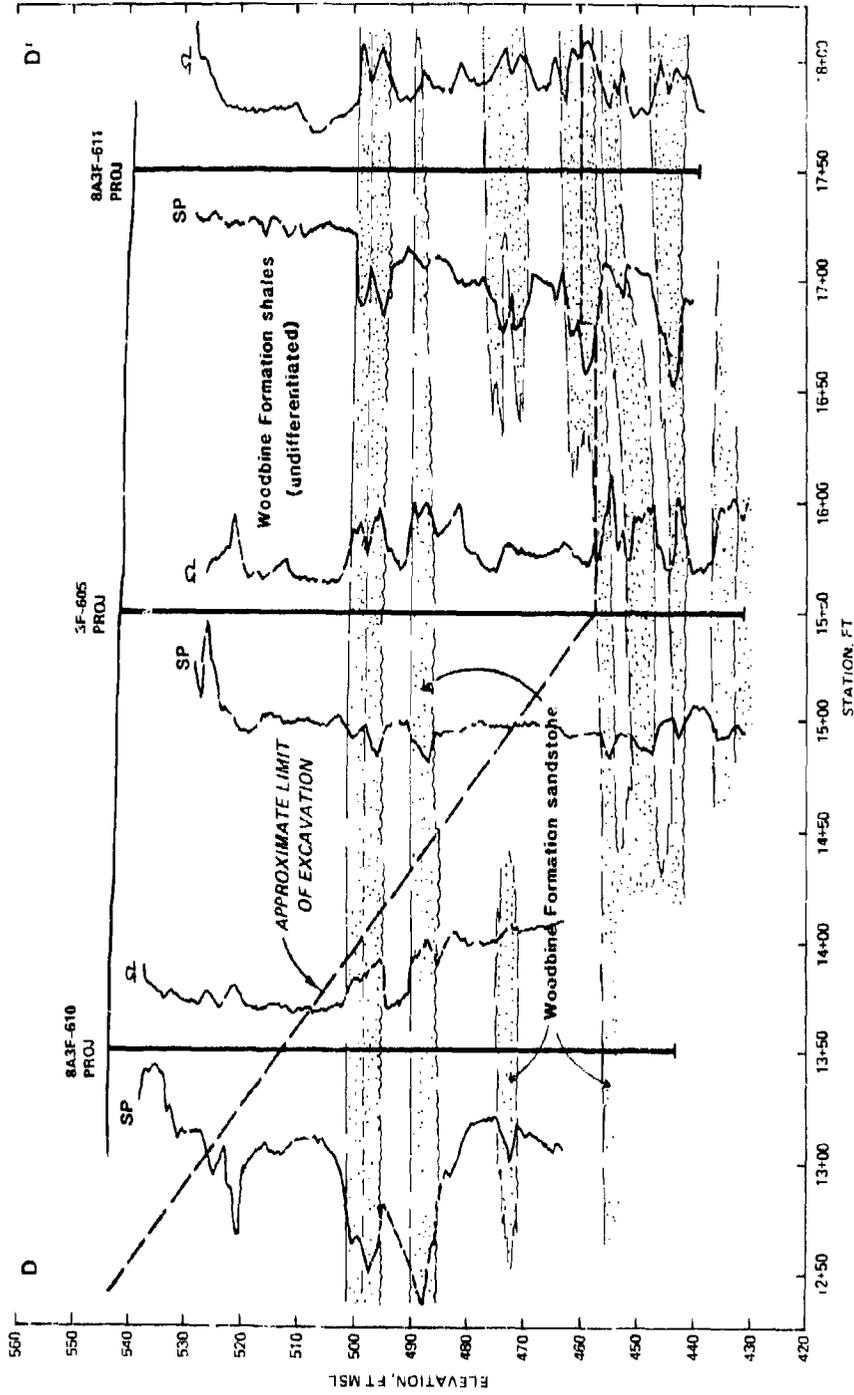
Figure 30. Geological cross section D - D' of the emergency spillway discharge channel at Grapevine Lake is based on borehole electric log interpretations and shows the infrared distribution of Woodbine Formation sandstones and shales

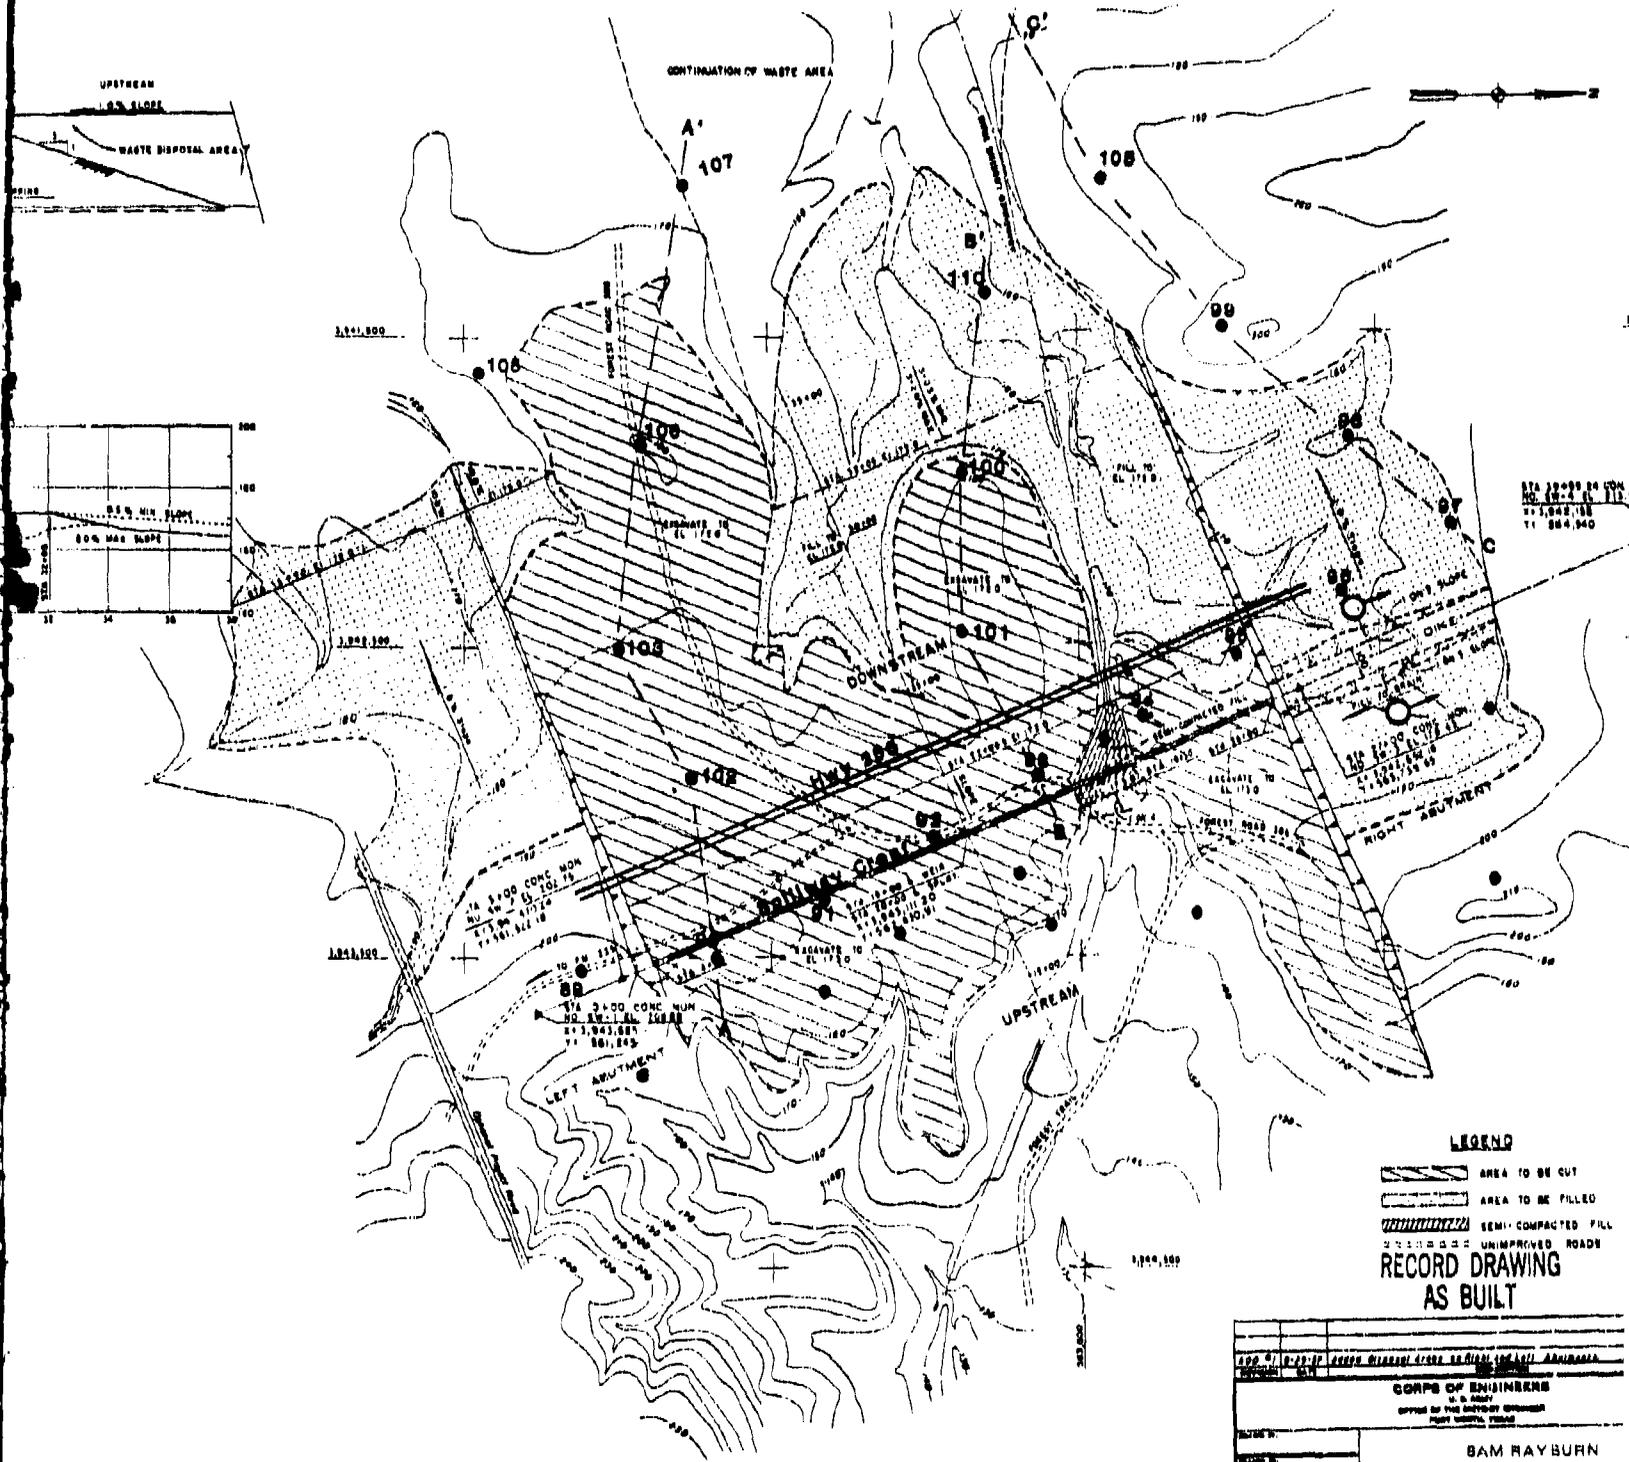
34. General plan, dike sections, and profile, Sam Rayburn Dam emergency spillway

53. The uncontrolled emergency spillway is located in a saddle about 7,000 ft west of the right abutment of the main embankment and about 5,000 ft west of the outlet works and powerhouse (Figure 32). The spillway is 2,200 feet wide at the crest el of 176.0. The control sill is an inverted concrete U-frame with a 15-ft-long by 2-ft-thick concrete slab (Figure 33). Inverted T-section cutoff walls extend into the LV on 2H sideslopes bordering the spillway floor. Figure 34 shows the general plan, dike sections, and profile of the spillway as well as locations of auger and core boreholes used to evaluate subsurface conditions in the unlined discharge channel.

54. The unlined spillway discharge channel floor is formed by natural ground made relatively flat by alternately cutting and placing fill in separate areas of the spillway during construction. Below the concrete weir, the channel slopes downstream from el 175.5 to el 174.4 in 50 ft, then to el 172.0 in 133 ft and continues at this elevation for about 1,200 ft prior to entering a wooded draw which intersects Jordans Creek at nearly a right angle approximately 2 miles from the weir (Figure 32). Jordans Creek in turn empties into the Angelina River about 7 miles downstream from the dam.

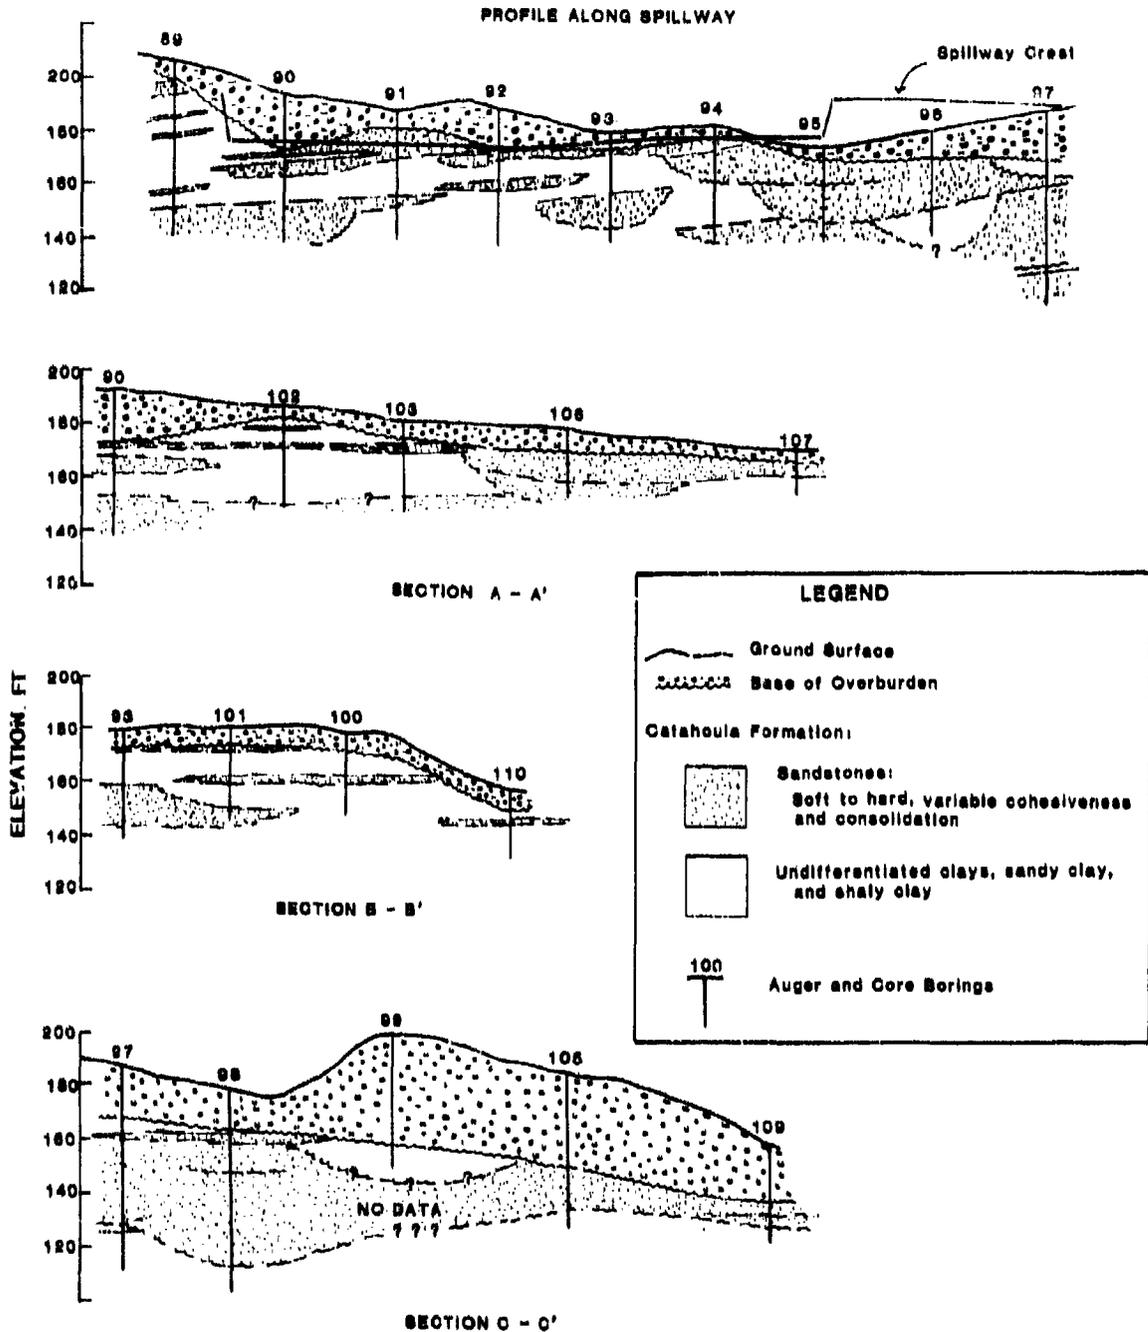
strata is illustrated by the interpretive drilling cross sections shown in Figure 35.

61. This pattern of variable cementation means that should scour during spillway overflow remove the resistant surface exposure of a Catahoula sand body, the rate of erosion might increase dramatically if the flow encounters loose, nonresistant, subcropping sands of the same unit.

63. Recent District geotechnical investigations of the spillway revealed that no significant erosion-resistant strata which occur near the

Figure 35. Interpretive geological cross sections, Sam Rayburn emergency spillway discharge channel

surface of the spillway are continuous across the entire spillway discharge channel area. The rocks underlying the spillway channel, especially when compared with the material recently eroded from the Grapevine Lake spillway, are classified as being highly erodible.

- a. Concrete paving on the spillway channel. This measure would minimize the erosion potential of the spillway but would require 18 in. of reinforced concrete paving to be laid on the first 2,000 ft of the channel. This alternative has an estimated cost of \$85 million. Passage of the PMF spillway overflow could still result in failure of the spillway weir. Lesser flows might result in extensive damages to the channel.

- b. Rollcrete paving on the spillway channel. This alternative requires 24 in. of reinforced rollcrete paving covering the first 2,000 ft of the discharge channel. Damages requiring extensive repairs may result from passage of significant spillway discharge, and the integrity of the spillway is not "guaranteed" should passage of the PMF spillway overflow occur. This alternative has an estimated cost of approximately \$62 million.

- c. Soil-cement stabilization of the spillway channel. Soil-cement stabilization of the first 2,000 ft of the discharge channel to a depth of 36 in. could also minimize the erosion potential of the channel. Like the first two alternatives, this measure does not guarantee the survival of the spillway during PMF overflow, and extensive repairs are anticipated after the passage of significant discharge. The soil cement stabilization of the channel could be completed for an estimated cost of \$26 million.

- d. Drilled pier cascade system. The construction of a deep drilled pier cutoff wall along the alignment of the existing spillway weir and a series of three additional cascade walls across the spillway discharge channel could prevent total failure of the spillway. Extensive repairs would be required after the passage of any significant spillway discharge. This system has an estimated cost of \$50 million.

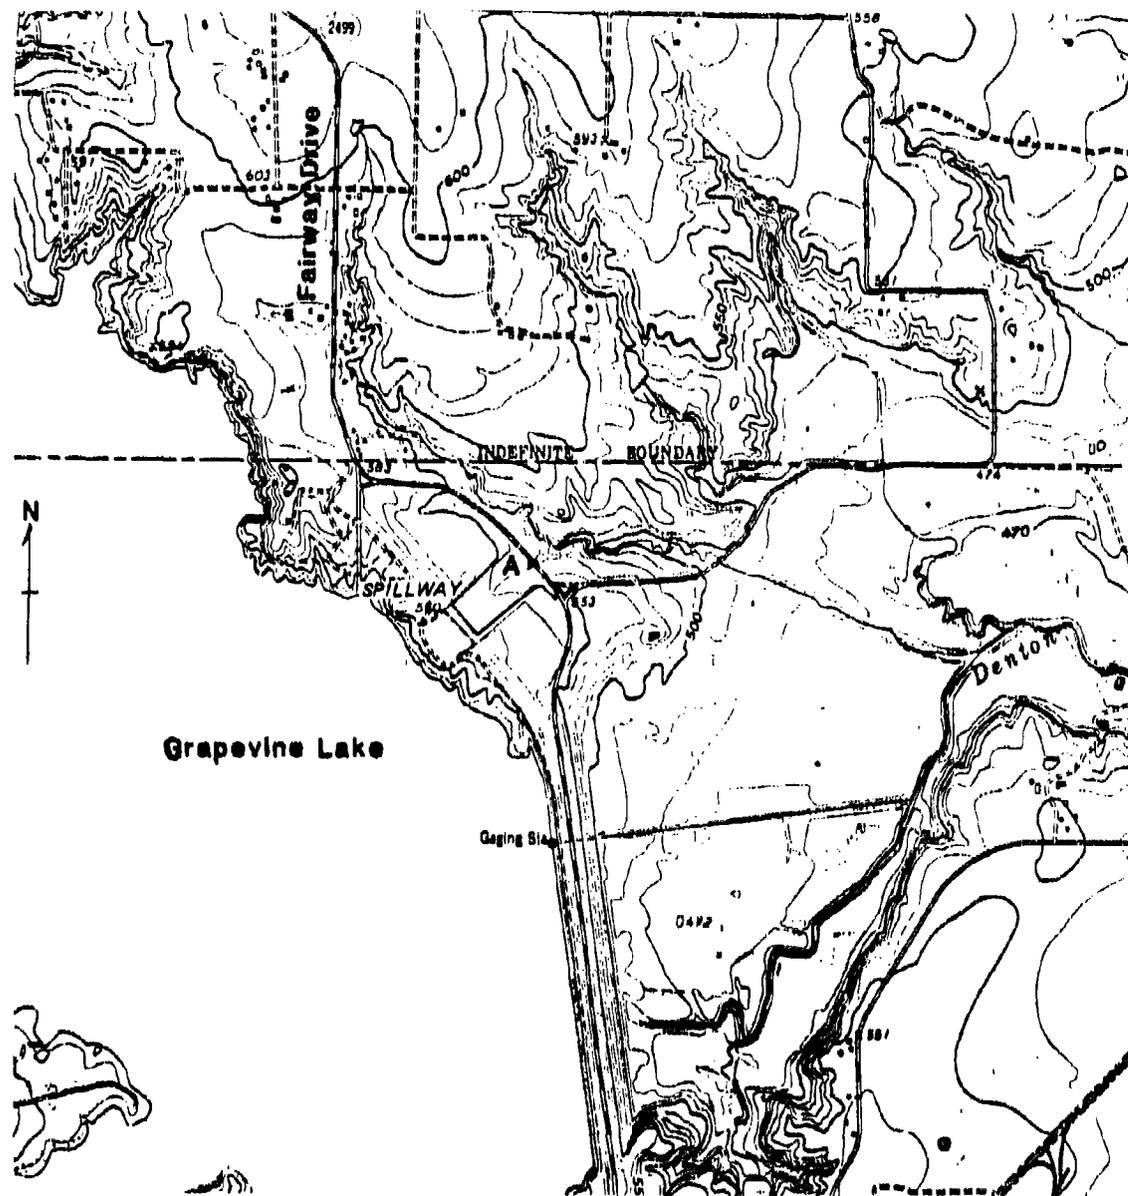
97. The Grapevine channel course followed a small, previously incised, steep and somewhat tortuous stream for the first 1/2 mile. The channel gradient is about 2.0 percent upstream of the road (point A on Figure 39) but steepens to 8 percent just downstream of the road (built on the downstream end of the sandstone ledge forming the foundation of the spillway structure).

98. The only place where noteworthy erosion occurred at Lewisville was downstream in the vicinity of the railroad bridge (Figure 40). The severe erosion which threatened the Grapevine structure was initiated just downstream from the road (Point A, Figure 39). In both cases these were the locations of the steepest gradients. In the case of Grapevine, the sharp gradient change also corresponded to a lithologic discontinuity which formed an encroaching waterfall too close to the structure.

Figure 39. Spillway at Grapevine Lake, from Grapevine 7-1/2 min topographic quadrangle (1959), 10-ft contours. Spillway crest left center (Note the marked increase in gradient where the road crosses spillway channel (Point A)--severe erosion originated at this knickpoint)

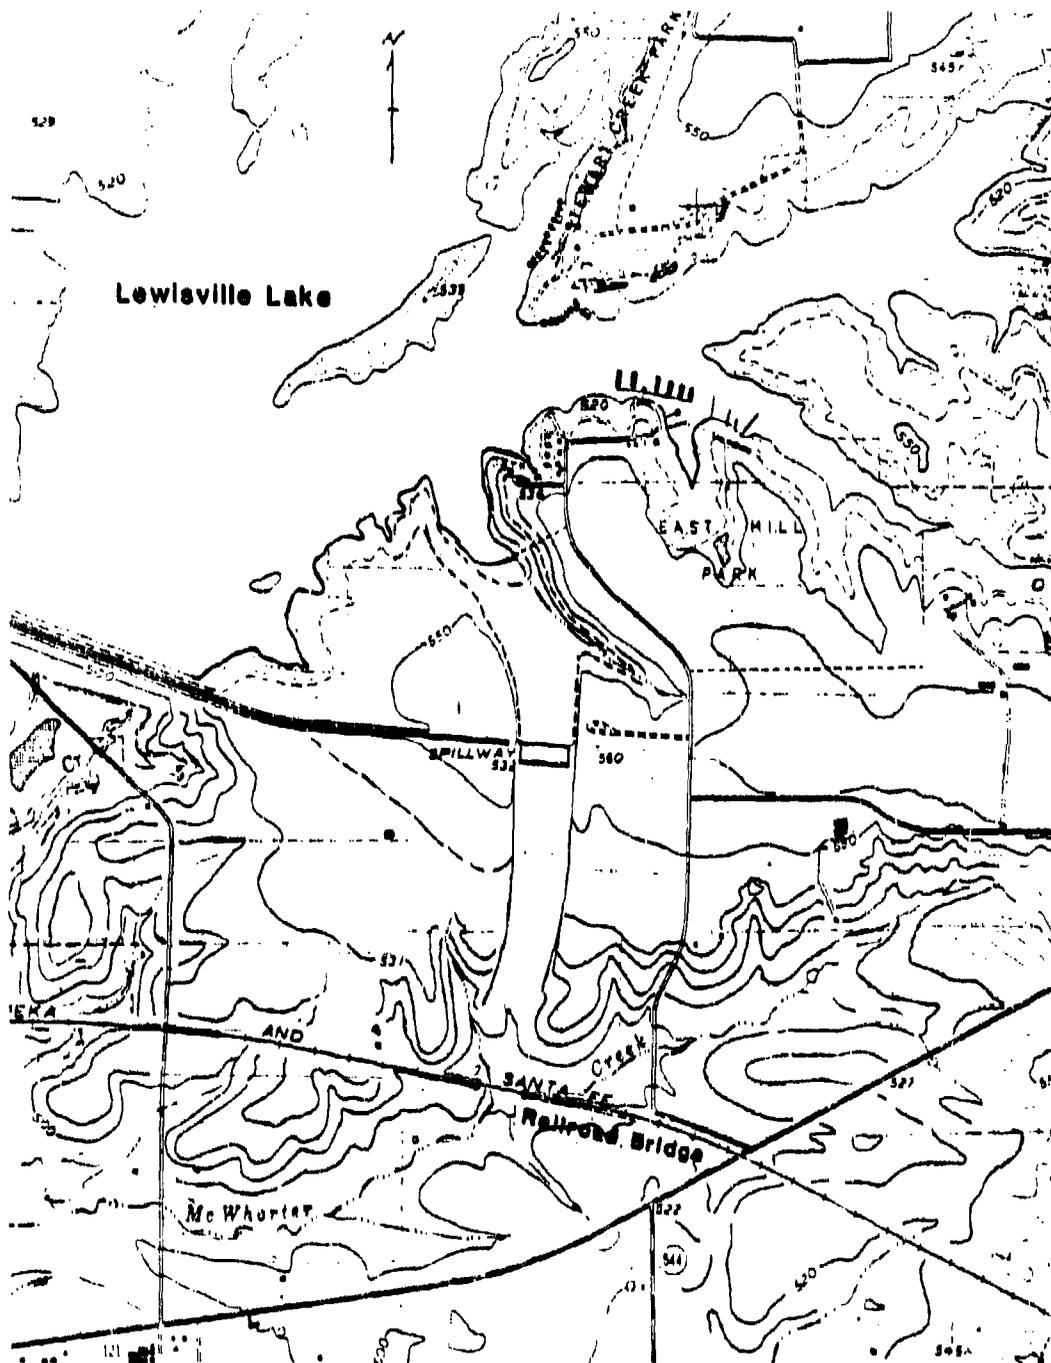
96. Figures 39 and 40 show the pre-flood spillway channels at Grapevine and Lewisville, respectively, on USGS topographic maps. The differences in gradient, width, and shape between the two channels are noteworthy. The Lewisville channel is practically straight for 1/2 mile and is 600 ft wide throughout this length. The gradient of the Lewisville channel is about 0.5 percent, although it steepens to about 1.7 percent for a short stretch near the railroad.

Figure 40. Spillway at Lewisville Lake, from Lewisville East 7-1/2 min topographic quadrangle (1960), 10-ft contours. Spillway crest is in the center of the figure (Note slight increase in gradient near railroad, lower center)
