THE MAINTENANCE AND OPERATION OF A SMALL WIND GENERATOR IN THE MARINE ENVIRONMENT

WARREN HEERLEIN

U.S. COAST GUARD RESEARCH AND DEVELOPMENT CENTER
AVERY POINT, GROTON, CONNECTICUT 06340-6096

FINAL REPORT
July 1986

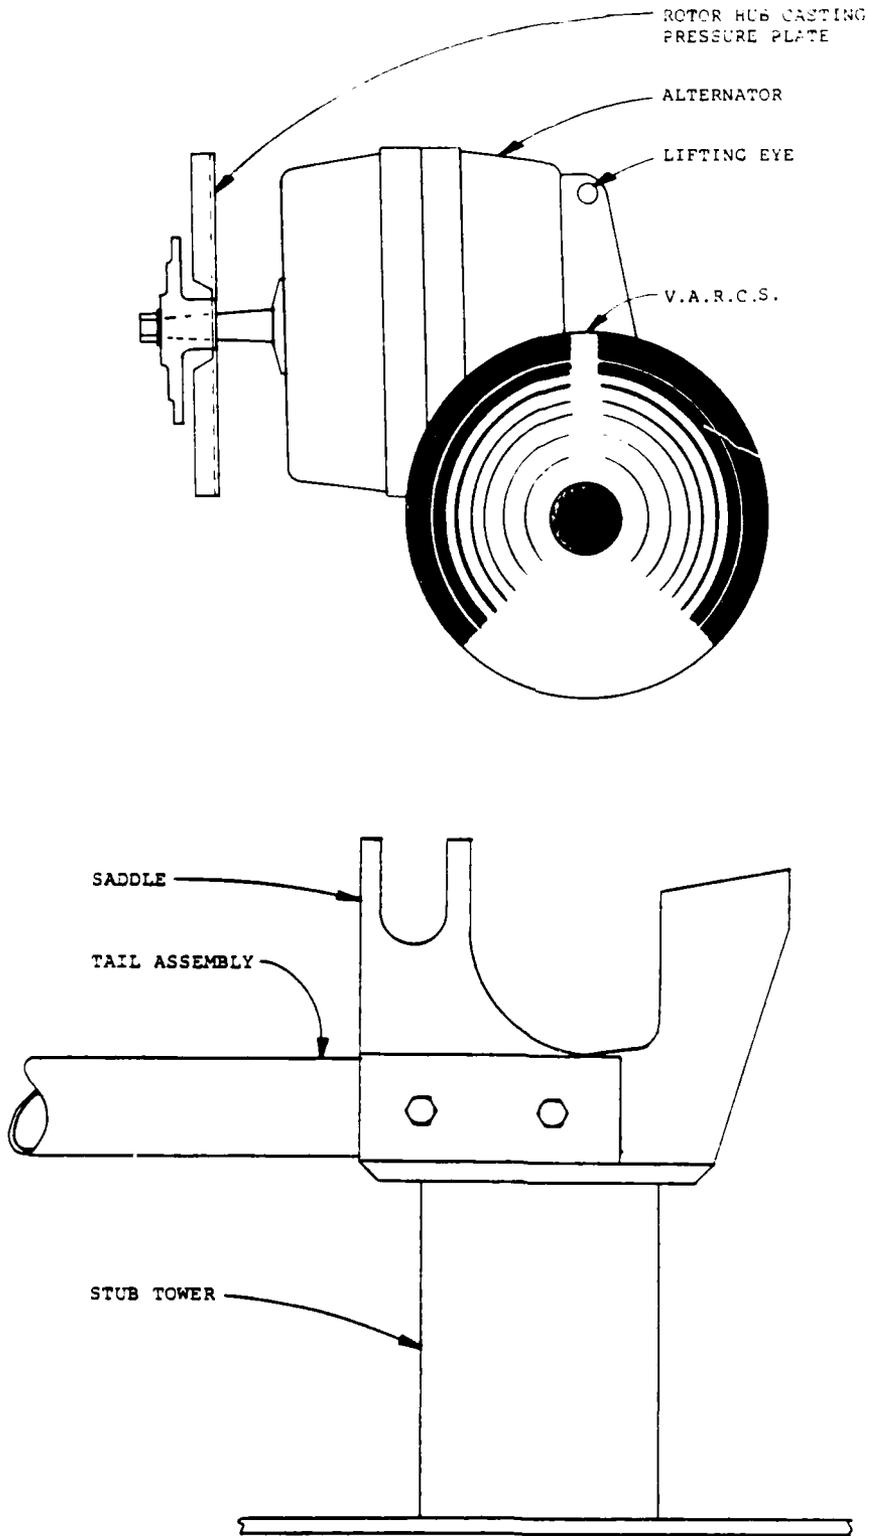
FIGURE 3. HR2 ASSEMBLIES

The third sub-component is the saddle/yaw control system. The HR2's base, or saddle, contains a large bearing and tail/vane assembly that allows the generator to rotate and stay directed into the wind. The saddle provides the pivot axis for the VARCS hinge, (see Figure 3). Also included in this piece is the electrical power connection through a brush and ring system that allows unlimited turning of the machine without the limit stops necessary with directly connected wires.

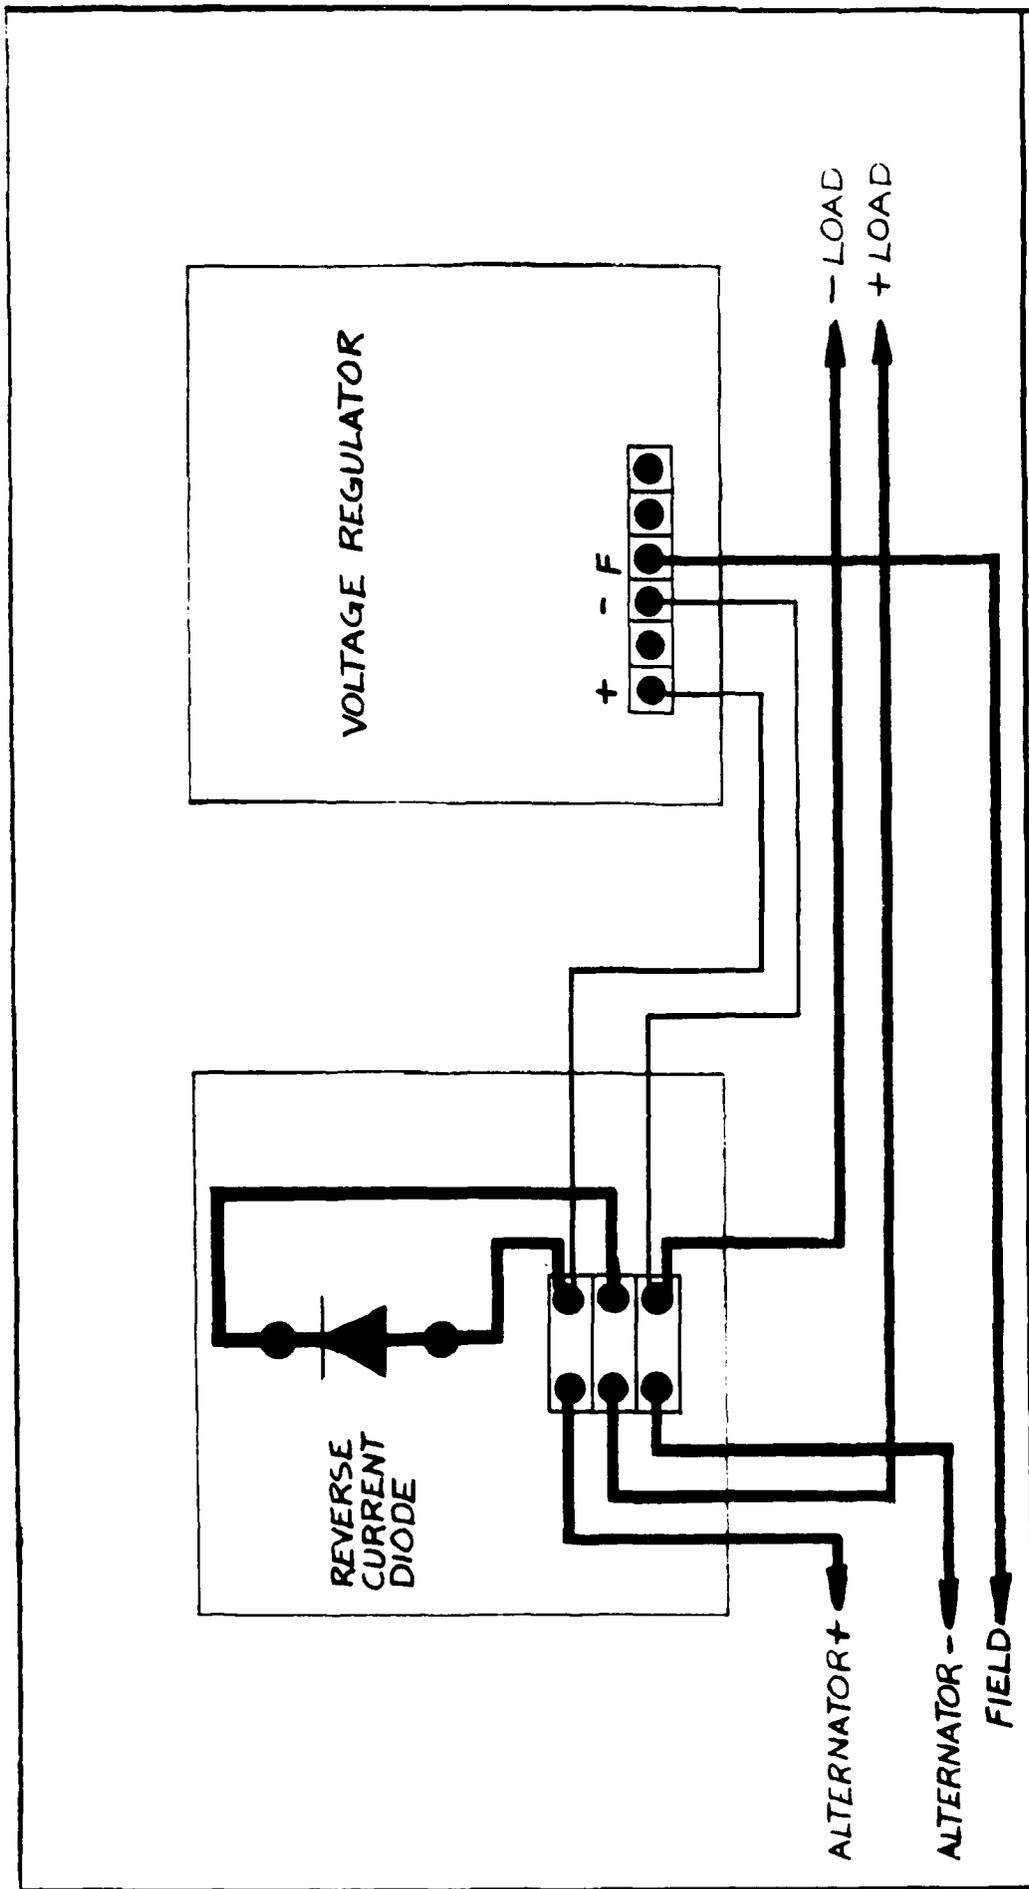
FIGURE 4. VOLTAGE REGULATOR AND RCD WIRING SCHEMATIC

The reverse current diode (RCD) provided with the HR2 is a GE model #A70PB(1N3296), (see Figure 4). It is rated at 150 amps and its peak reverse voltage (PRV) is rated for 1400 volts. The RCD is necessary for a battery charging application to prevent reverse current flow from the batteries to the HR2.

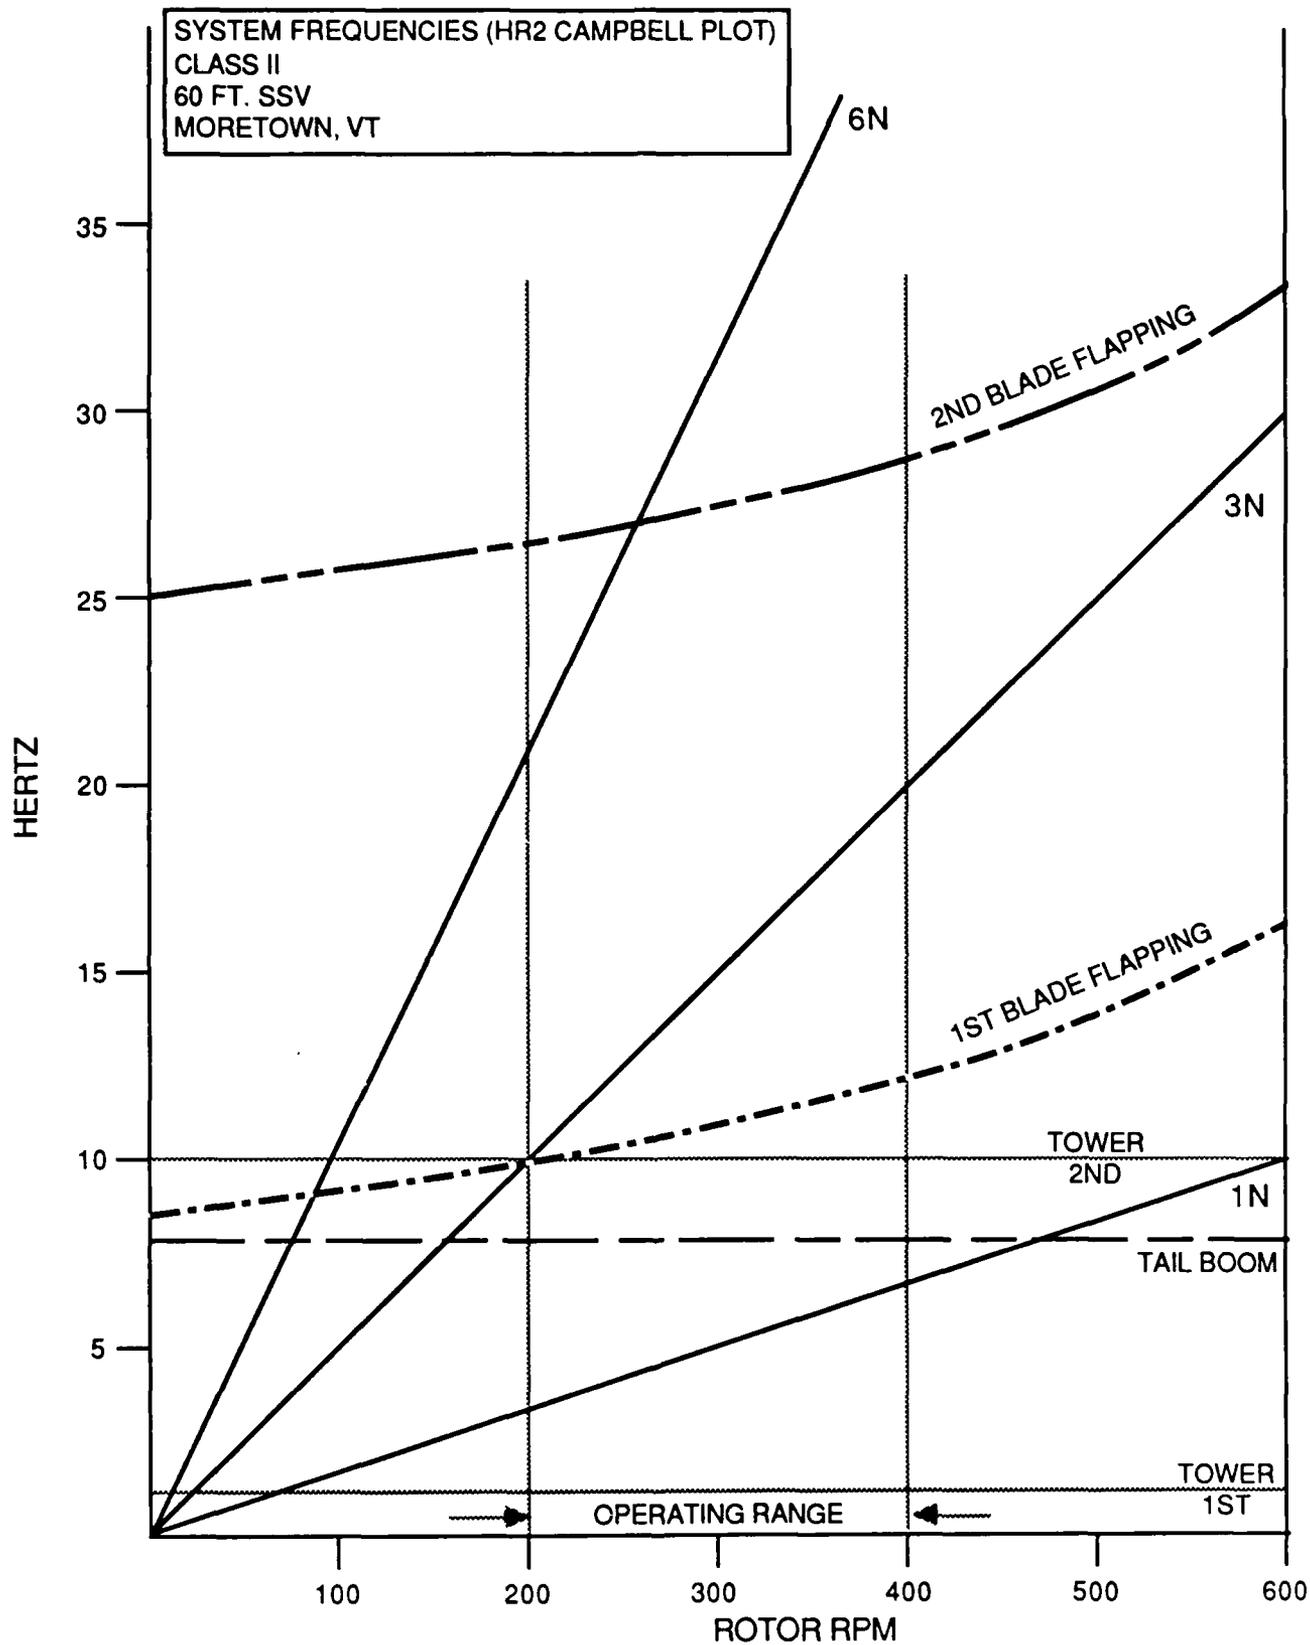
FIGURE 11. TOWER HARMONICS AS RELATED TO HR2 RPM

Coast Guard personnel observe normal tower vibration during site visit probably due to system harmonics, (see Figure 11).
