STAGE I AND II PLATFORM STRENGTH EVALUATION OFFSHORE

PANAMA CITY FLORIDA (U) BARNETT AND CASBARIAN INC

METAIRIE LA FEB 81 CHES/NAUFAC-FPO-8331A

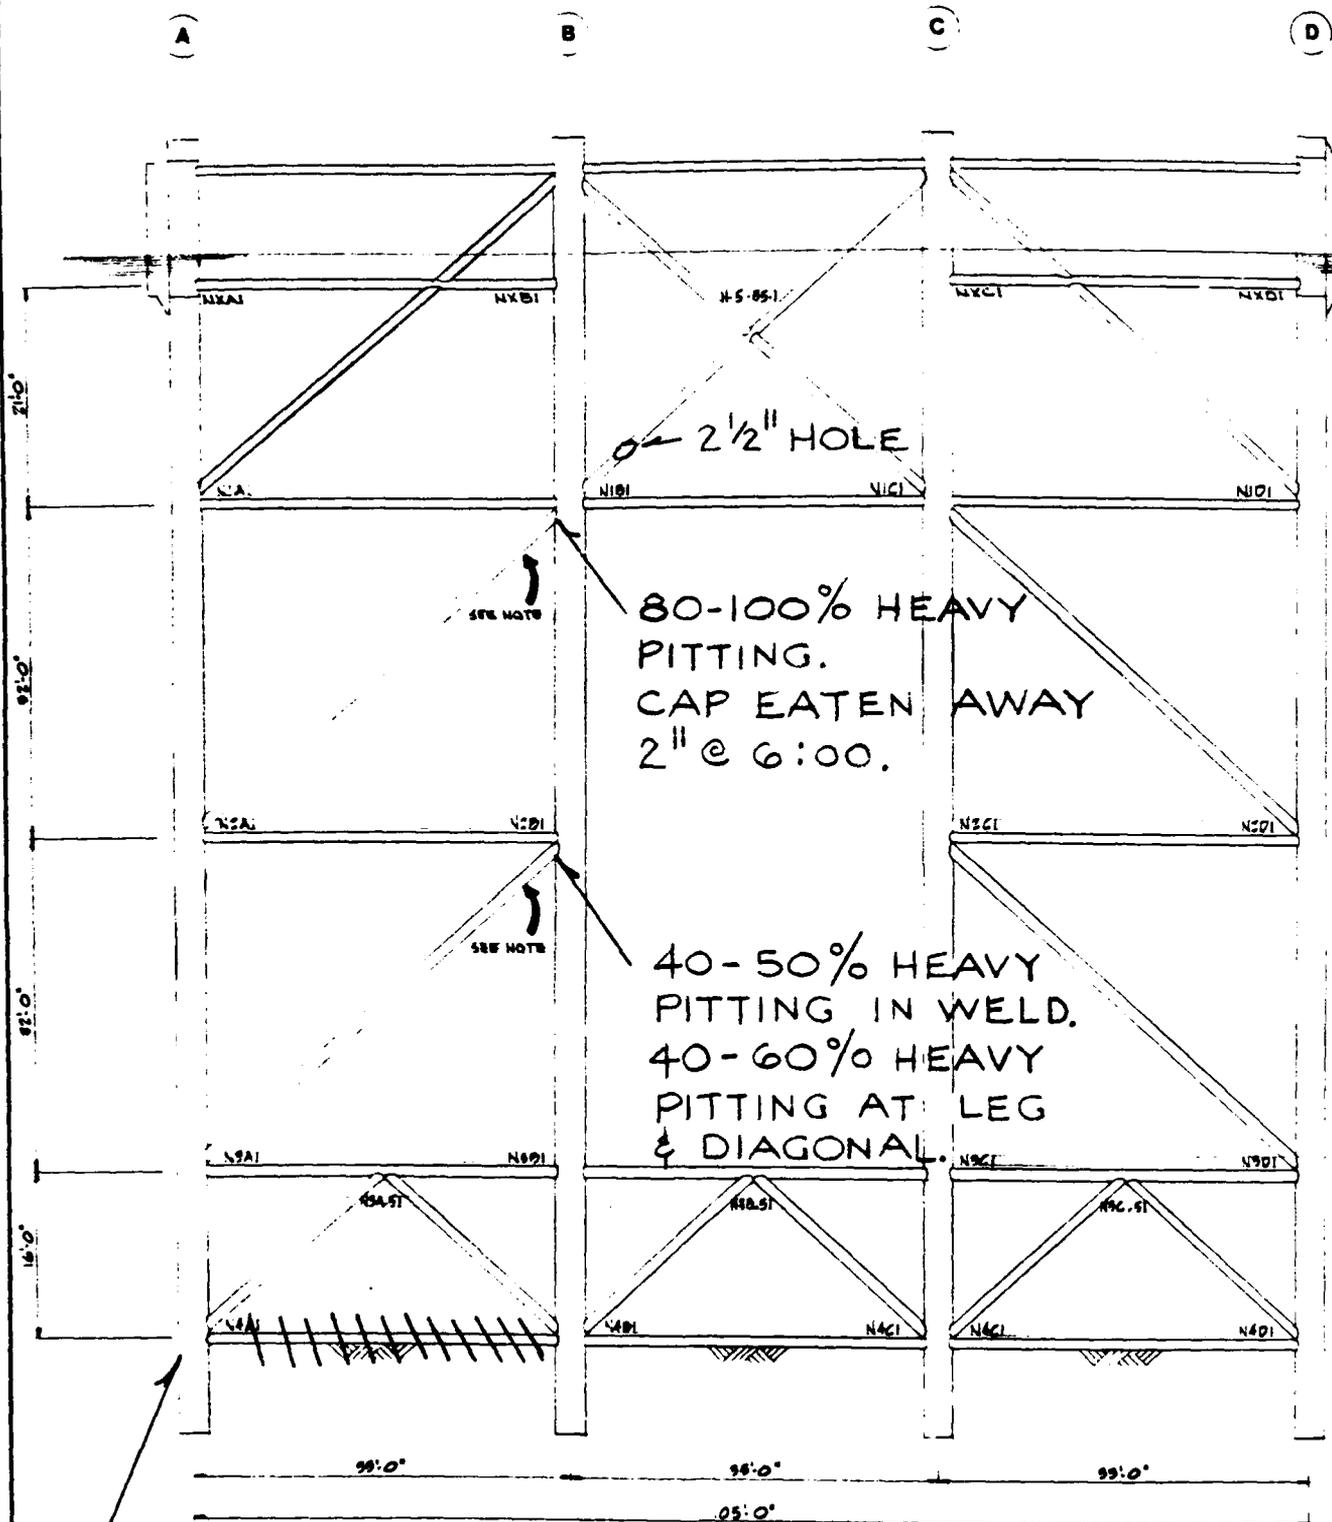
2 ANODES RUBBING ON INNER PART OF LEG. ROW "1"
 6" TO 1' BARE METAL IS VISIBLE ON LEG.

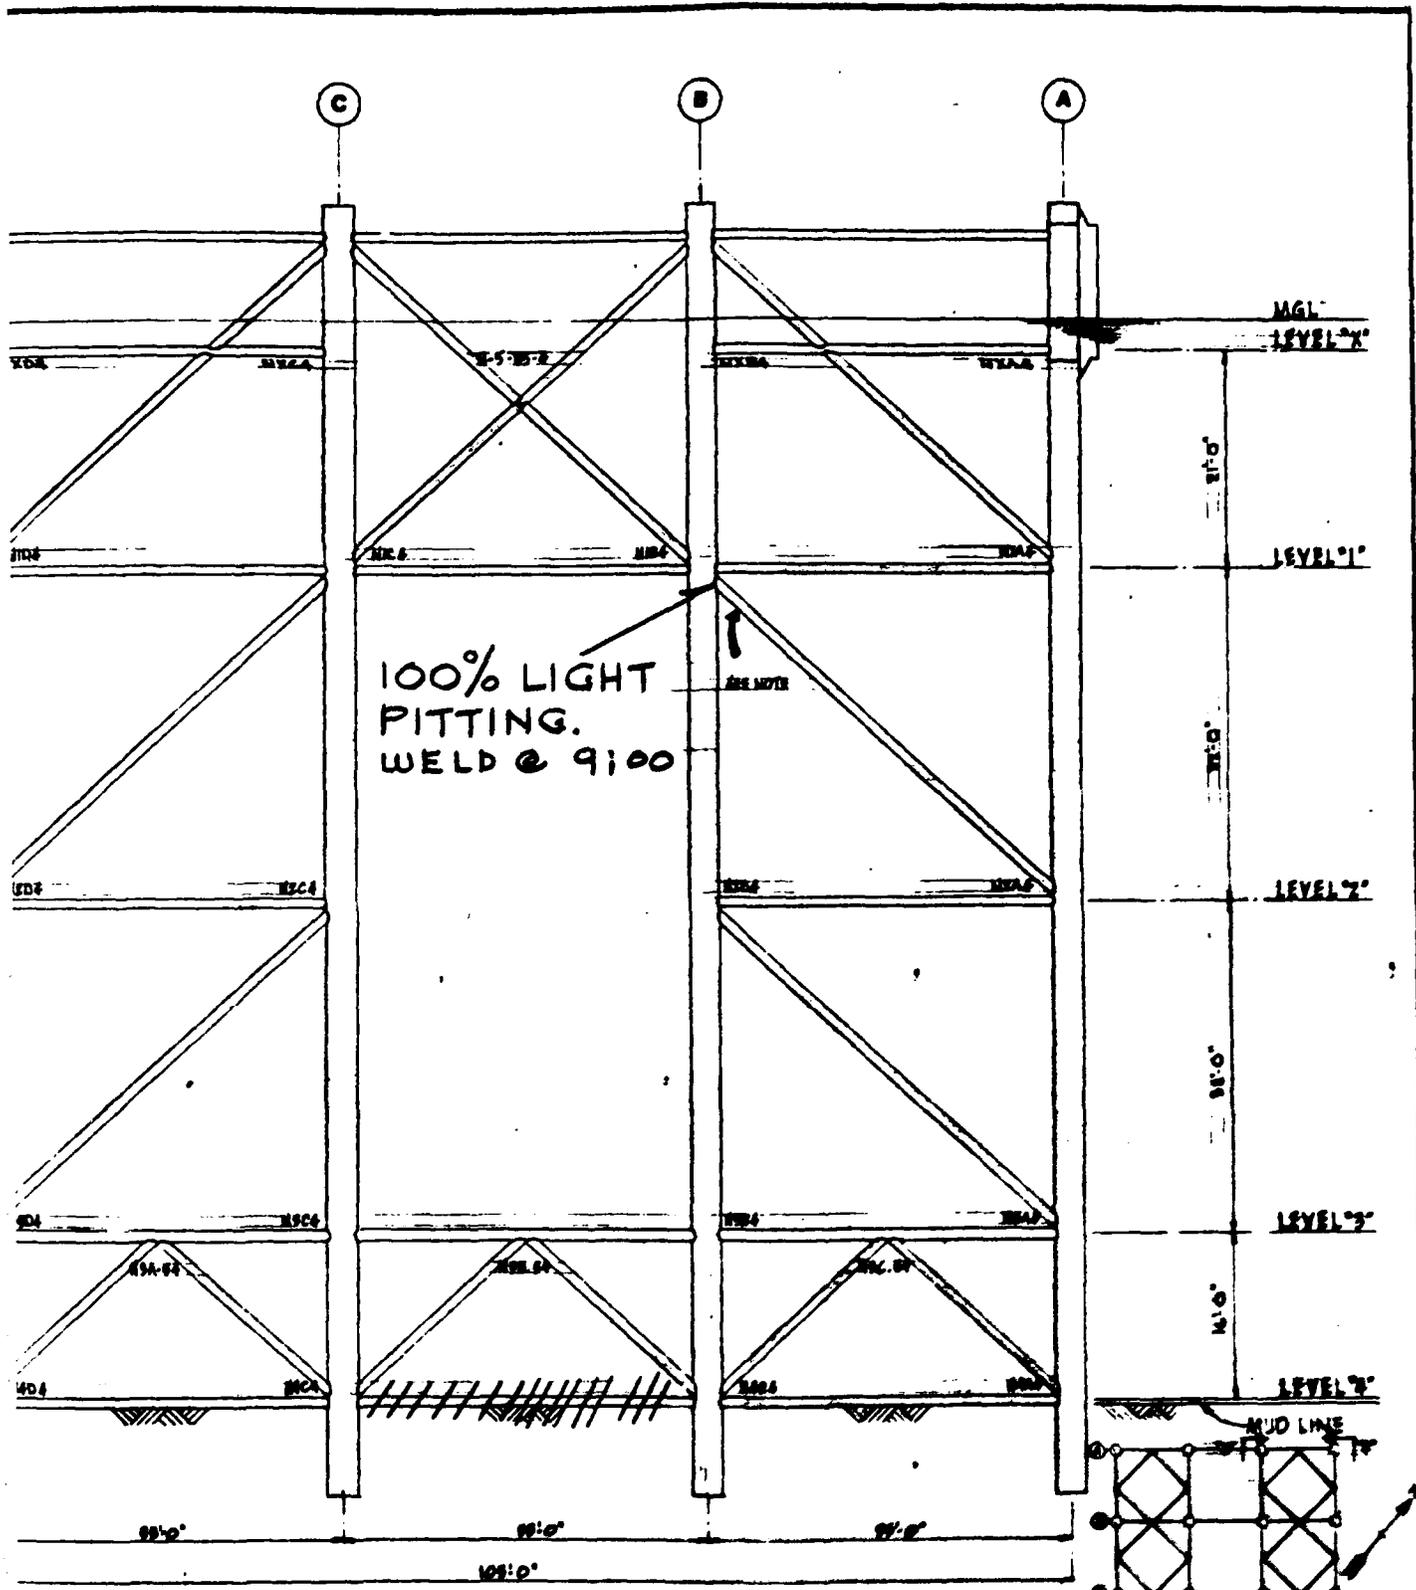
STAGE 3, ROW '5' & ROW '4'	
BC-006A

100% LIGHT FITTING.
WELD @ 9100

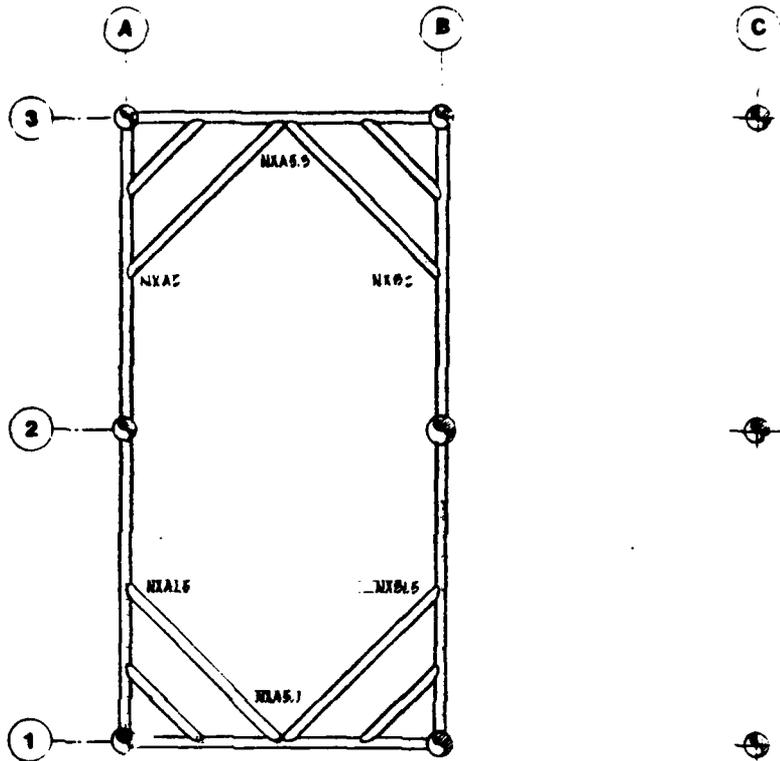
LEVEL "X"

6' CABLE SCAR

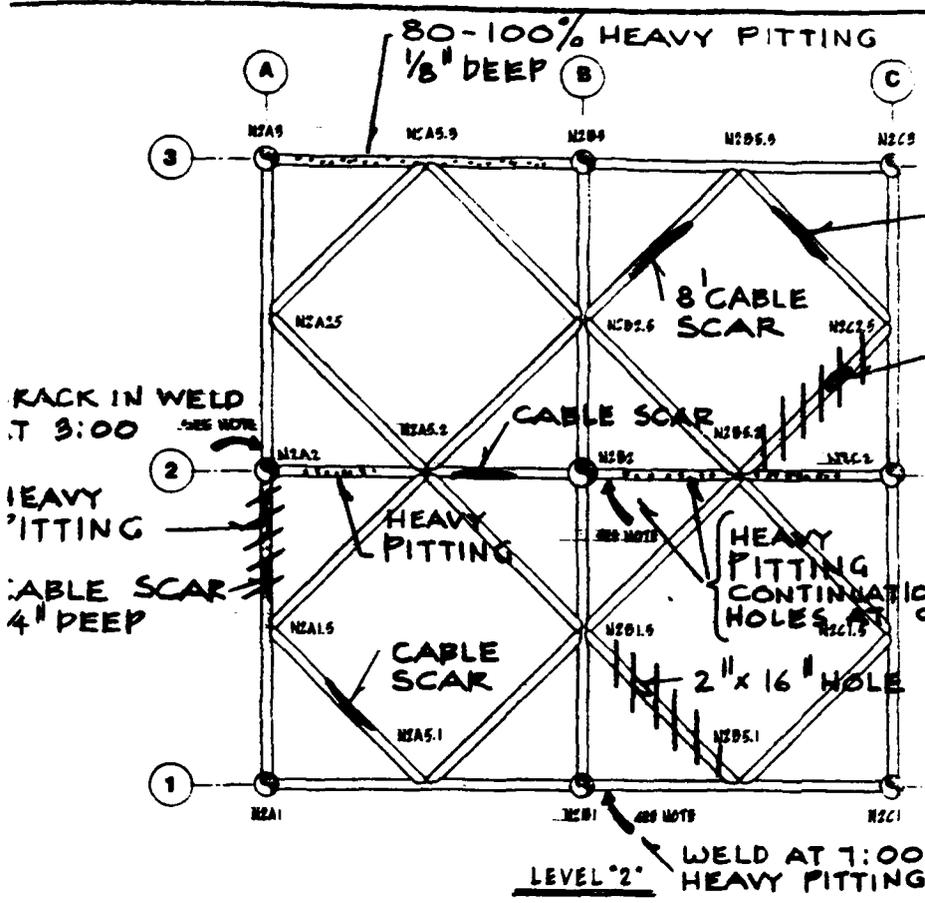
GENERAL LIGHT PITS OCCURRING ALL OVER.

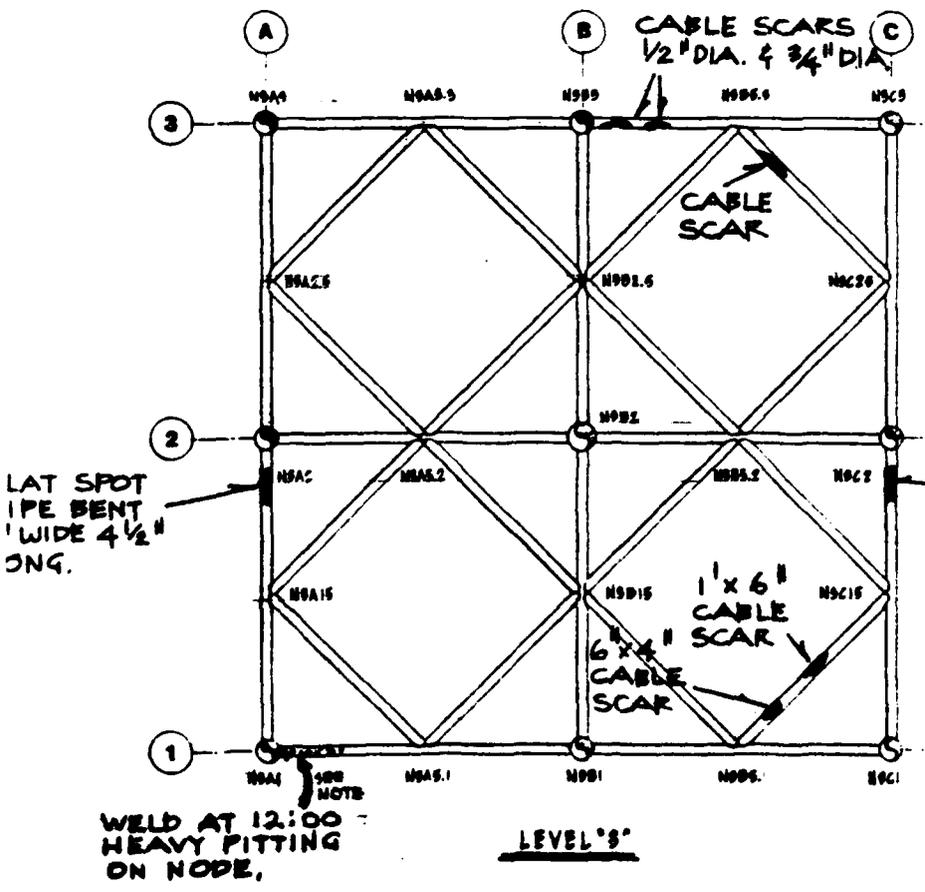
FLAT SPOT 3' LONG

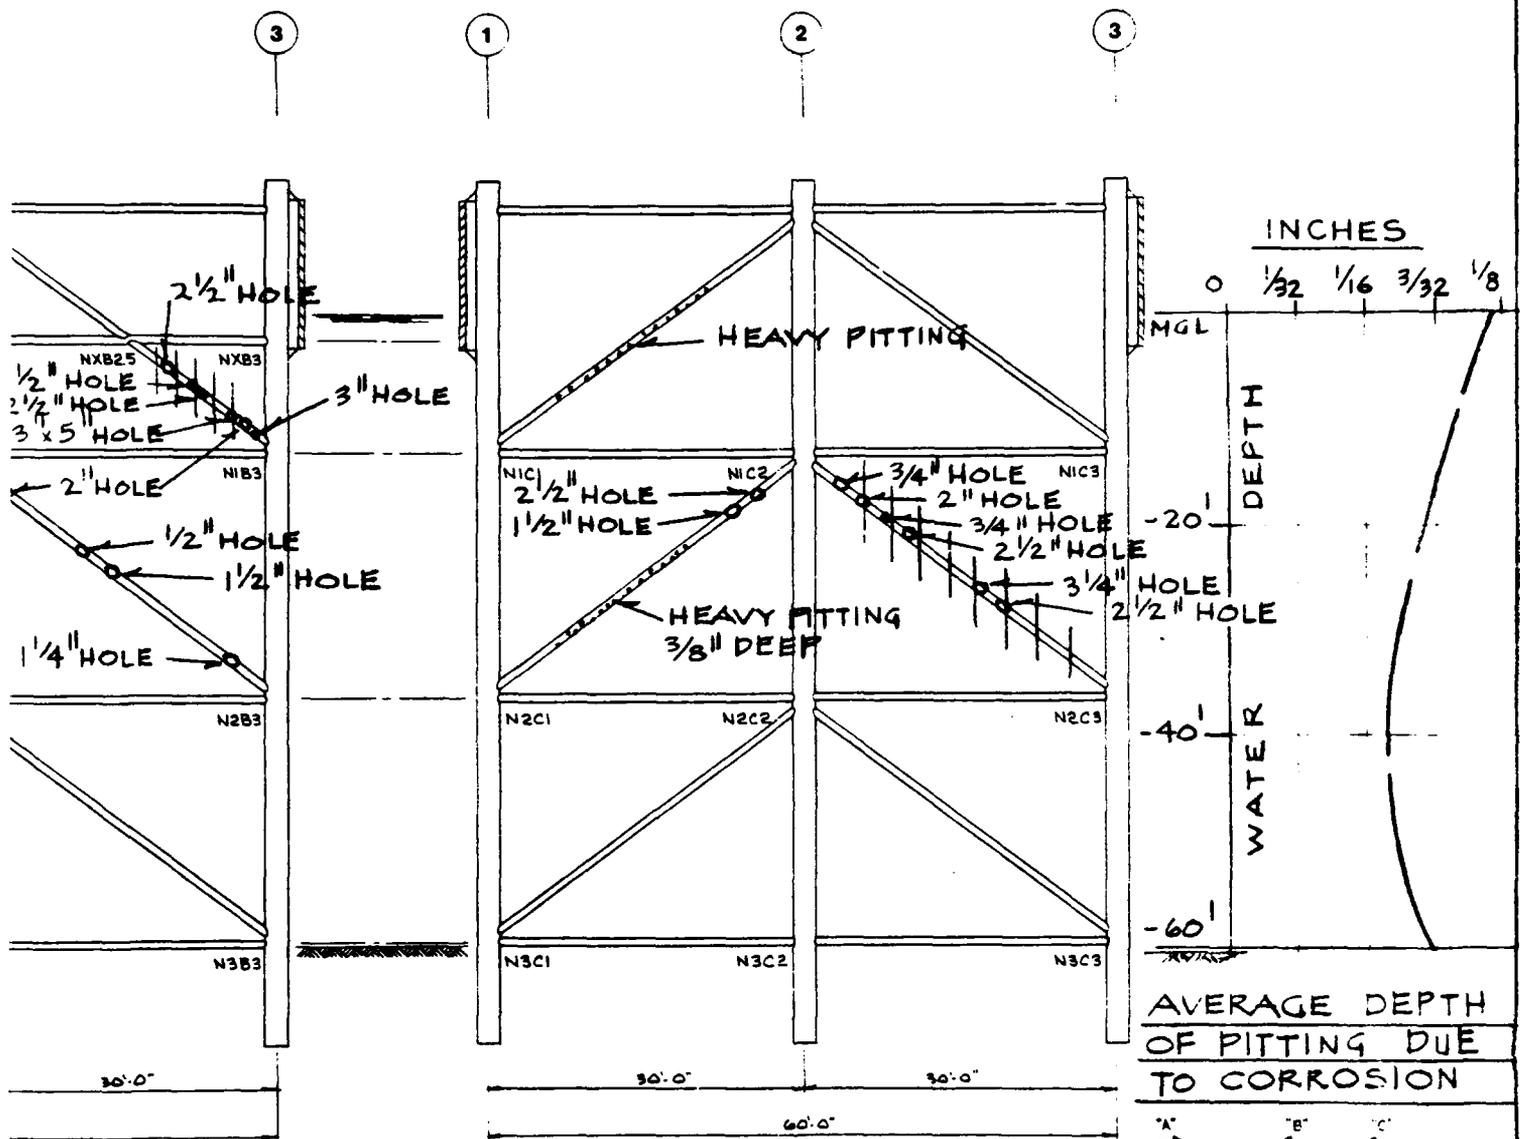
FACE "C"

AVERAGE DEPTH OF PITTING DUE TO CORROSION

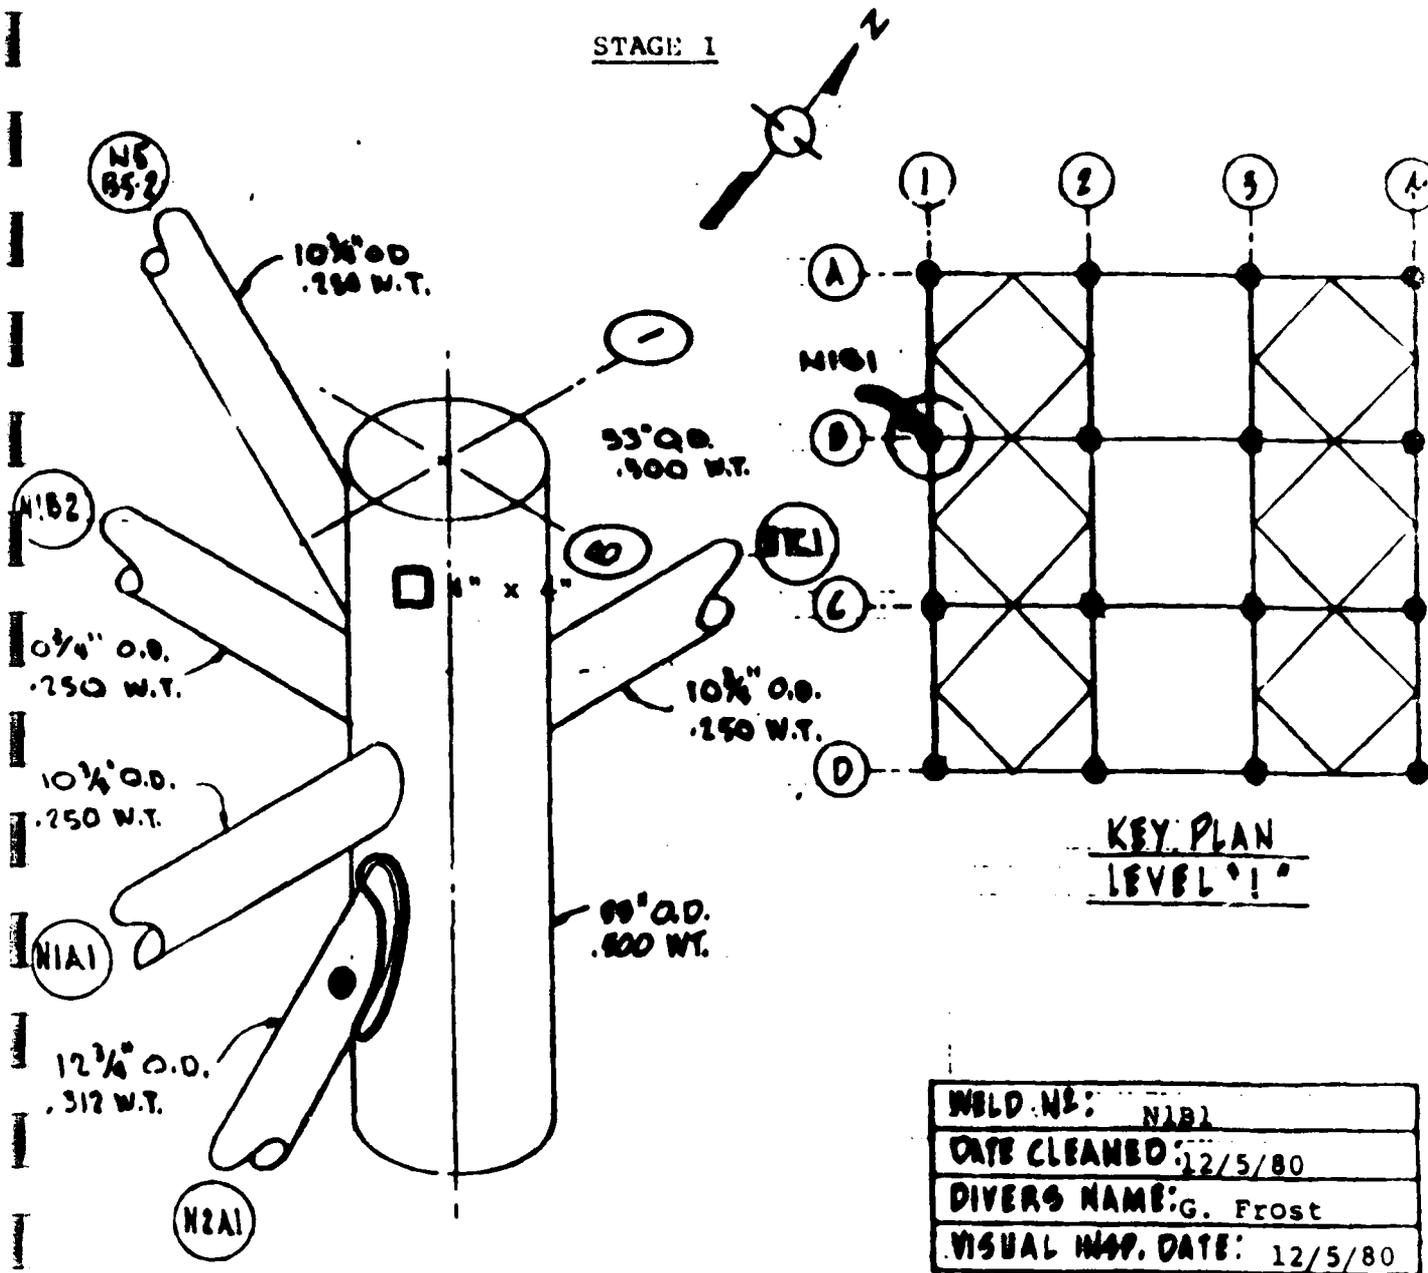
Fig. 2.1.12

CP 654
Bio-Fouling 1"

Large pits at 5:00 and 6:00
Weld cap eaten away 2" at 6:00
3/16" deep pit in brace

The sketch shows in yellow, areas on leg B-1 and at the B-1 junction of the brace down to N2A1, which are illustrated on the following pages. This is the format used for documentation of the seven locations selected for inspection. Clock-face designations are used to describe locations of the junctions of the braces. For example, the 3:00 side of the vertical diagonal junction is indicated by a star.

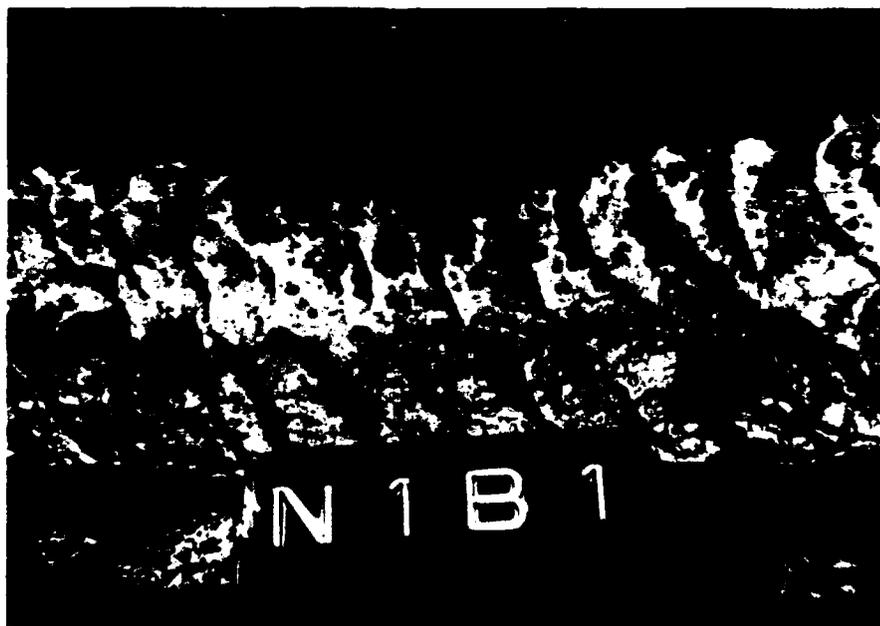
Fig. 2.1.14

Close-ups of same NiB1 weld. Upper photo shows pitting and under-cutting in weld. The photo below is of 4:00 portion of weld where weld is undercut on brace side.

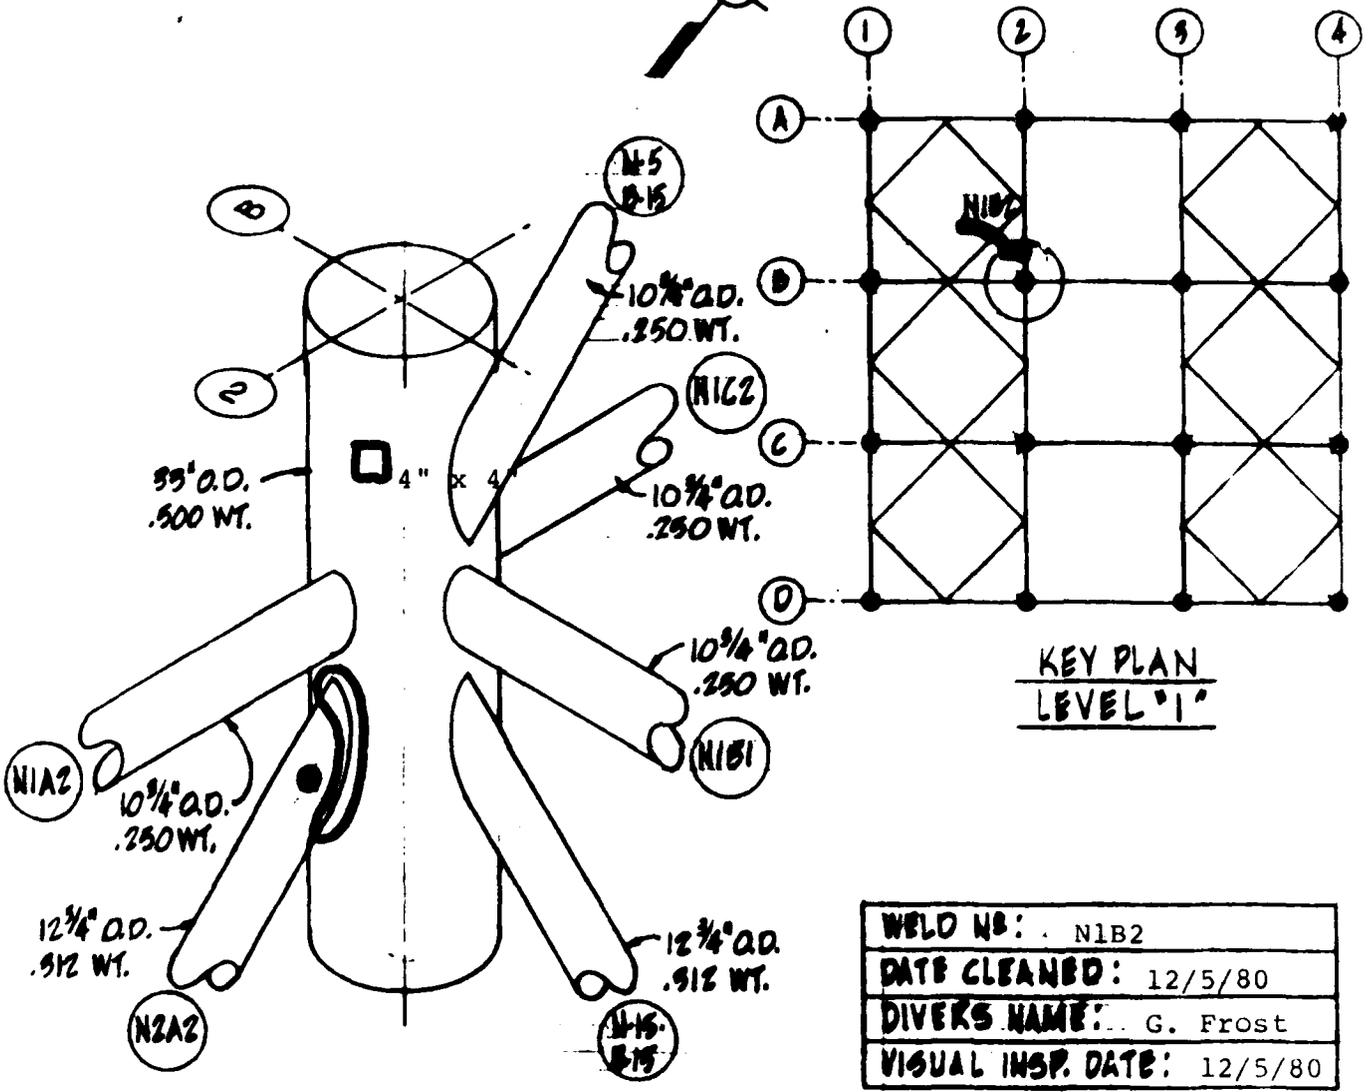
Fig. 2.1.16

WELD NO:	N1B2
DATE CLEANED:	12/5/80
DIVERS NAME:	G. Frost
VISUAL INSP. DATE:	12/5/80

CP 653
Bio-Fouling 1-5/8"

Weld at 8:00
 Numerous pits 1/8" to 3/16" deep

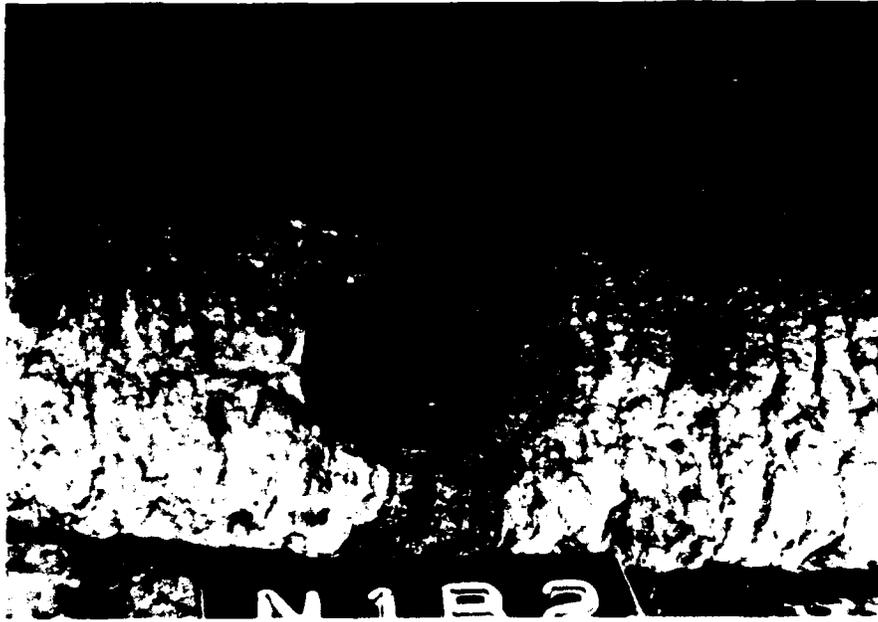
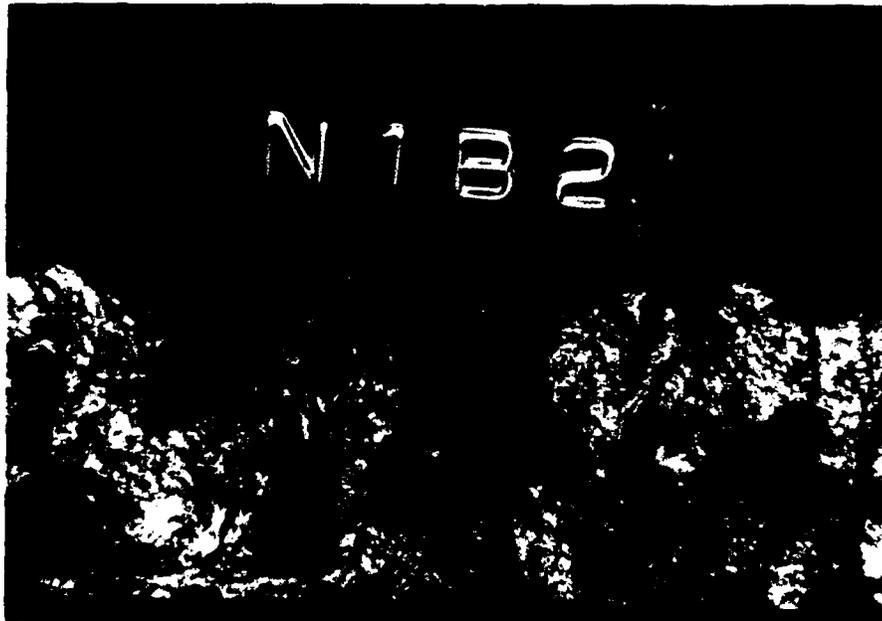
Fig. 2.1.18

Above is close-up of the largest of the pits near 8:00, which is 1/4 inch deep and 1/2 inch in diameter. Below is the 3:00 portion of weld.

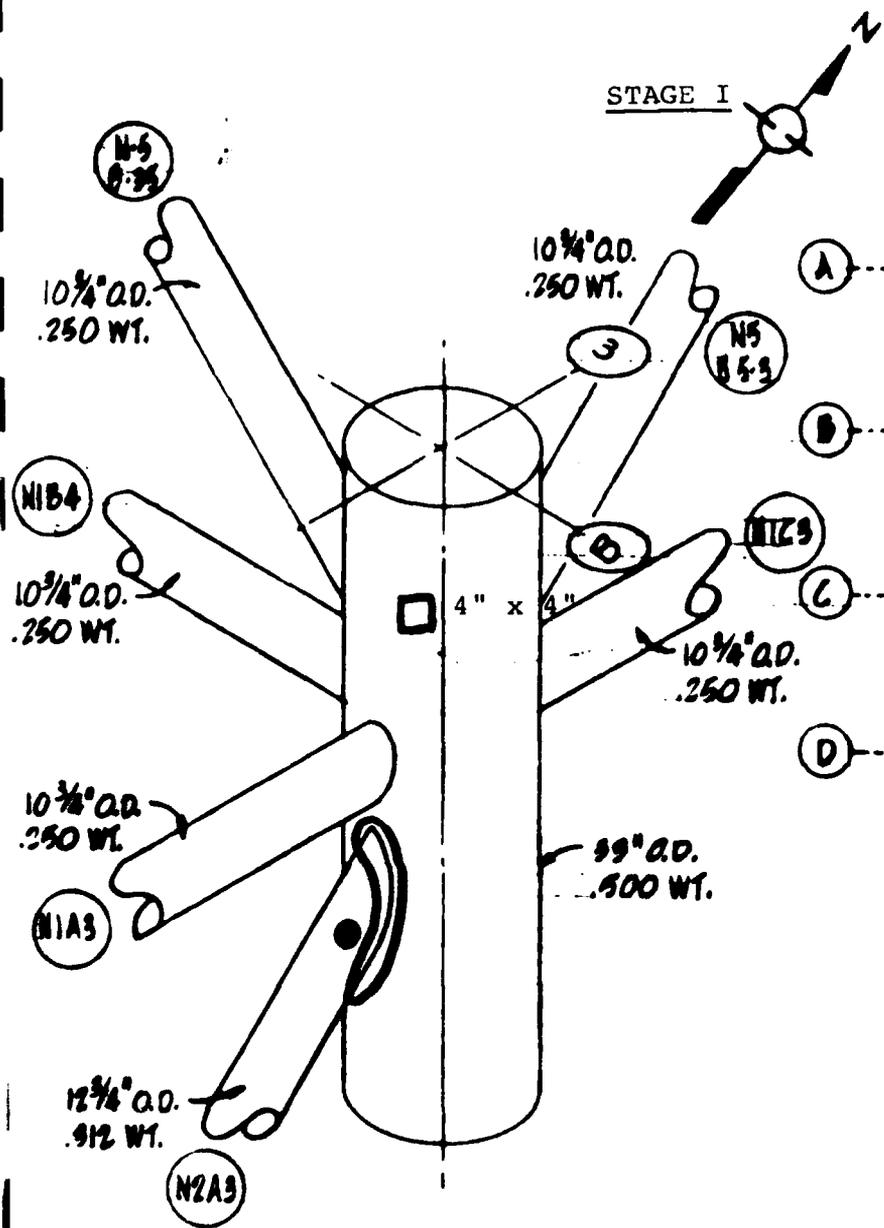
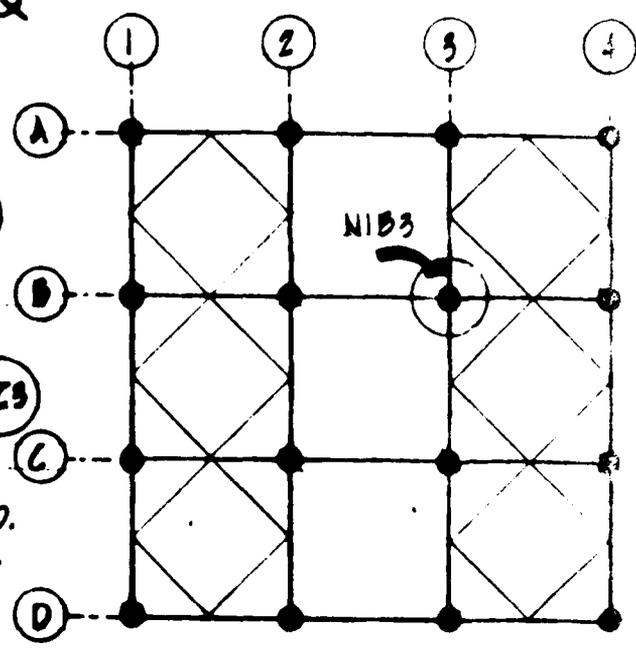
Fig. 2.1.20

WELD NO:	N1B3
DATE CLEANED:	12-8-80
DIVERS NAME:	S. Manlove
VISUAL Insp. DATE:	12-8-80

CP 614, 619
Bio-Fouling 1-1/2"

Weld at 10:00
3/8" deep pits in weld

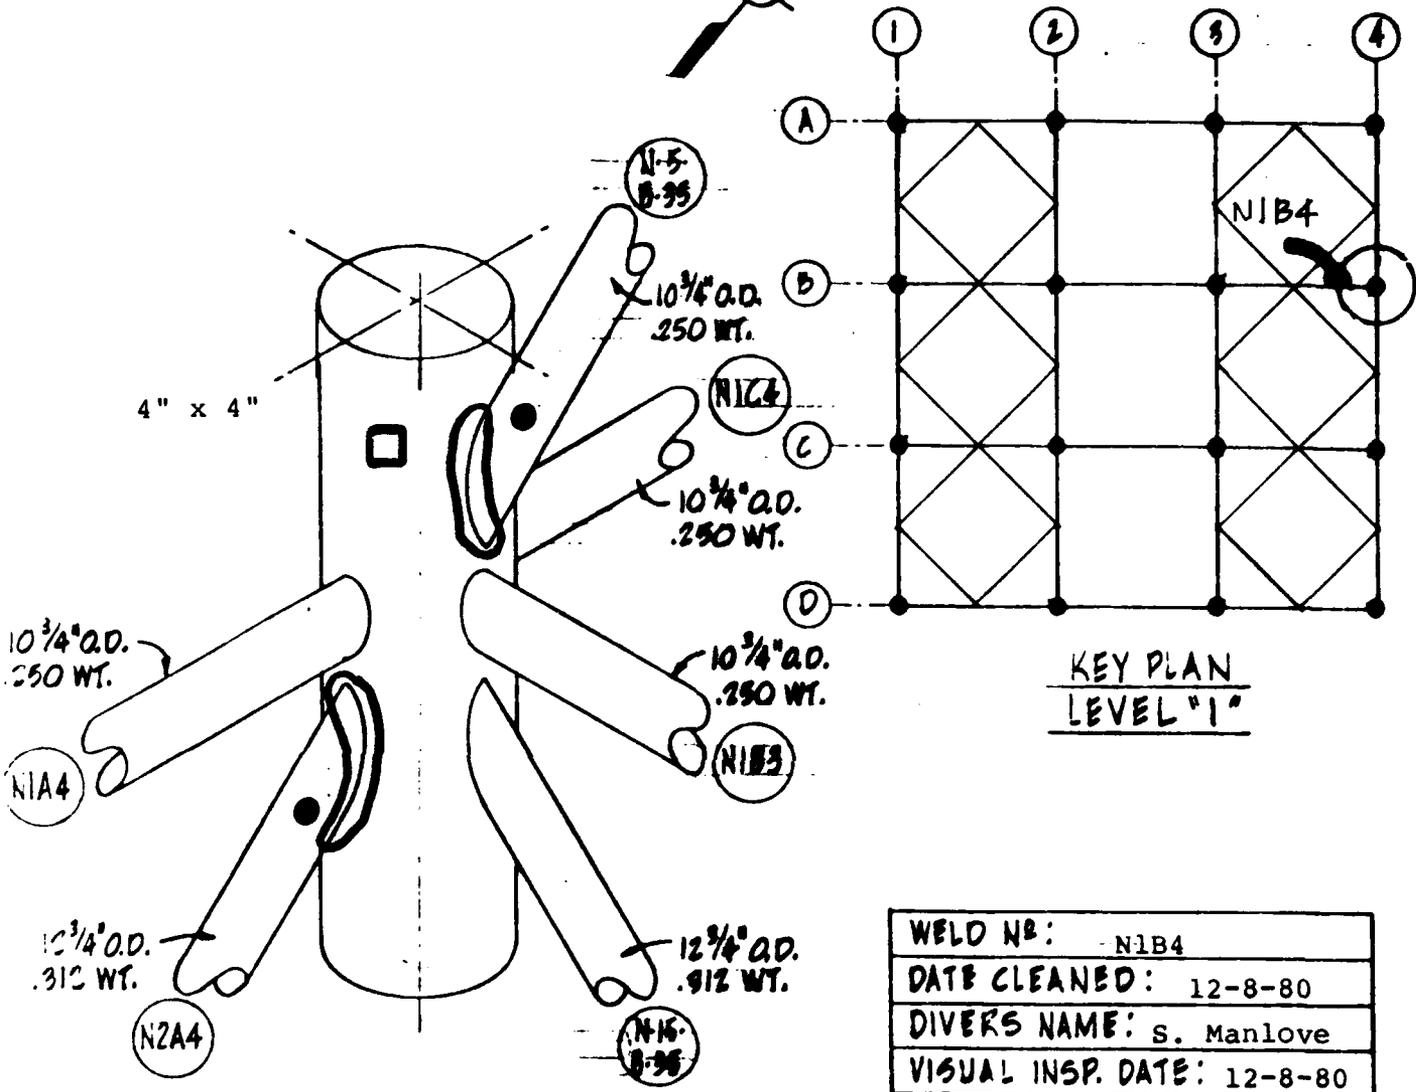
Fig. 2.1.24

WELD NO:	N1B4
DATE CLEANED:	12-8-80
DIVERS NAME:	S. Manlove
VISUAL INSP. DATE:	12-8-80

Weld at 9:00 to N2A4
100% light pitting

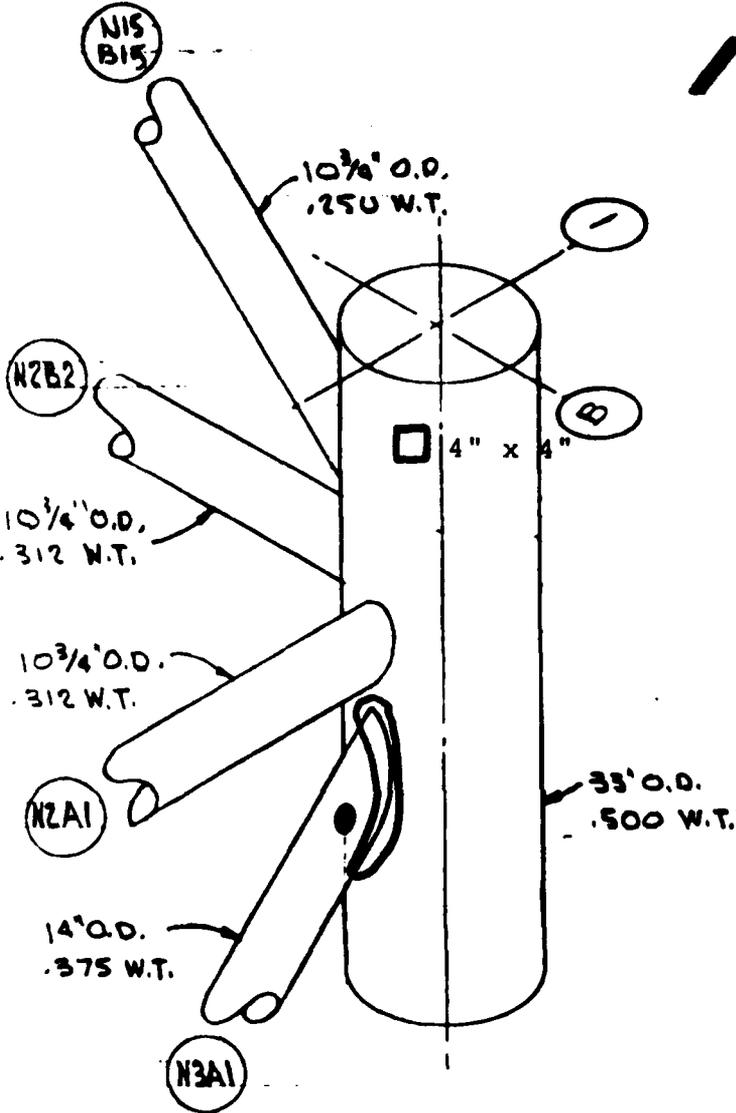
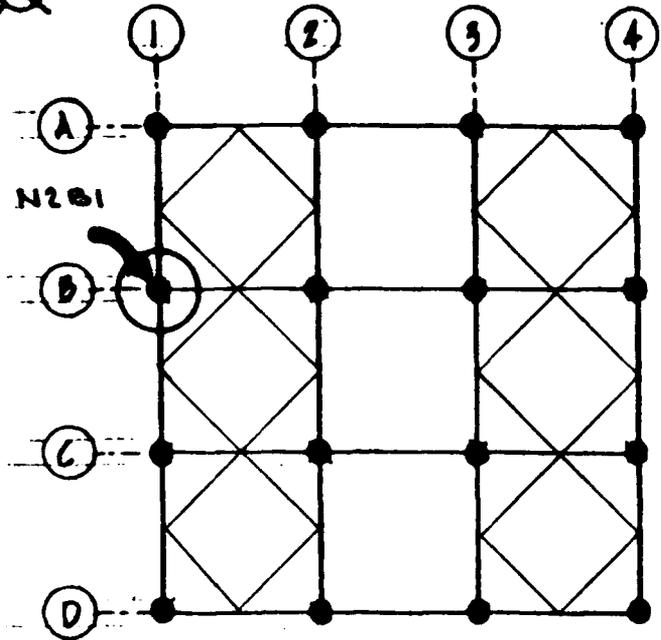
Fig. 2.1.28

WELD NO:	N2B1
DATE CLEANED:	12/5/80
DIVERS NAME:	G. Frost
VISUAL INSP. DATE:	12/5/80

4" x 4" sq.
 $\frac{1}{8}$ " deep pit, $\frac{1}{2}$ " wide,
 $\frac{3}{4}$ " long

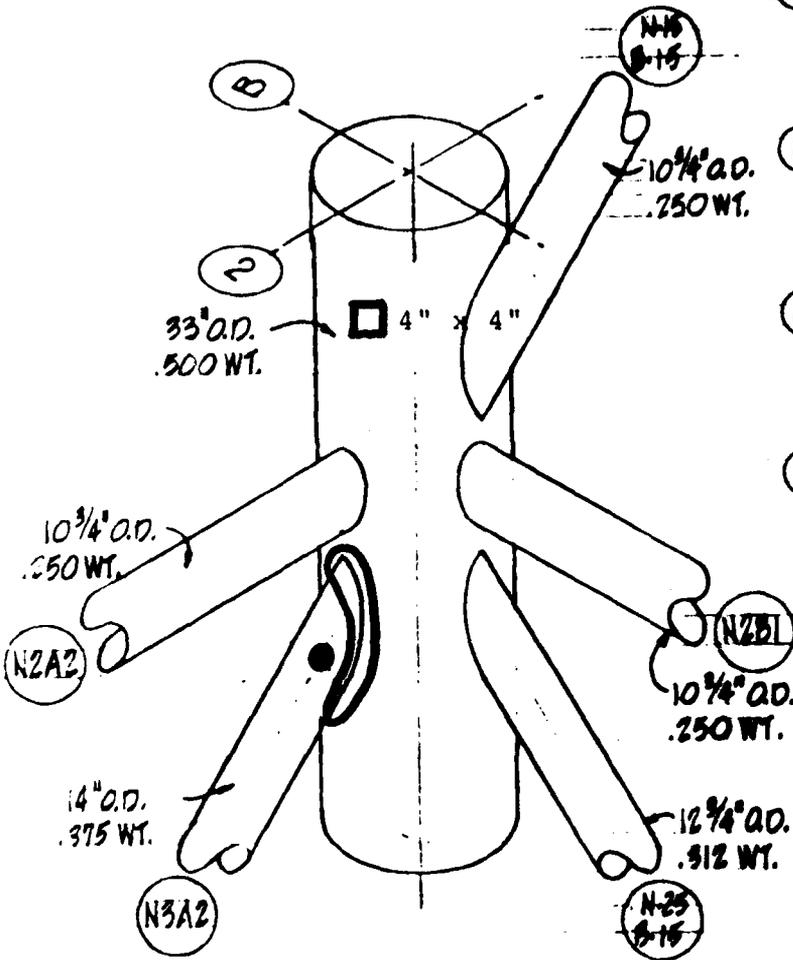
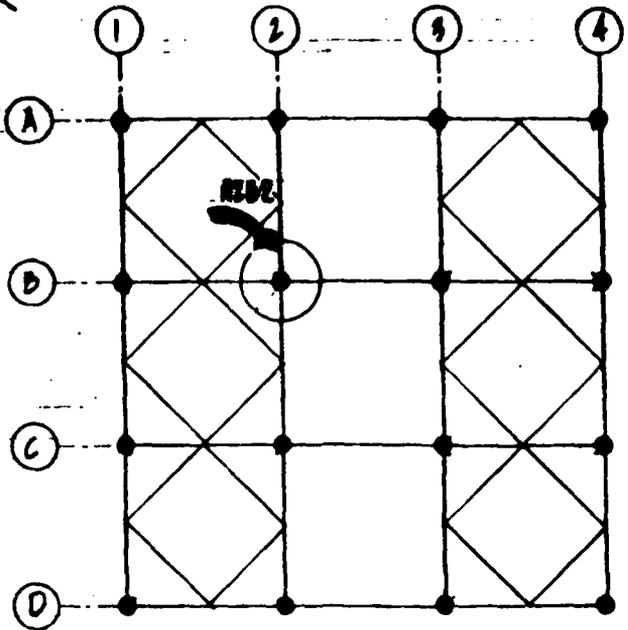
Fig. 2.1.32

WELD NR.: N2B2
DATE CLEANED: 12/5/80
DIVERS NAME: G. Frost
VISUAL INSP. DATE: 12/5/80

4" x 4" sq.
Numerous pits in jacket leg

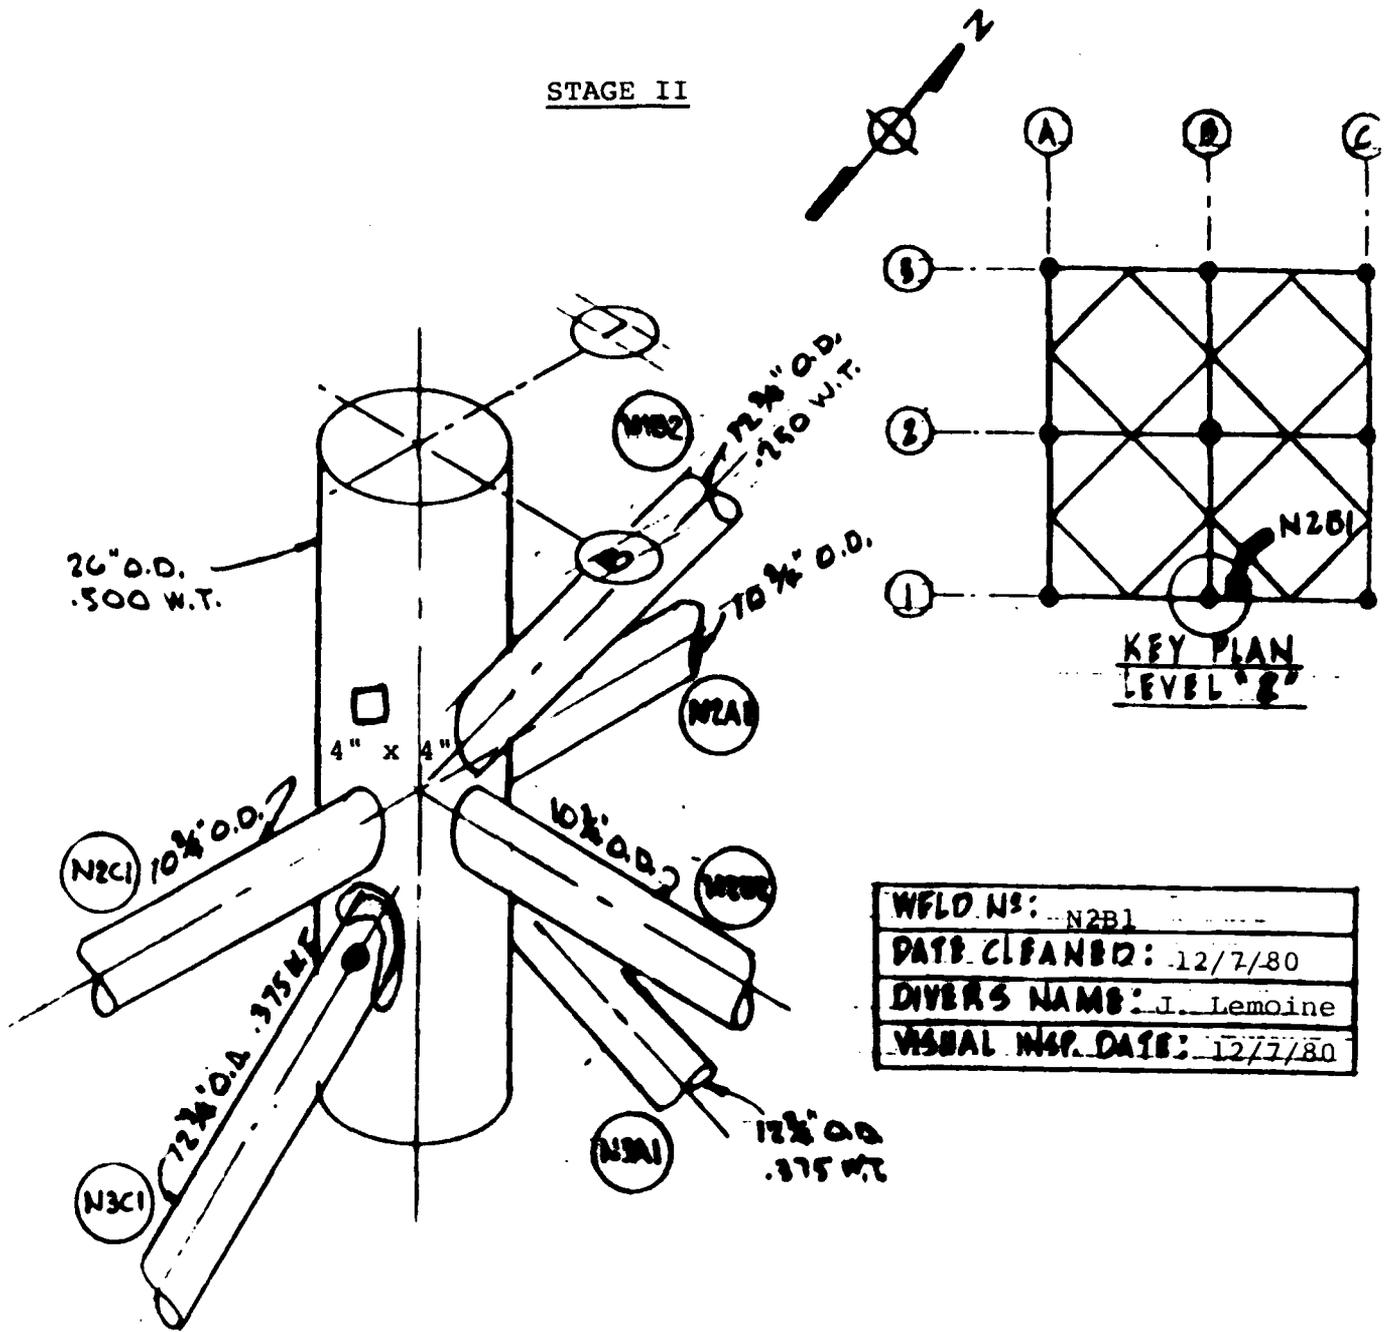
Fig. 2.2.17

WELD NO:	N2B1
DATE CLEANED:	12/7/80
DIVERS NAME:	J. Lemoine
VISUAL Insp. DATE:	12/7/80

CP 672, 697
Bio-Fouling $\frac{1}{2}$ "

Weld at 7:00
 Heavy pitting

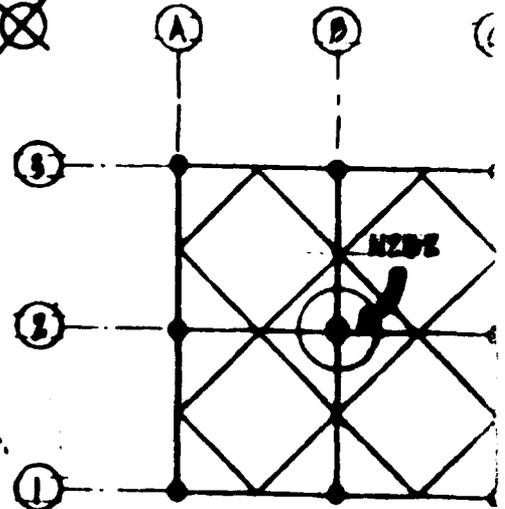
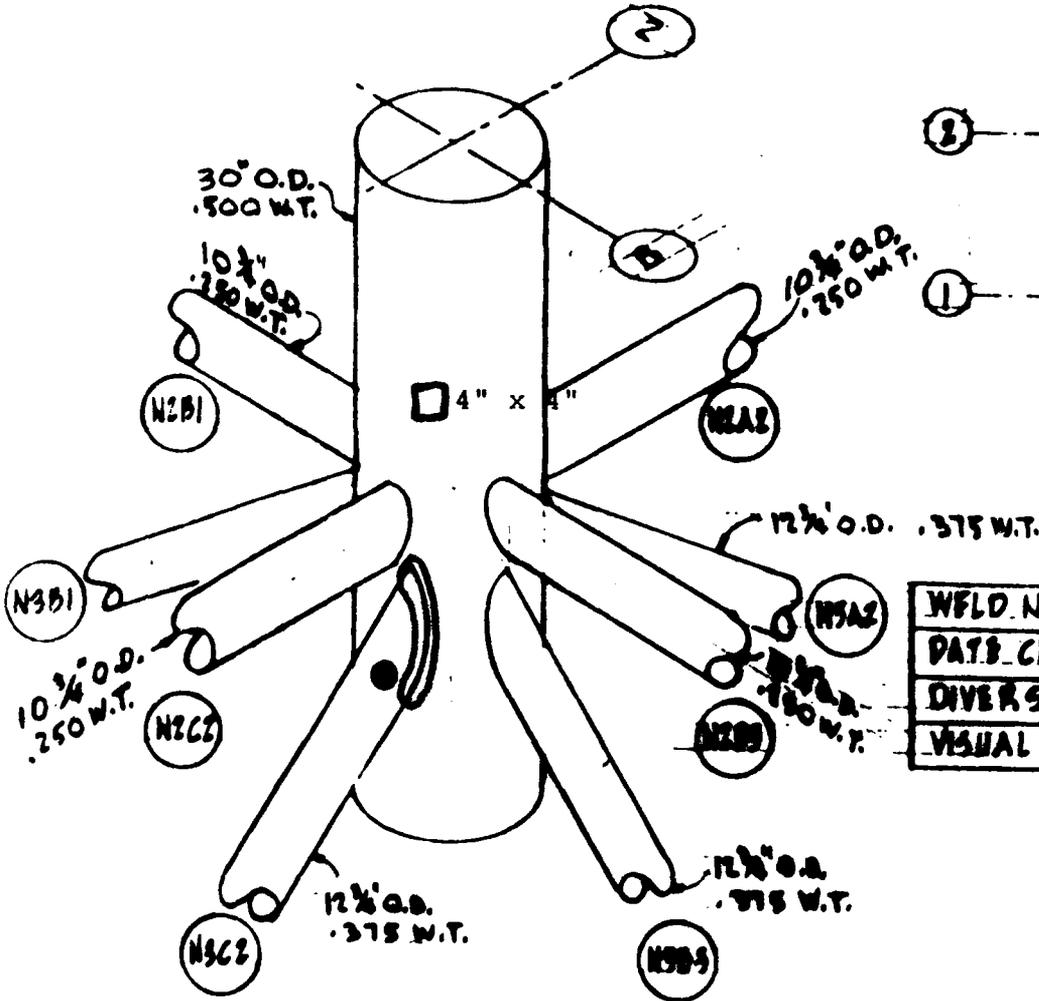
Fig. 2.2.22

WELD NO.:	N2B2
DATE CLEANED:	12/7/80
DIVERS NAME:	S. Manlove
VISUAL INSP. DATE:	12/7/80

NOTE: Diver was unable to detect hole prior to blasting, due to marine growth.

Weld area at 7:00 -
Hole at 9:00 on brace.
100% pitting on brace.
