STAGE I AND II PLATFORM STRENGTH EVALUATION OFFSHORE

PANAMA CITY FLORIDA (U) BARNETT AND CASBARIAN INC

METAIRIE LA FEB 81 CHES/NAUFAC-FPO-8331A

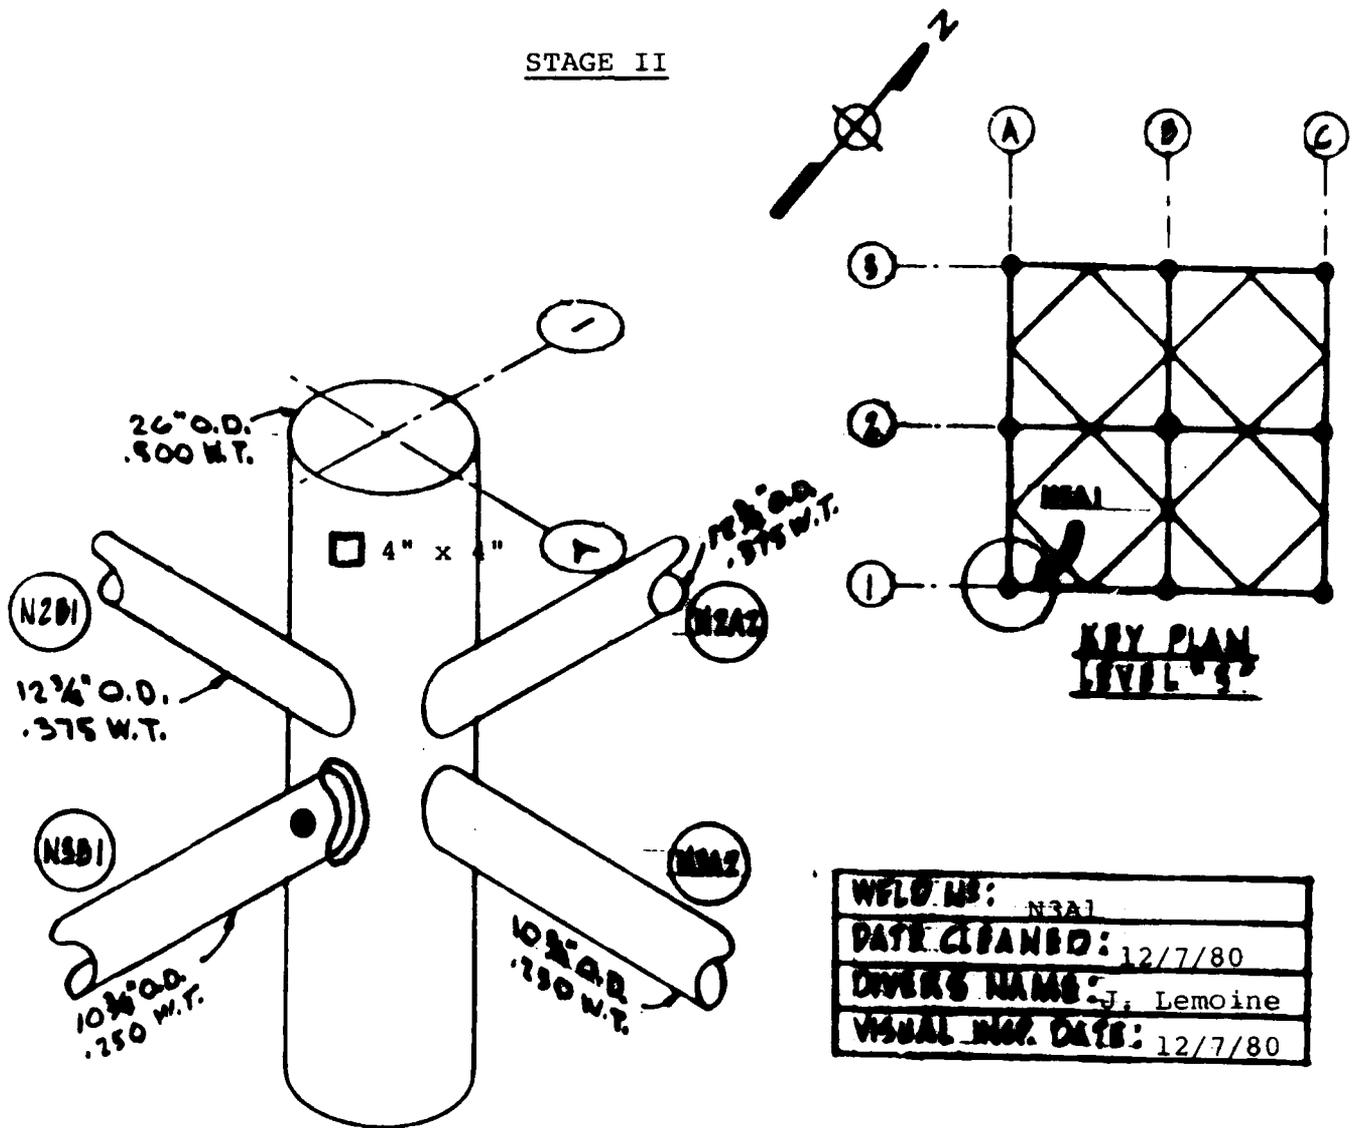
Fig. 2.2.29

WELD ID:	N3A1
DATE CLEANED:	12/7/80
DIVER'S NAME:	J. Lemoine
VISUAL INSP. DATE:	12/7/80

CP 660, 698
Bio-Fouling $\frac{1}{2}$ "

Weld at 12:00
 Heavy pitting on node.

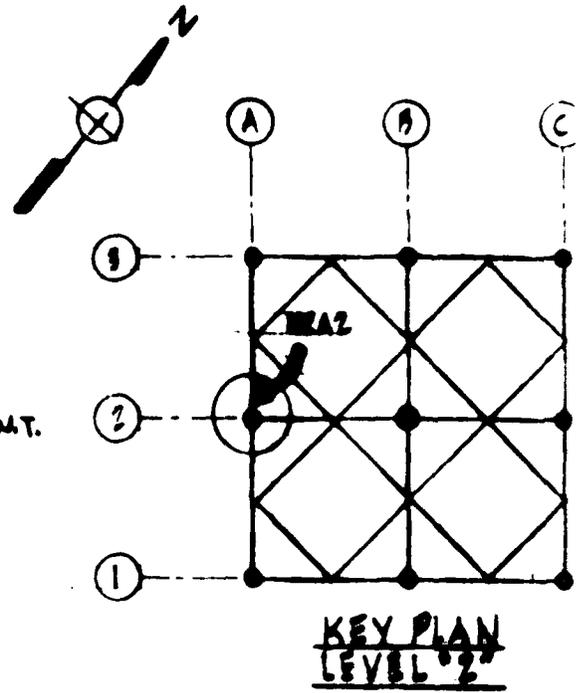
WELD NO: N2A2
DATE CLEANED: 12-7-80
DIVERS NAME: S. Manlove
VISUAL INSP. DATE: 12-7-80

NOTE: Diver reports that he was unable to detect damage noted above prior to water blasting, due to marine growth.

CP 649, 651
Bio-Fouling 1/2"
 N2A2 to N2A3 - Crack in weld
 at 3:00, 6:00, and 7:00.
