FAILURE ANALYSIS OF COMPOSITE STRUCTURE MATERIALS

Brian Smith
Ray Grove
Boeing Military Airplane Company
P.O. Box 3707 MS 73-43
Seattle, WA 98124

May 1987

Final Report for Period of 1 October 1985 to 31 August 1986

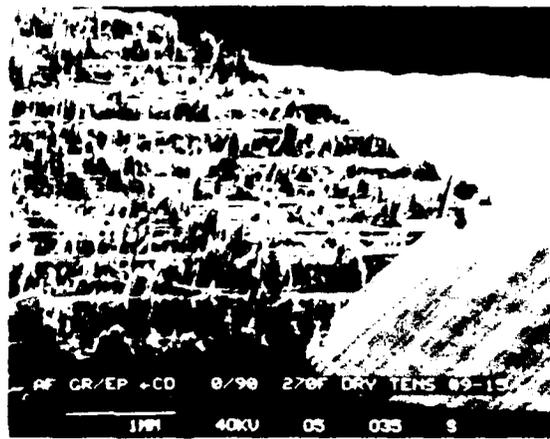
Figure 10. Low Magnification SEM Fractographs Illustrating Variation in Fiber Pullout With Temperature for 0/90-deg Laminates

For translaminar tension failures, alterations in the temperature of fracture were found to generate changes in the amount of fiber pull out. As illustrated for the 0/90 layup in figure 10, fracture at -65°F was found to produce relatively dense bundles of 0-degree fiber fracture. Fiber breakage within these bundles tends to occur along the same approximate plane. As a result, individual fiber pull out for this failure environment is

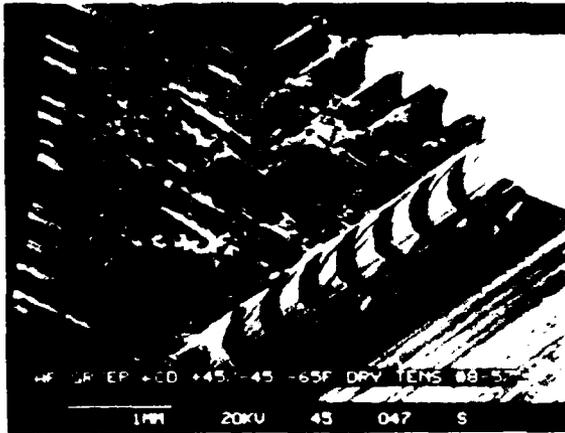
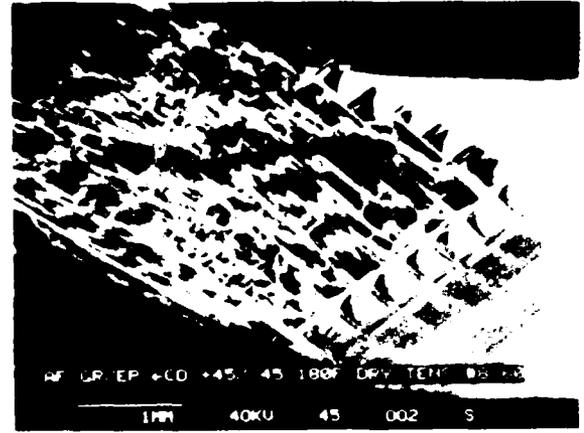
Figure 11. Low Magnification SEM Fractographs Illustrating Variation in Fiber Pullout With Temperature for +45/-45-deg Laminates

What is interesting is that these behaviors also appear to translate to 0/90 degree, +45/-45 degree (figure 11) and to a lesser extent, quasi-isotropic (figure 12) layups. This observation suggests that relative extremes in the environment prior to or during fracture may be identifiable for a variety of layups.

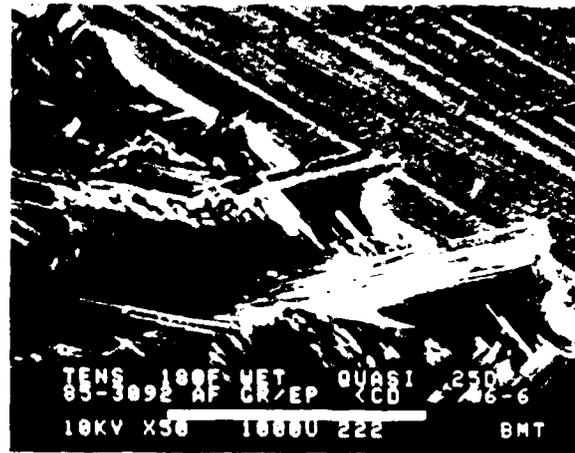
Figures 16 through 18 illustrate the gross morphology characteristic of 70°F, 180°F, and 270°F, wet, failures produced on 0/90, quasi-isotropic and +45/-45 degree laminates. Tensile loading for each laminate produced two basic modes of ply failure, tensile fiber fracture and intralaminar delamination. Tensile fiber fracture represents the more interesting of these two modes. As illustrated for each laminate orientation, the amount of fiber pull out increases dramatically with elevated temperature. This condition is particularly well illustrated in figure 18 for the +45/-45 degree laminate. Typically, the amount of fiber pull out exhibited by both dry and wet conditioned specimens increased in about the same manner. As a result, while relative extremes in fracture temperature can be identified, conditions of absorbed moisture do not appear to be discernable.

Figure 17. Low Magnification SEM Fractographs Illustrating Environmental Wet, Quasi-Isotropic Tensile Failures

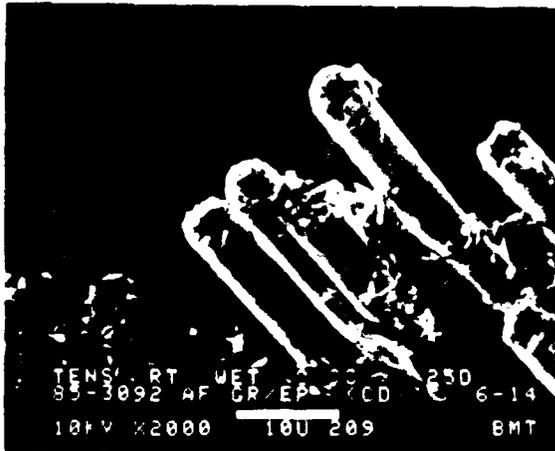
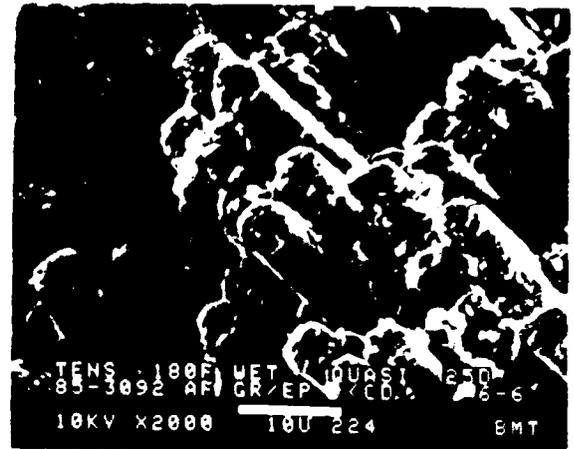
As noted in the above paragraph, examinations of tensile specimens revealed that the cumulative direction of individual fiber fracture coincides with the direction of the imposed fracture independent of environmental conditions prior to, or during, the actual fracture event. Figures 19 through 21 illustrate the directions of individual fiber fracture for each of the subject layups examined. As shown, the general direction of individual fiber fracture was found to progress in the direction of imposed crack propagation. This behavior was most pronounced for failures produced at 70°F. Typically, the heavily tiered structure characteristics of fiber pull out made SEM mapping difficult due to the limited numbers of fibers visible within the microscope depth of field. This difficulty was partially overcome by utilizing a 50 μ m objective aperture, instead of the normal 200 μ m aperture to provide an increased depth of field. As illustrated, even with this heavily tiered structure, the direction of crack

Figure 20. SEM Fractographs Illustrating the Direction of Individual Fiber Fractures for Environmental Wet, Quasi-Isotropic Tensile Failures

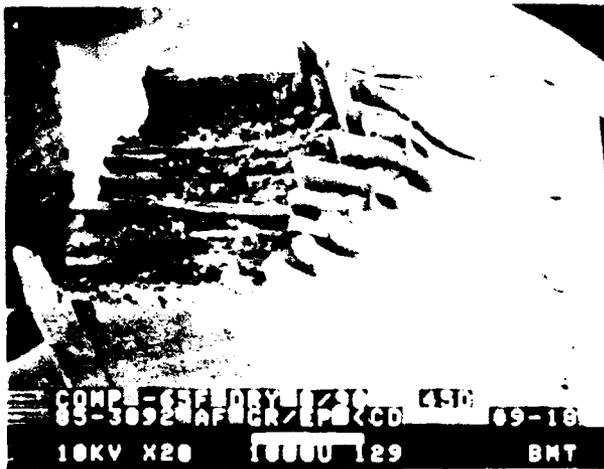
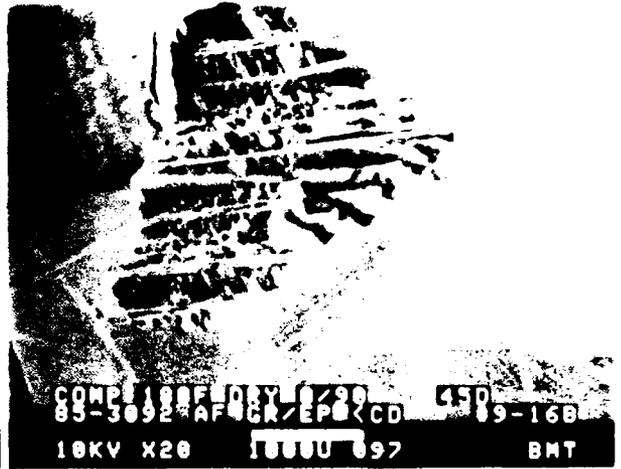
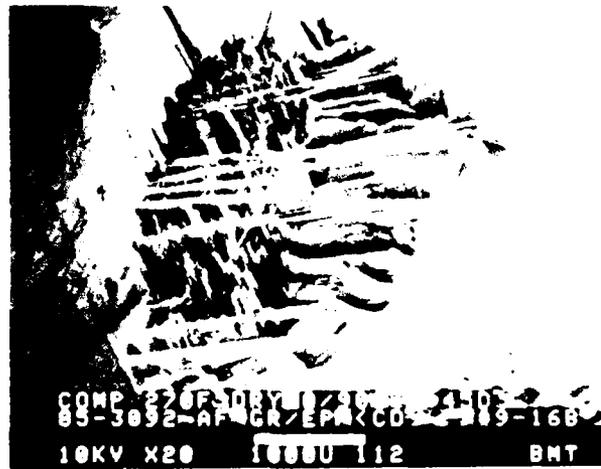
For translaminar compression fractures, failure under different temperature and absorbed moisture conditions was not found to produce any pronounced changes in fracture morphology. At low magnification each of the layups examined revealed a basic morphology consisting of distinct areas of tensile and compressive failure (see figures 22 through 25). Areas of compression fracture exhibited a flat, crushed morphology sharply contrasting the fibrous appearance of tensile fracture areas located near the end of this flexurally loaded specimen. As shown in these figures, variations in failure temperature from -65°F (-54°C) to 270°F (132°C) increased the relative size of compression fracture area but did not alter this basic morphology.

Figure 23. Low Magnification SEM Fractographs Illustrating Similar Appearances of Translaminar Compression Fracture at Different Temperatures for 0/90-deg Laminates

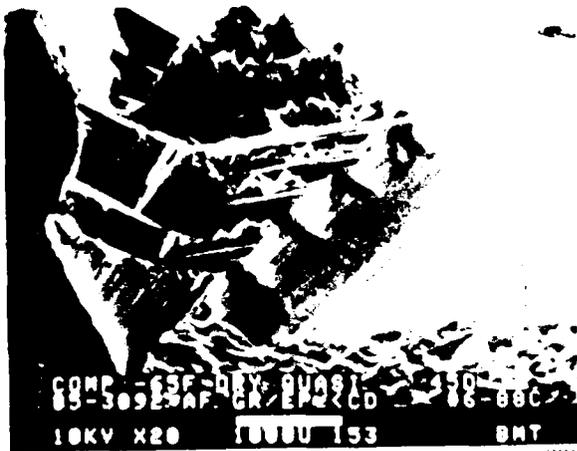
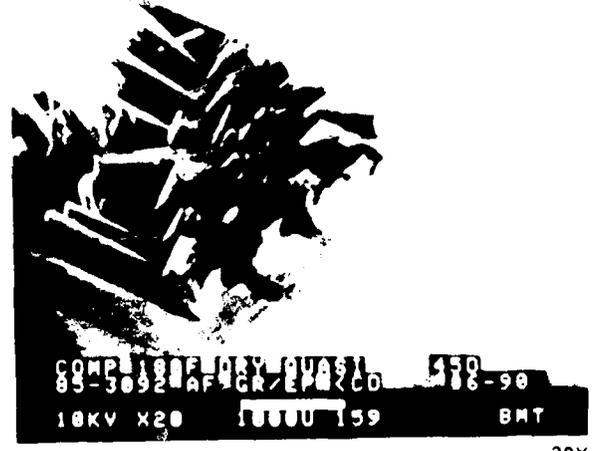
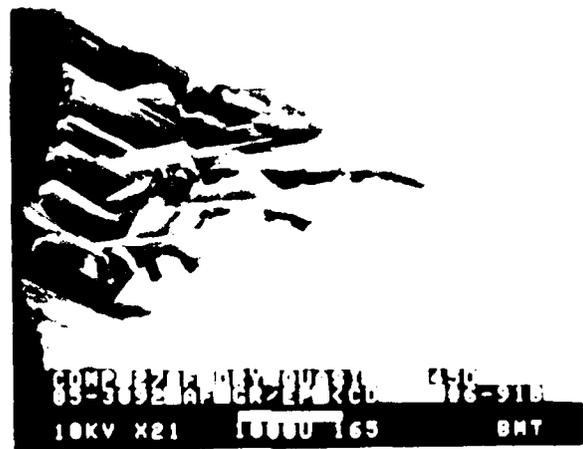
Figure 24 Low Magnification SEM Fractographs Illustrating Similar Appearances of Translaminar Compression Fracture at Different Temperatures for Quasi-Isotropic Laminates

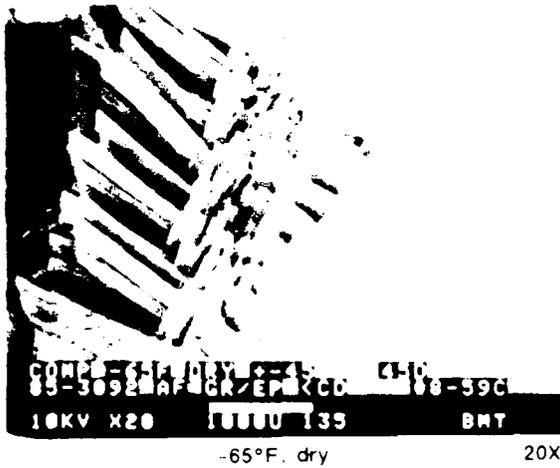
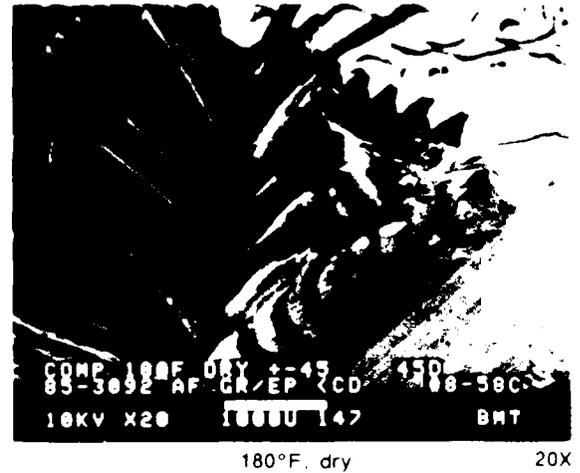
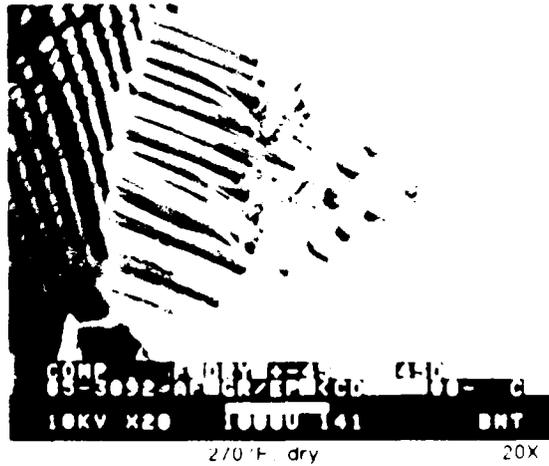
Figure 25 Low Magnification SEM Fractographs of Translaminar Compression Fracture at Different Temperature for +45/-45-deg Laminates

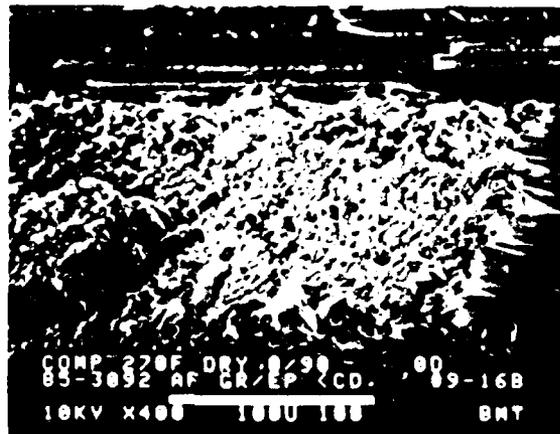
Figure 27 SEM Fractographs Illustrating Similar Appearances of Translaminar Compression Fracture at Different Temperatures for 0/90-deg Laminates

-65°F, dry 400X

180°F, dry 400X

270°F, dry 400X

The above results indicate that, while the overall mode of failure may be identifiable, no specific features exist indicative of either the environment or direction of crack propagation. While this finding suggests translaminar compression fractures to be relatively intractable, it is worthwhile to remember that significant amounts of delamination commonly accompany translaminar compression failures. As demonstrated in the interim report, these failure modes can often be analyzed with fairly good success.

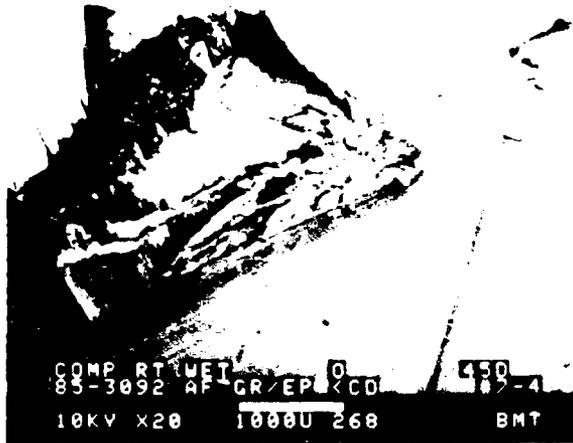
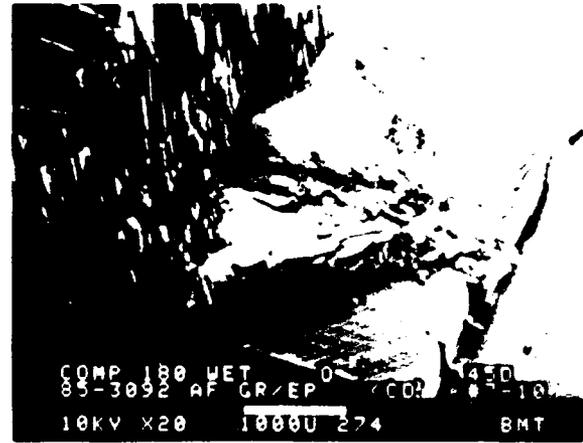
Figure 37. Low Magnification Fractographs of G-deg Laminate Compression Failures Produced at 70°F, 180°F, and 270°F Wet.

At an immediately obvious level of detail, failure occurred in the notch area by compression followed by a distinct transition into tensile failure (see figures 30 through 33). At this level of inspection, increasing test temperature can be seen to produce enlargement of the compressive failure zone as well as more distinct fiber pull out in areas of tensile separation. This alteration in compression failure zone size probably reflects the decreased compression stability of the notched region due to lowering of the matrix modulus with increasing temperature. Based on this behavior, the size of compression failure would also be expected to increase with moisture absorption. However, in comparing the appearance of wet versus dry specimens (see previous paragraphs), no differences in the size of compression failure can be distinguished. Given the pronounced effects of temperature visible in figures 30 through 33, this finding tends to suggest that matrix modulus reductions due to moisture are less than those produced by increasing temperature.

70°F. wet

180°F. wet

270°F. wet

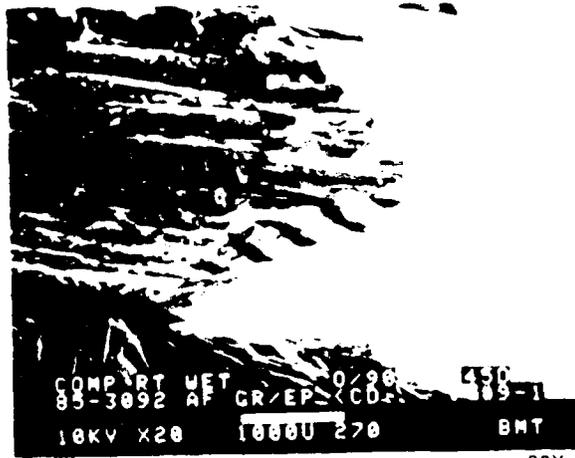
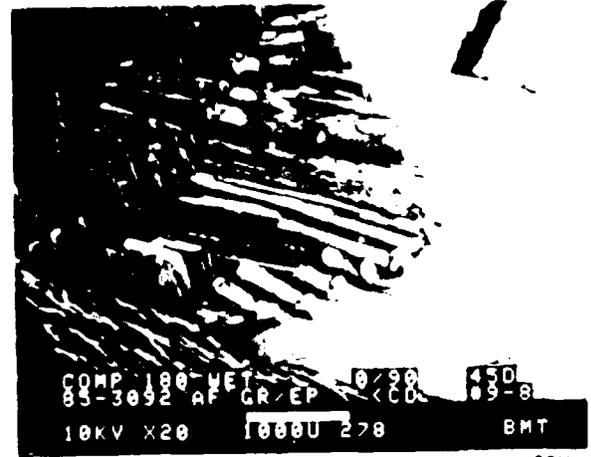
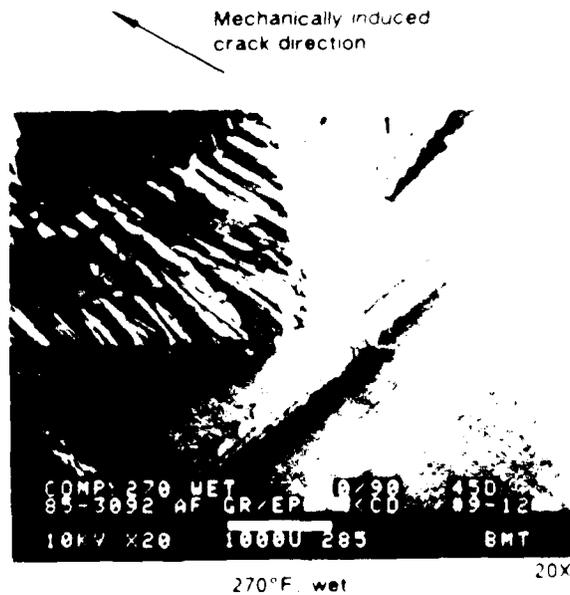
Figure 32 Low Magnification Fractographs of 0/90-deg Laminate Compression Failures Produced at 70°F, 180°F, and 270°F Wet

70°F. wet

180°F. wet

270°F. wet

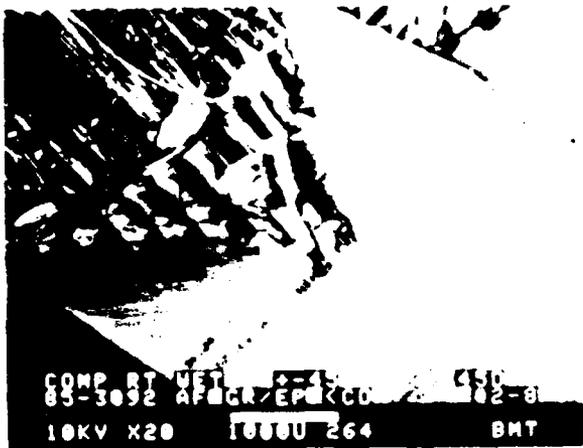
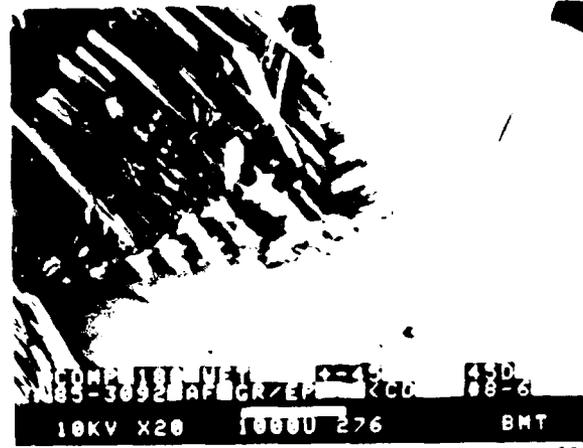
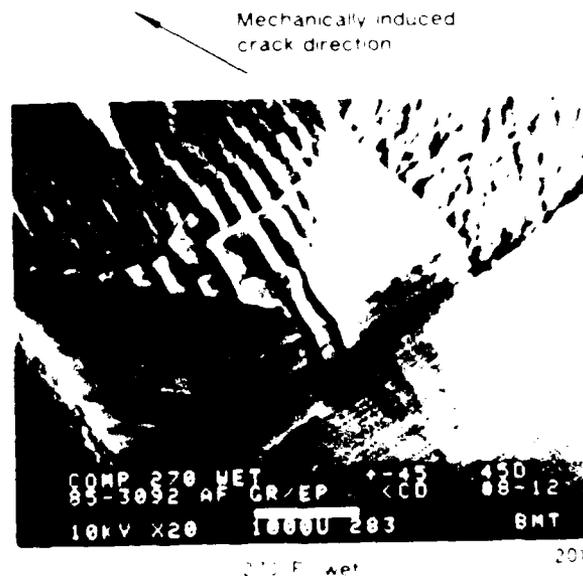
Figure 33 Low Magnification Fractographs of +45/ -45-deg Laminate Compression Failures Produced at 70°F, 180°F, and 270°F, Wet

70°F wet

180°F wet

270°F wet

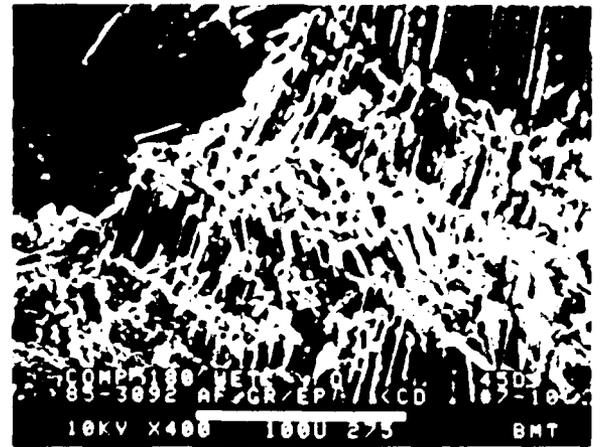
At higher magnification, failure by compression can be seen to produce a distinctly flattened topography. As depicted in figures 34 through 37, fiber failure appears to occur by axial microbuckling as evidenced by the extensive amounts of fiber kinking. Surface damage generated by the compression event, however, generally precludes the

70°F wet

180°F wet

270°F wet

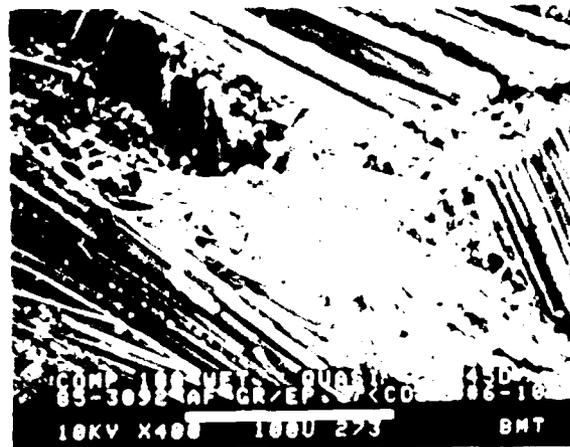
Figure 35 SEM Fractographs of Quasi-isotropic Laminate Compression Failures Produced at 70°F, 180°F, and 270°F Wet

70 F wet

180°F wet

270 F wet

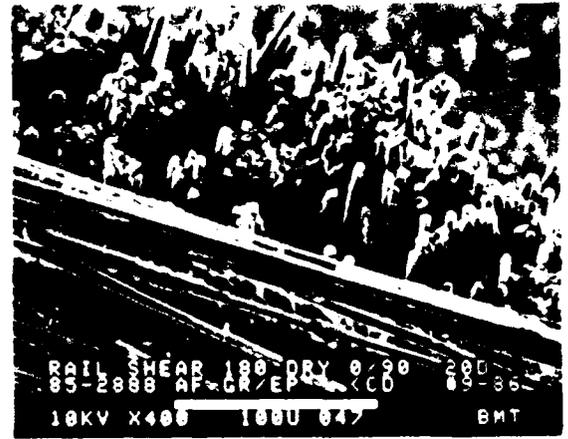
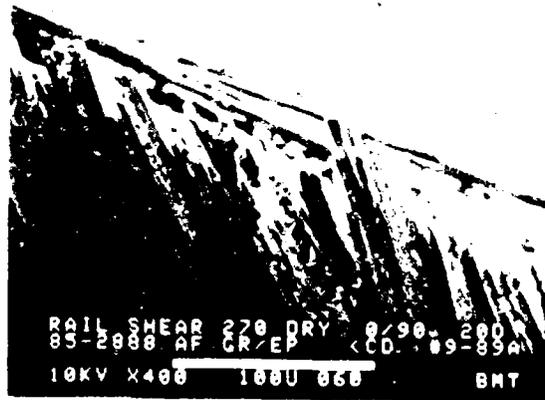
Figure 41 Low Magnification Fractographs Illustrating Morphology of 0/90-deg Rail Shear Failures Produced at -65°F, 180°F, and 270°F, Dry

As illustrated in figures 40 through 47, translaminar failures produced under shear did not exhibit any pronounced sensitivity to either environment or absorbed moisture. Figures 40 through 43 illustrate the gross fracture topography of specimens failed at 270°F wet and dry, 180°F wet and dry, 70°F wet and -65°F dry. For each

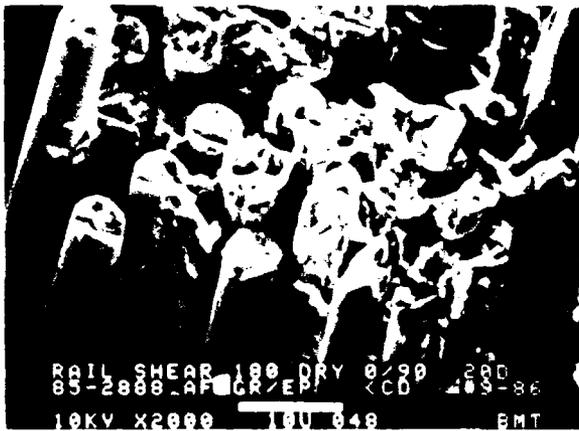
Figure 45. Detailed Fracture Characteristics of 0/90-deg Rail Shear Laminates Failed at -65°F, 180°F, and 270°F, Dry

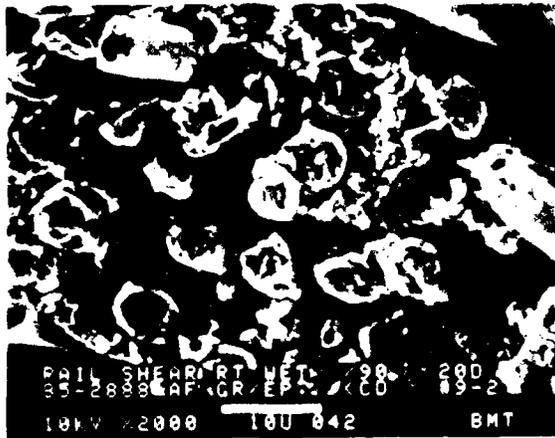
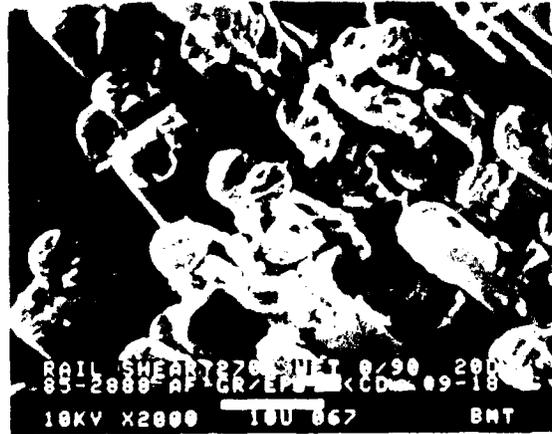
Figure 47 Detailed Fracture Surface Characteristics of 0/90-deg Rail Shear Laminates Failed at 70°F, 180°F, and 270°F, Wet

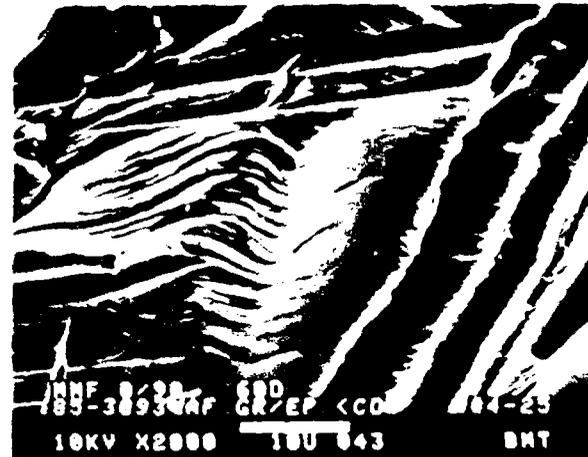
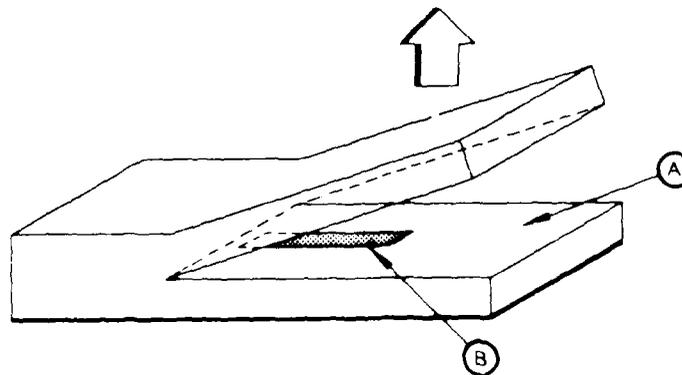
Note. Area A exhibited hackles formed by mechanism B, whereas area B exhibited river marks oriented coincident with, as well as opposite to, the induced direction of propagation.

Figure 49. SEM Fractographs Illustrating Mixed Mode Fracture of 0/90-deg Laminate

Mixed mode separation for several of the other crossply orientations (0/90 and 0/45) produced an interesting mixture of Mode II and Mode I fracture areas. The majority of separation occurred predominantly by Mode II fracture (see figures 49 and 50). Consistent with the 0-degree laminate specimen the overall morphology of these hackles exhibited no difference from that described previously for pure Mode II induced delaminations. With the exception of the 0/90 laminate, hackle separation for both 0/45 and +45/-45 laminates occurred predominantly by mechanism A (figures 50 and 51). Hackle separation for the 0/90 laminate occurred by mechanism B. These results

As indicated in figures 49 and 50, several areas of Mode I fracture were evident on each specimen. Typically, this morphology occurred in those areas where groups of fibers have been pulled from the main fracture plane. These areas of Mode I fracture exhibited river marks oriented both coincident with, as well as opposite to, the direction of crack propagation (see figure 49). This basic behavior appears to be understandable based upon how these areas of fracture are formed. As indicated earlier, these areas correspond to regions of fiber pull out. As schematically illustrated in figure 52, areas of pull out occur when local crack divergence produces fiber bridging across the crack tip. Under continued opening displacement such bridged areas can extend areas of delamination both toward, as well as away from, the direction of crack propagation. In terms of carrying out a failure analysis, this behavior can generate spurious directions of crack growth. However, examining a large number of fracture areas by optical microscopy should provide a means of averaging out such spurious areas and identifying the general direction of crack growth.

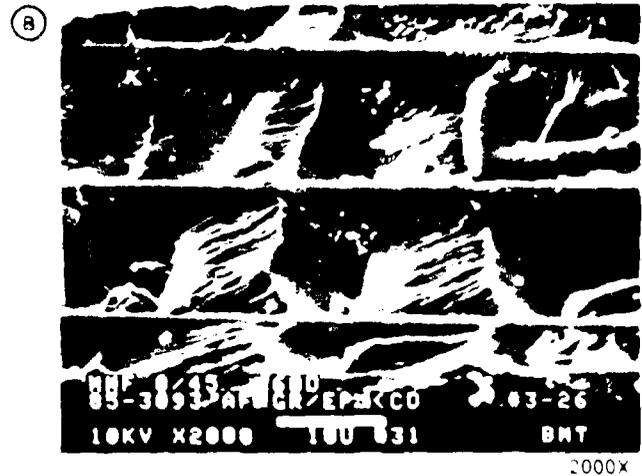
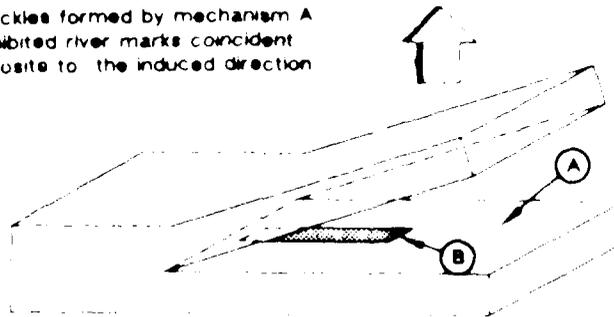
Note: Area A exhibited hackles formed by mechanism A whereas area B exhibited river marks coincident with, as well as opposite to, the induced direction of propagation.

Figure 50 SEM Fractographs Illustrating Mixed Mode Fracture of 0/45-deg Laminate

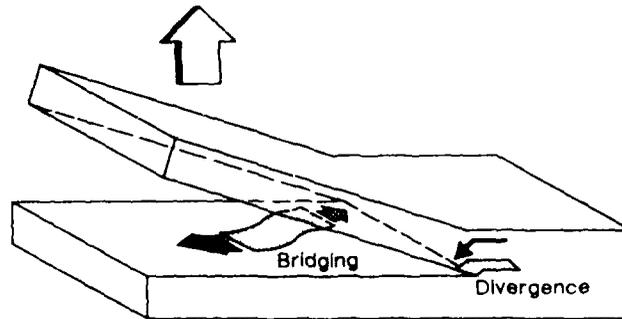
Figure 52. Schematic Showing Formation of Reverse Crack Directions Because of Out-of-Plane Crack Divergence and Subsequent Crack Tip Bridging

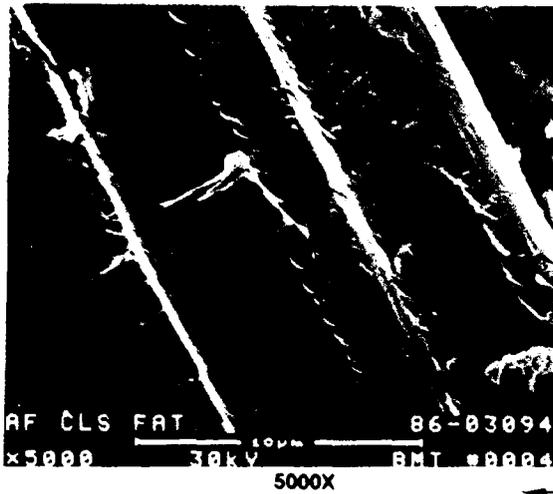
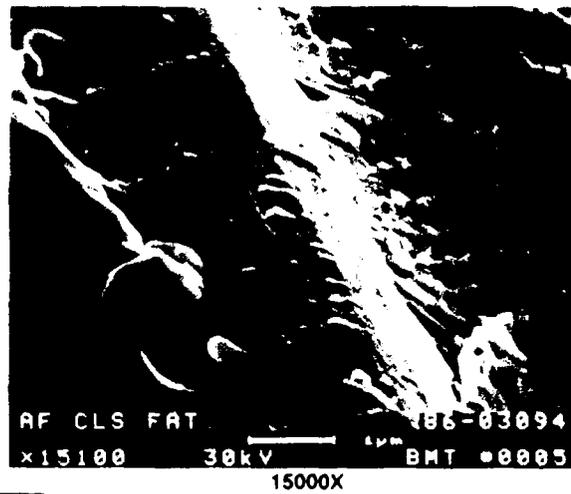
Figure 54. SEM Photomicrographs of Typical Fatigue Striation Formation of Mode II CLS Specimen

Cyclic loading ranged from 60% to 20% maximum static fracture stroke.

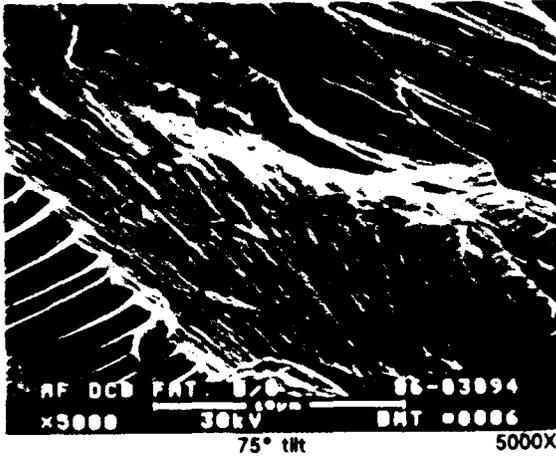
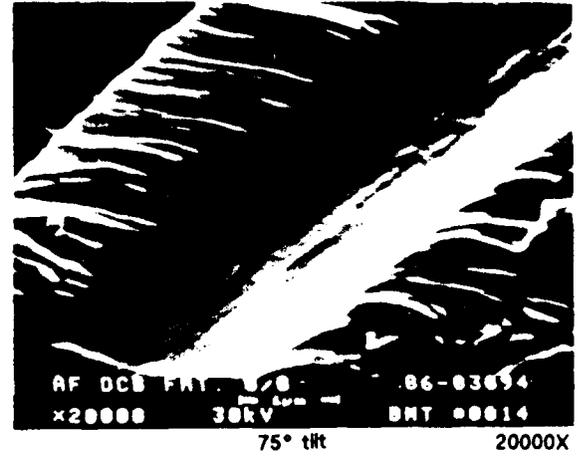
Figure 55. High Magnification SEM Photomicrographs of Regions That Exhibit Faint Striations

The left photo is in the resin fracture region, while the right photo presents the fiber-matrix interface region.

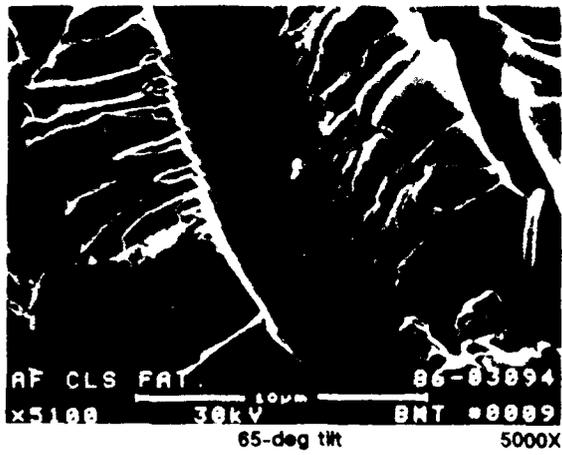
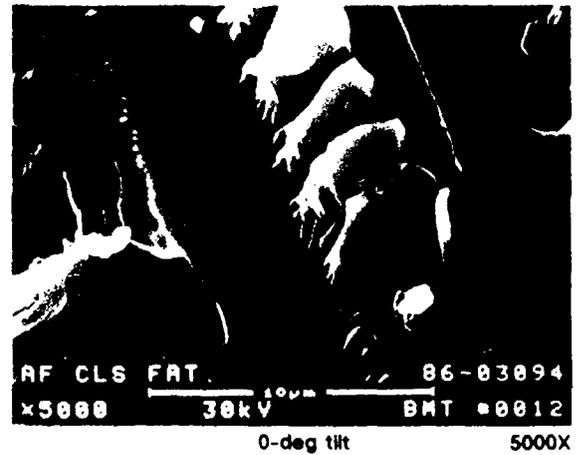
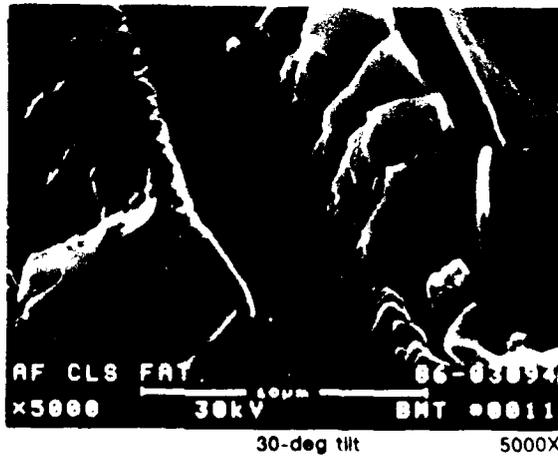
Figure 59. SEM Photomicrographs of Effect of Tilt on Striation Resolution

Figure 59 presents a comparison of a single field at 0-, 30-, and 65-degree tilts. Note that the striations are not resolvable or high enough contrast to identify in the 0- and 30-degree tilts.

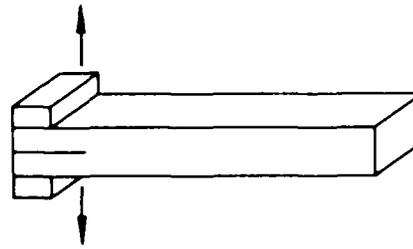
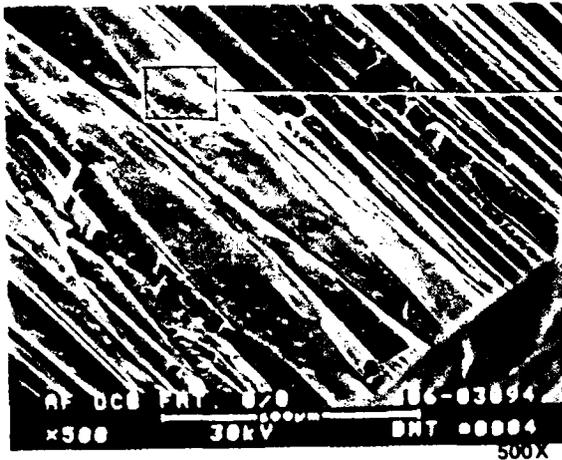
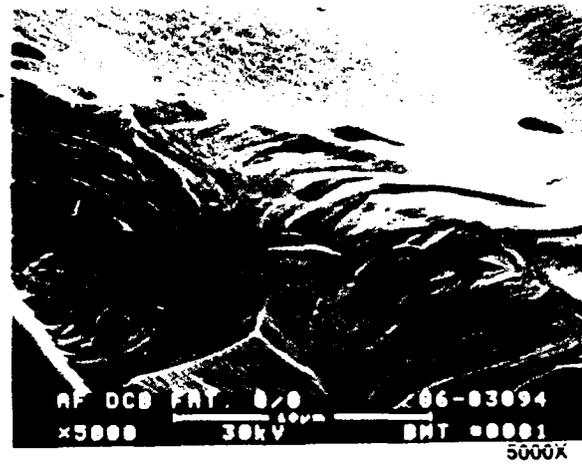
Figure 60. SEM Photomicrographs of Effect of Tilt on Striation Resolution (500X and 5000X)

Optical microscopy did not identify striations in the lower amplitude fatigue cycle region (20% to 60% maximum). SEM analysis using high tilts and optimum specimen rotation resulted in identification of striations which were much finer and closer spaced than those found in the high amplitude region (40% to 80% maximum). Additionally, these striations were very inconsistent in spacing. As with metals, this observation suggests fatigue crack growth is at, or very near, the threshold of striation formation. At low stress intensities of the crack tip, slight variations in localized loading (due to the load shedding nature of the fibers) can cause inconsistent crack front behavior as illustrated in figure 60.

Note smooth fracture topography and faint striations in right photo.

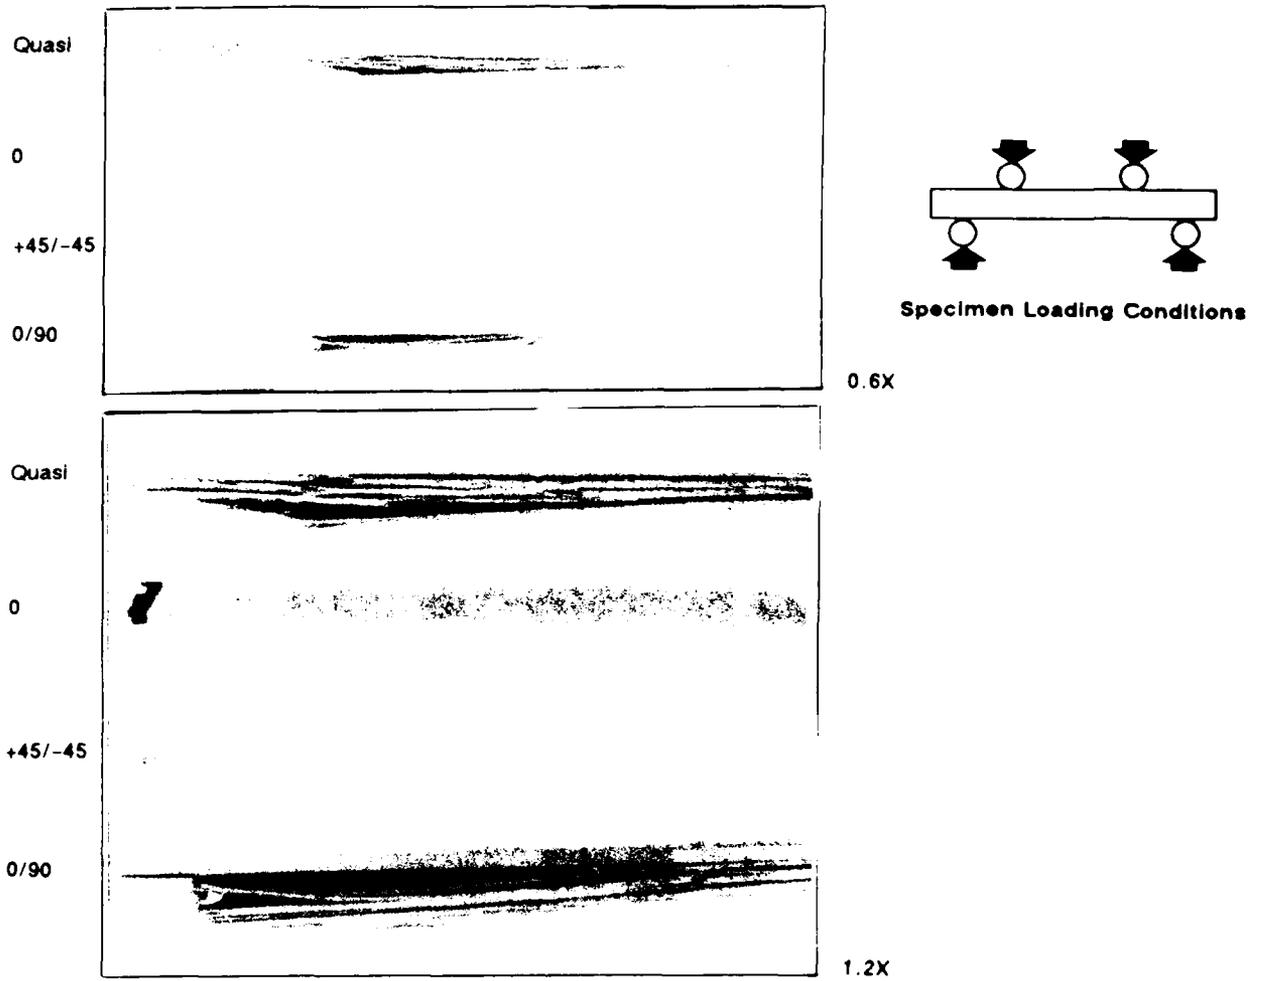
Figure 62. Overall Macrographs of Laminate Flexure Specimens

Specimens failed under laminate flexure proved interesting in that pronounced differences in failure mode occurred for each specimen layup. Figure 62 illustrates each of these failure modes. As shown, failure of the 0/90 and quasi-isotropic laminates occurred along the tensile surface and involved both translaminar splitting and delamination. In contrast, failure of the 0-degree specimen occurred through the full specimen thickness with very little delamination. Failure of the +45/-45 specimen occurred without any identifiable conditions of fracture. This condition clearly illustrates the inadequacy of trying to characterize all flexural failures based on the appearance of 0-degree coupons as some authors have attempted.

As shown in figure 62, both the 0/90 and the quasi-isotropic laminates exhibited similar failure modes. Failure of these specimens typically involved the following characteristics:

- Translaminar tensile failure from the tensile loaded surface toward the specimens neutral axis.
- Extensive delamination of the plies located on the tensile side of the beam neutral axis.

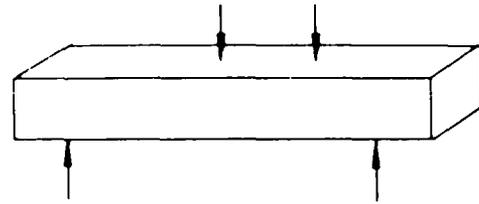
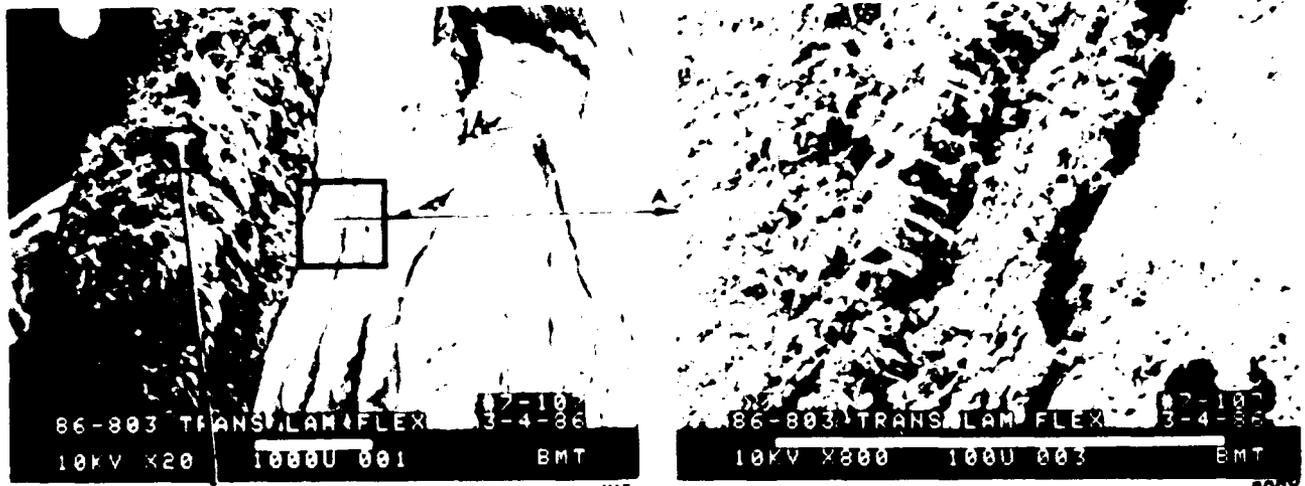
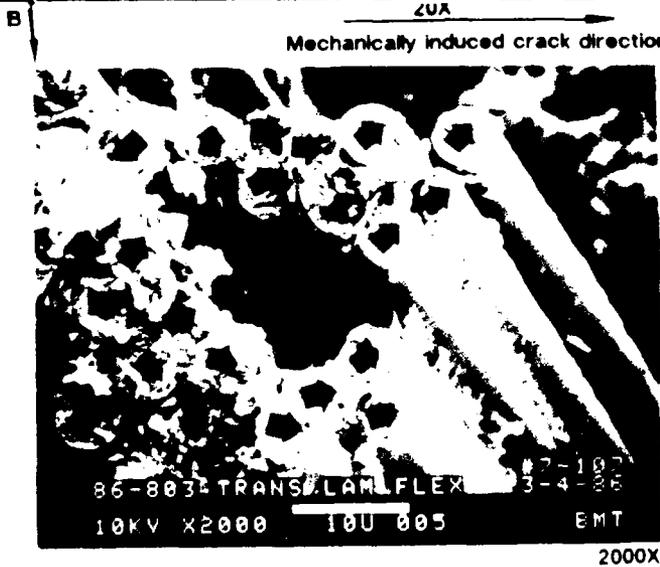
In a manner similar to the singular translaminar compression failure specimens previously evaluated within this program, detailed examinations of the compressive failure surface revealed no morphological clues as to the direction of crack growth. However the tensile fracture zone exhibited features corresponding to the direction of crack growth. As illustrated in Figure 63, examination of the tensile area of fracture reveals a coarser pattern of lines running between the specimen edge and neutral axis. These lines appear analogous to ratchet lines often described in metals, where these lines are formed by the intersection of parallel zones of crack growth. Given this interpretation, these optical lines (see figure 63) suggest that crack initiation occurred at multiple locations along the specimen tensile surface and progressed inwards towards the specimen center. Evidence supporting this interpretation can be seen in figure 64 in which the direction of individual fiber breakage was found to occur parallel to the ratchet lines and towards the specimen centers.

A. Compression Fracture Region
B. Tensile Fracture Region

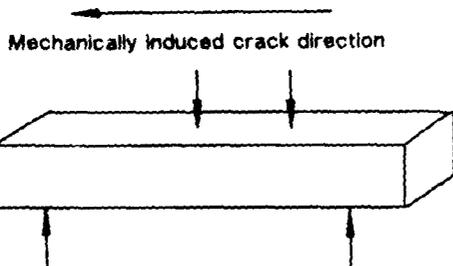
Figure 66. Interlaminar Fracture Surface Characteristics of the 0/90 Laminate Flexure Specimen

Inspection of delaminations on the tensile side of the specimen revealed that propagation occurred by inplane Mode II shear fracture. As presented in figure 66, scallop and hackle type features were observed throughout the specimen fracture surface. The direction of crack propagation for these features were assigned utilizing the same methods described for the compression after impact specimen. As shown,

- ← Mode I tension dominated crack growth direction
- ↔ Mode II shear dominated crack growth directions

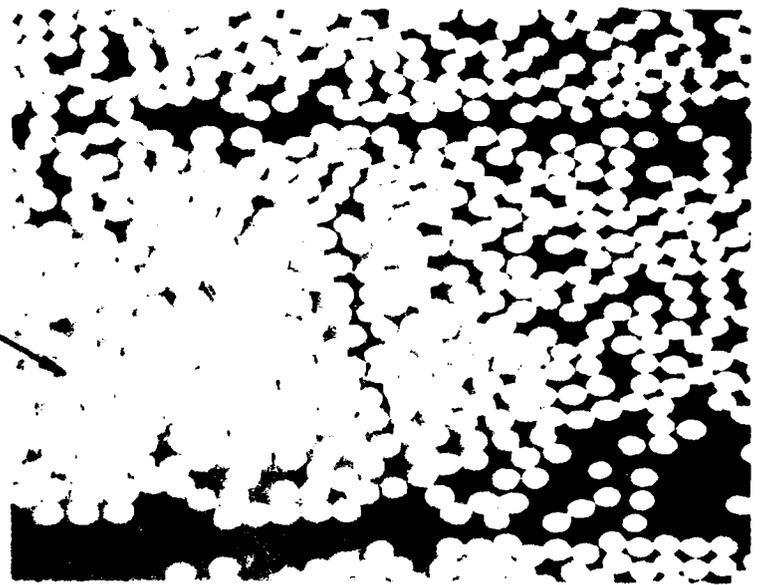
Testing damage was limited to localized intralaminar cracking within the plies.

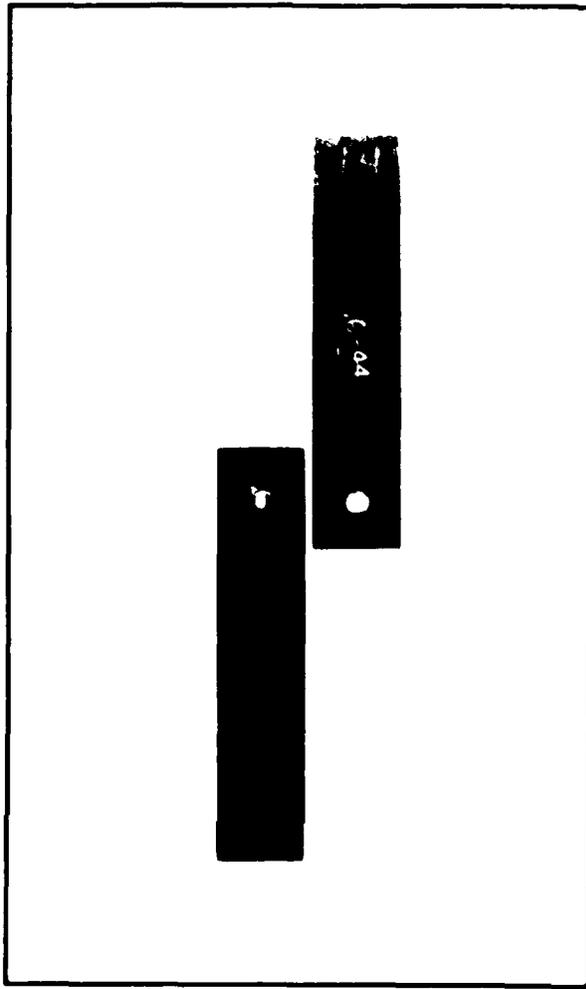
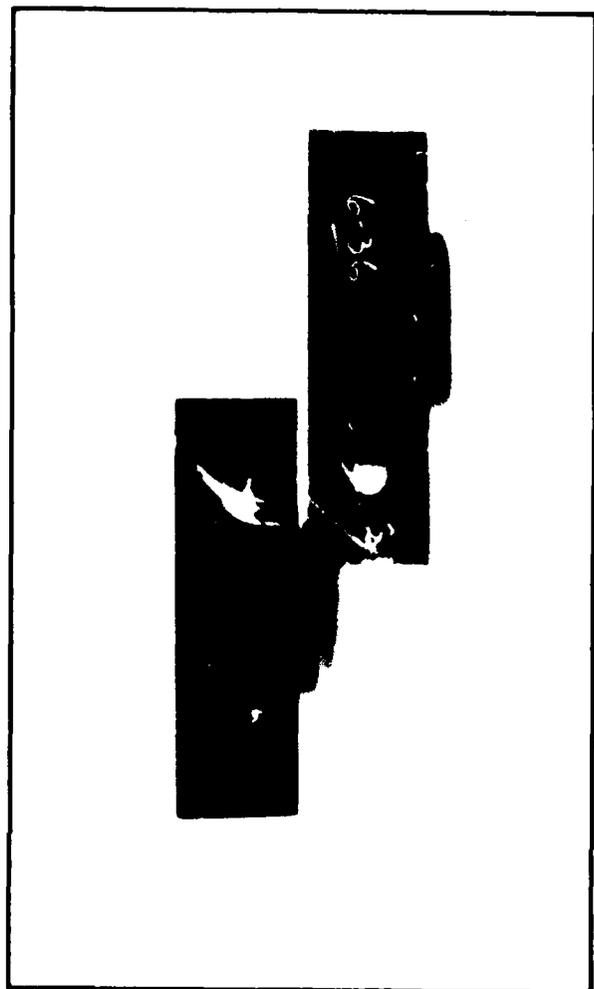
Figure 68. Overall Photomicrographs of the Fastener-Filled-Hole Tension and Compression Specimens Following Testing

overlap. Figure 68 presents the tension and compression overall photos following testing. Testing involved loading until joint failure, usually when the fastener had rotated and was pulled through a plank. Visual inspection of the tension specimen revealed extensive through-thickness translaminar bearing fracture where the fastener was dragged through the laminate during testing, as shown in figure 69. The direction of this damage with respect to the fastener hole was found to indicate the direction of axial loading (in this case, tension). As can be seen, a few surface plies were found to be delaminated and pushed up from the surface. No internal delamination damage was visually identified. Further cross sectional optical inspection indicated internal ply damage was restricted to the immediate fastener pull out region. The side view illustrated in figure 70 shows the lack of central ply delamination damage for the tension specimen.

Note: The planks were separated for photo documentation.

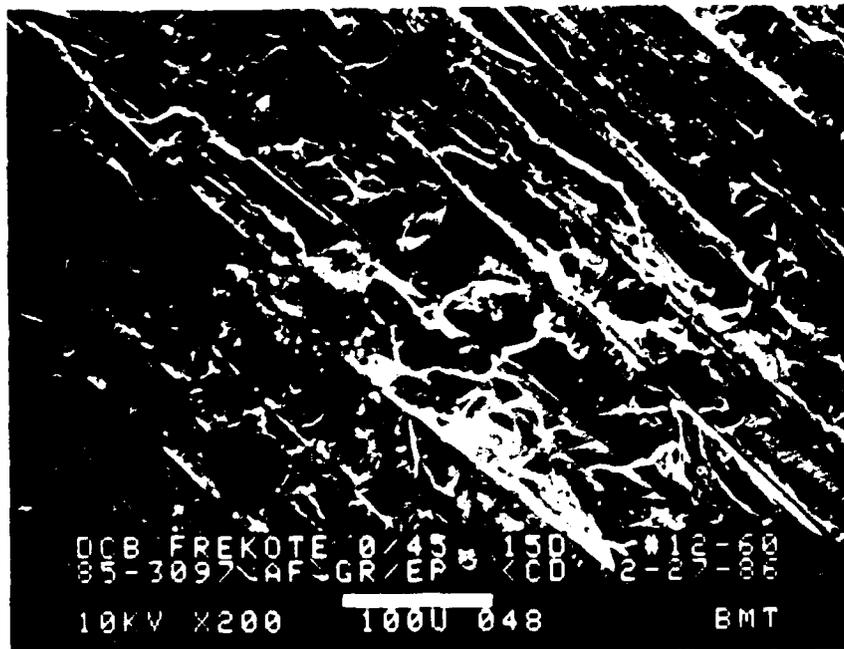
Figure 75. Typical Fracture Surface Morphology of Frekote Defect Specimens

Figure 75 presents the typical fracture surface morphology found on delaminations produced with Frekote defect conditions. The localized Frekote fracture regions were characterized as interconnected and very smooth, without resin fracture features, indicative of adhesive type separation. As found for the other defect types, the surrounding resin matrix exhibited typical fracture morphologies for both the DCB and ENF specimens. Additionally, crack propagation directions for the Mode I specimens were found to be coincident with the observed direction of imposed macroscopic crack growth.

The large smooth regions are Frekote contaminated.
