FAILURE ANALYSIS OF COMPOSITE STRUCTURE MATERIALS

Brian Smith
Ray Grove
Boeing Military Airplane Company
P.O. Box 3707 MS 73-43
Seattle, WA 98124

May 1987

Final Report for Period of 1 October 1985 to 31 August 1986

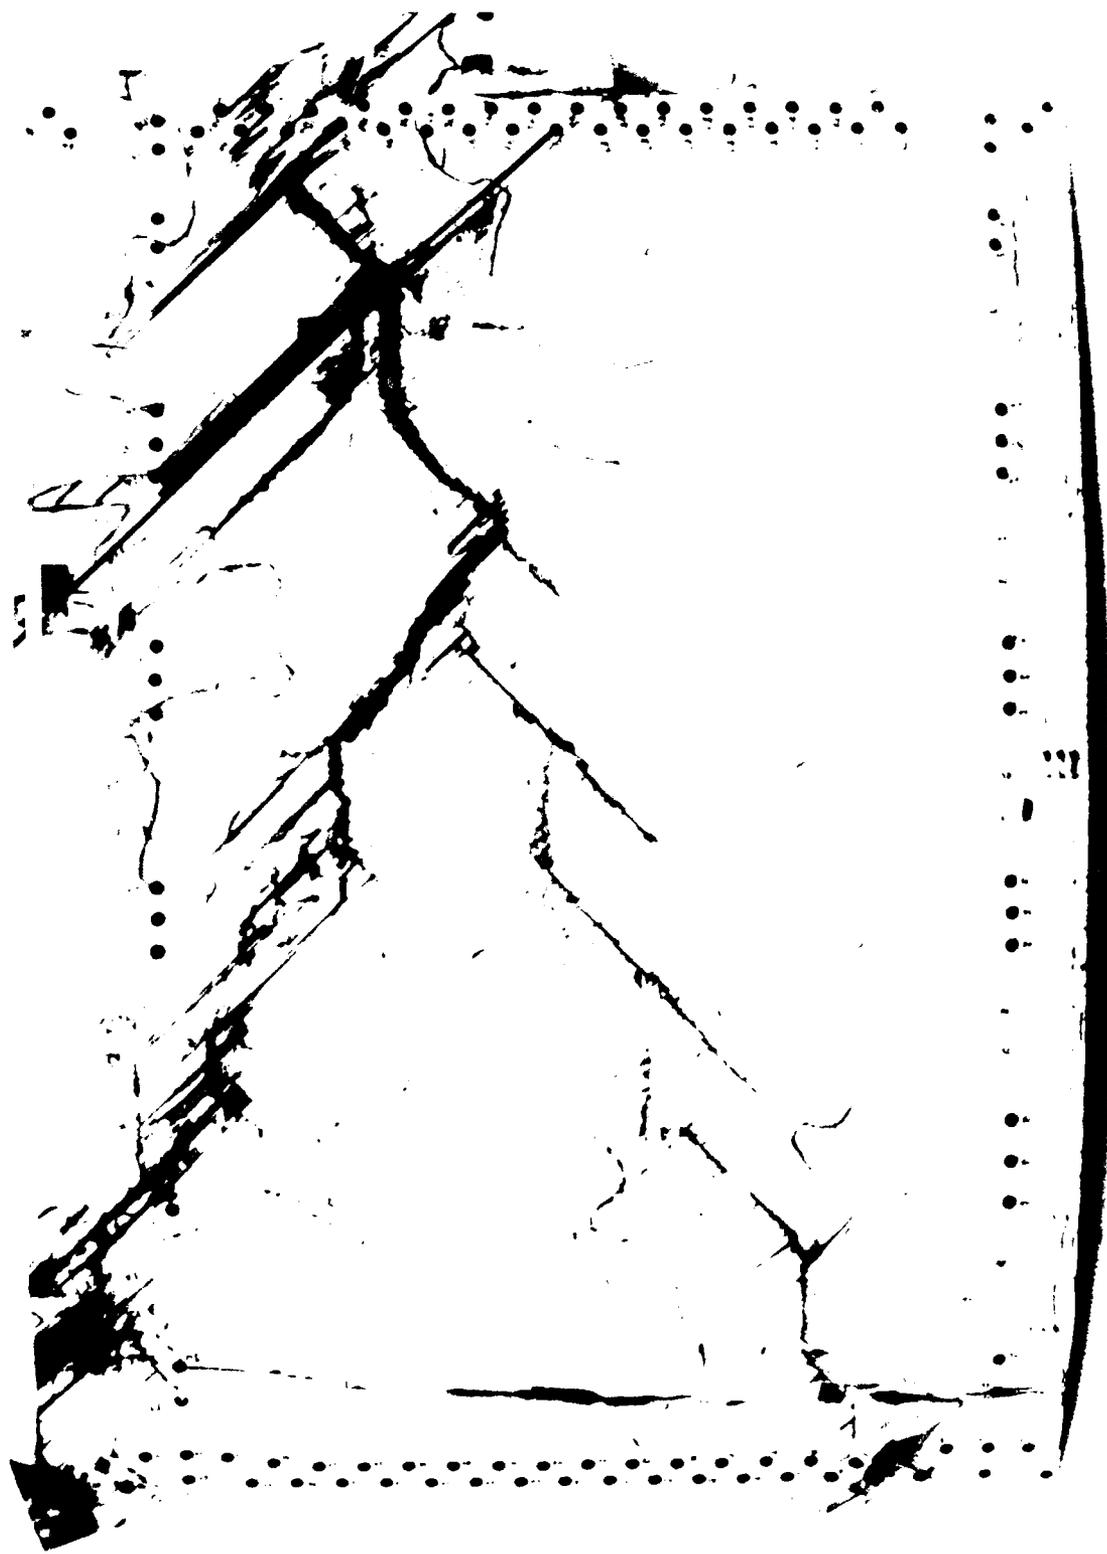
Figure 92. JVX Wing Test Box Upper Skin Surface

Initial visual inspections of the damage region were carried out to identify the areas of visible fracture or deformation. As shown in figure 92, the upper skin surface exhibited a branching translaminar crack across the entire surface (severing all five stringers) and compression type translaminar fracture morphology for both the skin and stringers (as indicated by the flat fracture appearance). This macroscopic translaminar branching most likely indicated the gross overall fracture direction, such that the cracking progressed across the skin from the rear spar region in a chordwise direction toward the front spar. The translaminar cracking intersected the trailing edge of the skin at a radius for a runout of an overhanging tab. Extensive delamination was evident on each side of the translaminar cracking, often wedged open from mating fracture surface overrun during compression loading. Figure 93 presents the underside of the upper skin surface, at the trailing edge tab region, illustrating the type and extend of damage.

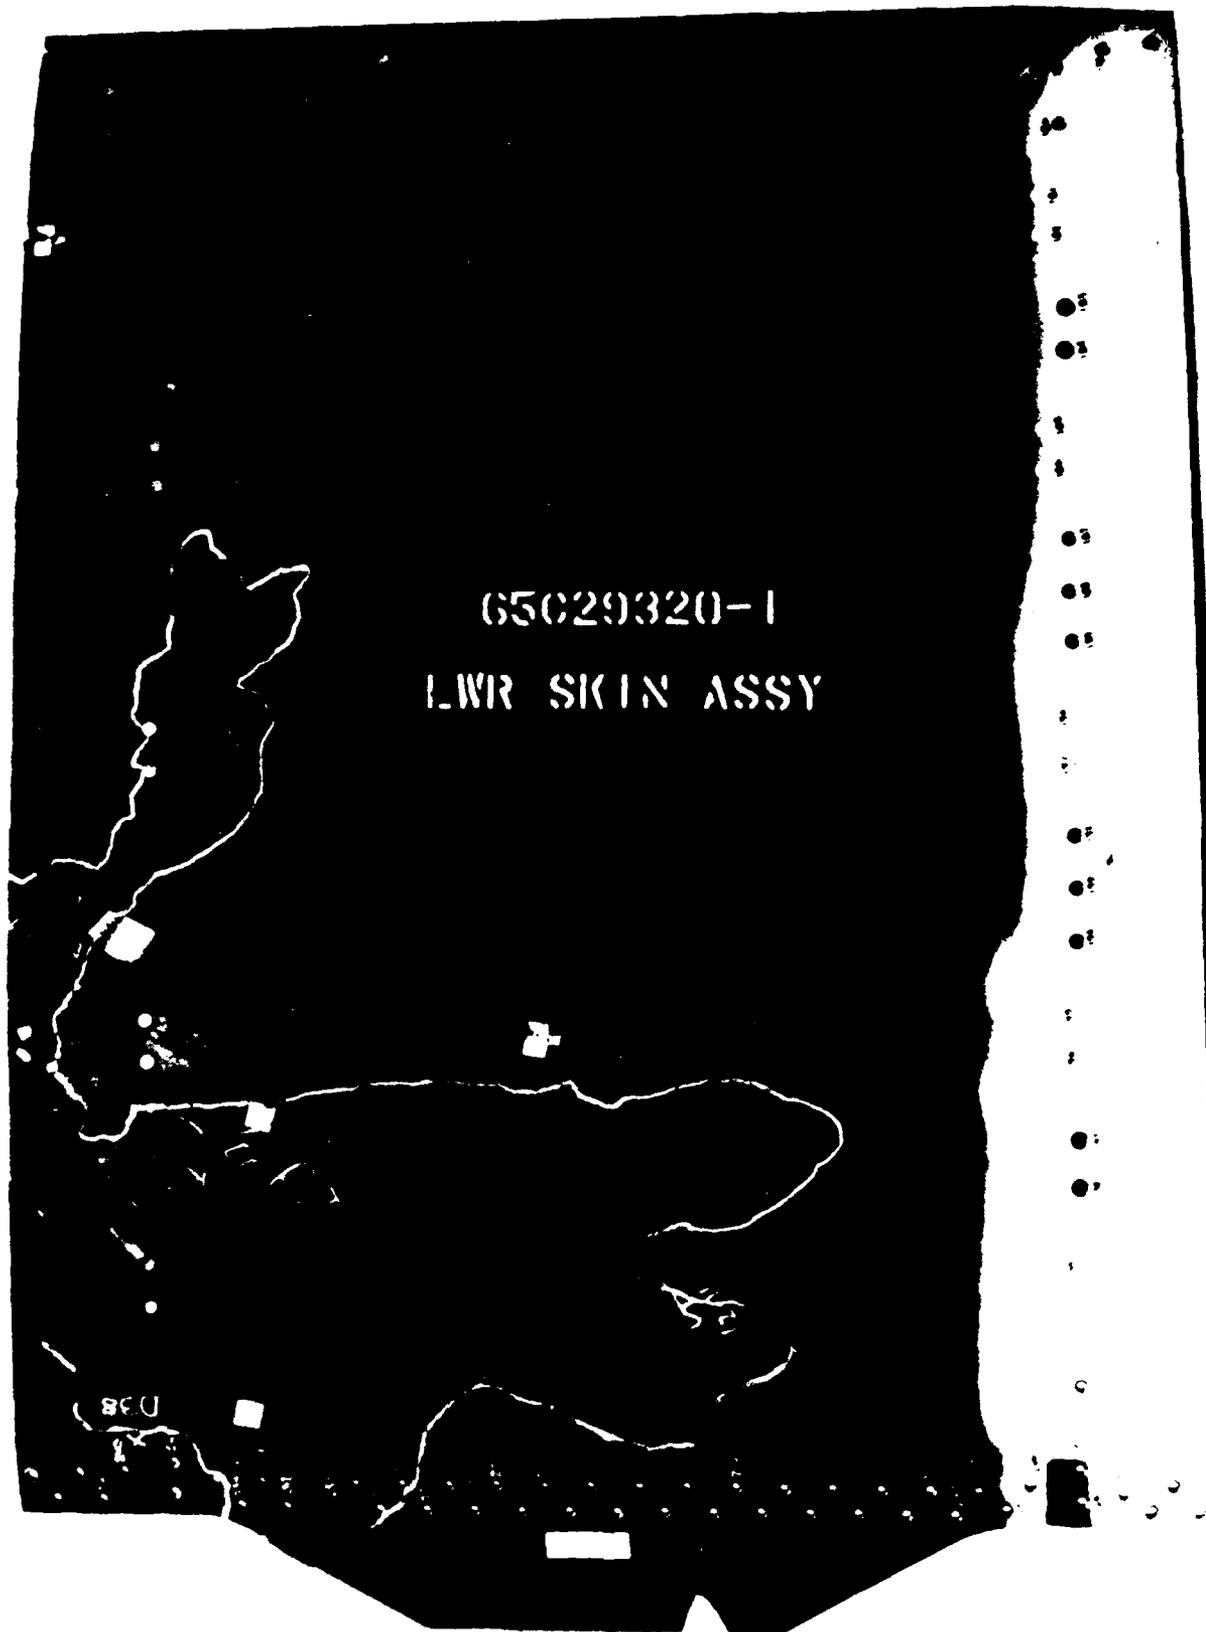
Figure 95. J VX Wing Test Box Lower Skin Surface

The lower skin surface, shown in figure 95, was damaged in a similar manner to the upper skin, although to a lesser extent. The skin buckling also indicated a compressive loading. Because the stress prior to fracture was supposed to be tensile, the neutral axis between tension and compression must have shifted to below the lower skin surface during the failure process. As a result of these visual observations, it appeared that damage in the upper skin and spars occurred prior to cracking in the lower skin.
