DTIC FILE COPY TECHNICAL REPORT GL-88-9

# RETROGRESSIVE FAILURES IN SAND DEPOSITS OF THE MISSISSIPPI RIVER

EMPIRICAL EVIDENCE IN SUPPORT OF THE  
HYPOTHESIZED FAILURE MECHANISM AND  
DEVELOPMENT OF THE LEVEE SAFETY  
FLOW SLIDE MONITORING SYSTEM

PART II: CASE HISTORY OF THE CELOTEX BATTURE AND LEVEE FAILURE OF  
30 JULY 1985

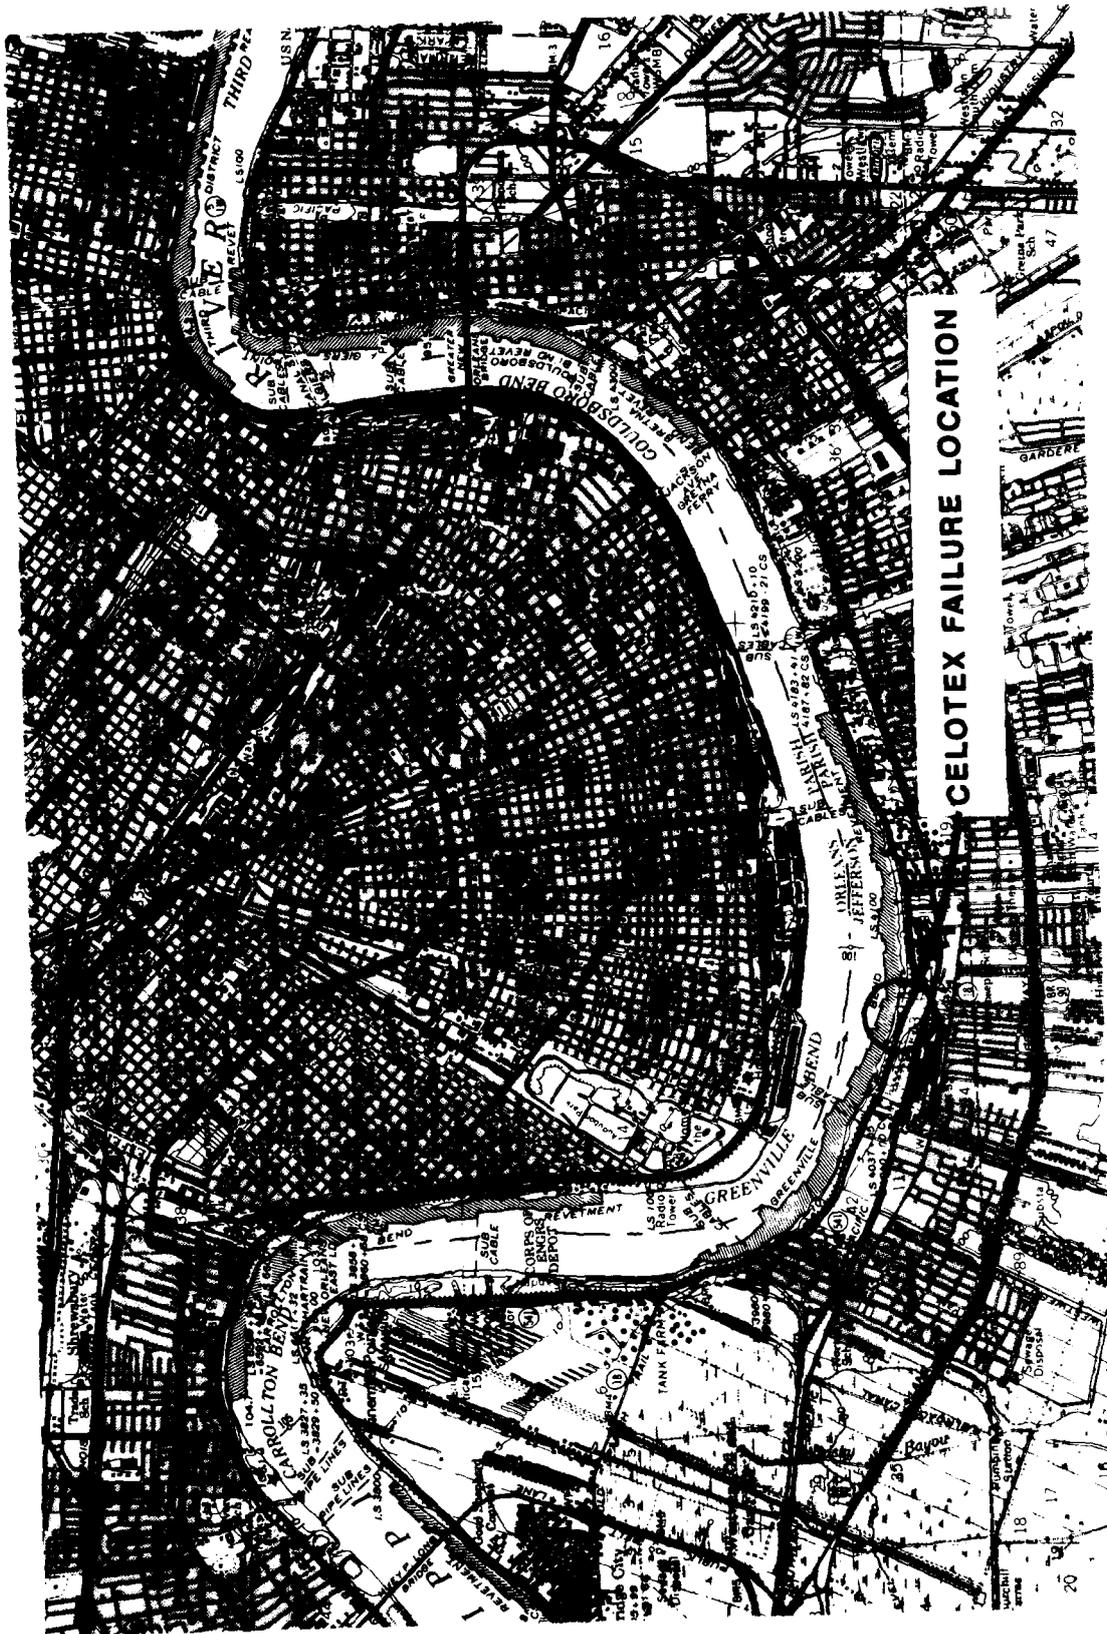
Figure 1. Vicinity map, Celotex batture and levee failure

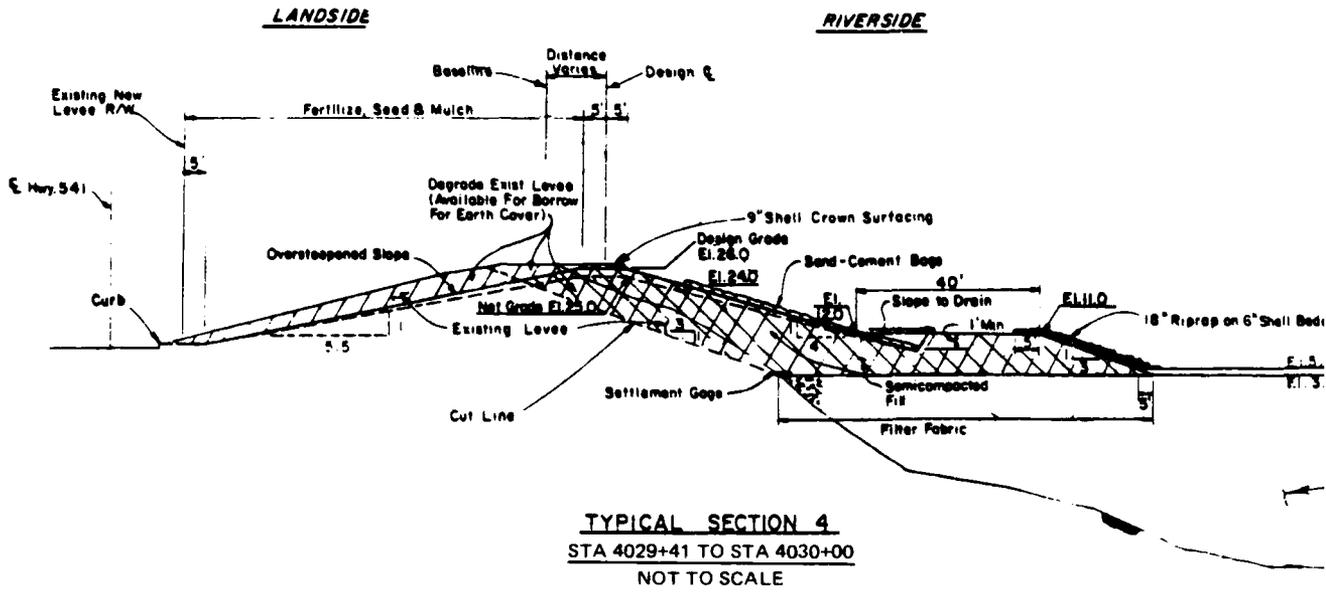
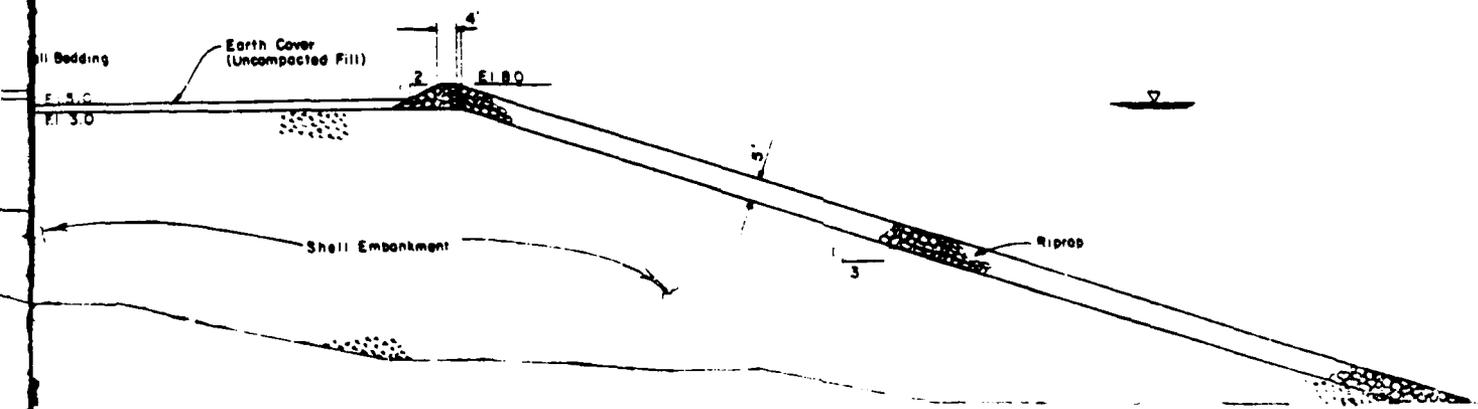
Figure 4. Batture and levee res

at restoration, Celotex failure site

9. The innovative and cost-saving restoration technique is best described by the following construction sequence. A typical section is shown in Figure 4.

- a. The failed batture was rebuilt with shell to el 3.0 ft.\* Approximately 272,000 cu yds of shell was placed in 60 to 70 ft of water.
- b. The remaining portion of the failed levee was reshaped to receive a new fill.
- c. Filter cloth was placed as a separator between new levee berm fill and the shell backfill. Prior to placement of the filter cloth, the shell batture was raised to el 5.0 in the area of the new levee fill to avoid a rising river stage.
- d. Construction of the new levee berm to el 7.5 with semicompacted fill proceeded to keep the work above the rising river.
- e. The shell batture/bank was armored with a 5-ft-thick layer of riprap stone, and the new levee and buttress berm were completed.
- f. The slope of the buttress berm was armored with an 18-in.-thick layer of stone.
- g. The riverside levee slope was protected by placing sand-cement filled bags.

h. The armored shell riverbank was revetted with articulated concrete mattress (not shown in Figure 4).

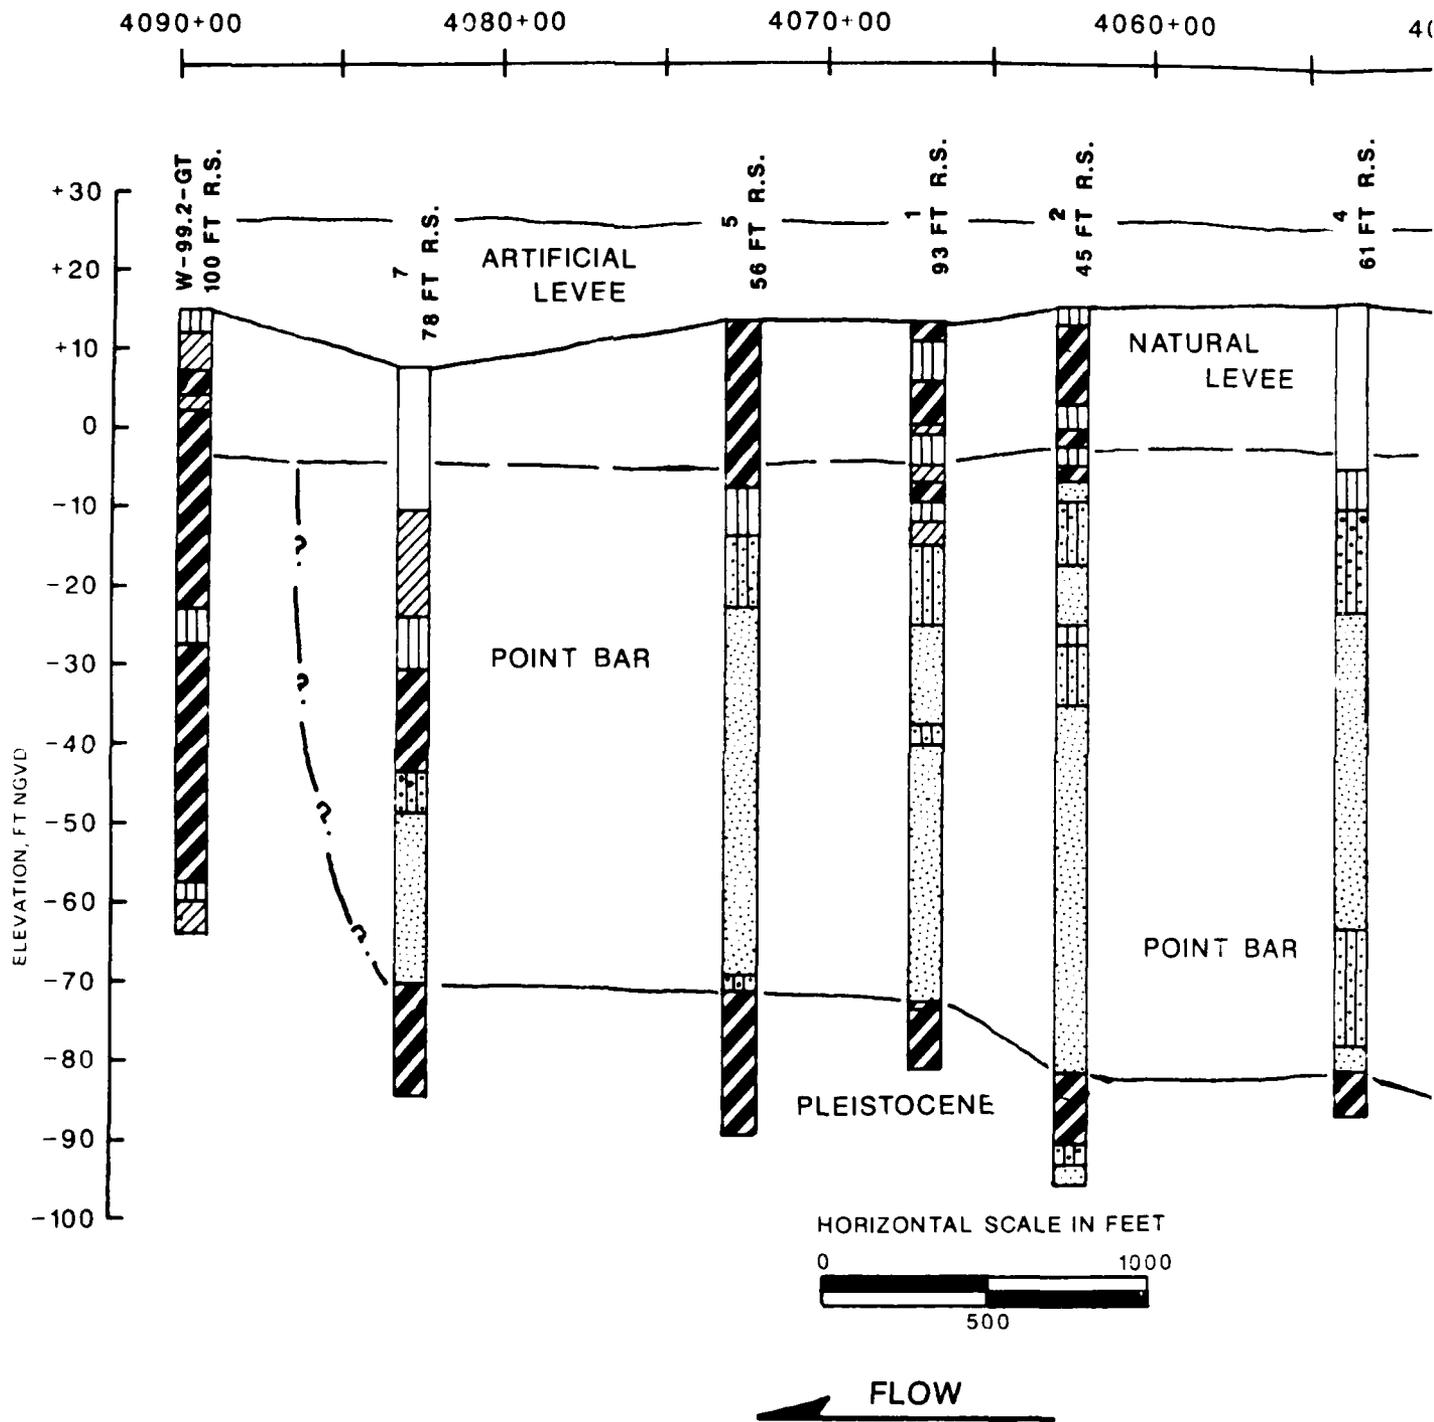
Figure 9. Soil profile along the bank reach containing the Celotex failure site

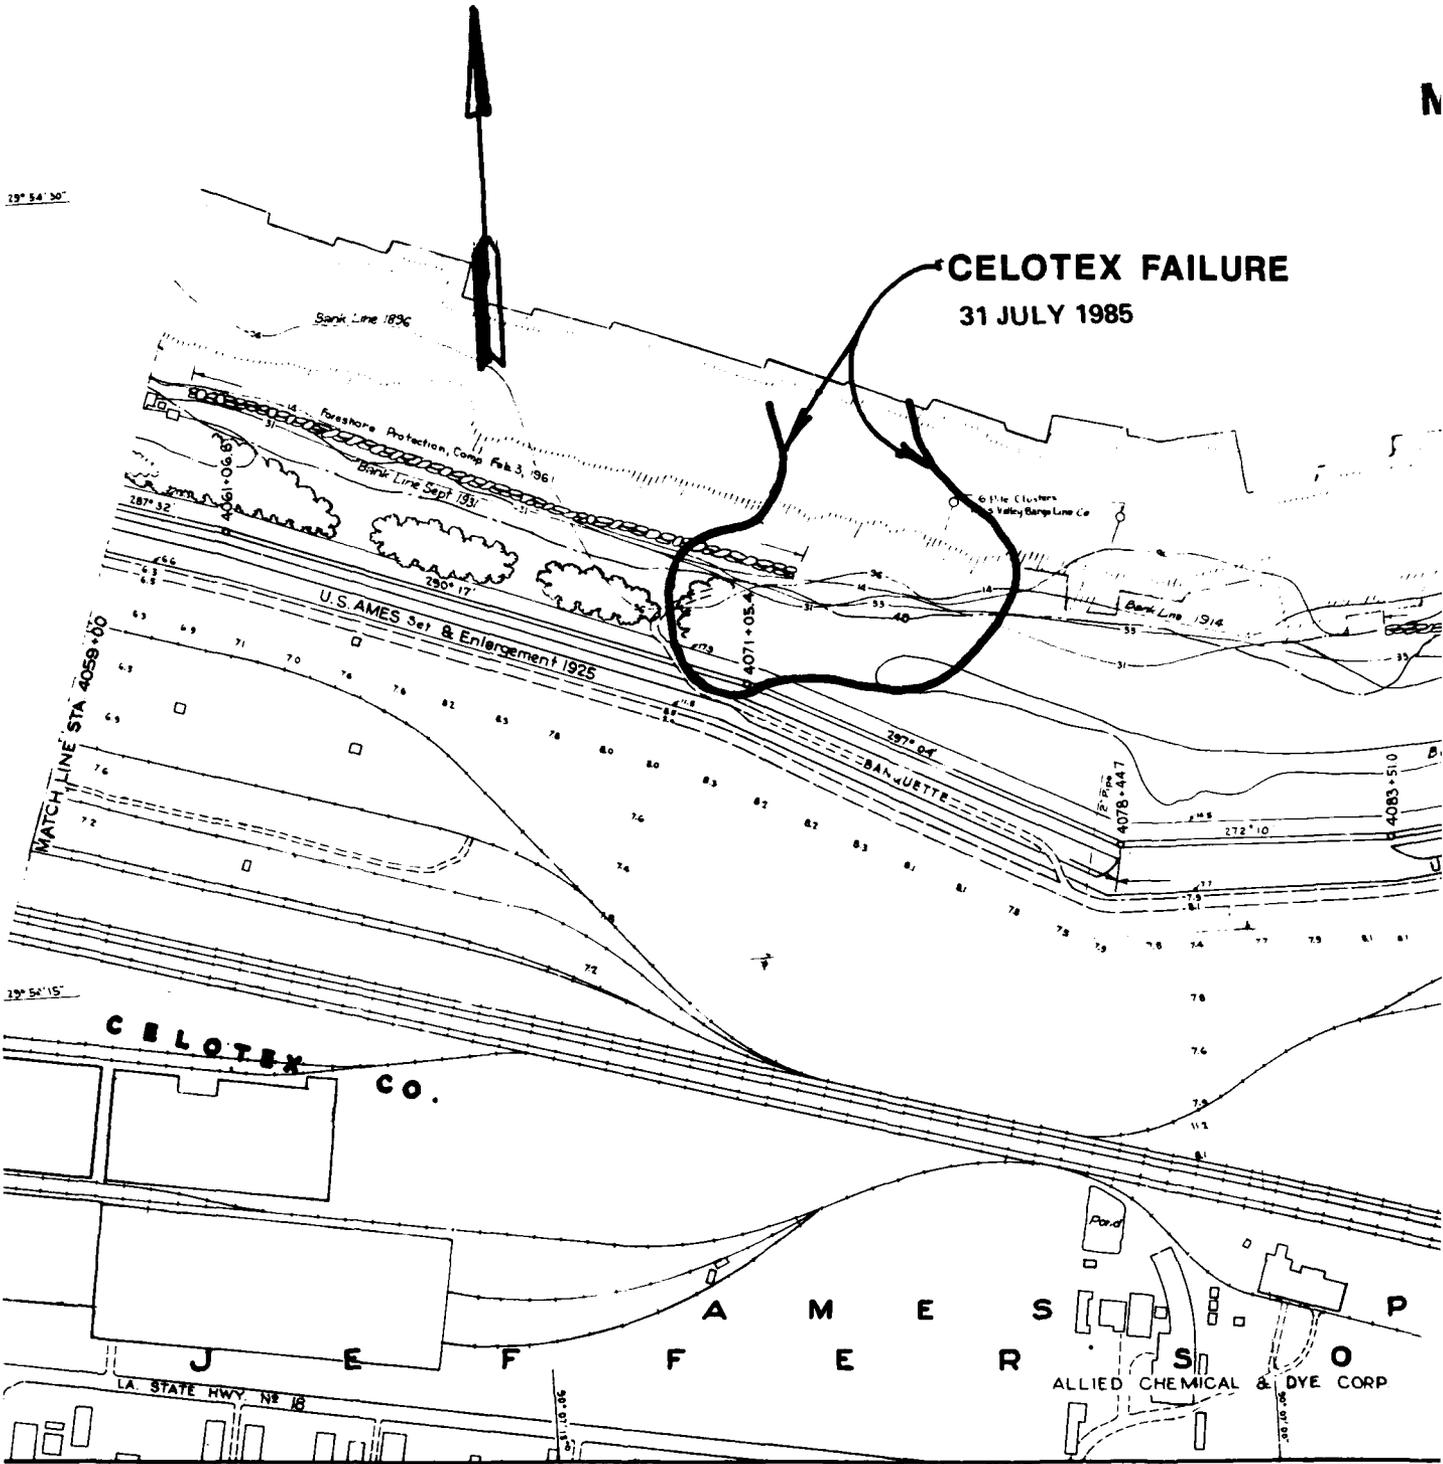
# CELOTEX FAILURE 31 JULY 1985

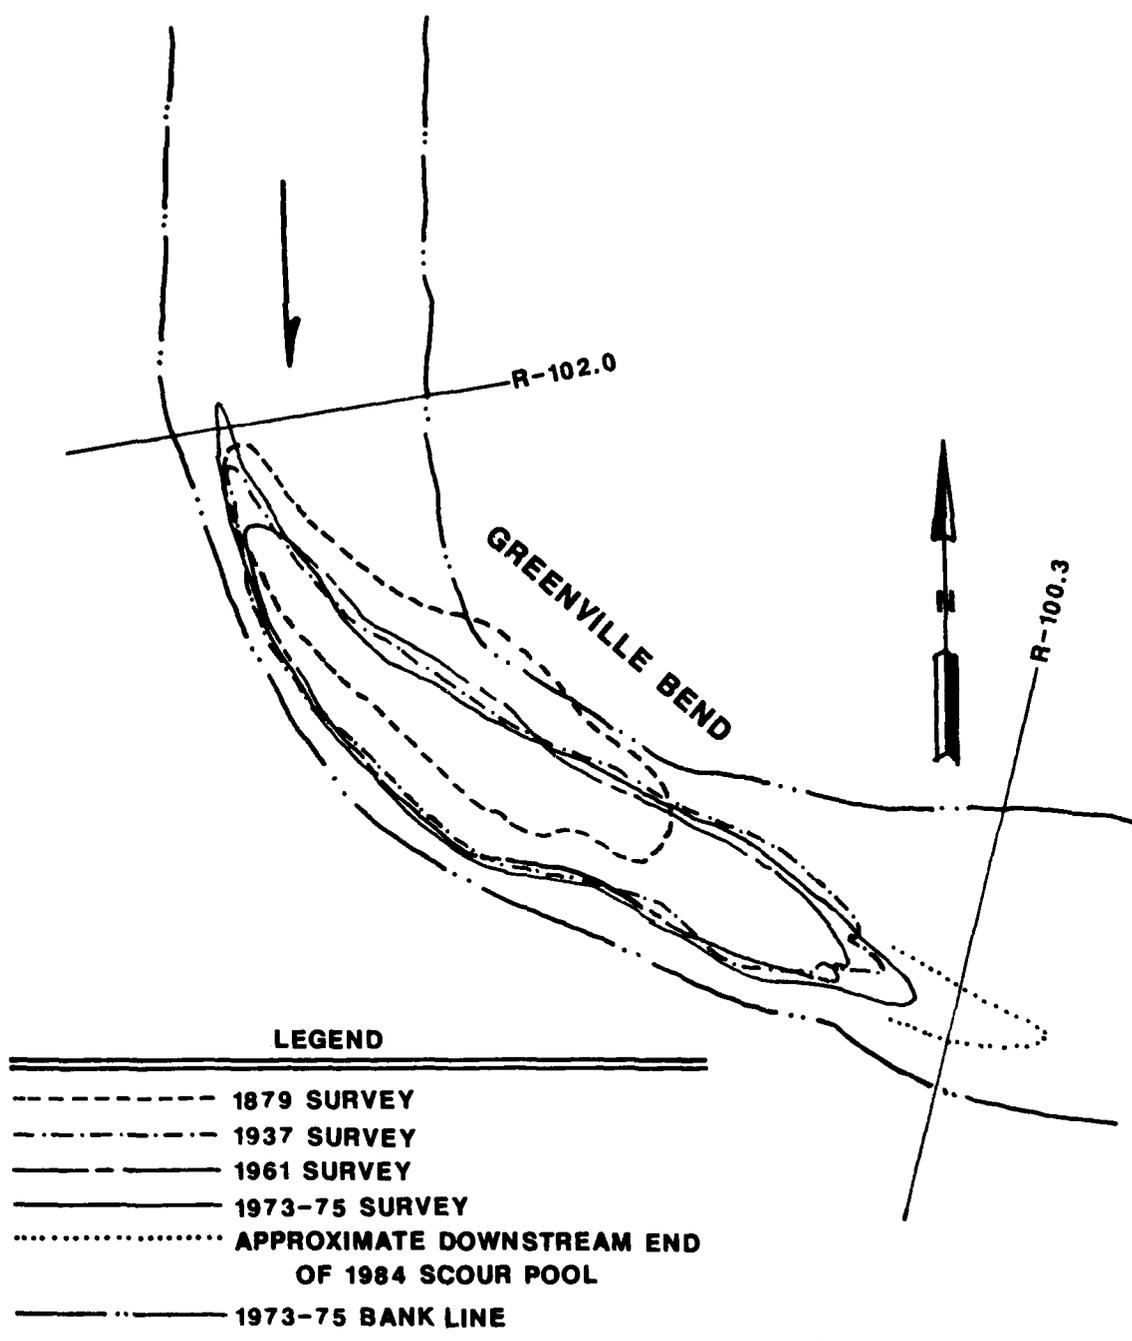
17. The historical migration of the Greenville Bend "permanent" scour pool is evident in Figure 13 where it is shown that the pool has been growing in length both upstream and downstream and moving in a southeasterly direction. The 1973-1975 hydrographic survey placed the downstream end of the pool based on el -100 at revetment range U-24. The previous discussion suggested that the pool in 1984 extended downstream close to range U-18 an additional 800 ft. The pool migration portends increasing attack along the Greenville revetment reach in the downstream direction. Particular watchfulness appears to be warranted from revetment range U-30 to D-15.

Figure 13. Historic trend in movement of permanent scour pool, Greenville Bend, Mississippi River

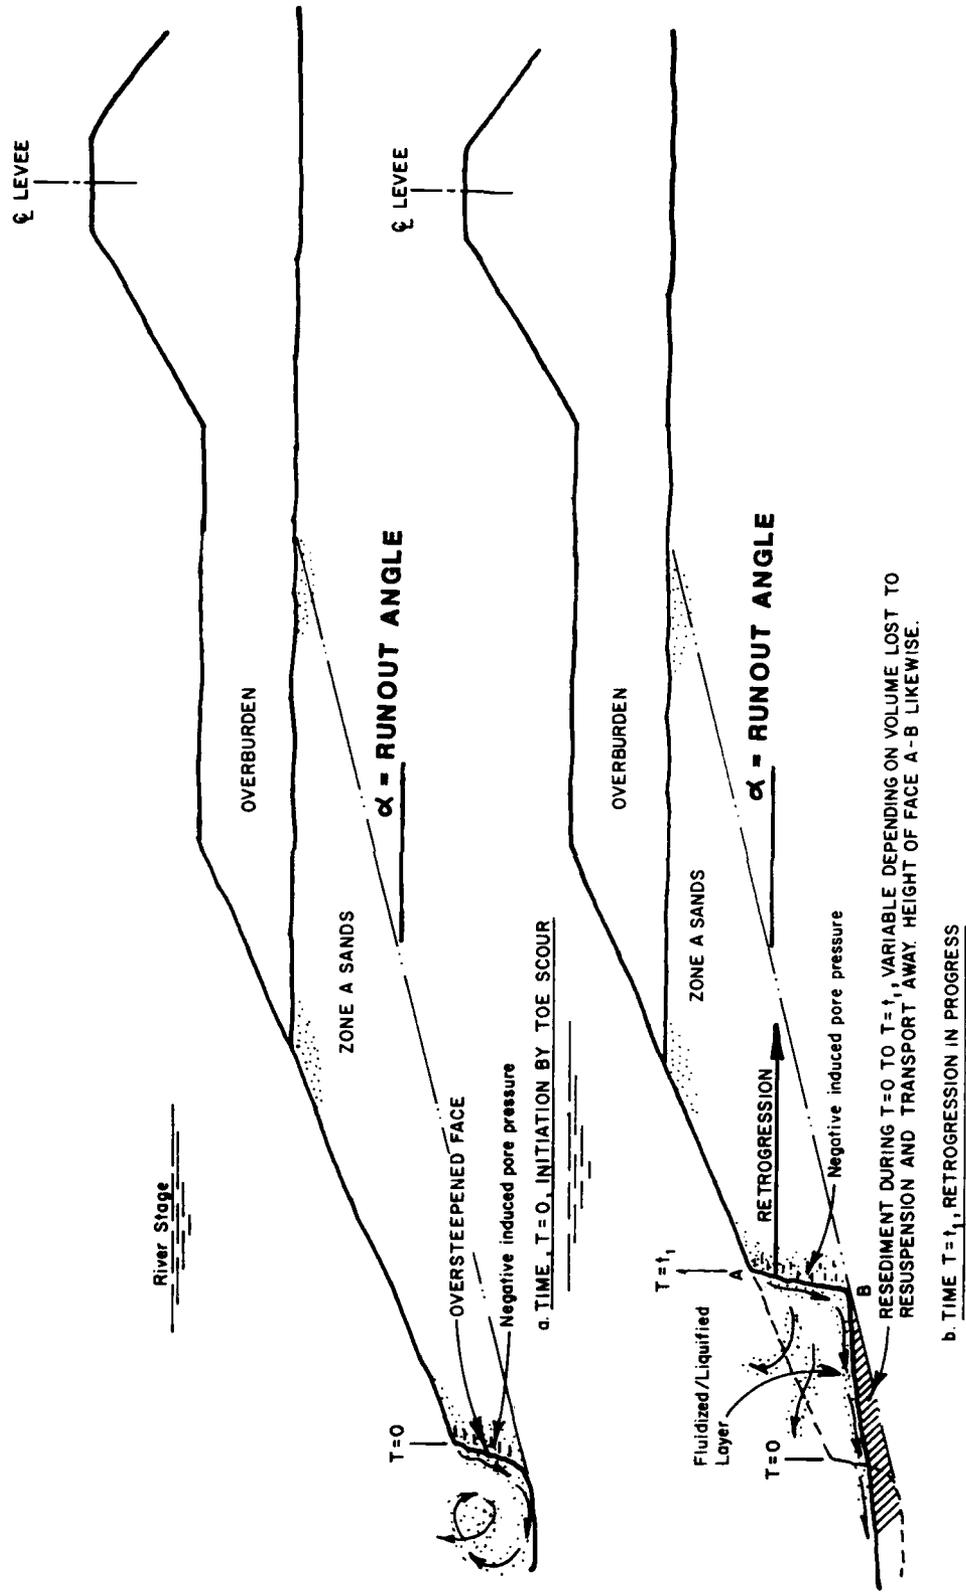
Figure 14. Sequential stages of retrogressive failure of a flow slide in dilatant sands (Sheet 1 of 3)

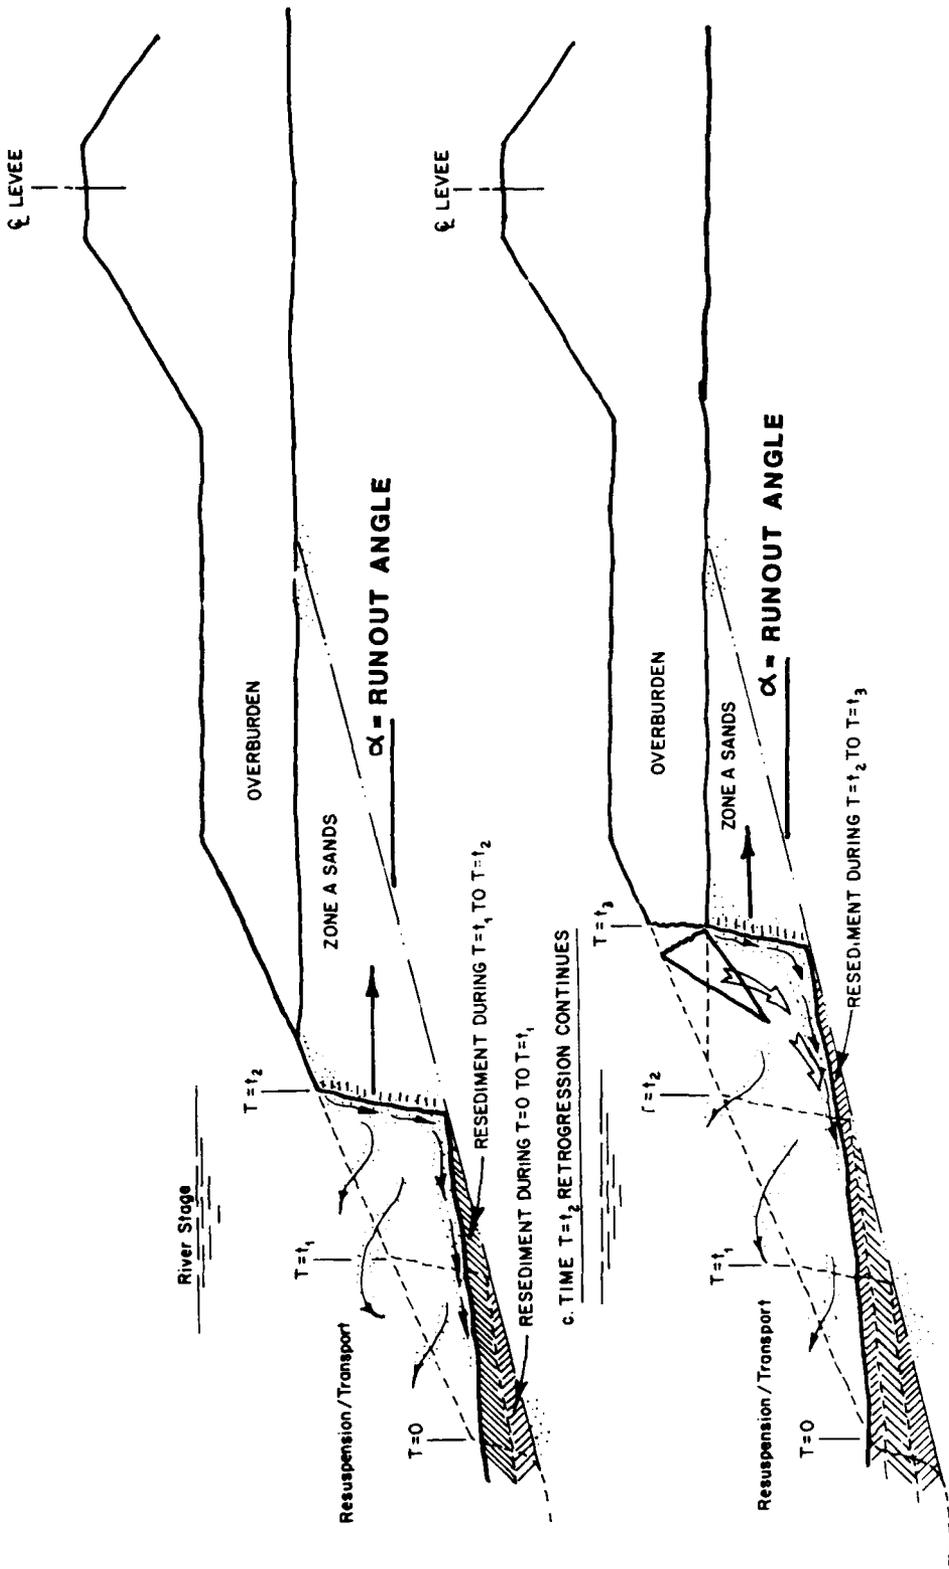
d. TIME T=t<sub>3</sub> OVERBURDEN UNDERCUT BEGINS, BLOCKS FAIL AND RIDE OUT UPON FLUIDIZED/LIQUIFIED LAYER

Figure 14. (Sheet 2 of 3)

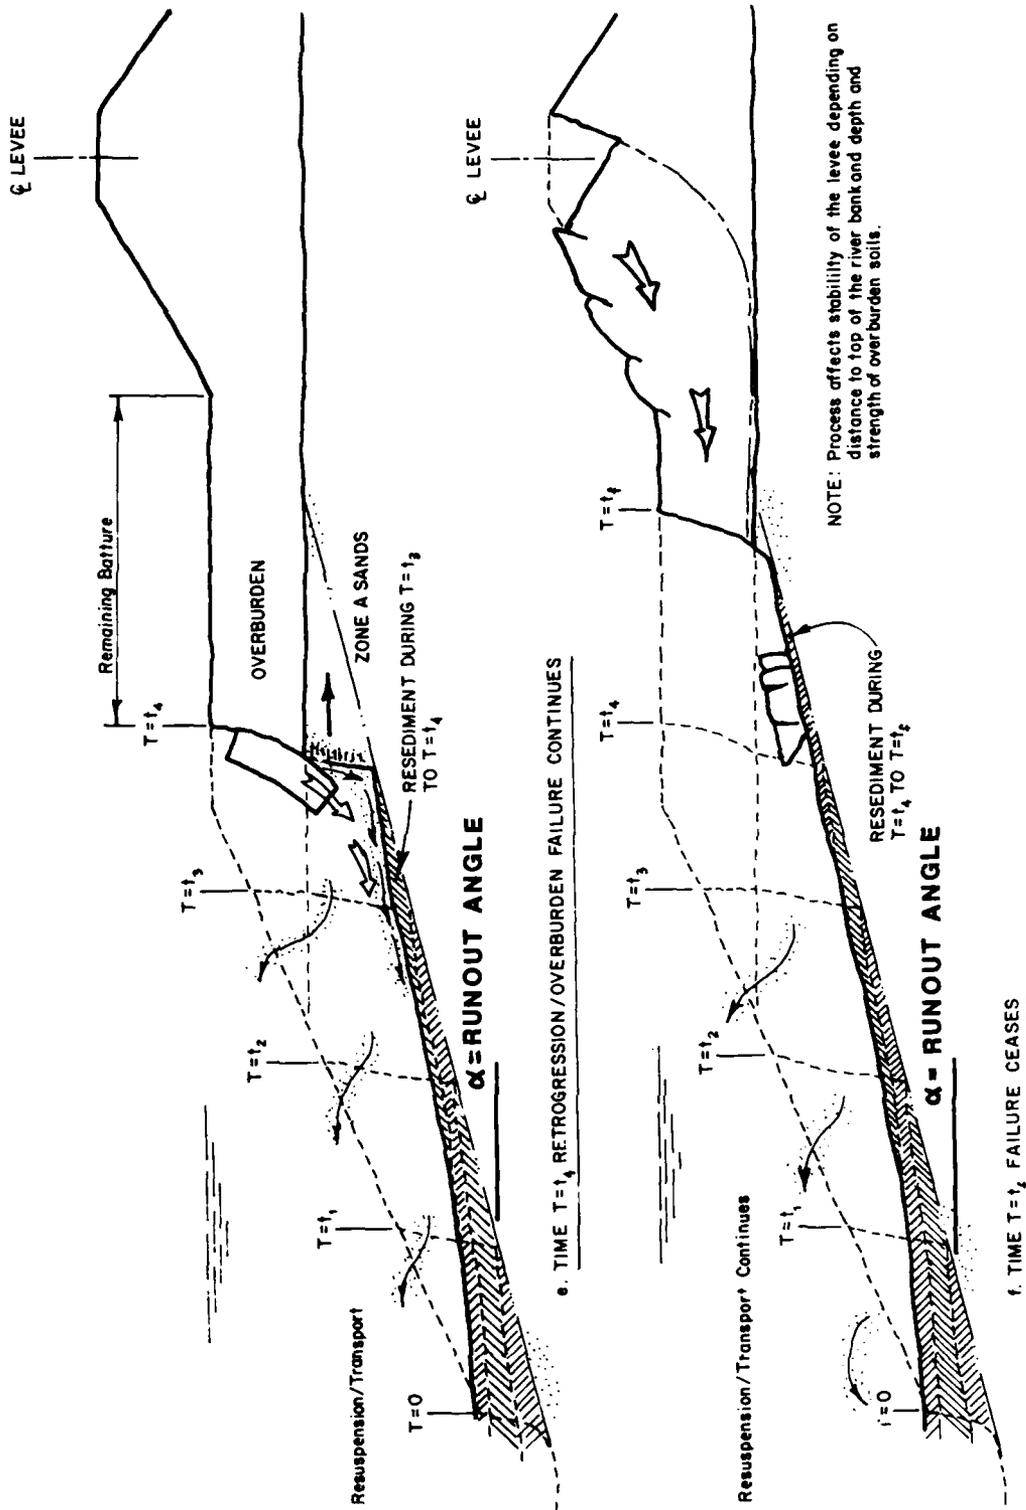
Figure 14. (Sheet 3 of 3)

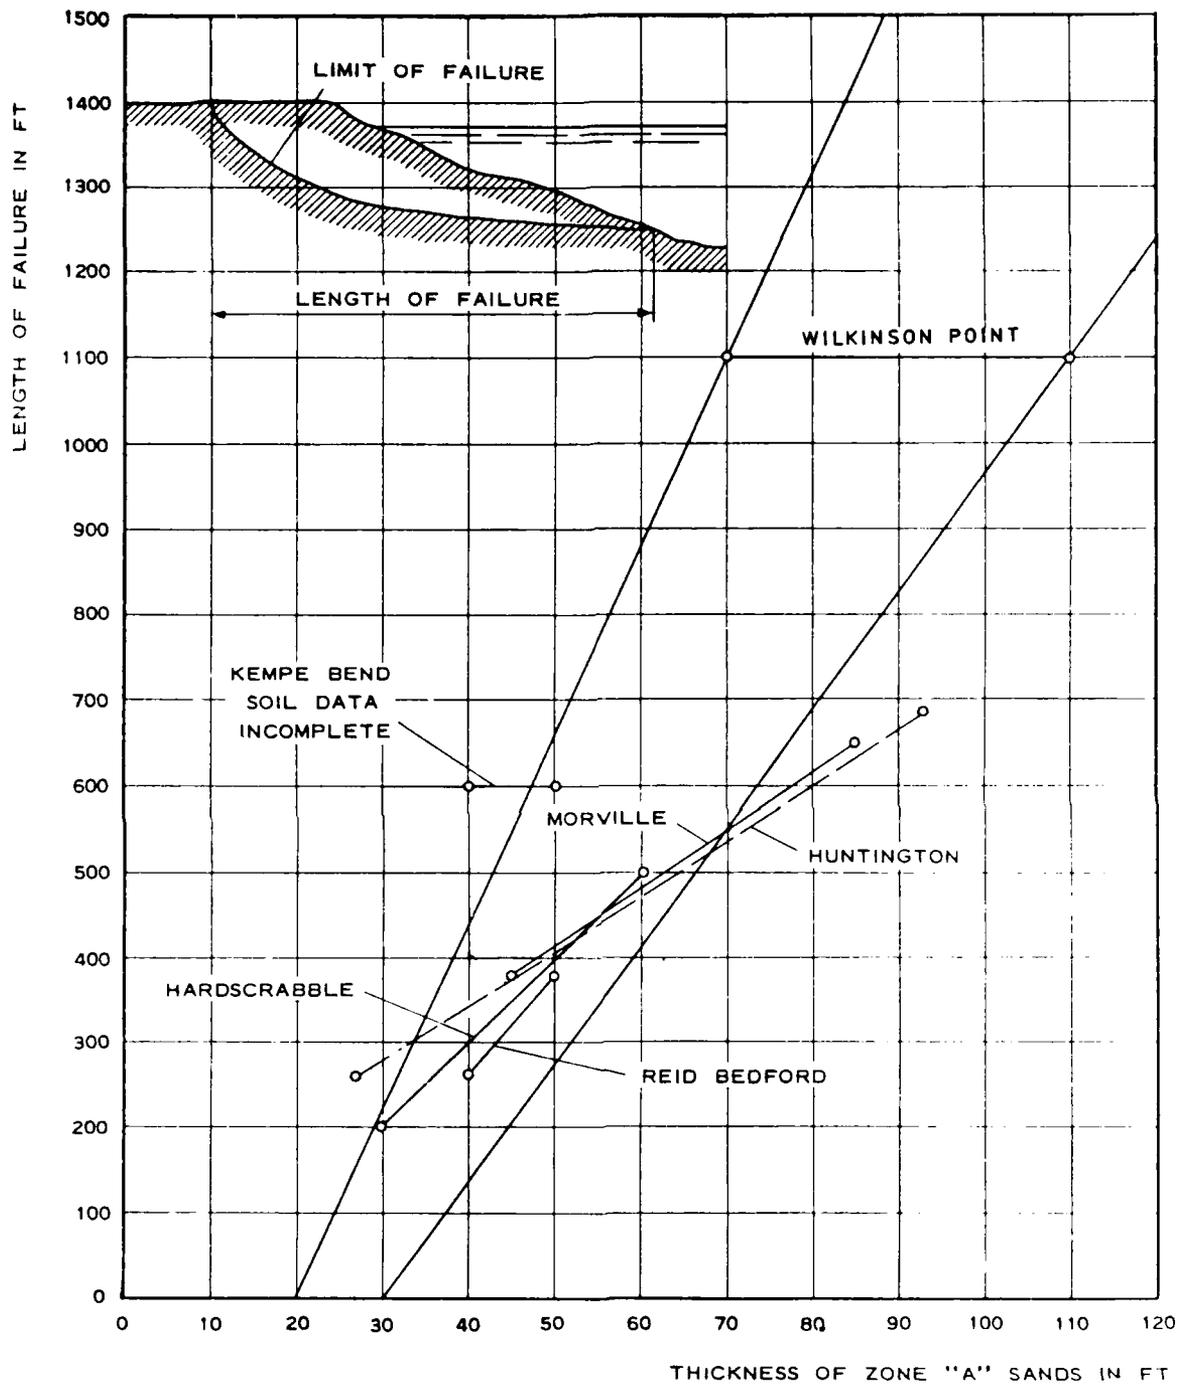
Figure 15. Length of failure versus thickness of Zone A sands  
(from Potamology Investigations Report 12-5)

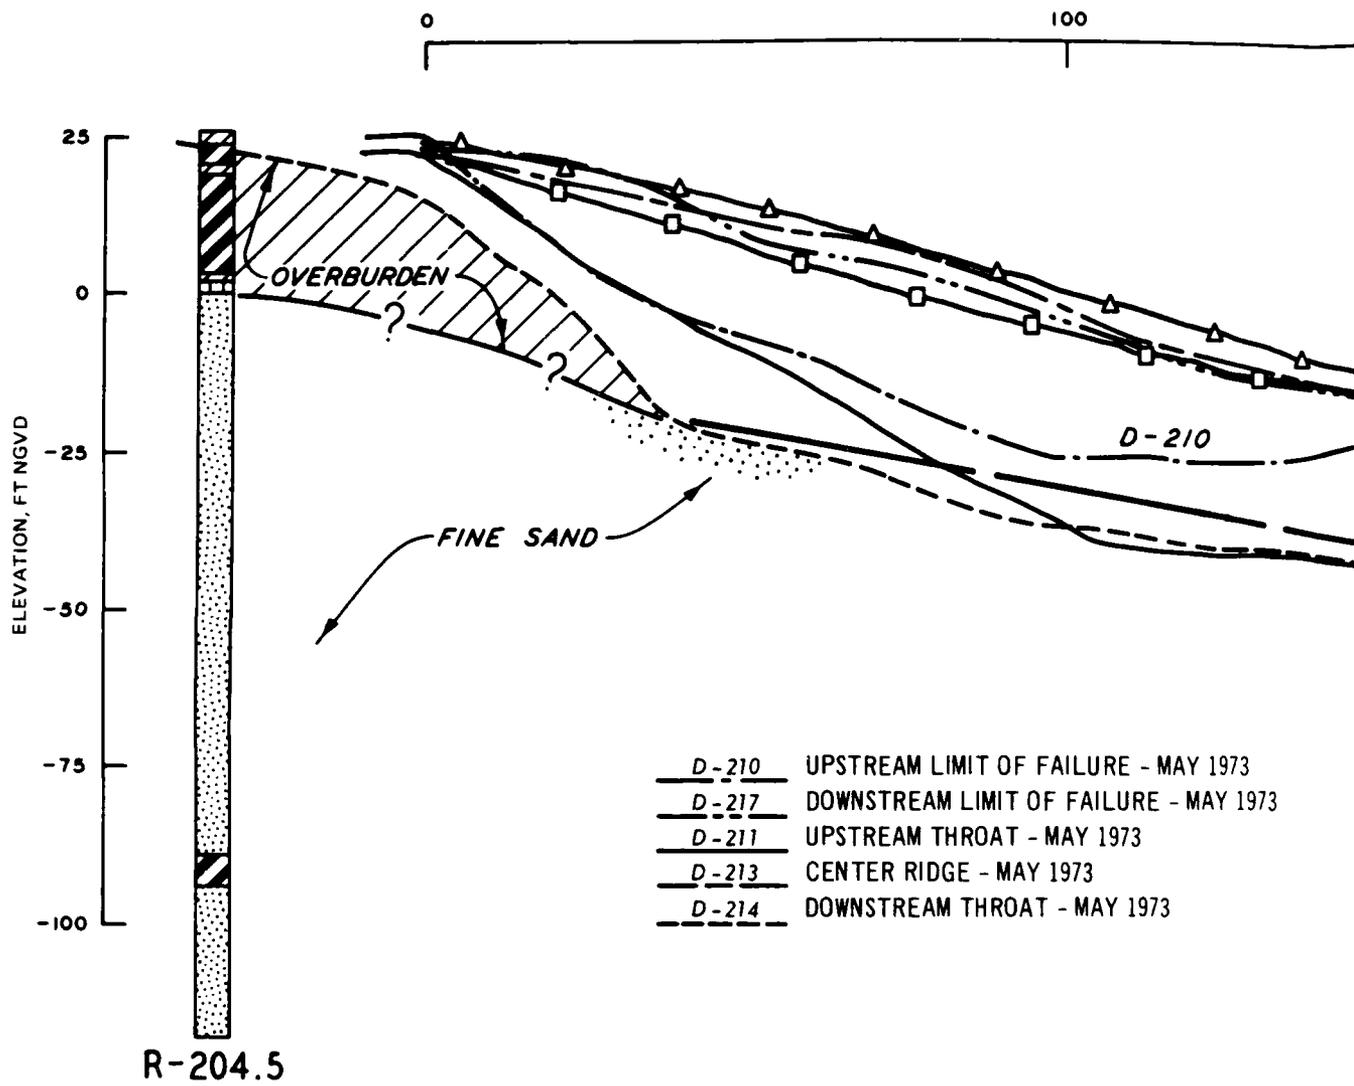
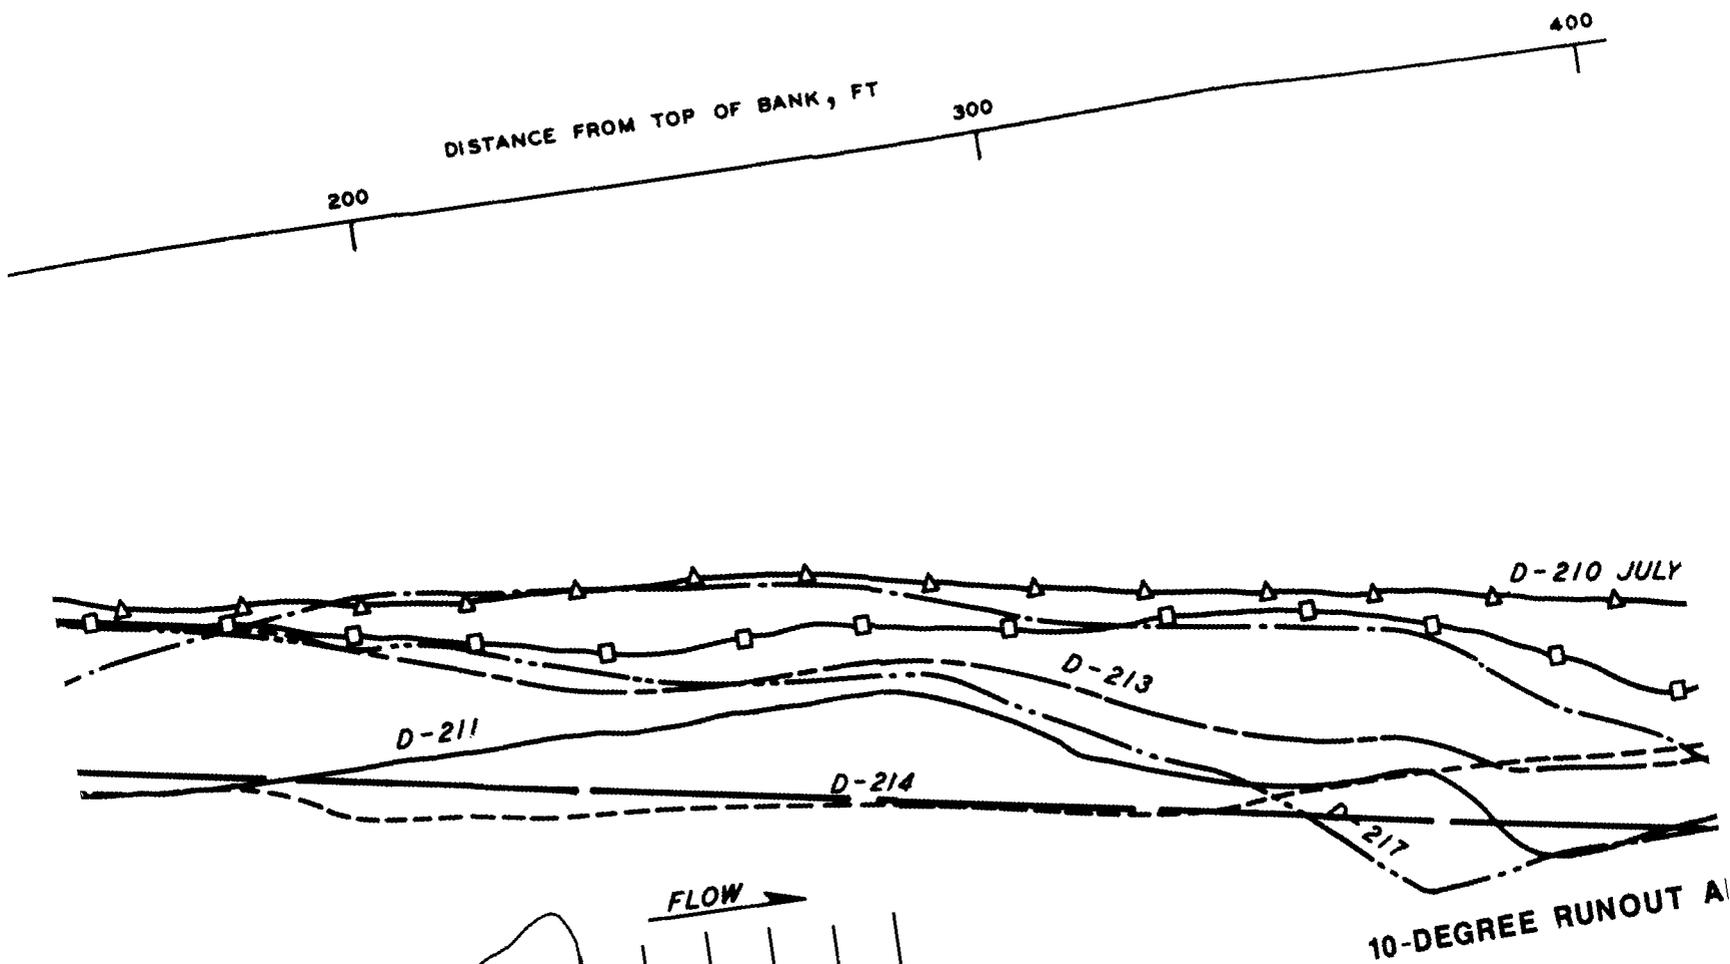
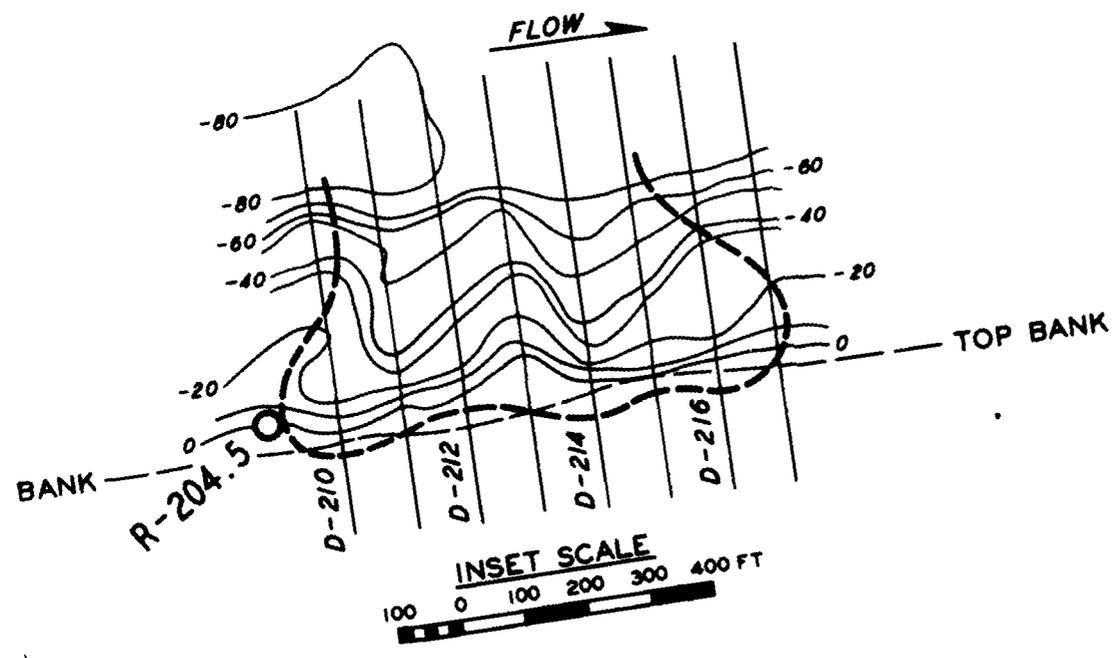
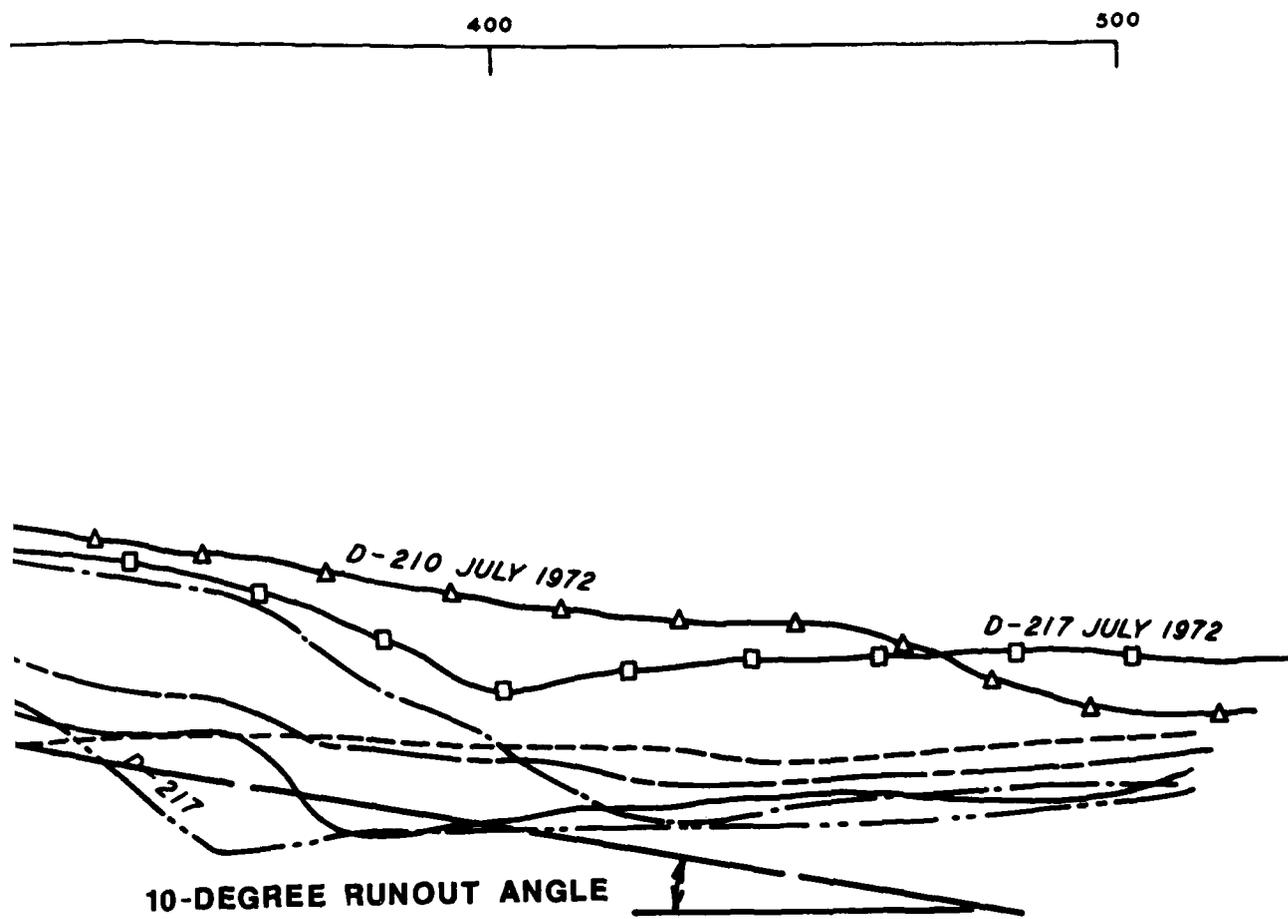
- D-210 UPSTREAM LIMIT OF FAILURE - MAY 1973
- D-217 DOWNSTREAM LIMIT OF FAILURE - MAY 1973
- D-211 UPSTREAM THROAT - MAY 1973
- D-213 CENTER RIDGE - MAY 1973
- D-214 DOWNSTREAM THROAT - MAY 1973

Figure 18. Sections perpendicular to the riverbank, 1973  
upstream failure at Plaquemine Bend, LA.
