DTIC FILE COPY TECHNICAL REPORT GL-88-9

# RETROGRESSIVE FAILURES IN SAND DEPOSITS OF THE MISSISSIPPI RIVER

EMPIRICAL EVIDENCE IN SUPPORT OF THE  
HYPOTHESIZED FAILURE MECHANISM AND  
DEVELOPMENT OF THE LEVEE SAFETY  
FLOW SLIDE MONITORING SYSTEM

PART II: CASE HISTORY OF THE CELOTEX BATTURE AND LEVEE FAILURE OF  
30 JULY 1985

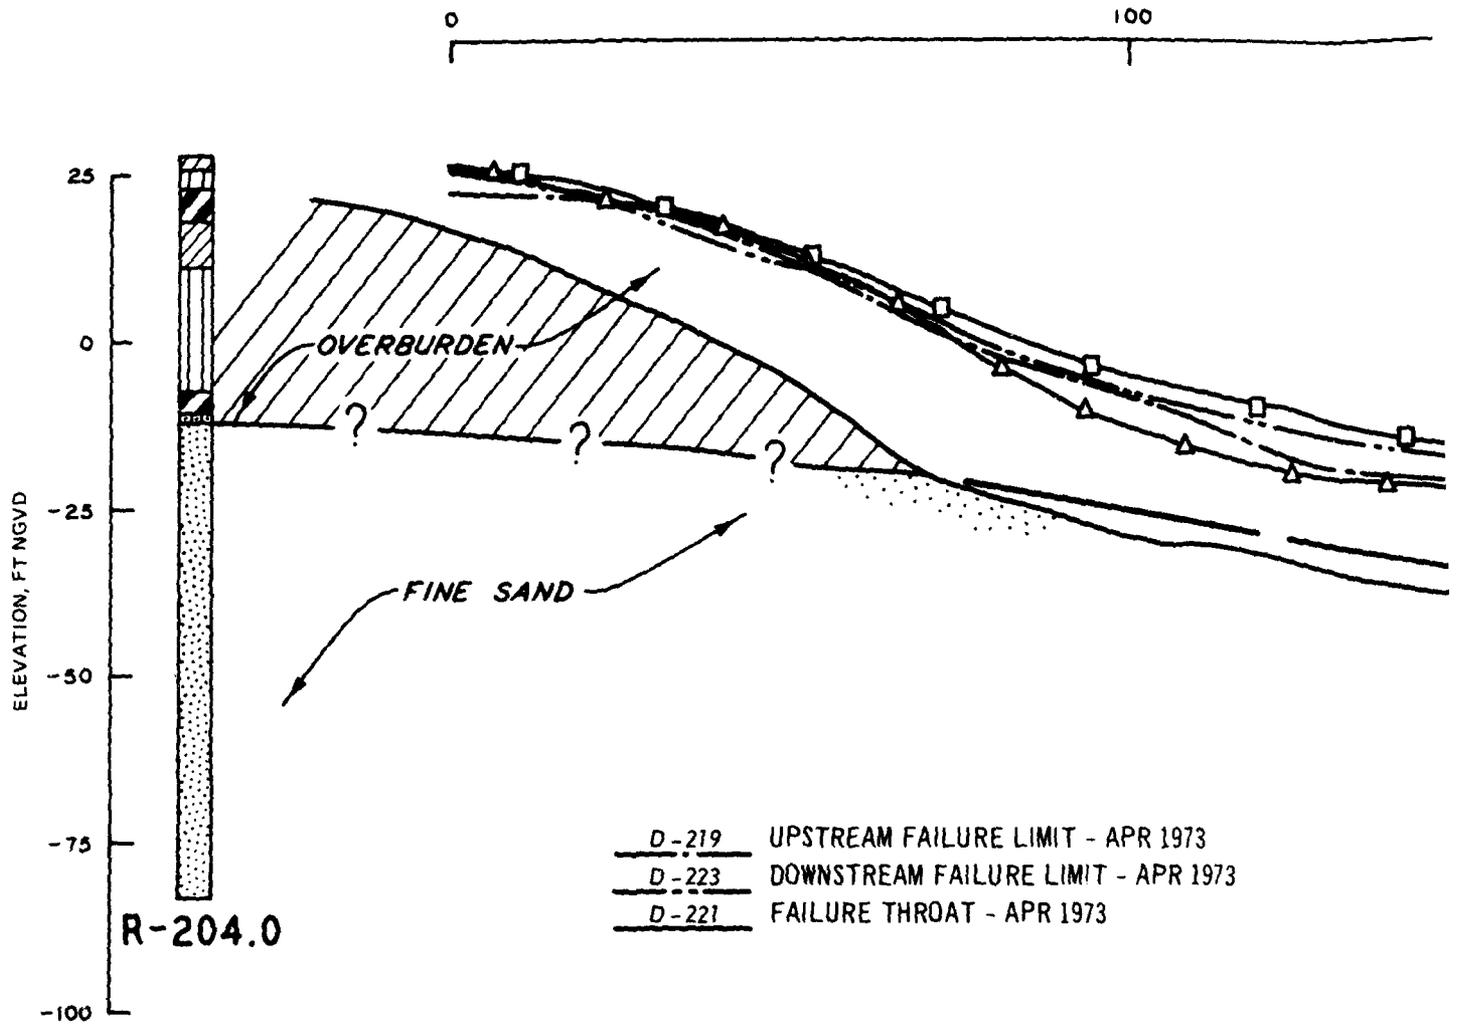
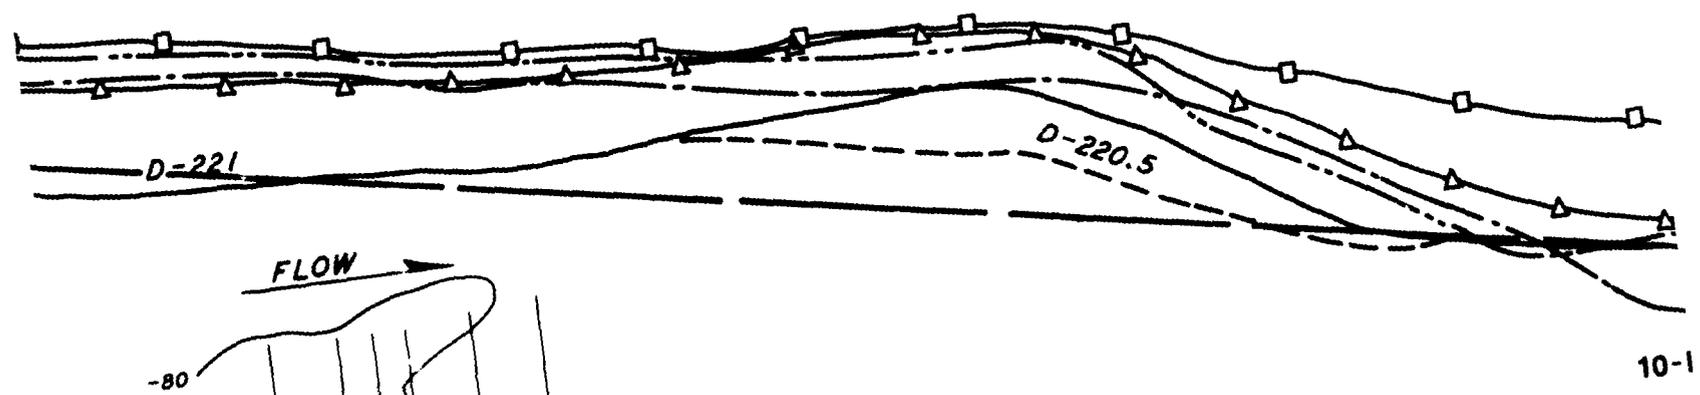
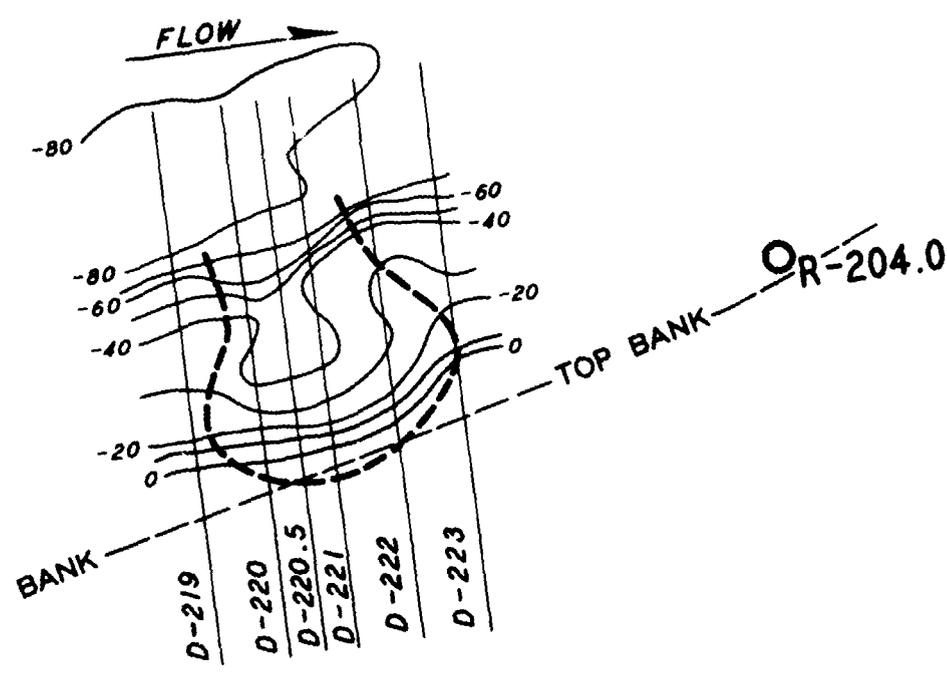
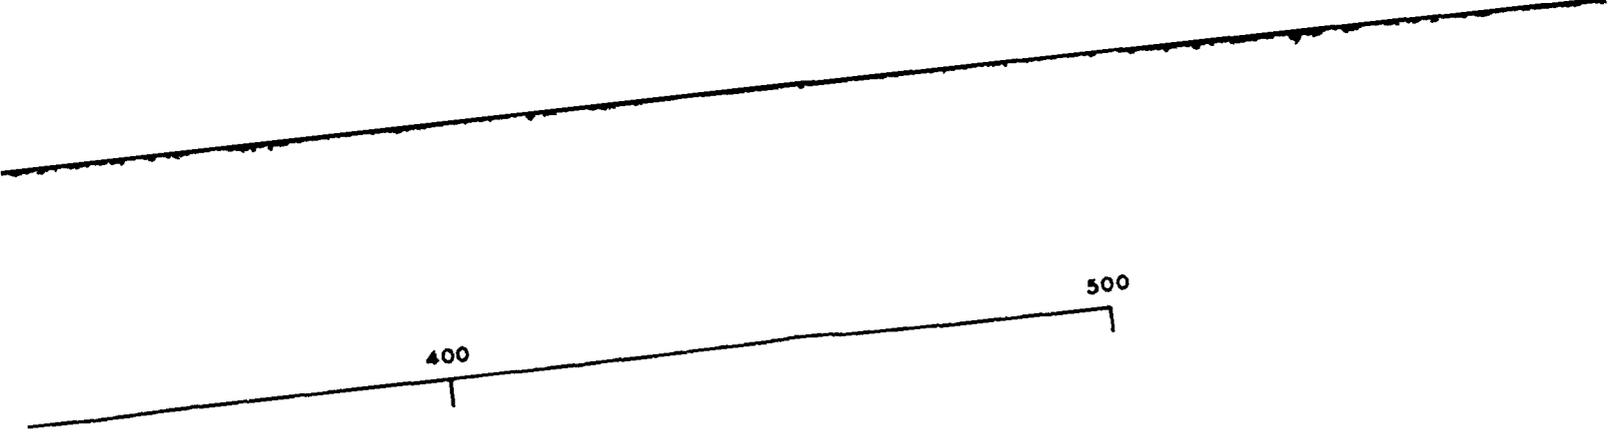
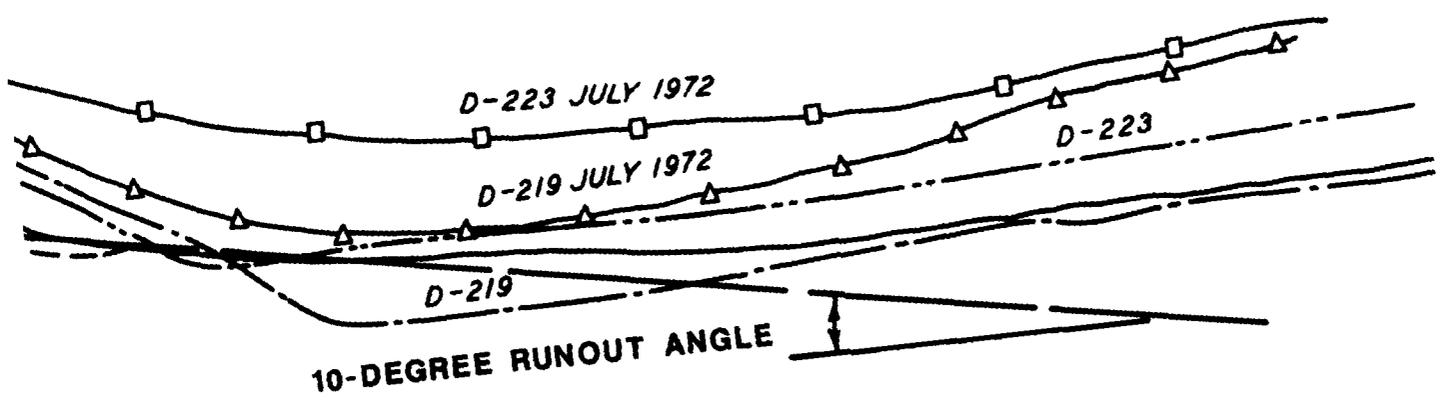
Figure 19. Sections perpendicular to the riverbank, 1973  
downstream failure at Plaquemine Bend, LA.

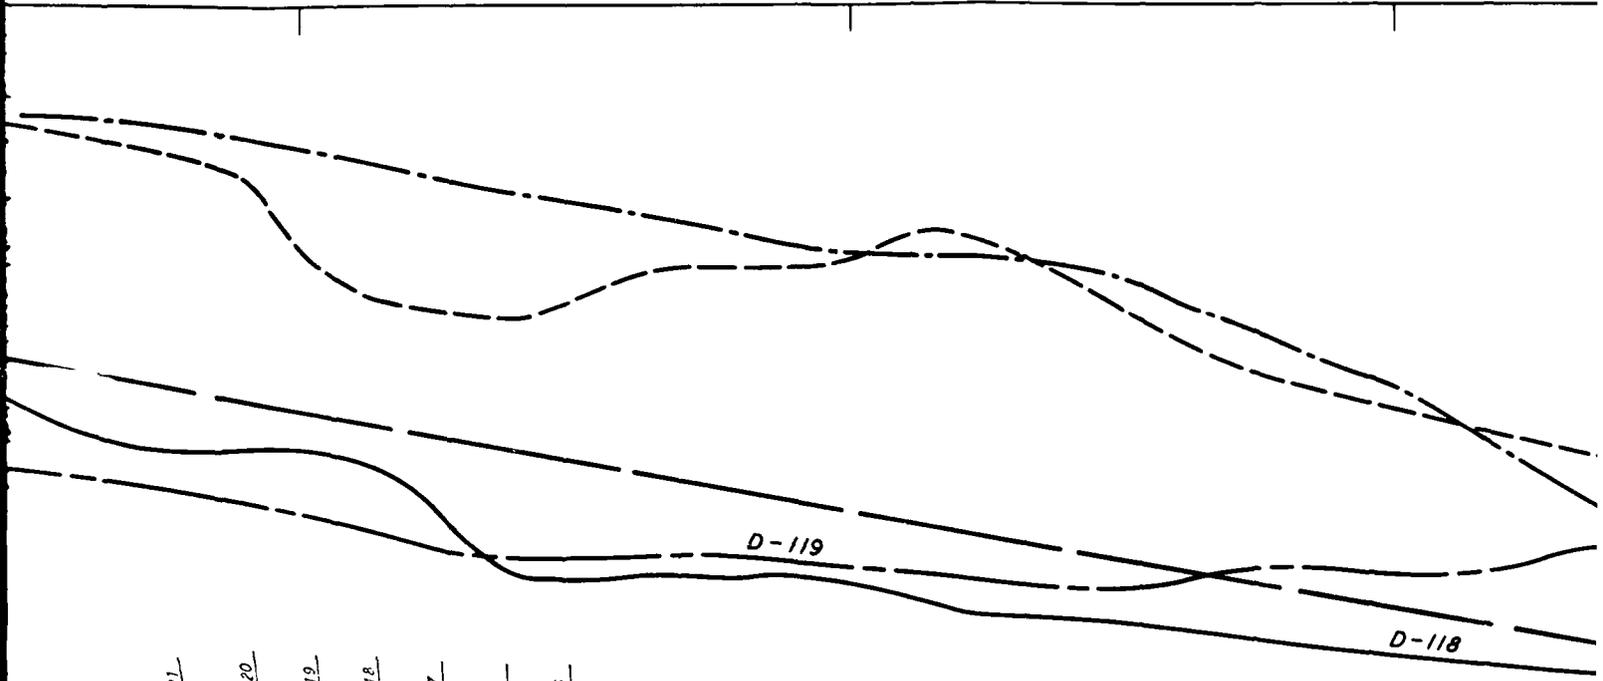
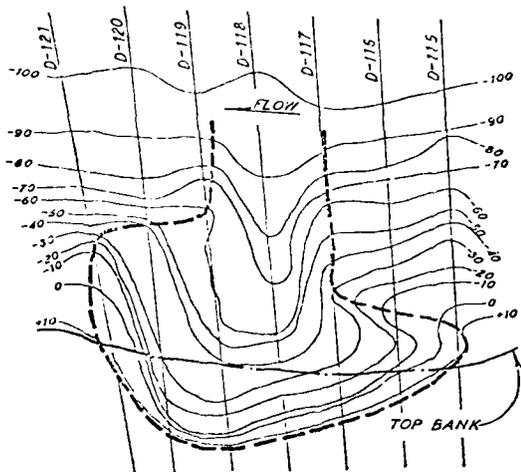
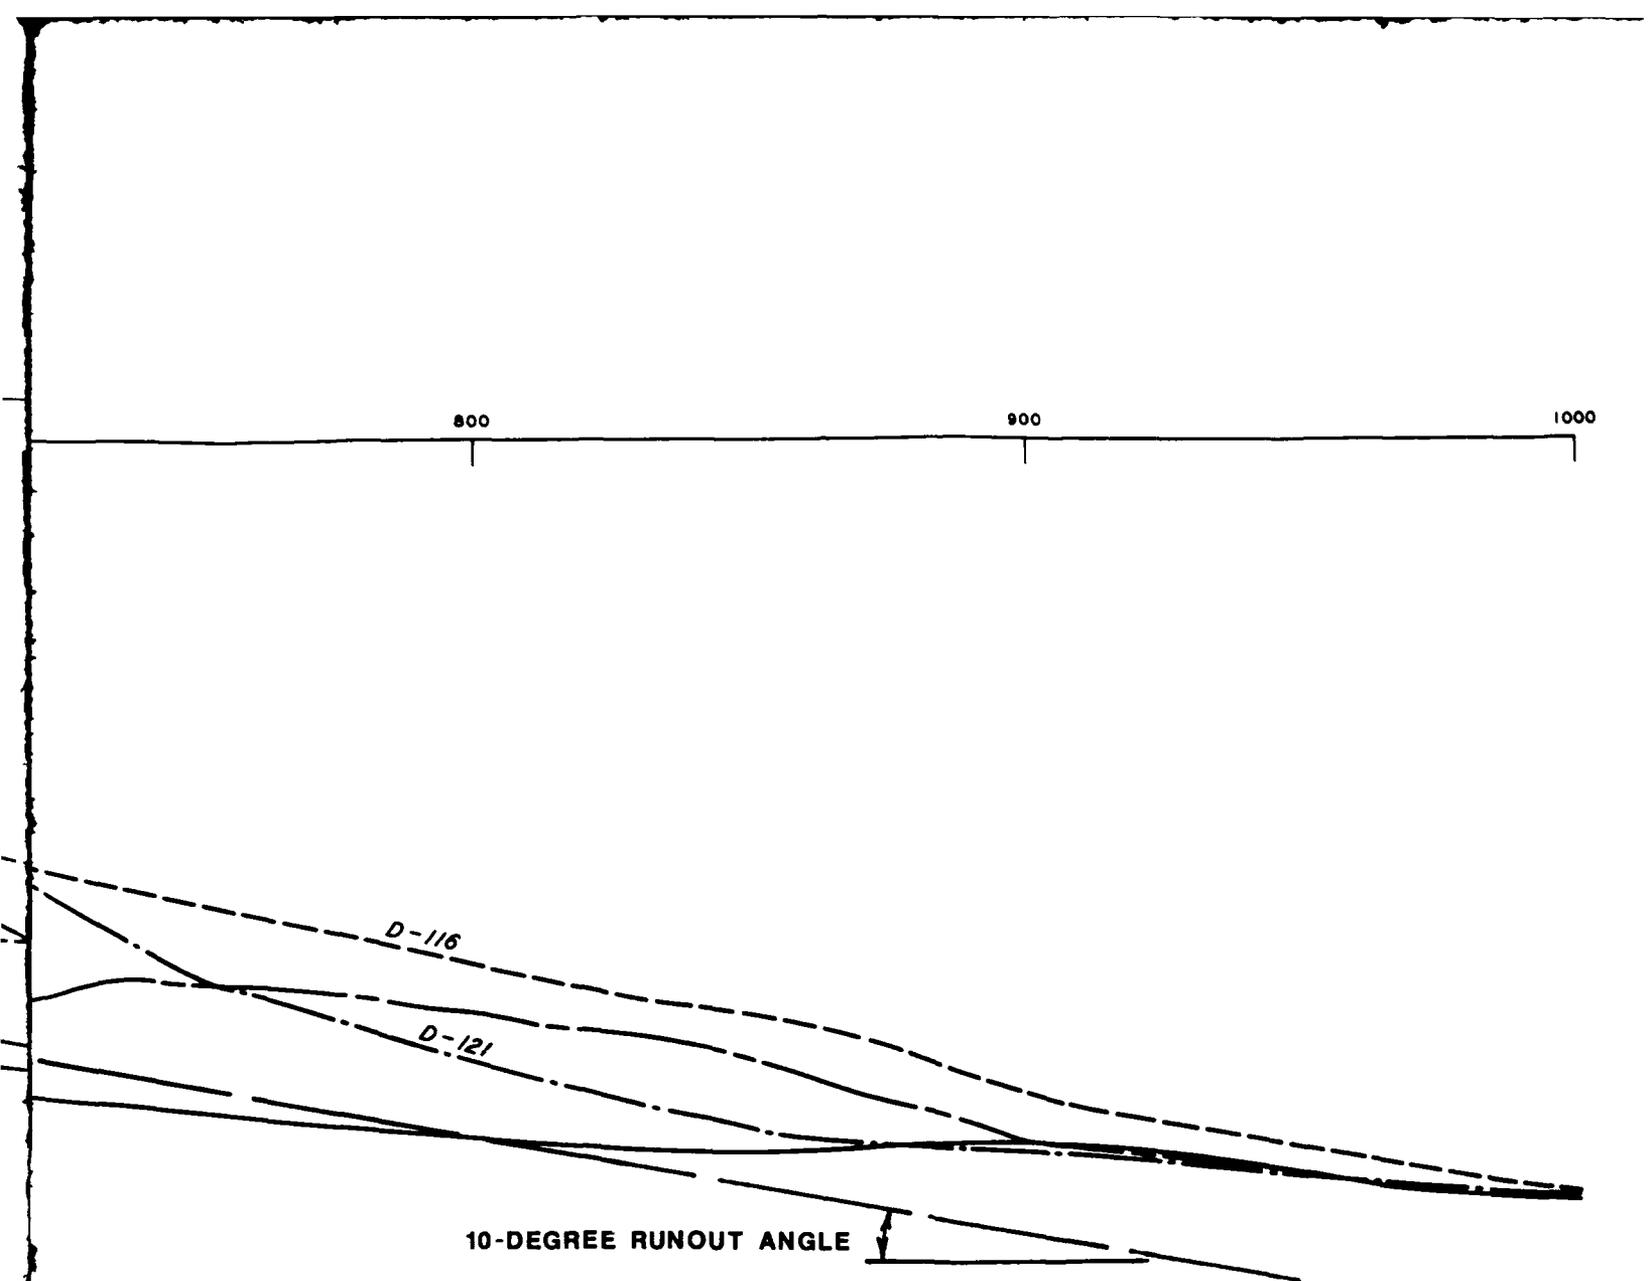
Figure 20. Sections perpendicular to the riverbank, 1973 failure at Montz, LA.

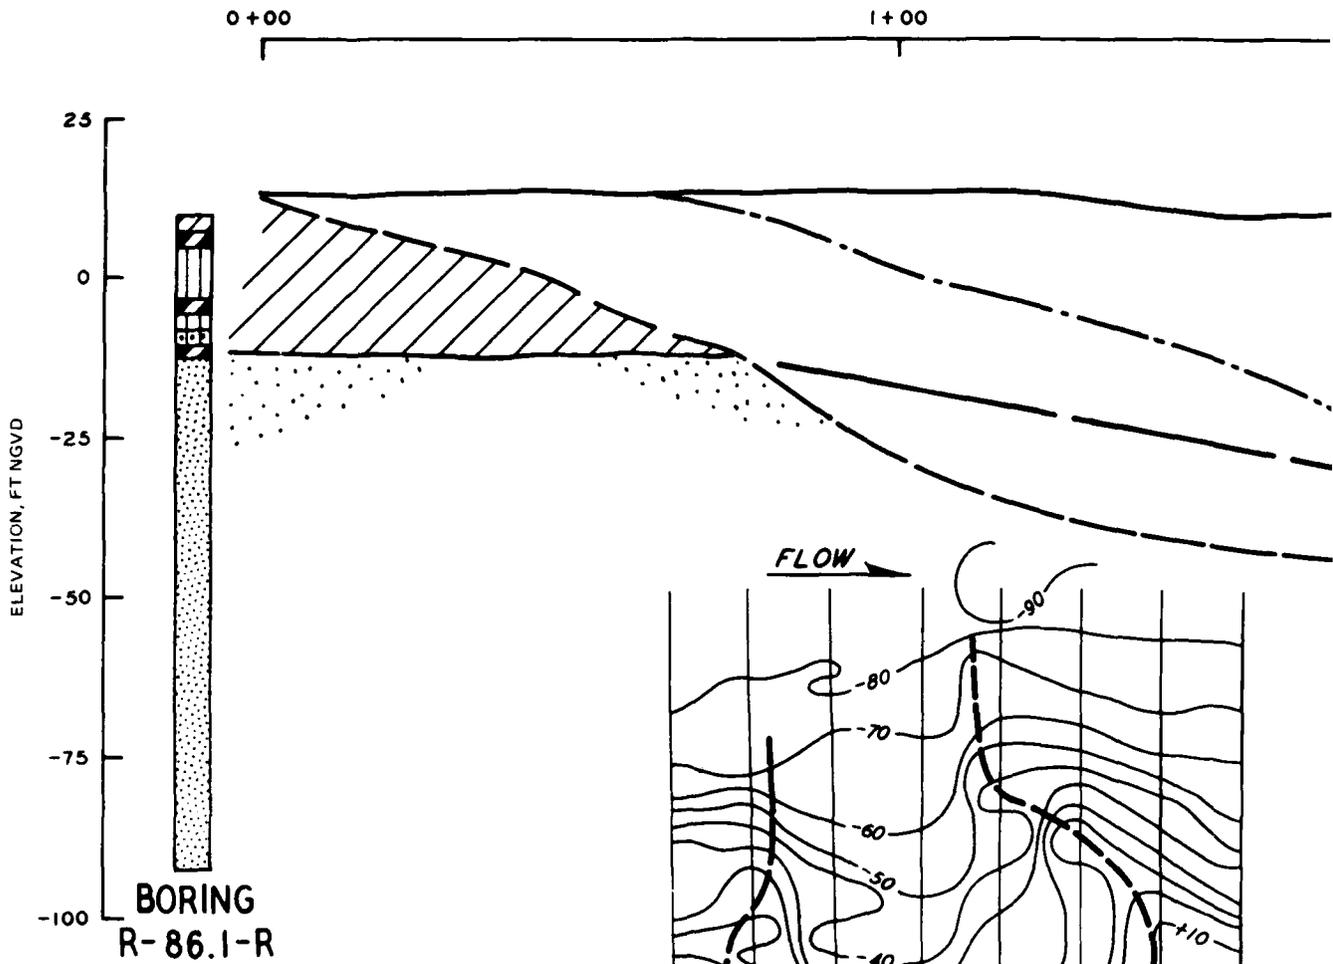
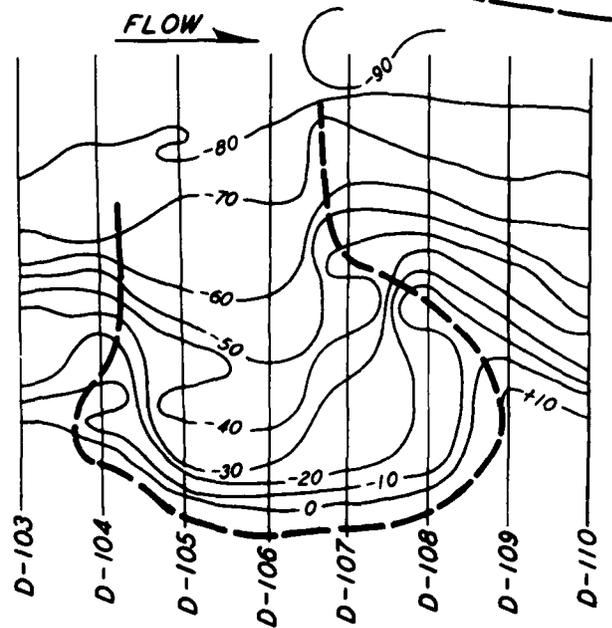
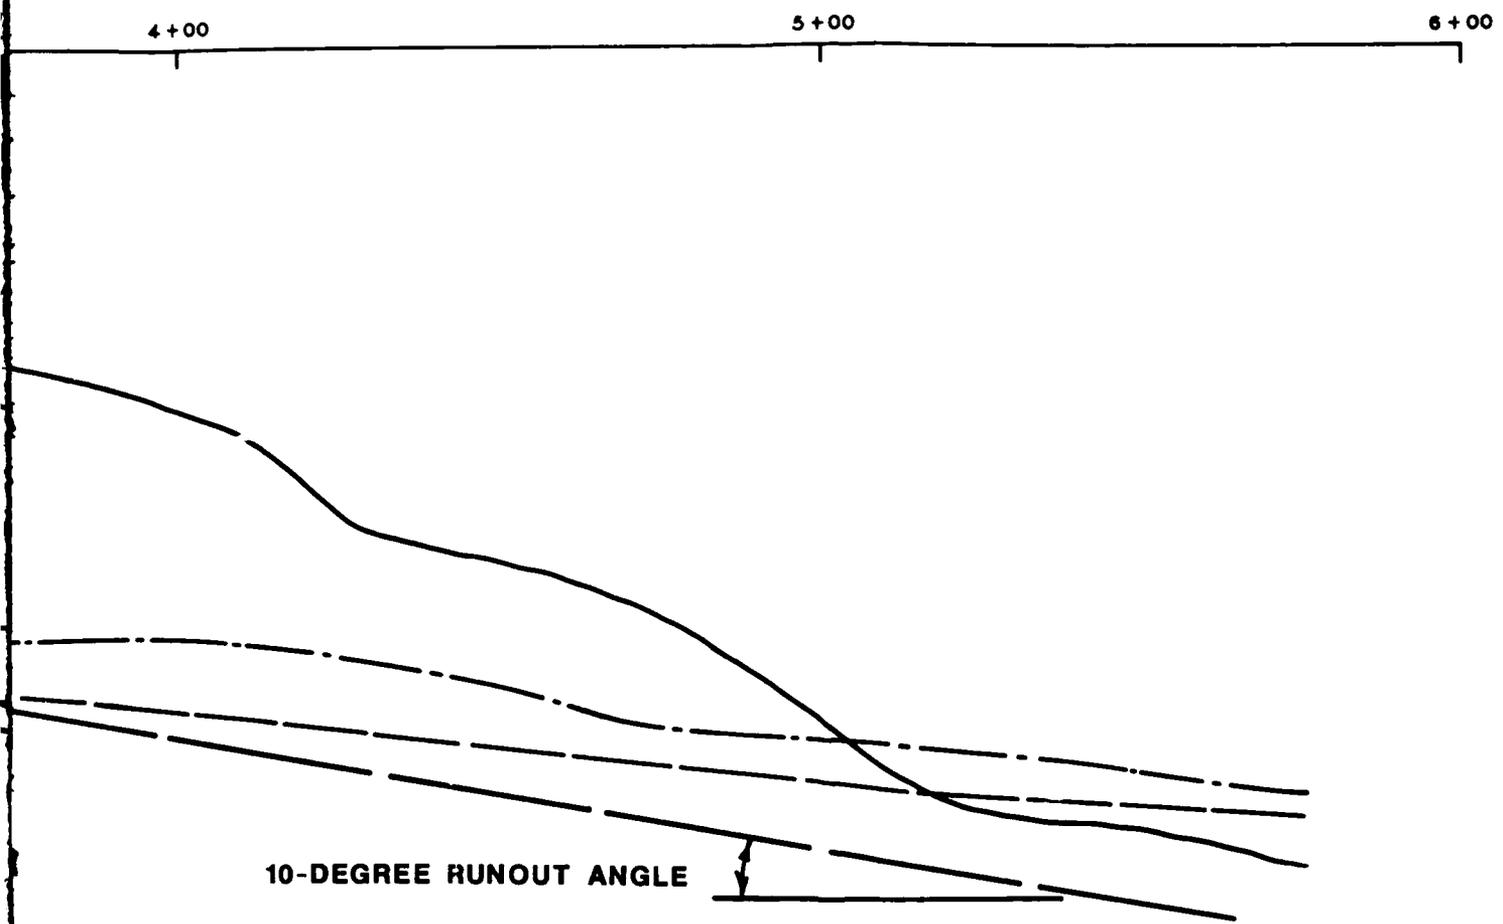
NOTE: RANGE D-105 REPRESENTED CENTER LINE OF FAILURE IN JUNE 1973. BY OCTOBER 1973, FAILURE CONFIGURATION CHANGED SO THAT RANGE D-106 REPRESENTED CENTER LINE.

Figure 21. Sections perpendicular to the riverbank, 1973 failure at Stanton, LA.

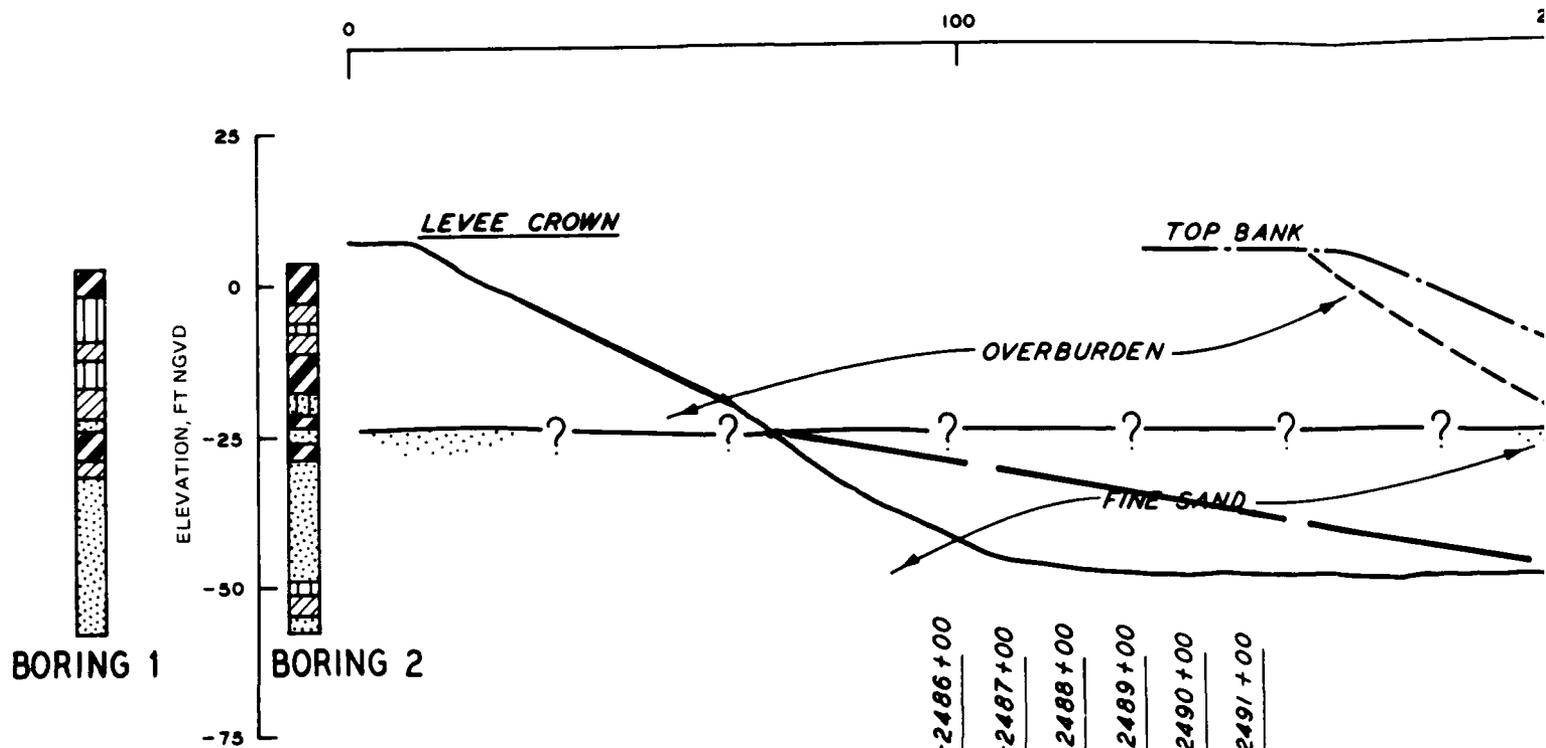
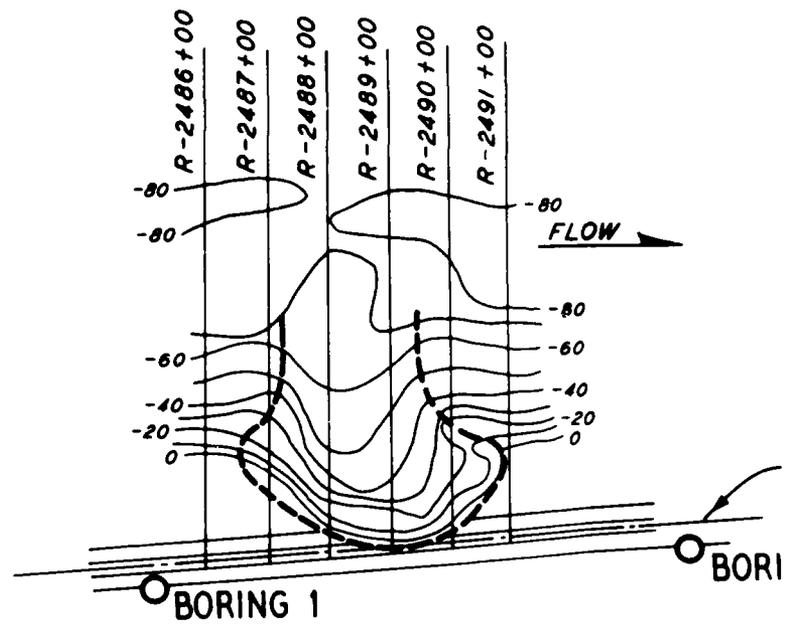
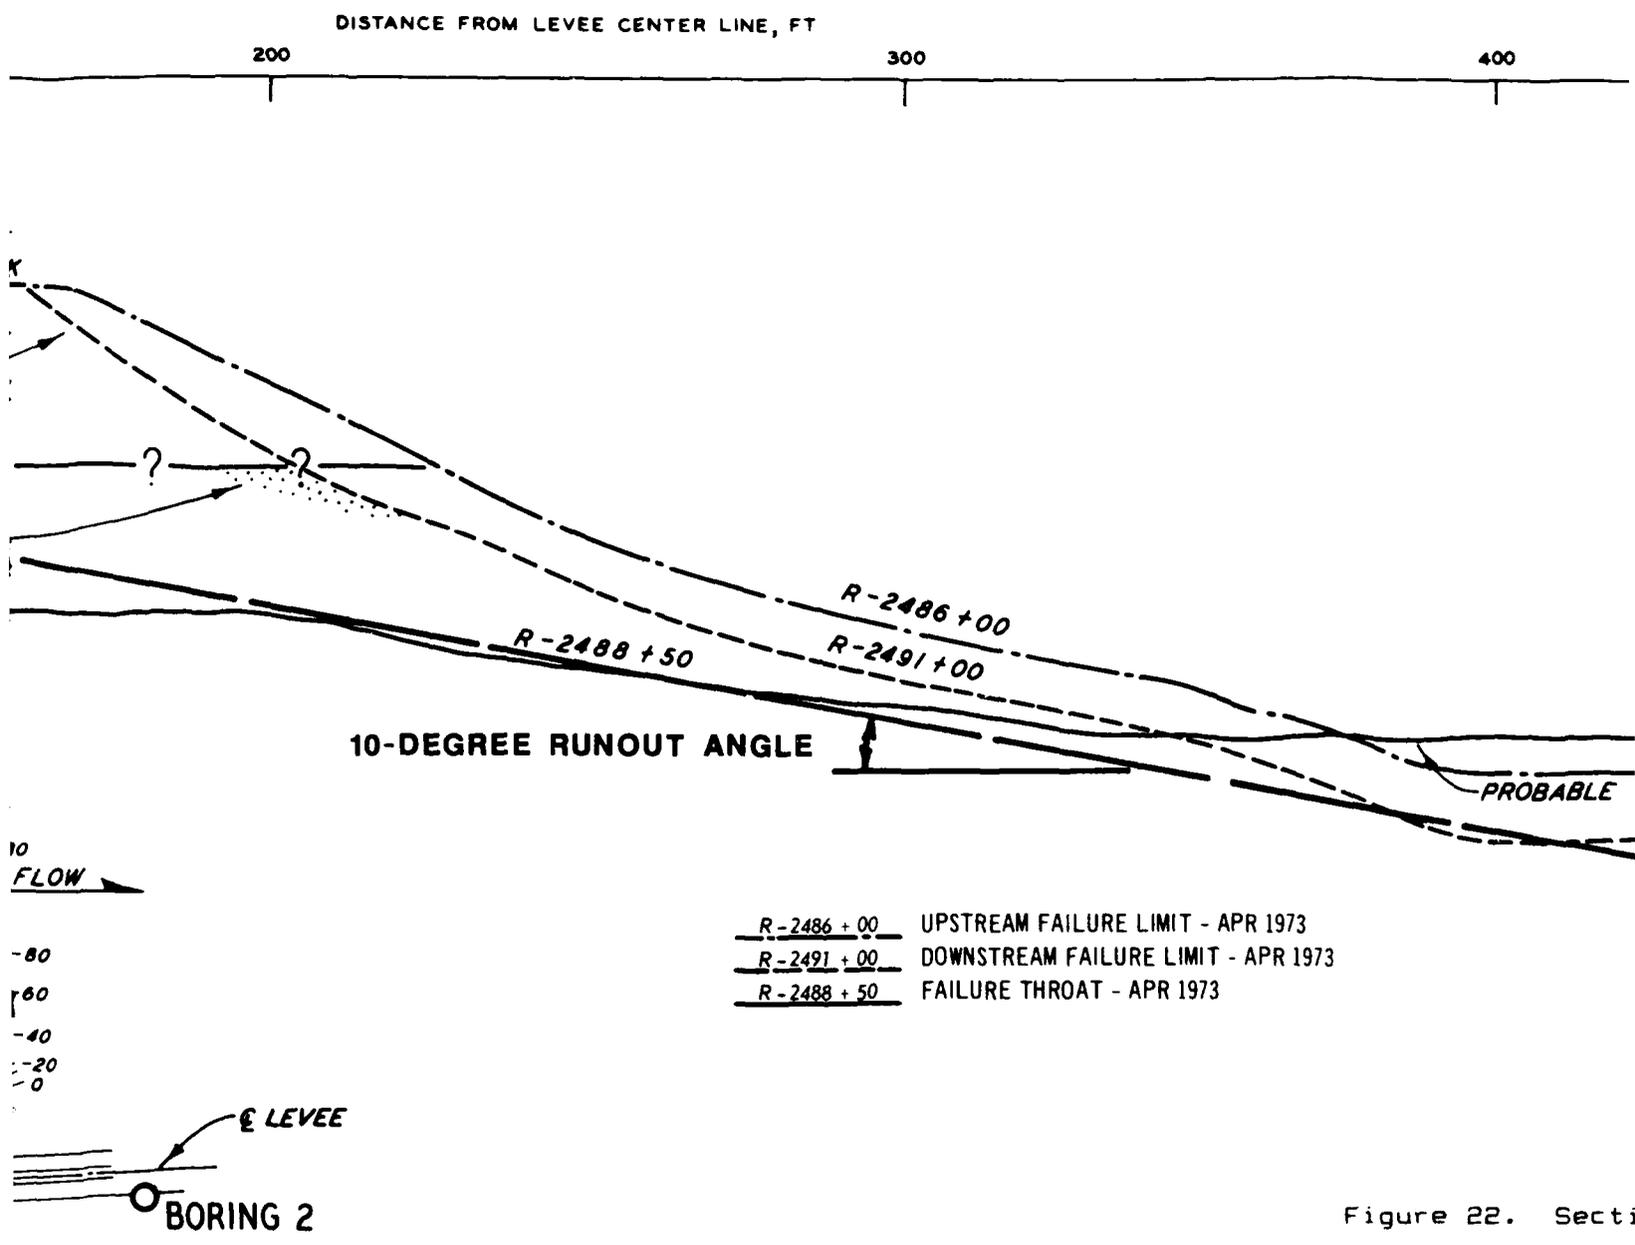
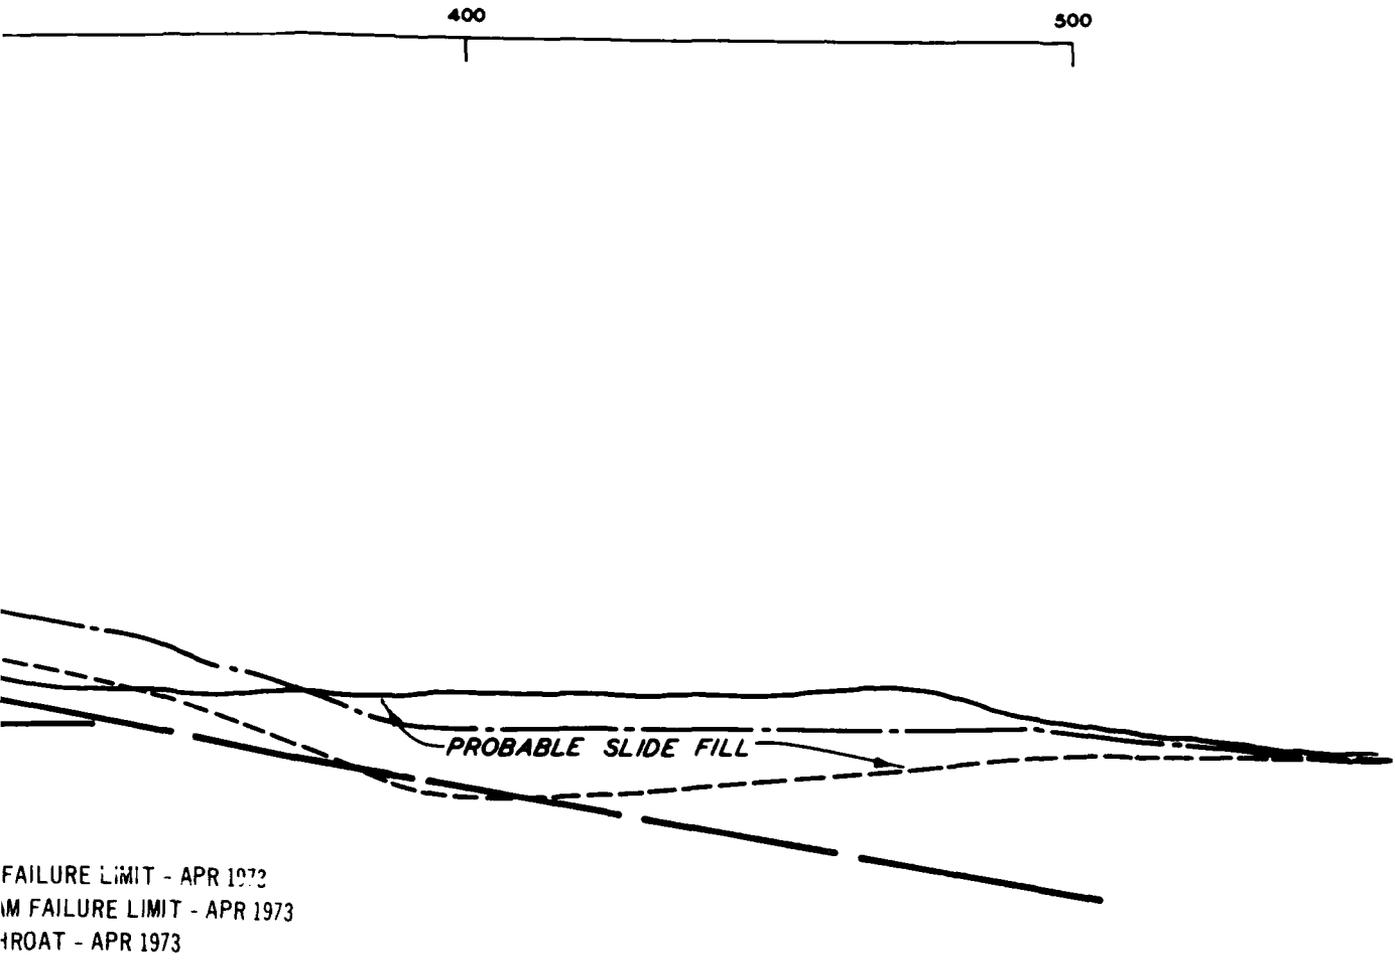
Figure 22. Sections perpendicular to the riverbank, 1973 failure at Nairn, LA.

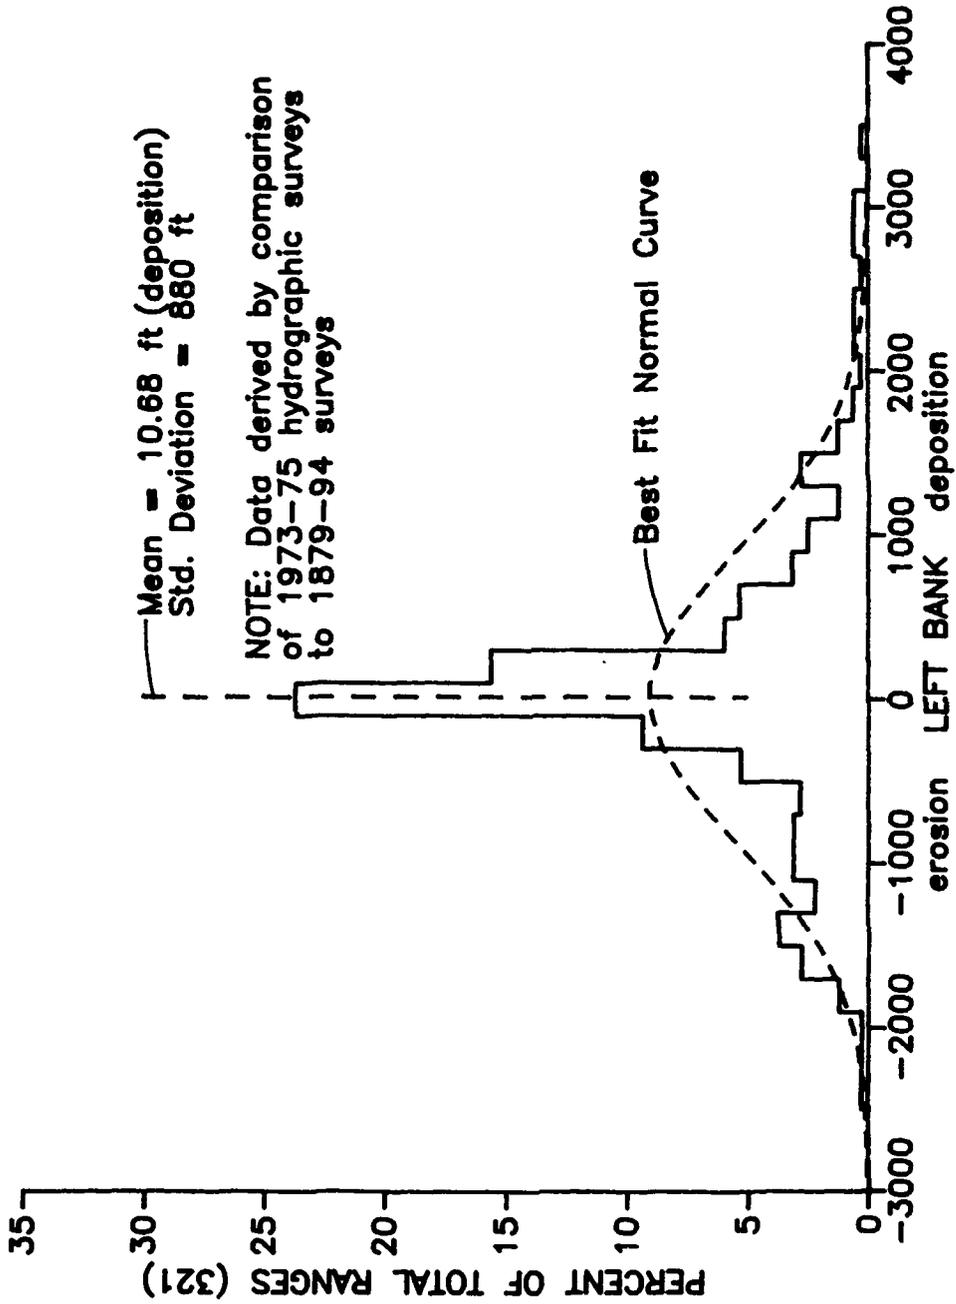
Figure 33. Frequency histogram, historical erosion/deposition, left bank, range 234.8 to 129.8, Mississippi River below Baton Rouge, LA

- b. When the total data sets are divided into the subsets above Bonnet Carre Spillway and below (right bank--Figures 30 and 31, left bank--Figures 33 and 34), the differences between the two reaches are again seen. The dispersions of the data for both banks above Bonnet Carre Spillway (hydrographic range R-129.8) are very similar (right bank standard deviation = 901 ft of batture; left bank standard deviation = 380 ft of batture). This reiterates the previous statement that the river has been much more active above Bonnet Carre Spillway than below. It is also seen that above R-129.8 the mean trend has been deposition for both banks, while below R-129.8 the mean trend has been erosion for both banks. Therefore, on the average, the river has tended to become narrower above Bonnet Carre Spillway but wider below.

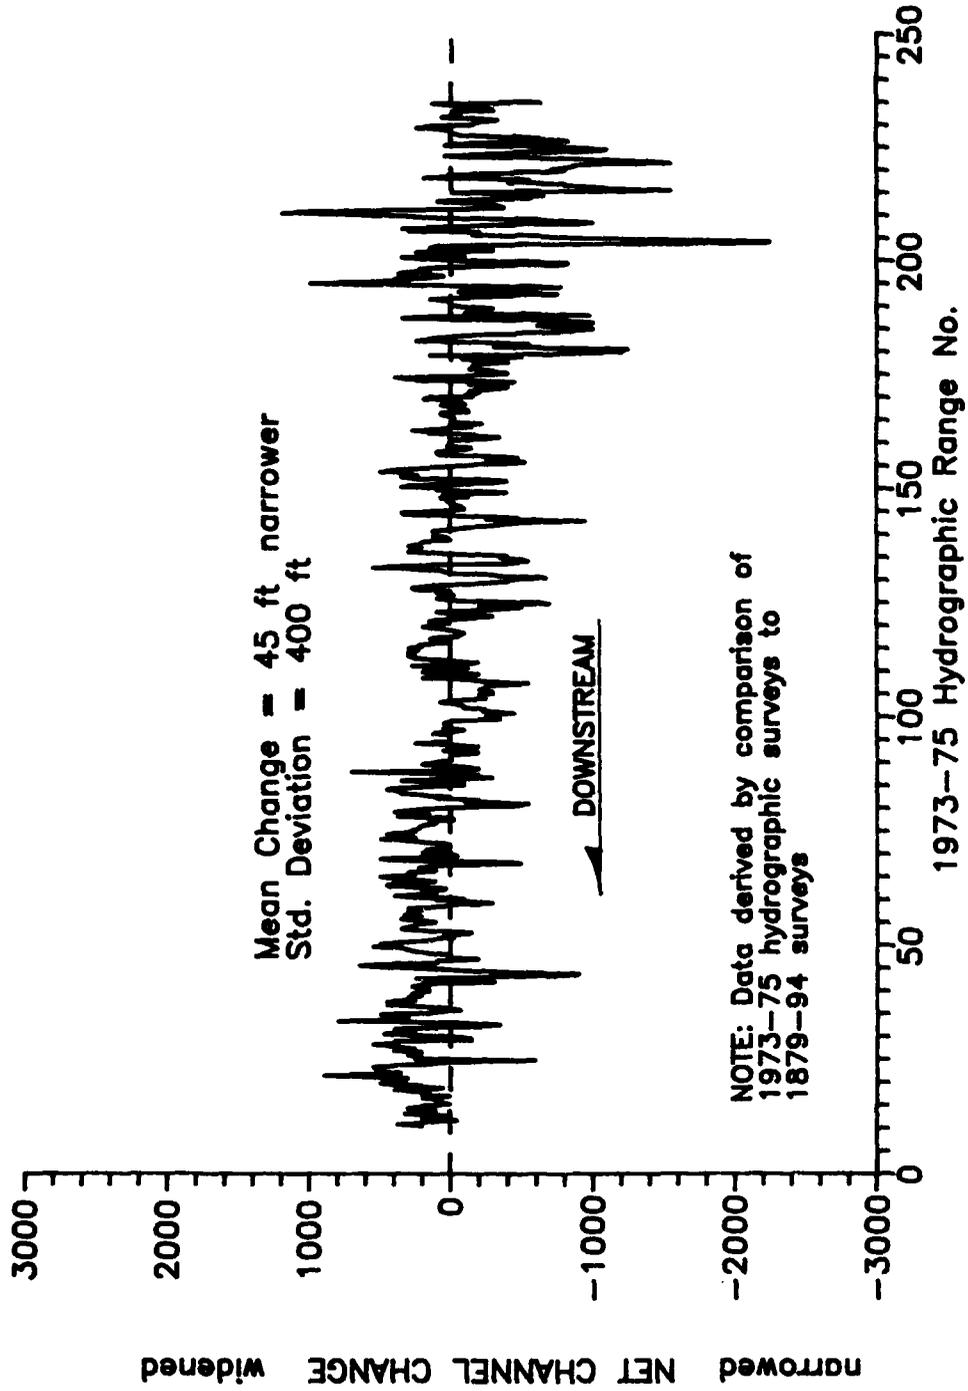
Figure 35. Historical change in channel width, Mississippi River below  
Baton Rouge, LA

41. Figures 35 and 36 show the changes in channel width and maximum depth, respectively, over the period of record. The changes in depth are based roughly (maximum error judged to be less than 5 ft between the old and latest surveys) on LWRP. The change in width shown in Figure 35 exhibits a clear trend from upstream to downstream in that the river has tended to transition from becoming narrower to becoming wider with the crossover point again being near Bonnet Carre Spillway. This trend is not favorable since Figure 36 reveals that very little significant changes have occurred with respect to depth. If the river remains at the same depth above R-129.8 while it tends to become narrower in that same reach, it portends increasing average current velocities. This will cause trouble where erosion/scour hole formation, general bank stability, and flow slide problems are concerned. In addition, the tendency of the river to slowly widen below R-129.8 portends bank caving problems mostly in the "minor" category but, nonetheless, relentless. These trends just indicate that there is no relief in sight, and that the problems are likely to multiply.

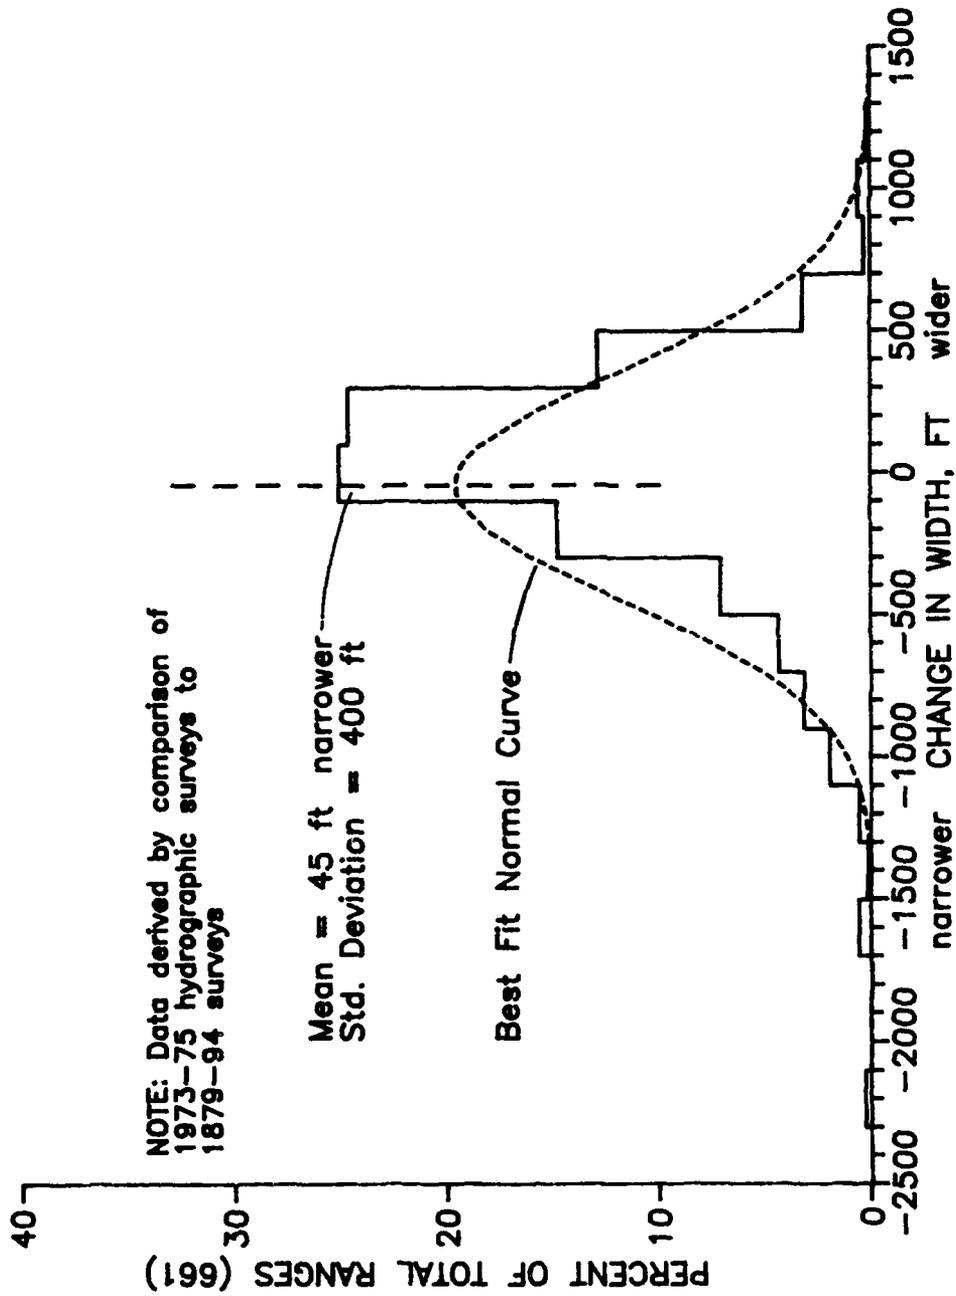
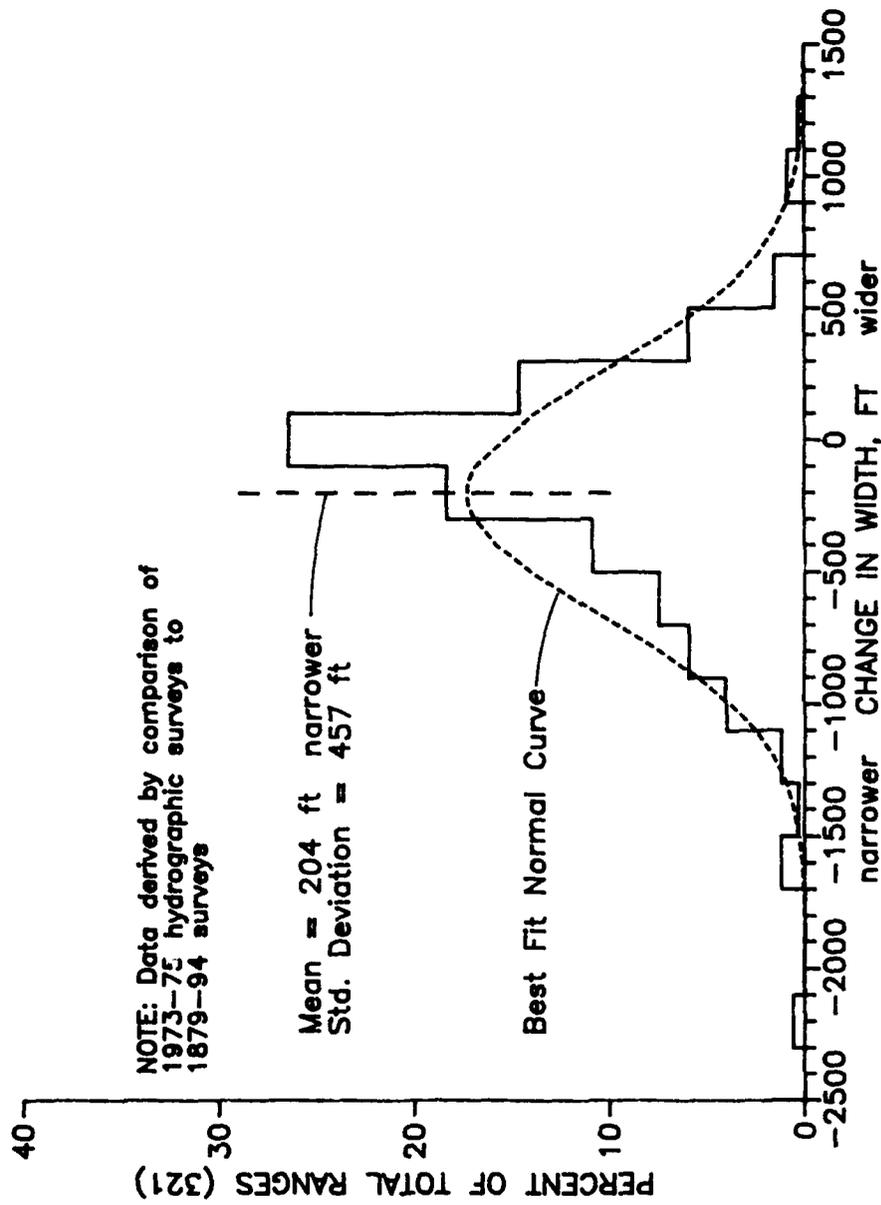
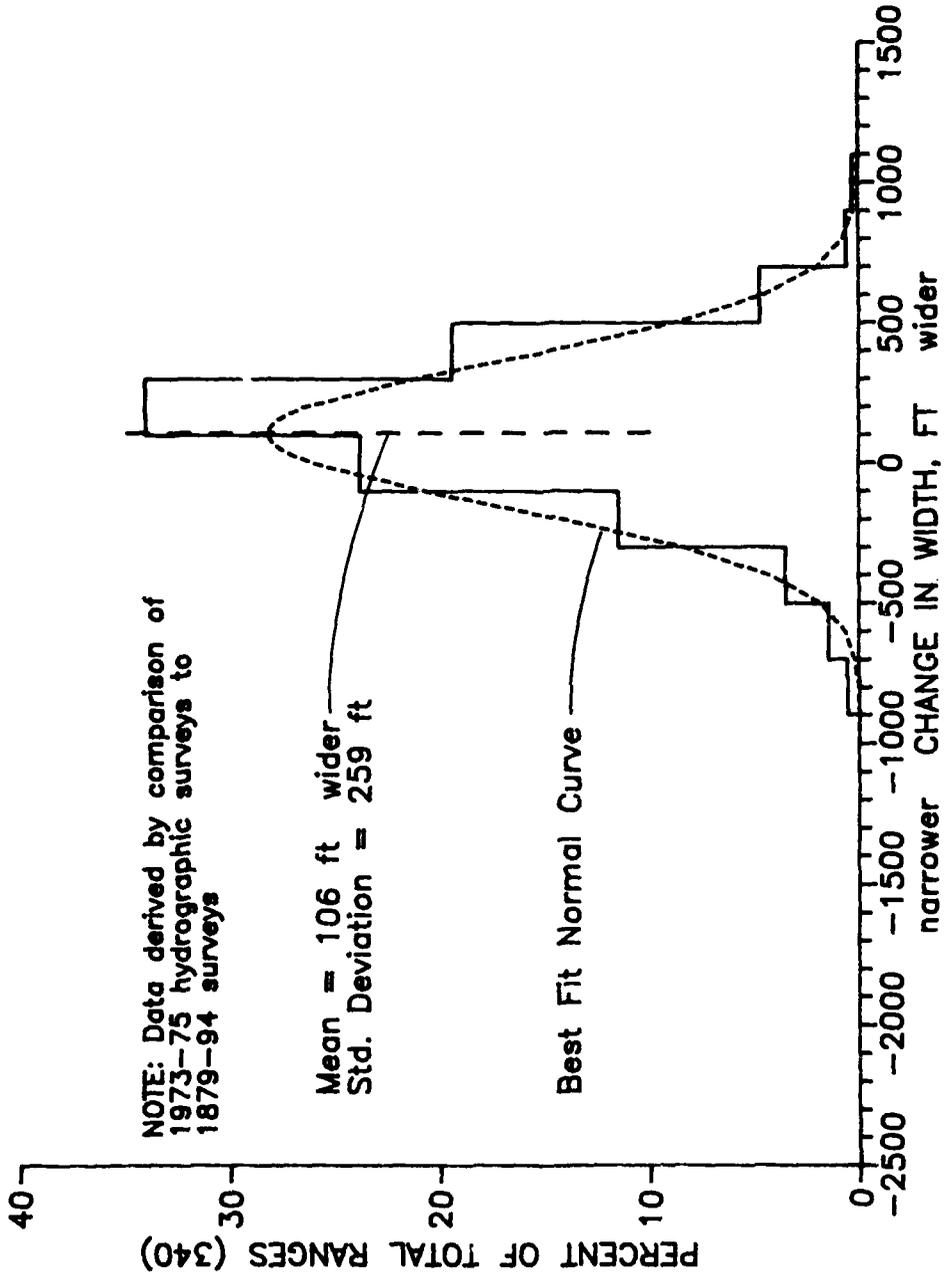
42. Frequency histograms for the change in channel width are given in Figures 37-39 and for change in channel depth in Figures 40-42. The change-in-width histograms illustrate the trends addressed above. The change-in-depth histograms show strong normal distribution tendencies and reveal how little depth has changed over the total period of record. For the total reach of river below Baton Rouge, over 90 percent of the ranges reflected a change
