DTIC FILE COPY TECHNICAL REPORT GL-88-9

# RETROGRESSIVE FAILURES IN SAND DEPOSITS OF THE MISSISSIPPI RIVER

EMPIRICAL EVIDENCE IN SUPPORT OF THE  
HYPOTHESIZED FAILURE MECHANISM AND  
DEVELOPMENT OF THE LEVEE SAFETY  
FLOW SLIDE MONITORING SYSTEM

PART II: CASE HISTORY OF THE CELOTEX BATTURE AND LEVEE FAILURE OF  
30 JULY 1985

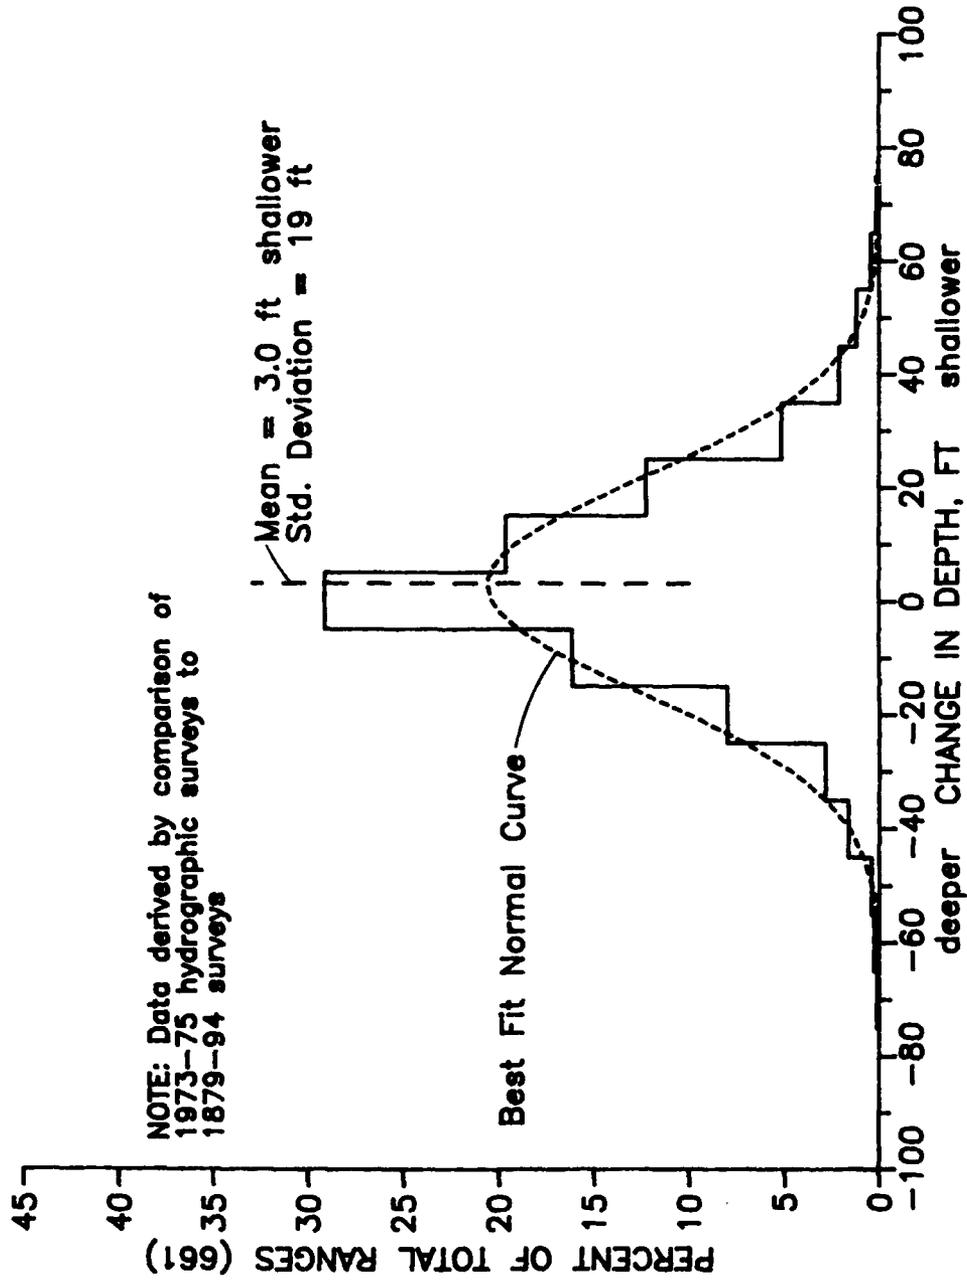
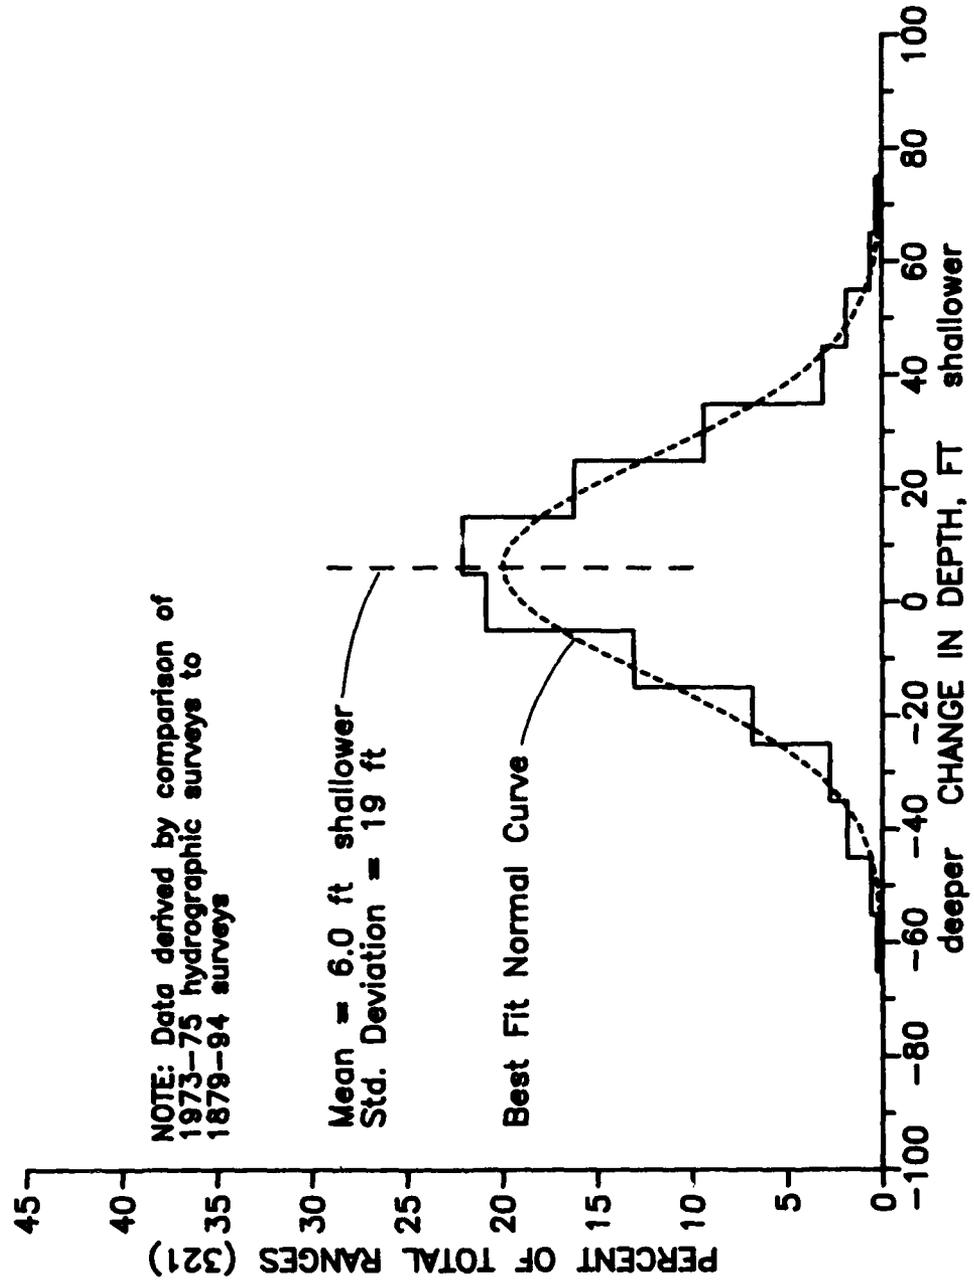
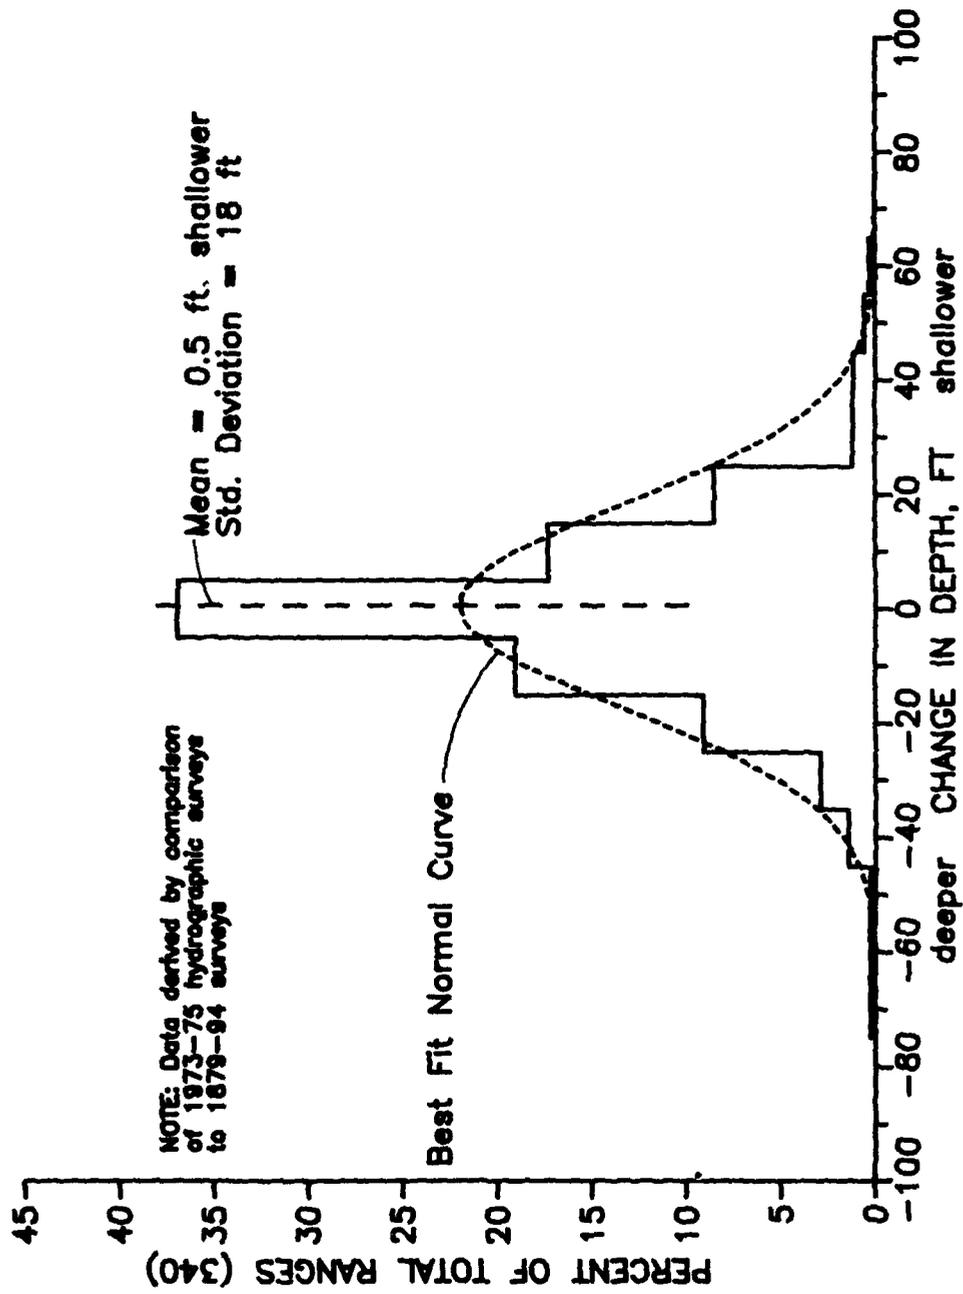
42. Frequency histograms for the change in channel width are given in Figures 37-39 and for change in channel depth in Figures 40-42. The change-in-width histograms illustrate the trends addressed above. The change-in-depth histograms show strong normal distribution tendencies and reveal how little depth has changed over the total period of record. For the total reach of river below Baton Rouge, over 90 percent of the ranges reflected a change

in depth of less than 30 ft in either direction. Considering the fact that such variations and larger are not uncommon on an annual basis (attributable to bottom sand waves or scour-fill cycles), it appears to be safe to say that only the rare events of changes in excess of 50 ft are significant. Only about 2 percent (16 of 661) of the range locations showed changes in depth either deeper or shallower in excess of 50 ft.

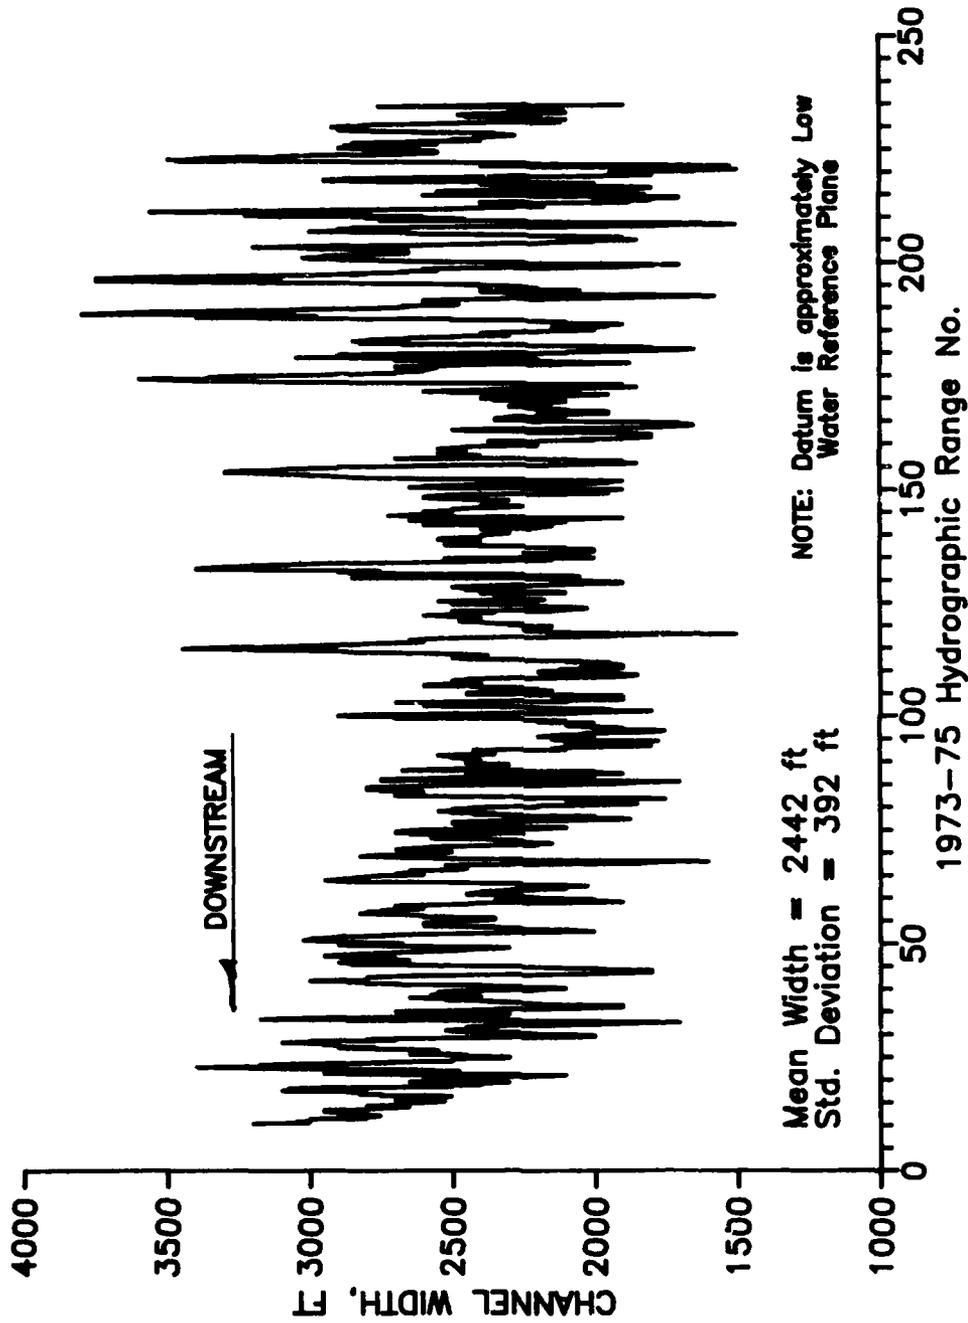
Figure 44. Channel width, Mississippi River below Baton Rouge, LA, 1973-1975 hydrographic survey

44. The discrete data for width, depth, W/D ratio, and triangular area are plotted in Figure 44-47, respectively. Corresponding frequency histograms are given in Figures 48-51. Figure 44 shows a slight tendency for the average channel width to be larger at both ends of the reach below Baton Rouge and for pronounced amplitude in width variation in the upstream half (R-234.8 to R-110.0) of the reach. Channel depth shown in Figure 45 tends to steadily

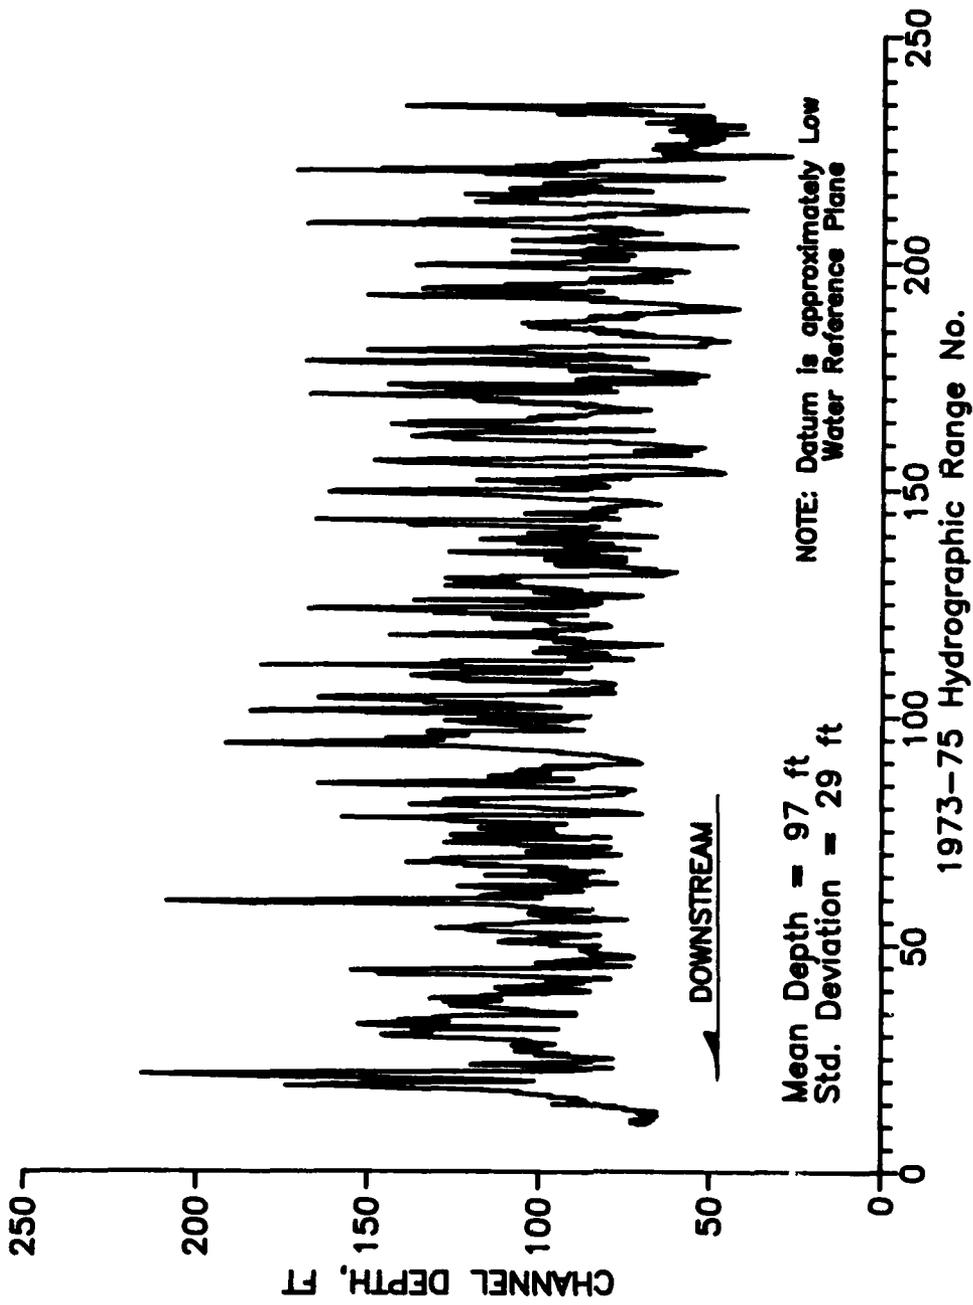
Figure 45. Channel depth, Mississippi River below Baton Rouge, LA, 1973-1975 hydrographic survey

increase on the average in the downstream direction. Width-to-depth ratio (Figure 46) shows a distinct change in pattern near range R-110 which reflects the trends in width previously mentioned. Channel triangular area (Figure 47) exhibits a consistent tendency to increase in the downstream direction. The histograms reveal that width (Figure 48) is almost perfectly normally distributed (random variable), while area (Figure 51) is relatively normally distributed and depth exhibits the least normal trend of the three parameters. Width-to-depth ratio (Figure 50) is clearly skewed in its distribution.
