**REPAIR, EVALUATION, MAINTENANCE, AND
REHABILITATION RESEARCH PROGRAM**

TECHNICAL REPORT REMR-CO-3

**CASE HISTORIES OF CORPS BREAKWATER
AND JETTY STRUCTURES**

PACIFIC OCEAN DIVISION

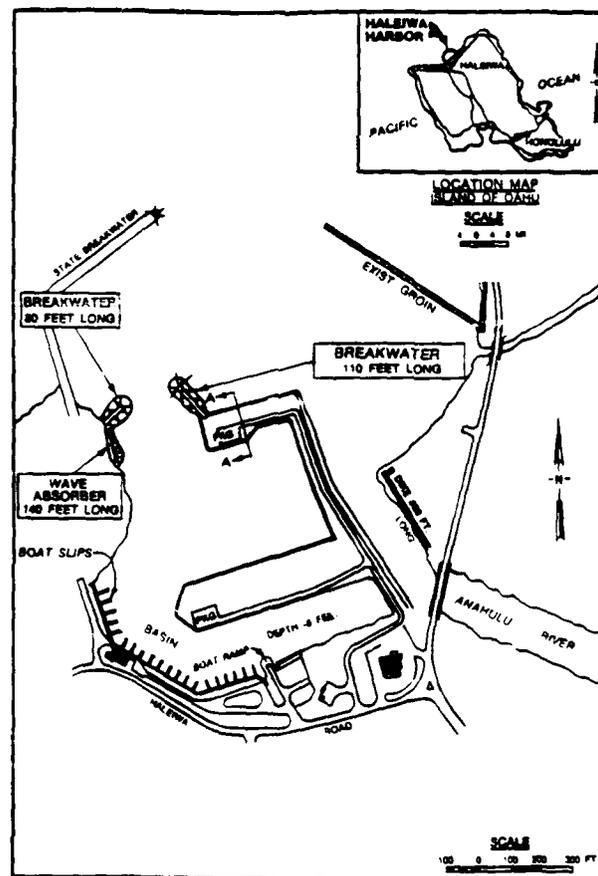
Figure 1. Haleiwa Small-Boat Harbor, Oahu, Hawaii

<u>Date(s)</u>	<u>Construction and Rehabilitation History</u>
1975	The 80-ft-long west and 110-ft-long east breakwaters were added to the existing project at a cost of approximately \$150,000 (Figure 1). The armor stone on the east and west breakwaters (Figure 2) was designed for 6- and 4-ft nonbreaking waves, respectively.
1978	The head of the west breakwater was rebuilt. Failure of the original head was thought to be due to the original structure toes not being placed on a firm foundation, thereby resulting in undermining of the toe and slippage of the armor stone layer. The head was rebuilt with the same size armor stone; but the sand was excavated, and the toe was placed on a firm coral bottom.
1984	Inspection of the stub breakwaters in July revealed that both structures were in good condition.

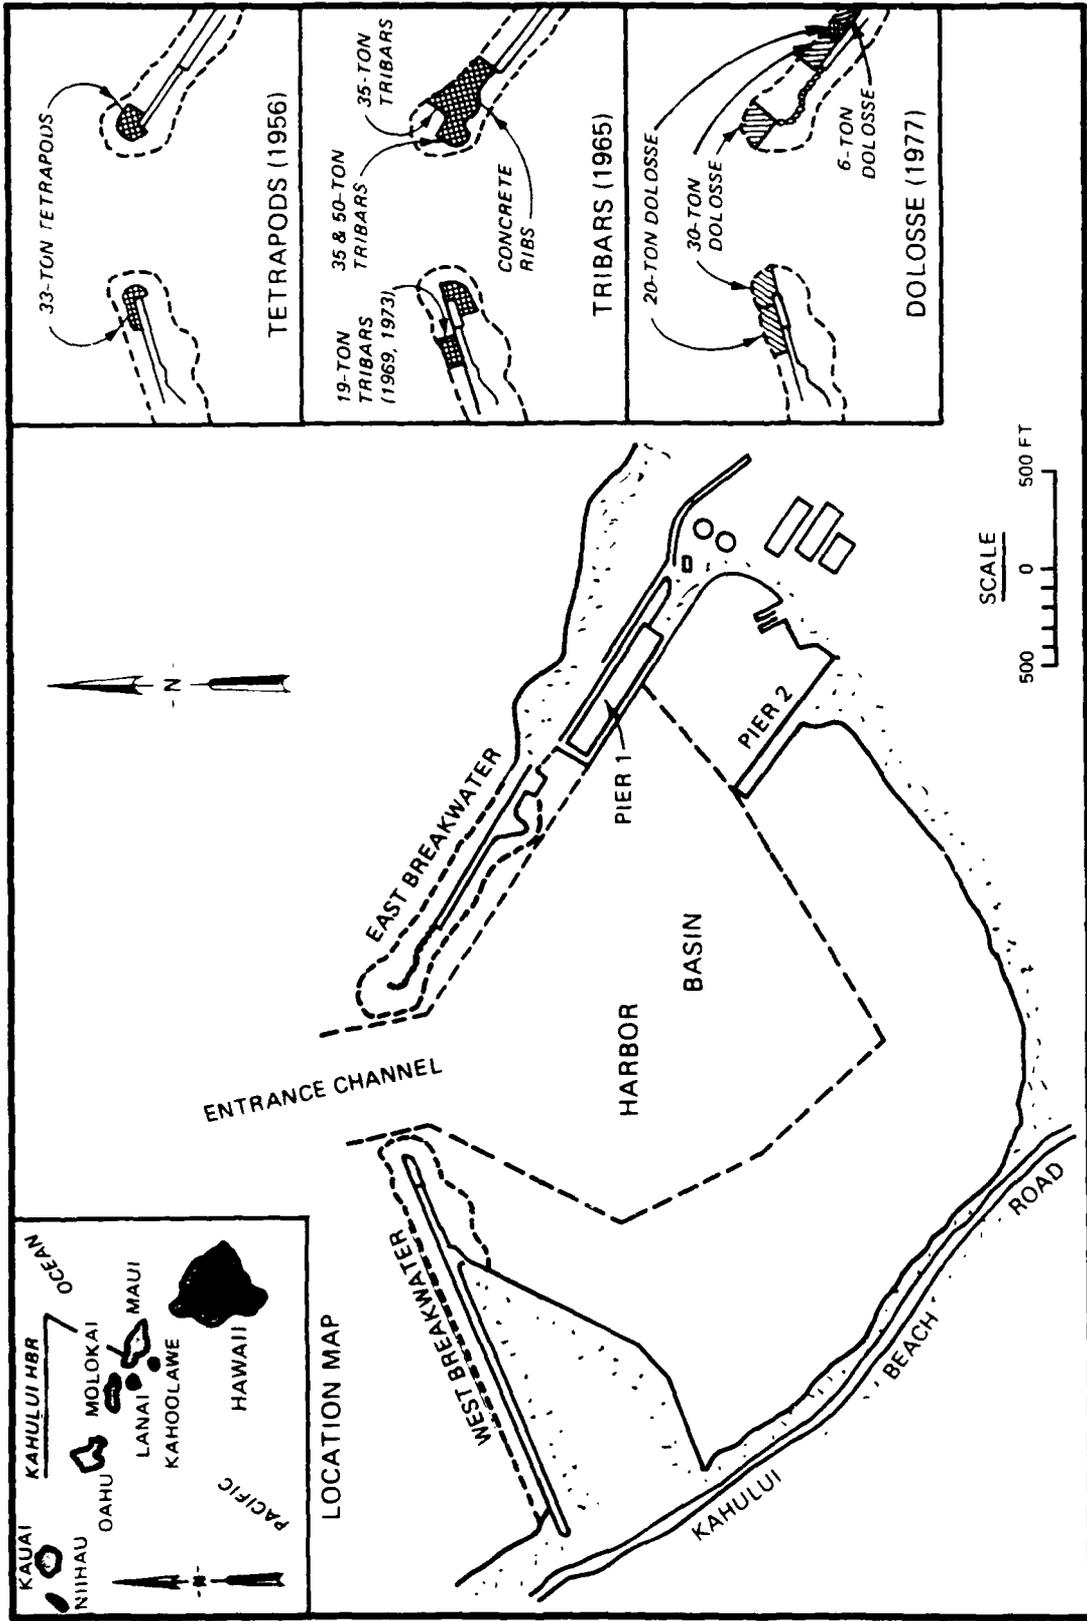
Figure 5. Kahului Harbor, Maui, Hawaii

<u>Date(s)</u>	<u>Construction and Rehabilitation History</u>
1900	The Kahului Railroad Company constructed the original harbor which consisted of a berthing area, a dredged channel, and a 400-ft-long east breakwater (Figure 5, location map).
1913	The first breakwater improvements constructed by the Corps of Engineers were completed (Figure 6). These improvements included a 400-ft-long extension of the east breakwater.
1919	The Corps constructed the west breakwater to a length of 1,950 ft.
1931	Extensions of the east and west breakwaters to lengths of 2,766 ft and 2,315 ft, respectively, were completed.
1931-1954	Maintenance costs exceeded \$1,000,000. Routine maintenance and repair involved approximate restoration of damaged breakwater sections to their original conditions.
	On 14-17 October 1943 the east breakwater was damaged. Approximately 45 tons of rock on the extreme east end were dislodged and washed into the inner harbor area. Approximately 150 ft shoreward of the east breakwater light a larger mass of stone was dislodged and washed into the harbor. This break was on the inside of the east breakwater and covered an area approximately 75 ft long and 20 ft deep. The Estimated repair quantity was 250 tons.

1977	<p>A 1973 breakwater inspection indicated considerable damage and settlement of the 33-ton tetrapods on the seaward quadrants of both breakwater heads. In addition, the 8-ton armor stone along both trunks was failing and required repair. In 1977 the following repairs were completed (Figure 5): on the west breakwater, 257 30-ton reinforced dolosse were placed in two layers over the 33-ton tetrapods on the sea-side quadrant of the head; 291 20-ton reinforced dolosse were placed on the sea-side slope of the west breakwater trunk; on the east breakwater 610 30-ton reinforced dolosse were placed in two layers over the 33-ton tetrapods on the sea-side quadrant of the head; 164 20-ton reinforced dolosse were placed in a double layer on the sea-side slope of the trunk beginning at the shoreward end of the 35-ton tribars; and, beginning at the point where the 20-ton dolos ended and extending shoreward, two layers of 6-ton unreinforced dolosse (455 units) were placed on the sea-side slope of the east breakwater trunk. The total cost was \$3,290,000.</p>

1956	<p>Repairs of damage caused by the March 1954 storm were completed (Figures 5 and 7). Head repairs consisted of a double layer of 33-ton unreinforced tetrapods on a 1-V:3-H seaward slope and a 1-V:2-H landward slope. Two layers of tetrapods also were extended 250 ft down the sea side of the west breakwater trunk, and the core of both was capped with 2 ft of concrete.</p> <p>A total of 400 tetrapods was placed. To prevent encroachment of the structures on the entrance channel, the breakwaters were shortened slightly, and a 1-V:2-H slope was used on the inboard quadrant of the armor wraparound on the breakwater heads. The total cost of repairs was \$1,200,000.</p>

Date(s)	Construction and Rehabilitation History
1969	<p>The damaged west breakwater trunk was repaired by placement of two layers of 19-ton reinforced tribars (260 units) on the sea-side slope, shoreward of the tetrapod area (Figure 5). A concrete rib cap was added to the crest for buttressing of the tribars. The total cost was \$443,000.</p> <p>In November 1969 another severe storm hit with estimated breaking wave heights of 15-20 ft; damage occurred to the west breakwater in the tribar-original armor stone transition area, presumably because of insufficient interlocking. Approximately 25 19-ton tribars were moved shoreward as much as 300 ft.</p>
1973	<p>The November 1969 damage was repaired by placement of 80 19-ton reinforced tribars (Figures 5 and 10). The tribars and concrete crest ribs were extended shoreward another 80 ft down the seaside of the west breakwater trunk, and the landward end of the tribar armor section was buttressed by 25 35-ton tribar units. The total cost was \$262,000.</p>

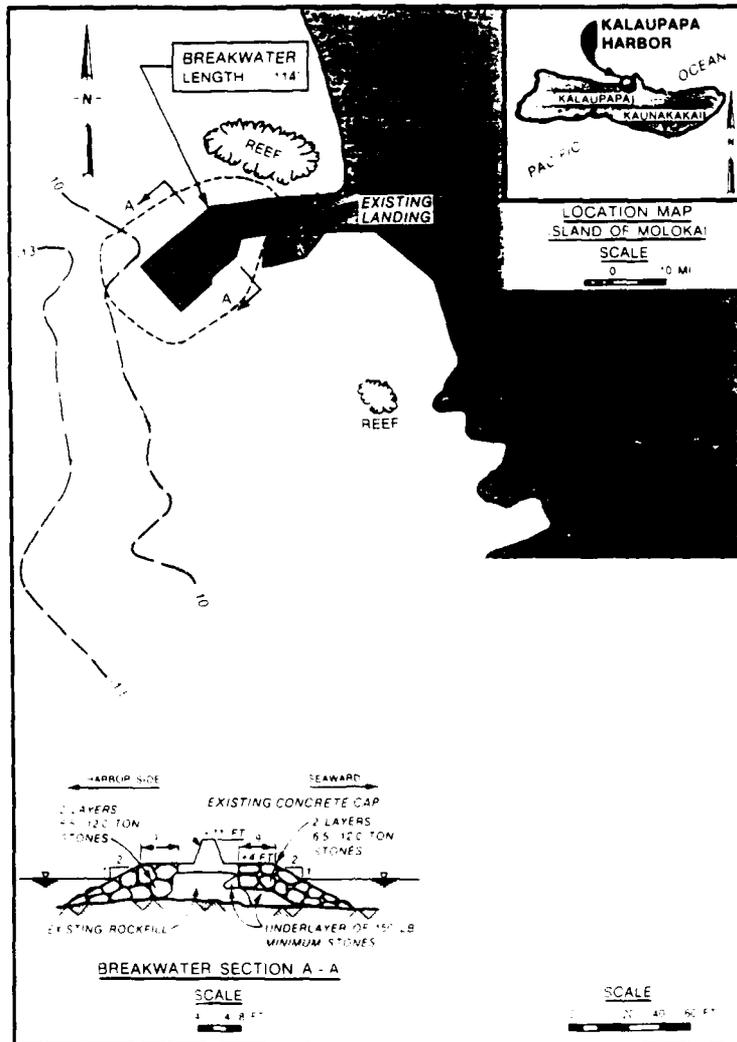
Figure 12. Kalaupapa Harbor, Molokai, Hawaii

Date(s)	Construction and Rehabilitation History
1967	An existing rock fill breakwater with a concrete cap was improved by widening the crown and armoring the structure slopes with 6.5- to 12-ton armor stone (Figure 12). The armor stone was designed for a 12-ft breaking wave in a water depth of 15 ft at the breakwater head. The breakwater modification cost approximately \$95,000. As of 1984, the structure has required no major maintenance.

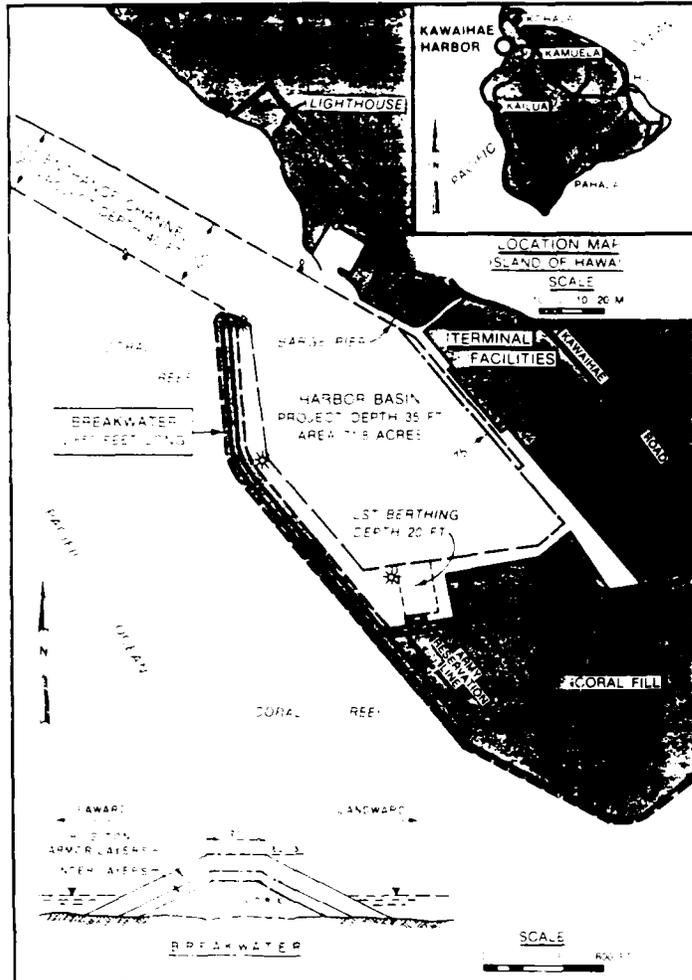
Figure 13. Kawaihae Deep Draft Harbor, Hawaii, Hawaii

<u>Date(s)</u>	<u>Construction and Rehabilitation History</u>
1962	A 2,650-ft-long armor stone breakwater was completed (Figure 13). Through 1973, the Corps spent just over \$6,000,000 for construction, enlargement, and maintenance of this deep-draft harbor. As of 1984, the structure had required no maintenance.

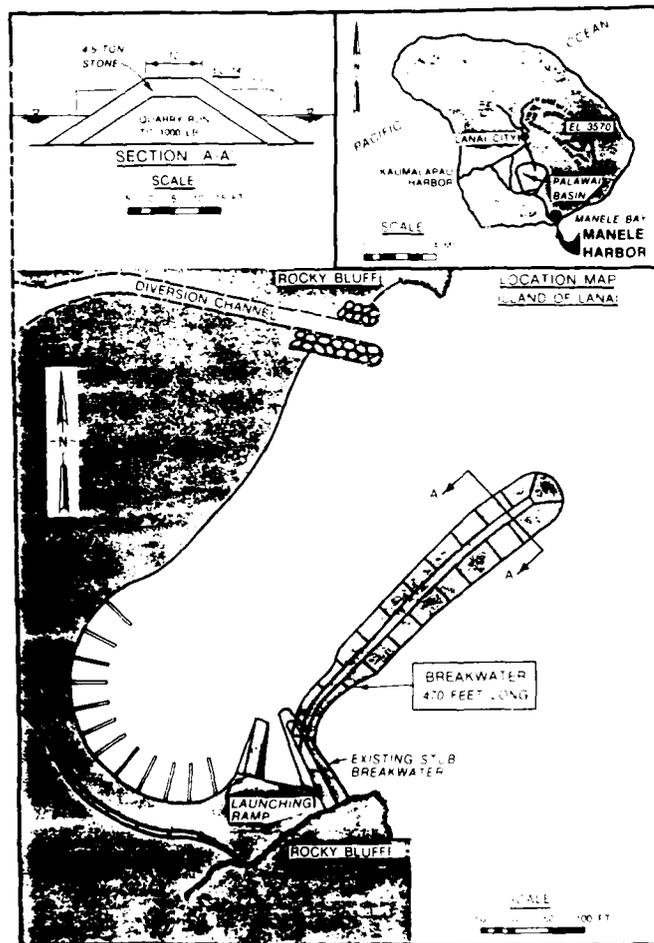
Figure 14. Manele Small-Boat Harbor, Lanai, Hawaii

<u>Date(s)</u>	<u>Construction and Rehabilitation History</u>
1965	A 470-ft armor stone breakwater extension was added to an existing stub breakwater. The breakwater was part of a light draft harbor project completed in 1965 (Figure 14). Total project cost was \$742,850. Along the breakwater's length the armor stone varied from 2 to 4.5 tons for design breaking-wave height ranging from 3 ft at the root to 10.1 ft at the head.
1984	Recent inspection of the breakwater revealed only minor damage that did not warrant immediate attention.

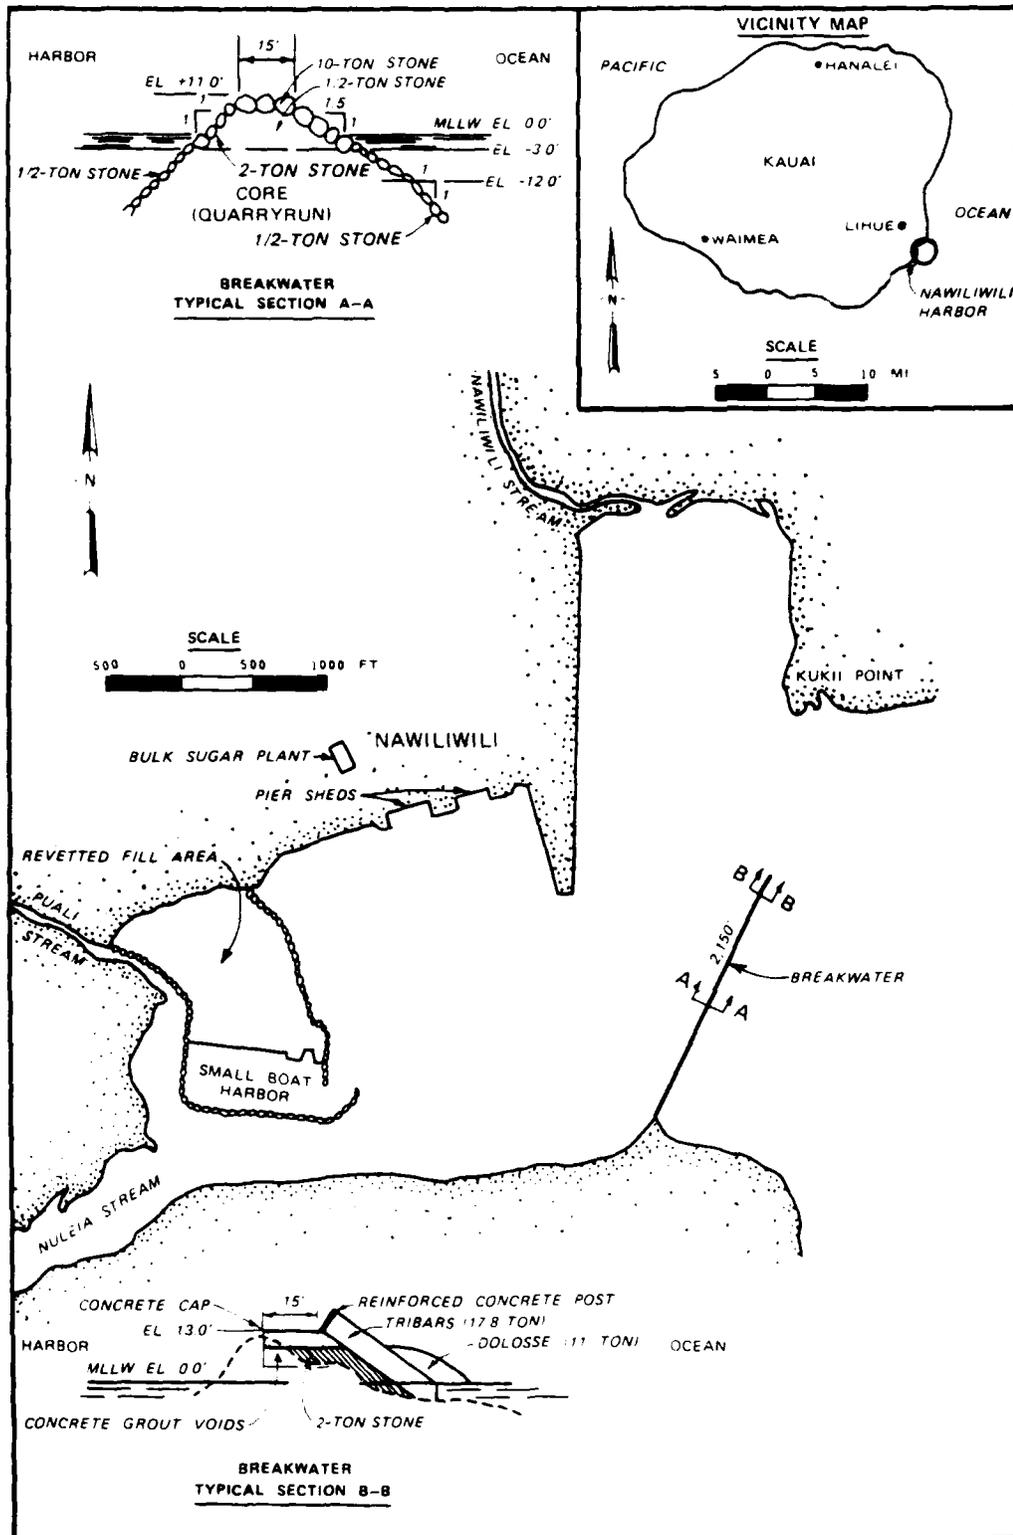
Figure 15. Nawiliwili Harbor, Kauai, Hawaii

<u>Date(s)</u>	<u>Construction and Rehabilitation History</u>
1926	The original Corps-constructed (Figure 15) 2,150-ft-long rubble-mound breakwater was completed (construction started in 1922). It consisted of one-layer 8-ton keyed and fitted armor stone over core stone (500 lb and less) with 1-V:1-H slopes and a 15-ft-wide crown at +11.0 ft mllw. Except for severe wave action, it was considered to be a satisfactory empirical design cross section.
1927- 1953	Minor repair work was done at various times during this period. In 1931 114 stones were reset, and 3,153 tons of stone and concrete blocks were placed (no details available) at a cost of \$46,040. In 1930, 1932-37, 1945, 1951, and 1952, 1,998 tons of stone were used in repair work at a total cost of \$76,285. Details of the repair work were not found.
1954- 1957	The breakwater was severely damaged as the result of a storm in 1954 (hindcasted depth-limited breaking wave height of 24 ft at structure) which destroyed the head, washed 100 ft of core stone shoreward, and settled capstone to an elevation of a few feet below mllw with little lateral movement. Storm waves displaced armor stone and exposed and removed core material between sta 17+50 and sta 20+45 in 1956. Observed wave heights of 16 ft at the breakwater in September 1957 caused additional armor stones and core displacement between sta 16+00 and 20+45 and displacement of a few armor stone and core exposure between sta 14+00 and sta 16+00. Hydrographic and topographic surveys of January 1958 revealed that Hurricane Nina (depth-limited breaking waves at structure on 1 and 2 December 1957) displaced a few armor stones and exposed core material on the sea-side slope between sta 14+00 and sta 15+00. It also caused settling and raveling of all armor stone on the crown and sea-side slope between sta 15+00 and sta 20+20, resulting in an exposed core and large voids between armor stones and all armor stone and core above mllw (sta 19+25 to sta 19+50 and sta 20+20 to sta 20+45) which was displaced shoreward.

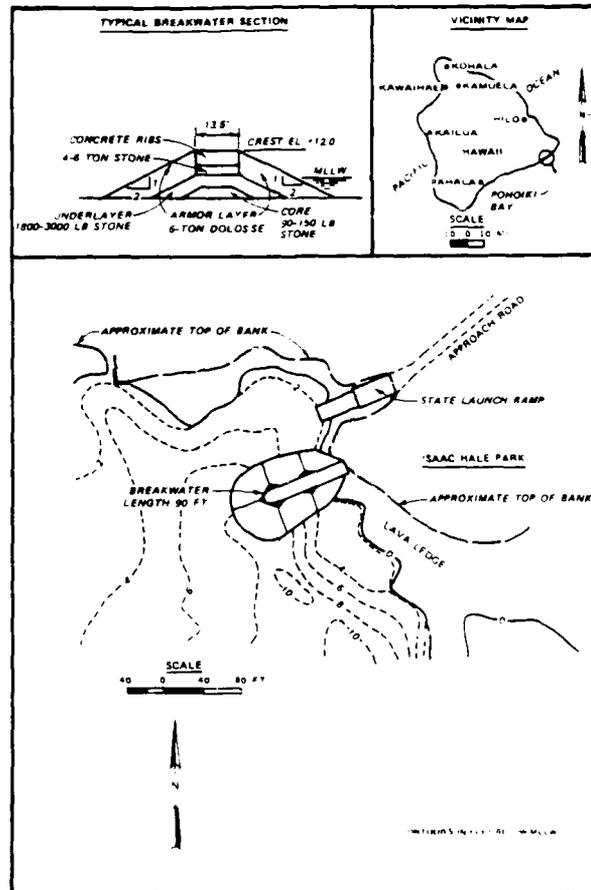
Figure 19. Pohoiki breakwater, Hawaii, Hawaii

Date(s)	Construction and Rehabilitation History
	<p>A 90-ft dolos-armored structure with a concrete rib cap was constructed in 1979 at a cost of approximately \$335,500 (Figure 19). The structure was designed for 12-ft depth-limited breaking waves at the structure. The wave condition has reportedly occurred on several occasions since completion of construction, and the structure shows no signs of deterioration. The 6-ton unreinforced dolosse (two layers) exceeded the needed weight for the design conditions but were found to be more economical than a lighter weight in that fewer units were needed. All existing dolosse breakage (5 units) occurred during construction and were left on the structure. Figure 20 is an aerial photograph of the breakwater taken in 1984.</p>

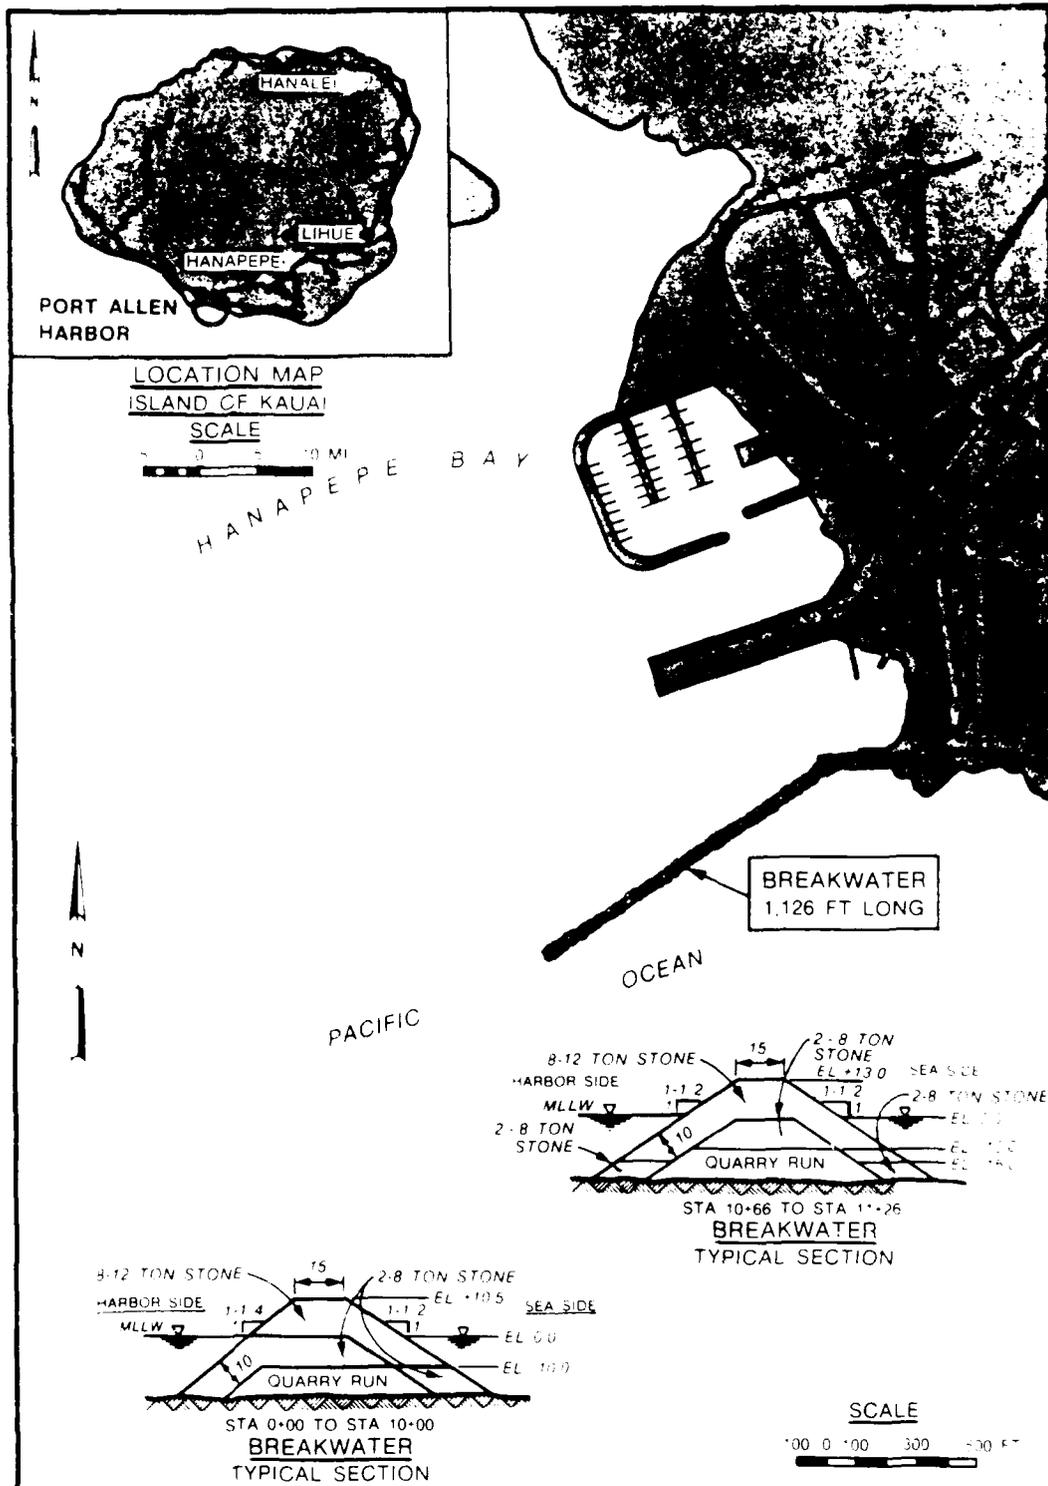
Figure 21. Port Allen Harbor, Kauai, Hawaii

<u>Date(s)</u>	<u>Construction and Rehabilitation History</u>
1935	The 1,200-ft-long structure was completed as an extension to a privately constructed breakwater (Figure 21).
1982	Until damaged by Hurricane Iwa of November 23, the old 8-ton keyed-and-fitted armor stone structure had no repair history. The breakwater light at the seaward end had been damaged and repaired several times (Coast Guard cost) prior to its present destruction. The estimated 20-ft breaking waves at the structure first dislodged the stones on the inboard crest which eventually resulted in the total destruction of the outer 130 ft of the breakwater. Overtopping waves also displaced crest stone and exposed under-layer stone on a 150-ft length at the extreme root of the structure. Minor damage also was sustained along the inboard slope.
1984	The head was rebuilt, and the minor damage on the inboard slope was repaired at a cost of \$178,000. The breakwater was shortened to a total length of 1,126 ft. The outer 74 ft was abandoned. The repair was accomplished by resetting stone remaining on the structure and by retrieving stone from the harbor and replacing it on the structure using the old keyed-and-fitted construction (Figure 22). The crown elevation on the last 80 ft of structure was increased to +13.0-ft mllw. This was done to improve the stability of the inboard slope by decreasing wave overtopping. The root of the breakwater was not repaired.

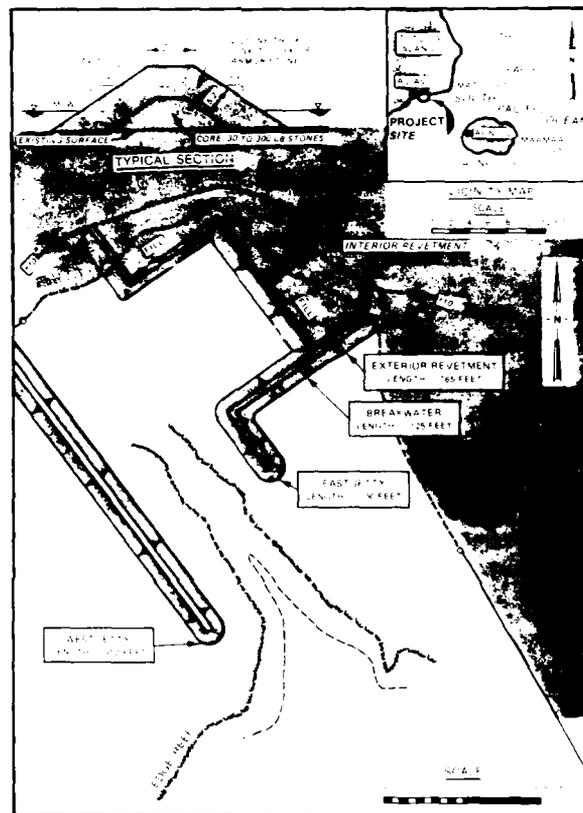
Figure 24. Auasi Small-Boat Harbor, Tutuila Island, American Samoa

<u>Date(s)</u>	<u>Construction and Rehabilitation History</u>
1981	<p>A 125-ft armor stone breakwater and 100- and 450-ft east and west armor stone jetties, respectively, comprised a portion of the project completed in 1981 (Figure 24). Total cost of the project was approximately \$1,166,300. The structures were designed for depth-limited breaking wave heights of 4.8, 7.0, 5.6, and 6.0 ft for the breakwater, west jetty head, west jetty trunk, and entire east jetty, respectively. Water depths for these wave heights were 6.2, 7.2, 7.2, and 7.7 ft, respectively. The structures have no history of damage or repair. There is some evidence of armor stone breakage. Although quarried basalt armor stone appeared to be free of cracks when placed, internal stresses may be responsible for breakage. Testing by dropping from a 10-ft height onto a stone bed did not result in breakage during construction. The condition is not widespread and is not considered serious at present.</p>

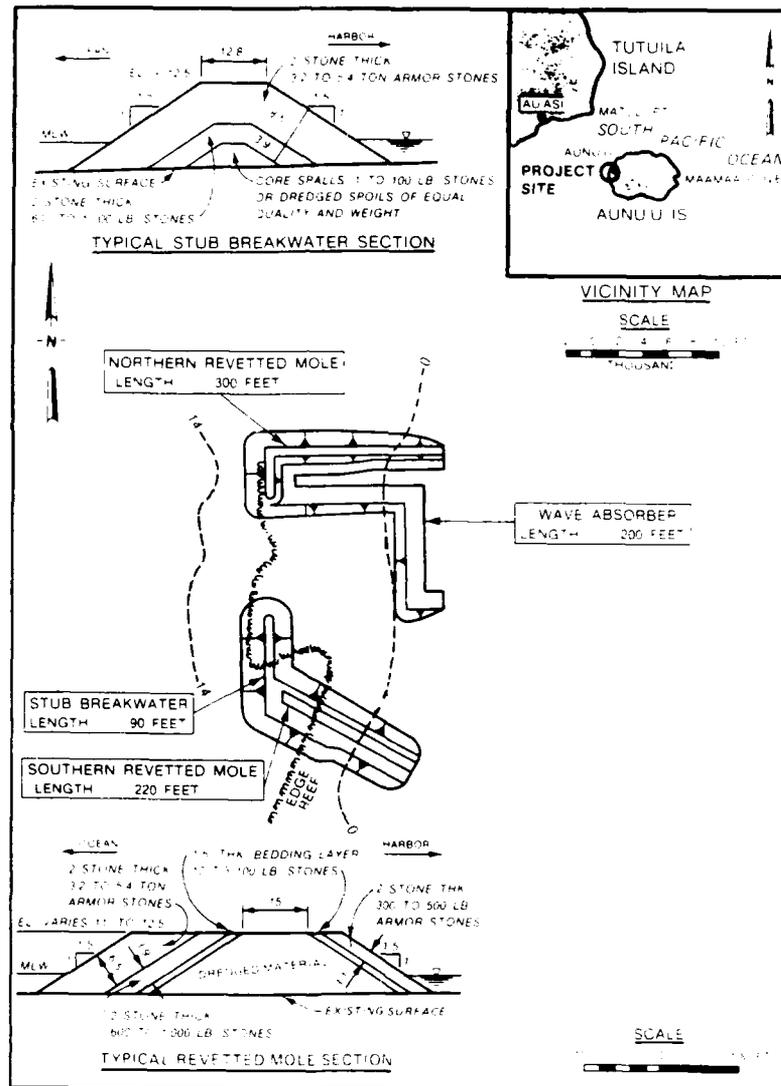
Figure 25. Aunu'u Small-Boat Harbor, Aunu'u Island, American Samoa

Date(s)	Construction and Rehabilitation History
1981	The 90-ft armor stone breakwater was a portion of the project completed in 1981 (Figure 25). The total project cost was approximately \$2,018,400. The breakwater section was designed for a depth-limited breaking wave height of 10.0 ft. The structure has had no documented damage or repair work since its completion.

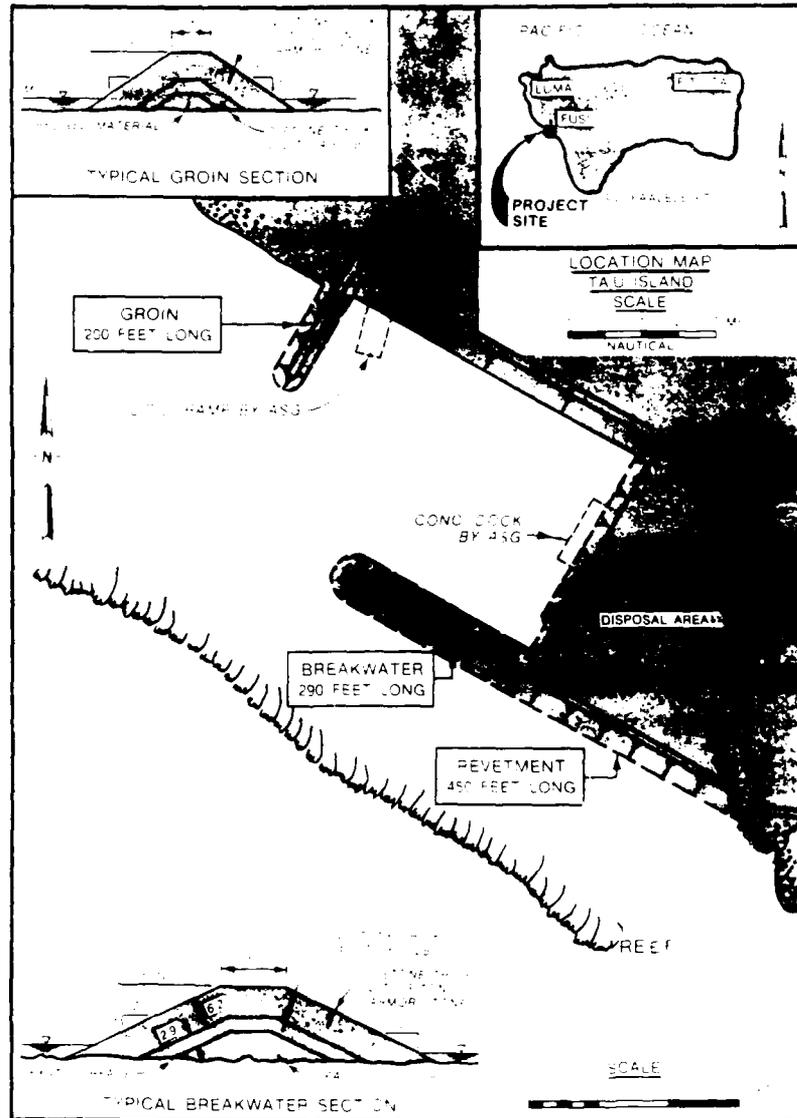
Figure 26. Ta'u Small-Boat Harbor, Ta'u Island, American Samoa

The 290-ft armor stone breakwater is part of the project which was completed in 1981 at a cost of approximately \$2,020,400 (Figure 26). The breakwater armor was designed for a 7.0-ft depth-limited breaking wave in a water depth of 9.0 ft. The structure has required no repair since completion.

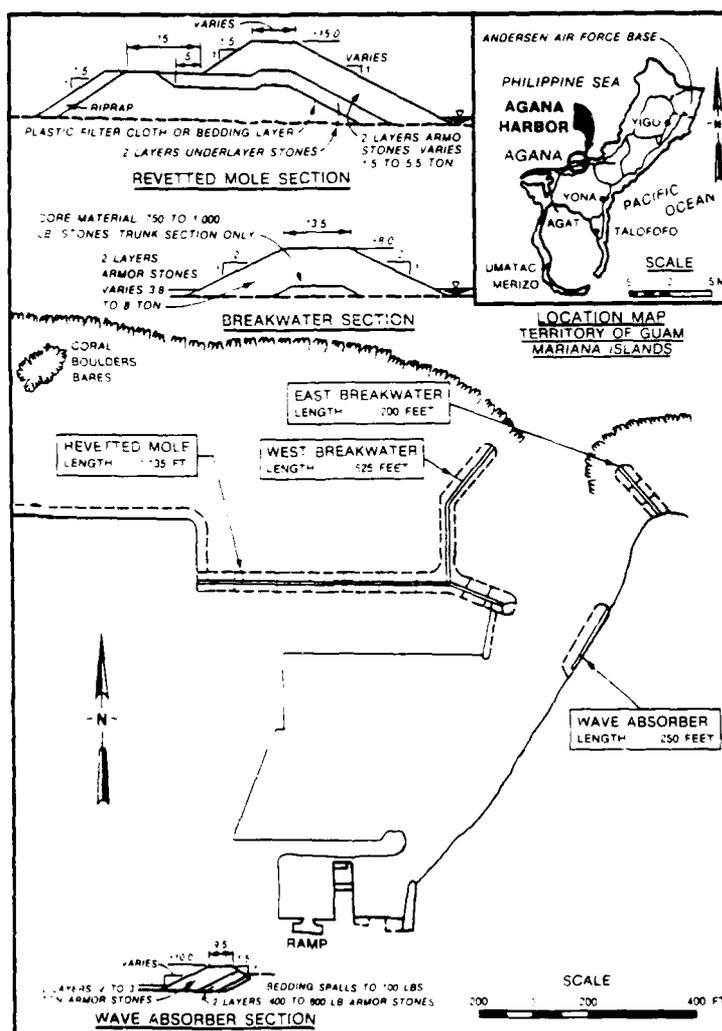
Figure 27. Agana Small-Boat Harbor, Agana, Guam

Date(s)	Construction and Rehabilitation History
1977	The 200-ft and 525-ft east and west armor stone breakwaters, respectively, were a portion of the project completed in 1977 (Figure 27). The total project cost was approximately \$1,220,550. The heads and trunks of the breakwaters were designed for 10- and 9-ft depth-limited breaking waves, respectively. The structures have no damage or repair history since their completion.
