US Army Corps
of Engineers
Construction Engineering
Research Laboratory

USA-CERL TECHNICAL REPORT N-88/21
August 1988

An Economic Assessment of Renovating Temporary Wood Frame Buildings

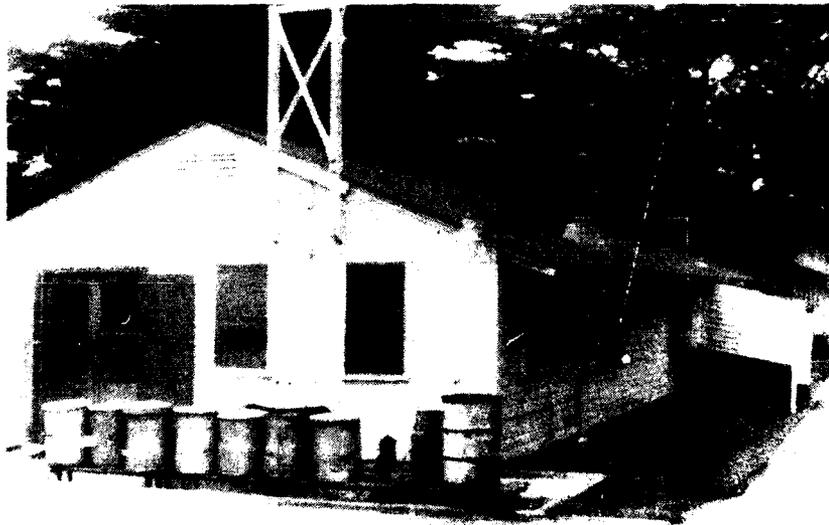
Dining halls have a more specialized function. In plan, dining halls at all installations were uniform. All the buildings were one-story and raised on wood-pile foundations. A large open room, about two-thirds of the total building area, was dedicated to troop dining. The remaining area housed the kitchen facilities, including all food preparation and food storage equipment, plumbing, ventilation, electrical circuit box, water heater, and dishwasher. In most cases this room was partitioned, thereby creating a small room in one corner. In several instances, this partition was removed to create more space for the kitchen equipment. A space heater in the dining room provided heat during cold weather. Typically, an overhang or covered passageway sheltered the entrance. Health regulations require screens on all dining hall windows and doors. Behind the building, directly outside the kitchen, was a concrete pad which served as a loading area for supplies and services (Figure 6). Because storage space was sometimes insufficient, sheds were placed in this area.

Figure 6. Dining hall for enlisted personnel.
