TECHNICAL REPORT CERC-88-16

# SIDE-SCAN SONAR APPLICATIONS FOR EVALUATING COASTAL STRUCTURES

James E. Clausner, Joan Pope

November 1988  
Final Report

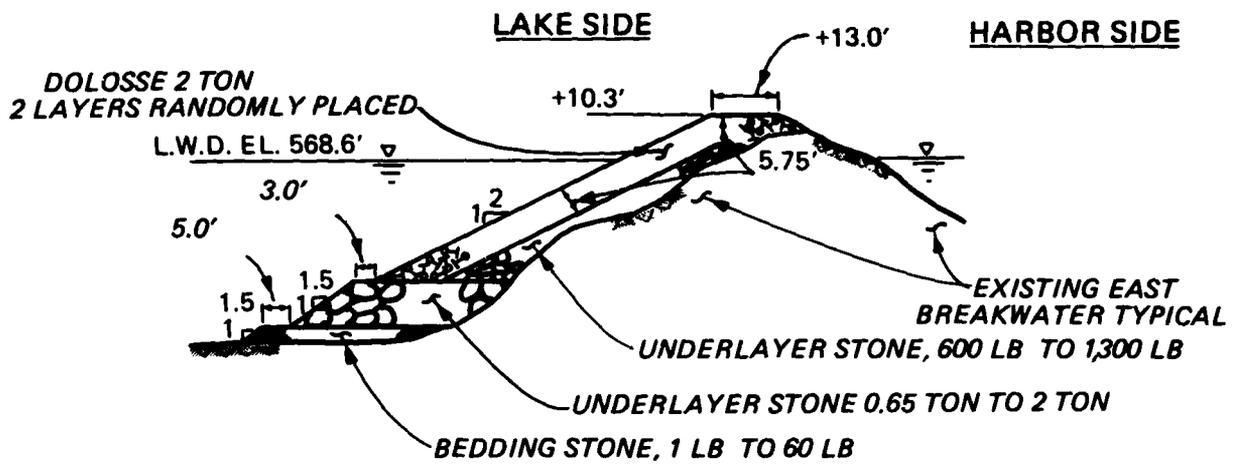
Figure 8. Dolos rehabilitated section of Cleveland harbor breakwater

water level) damaged the structure. Effects of the high water level on the structure were amplified by large waves which included ice chunks and debris.

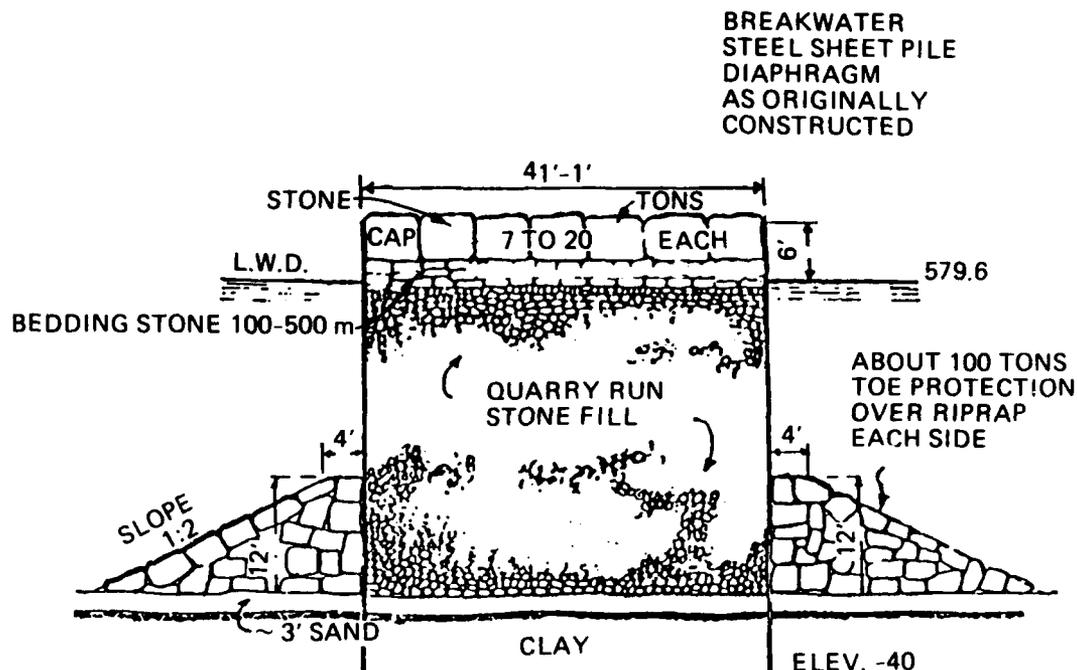
detached breakwater section, consists of 131 stone-filled, sheet-pile diaphragm cells (Figure 20). According to NCC reports, areas of hard limestone limited pile penetration into the sandy lake floor to approximately 7 ft.

Figure 20. Diaphragm sheet-pile cell construction typical of section C of the Calumet Harbor breakwater

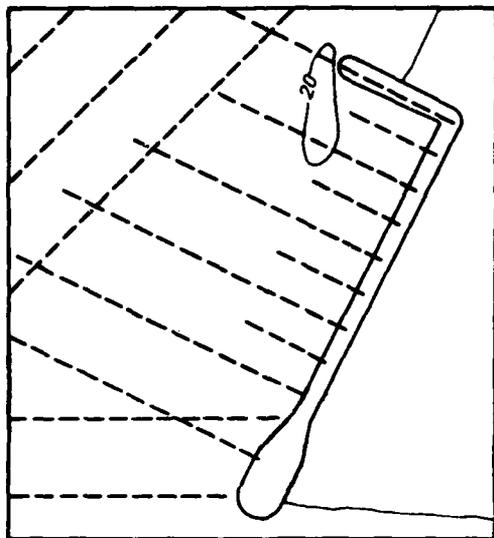
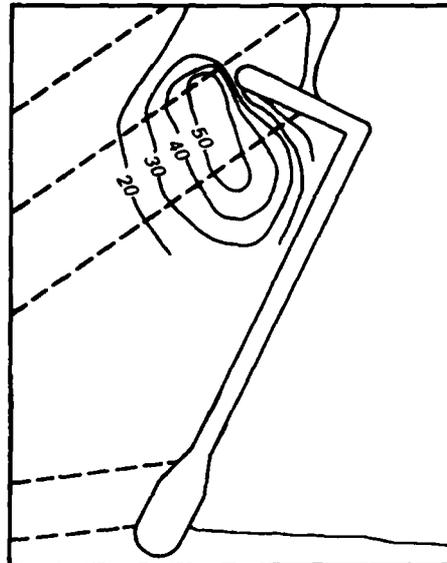
57. The records clearly showed the toe and the face of the structure. Also apparent were individual stones dislodged from the face and an approximately 1-ft-diam steel pipe, probably lost during dredging operations. Of particular interest are features that require more interpretation of the record. By examination of the initial bottom return and the shadow zones, it is possible to discern a scour-induced trench along a portion of the east jetty and a deeper scour hole at the southwest tip of the spur jetty.

58. Standard bathymetric surveys around the jetties were also obtained at 200-ft intervals. Comparison of Figures 32a (showing the results of a survey taken in July 1985) and 32b (showing the results of a survey taken in August 1986) illustrates the difficulty of delineating small-scale features at typical bathymetric survey line spacings. Notably, the fathometer survey tracklines miss the center of the scour hole. The principal benefit of a side-scan sonar survey, in this instance, is to identify and locate areas that require closer spacings between bathymetric survey lines.

Figure 32. Scour hole development at southwest tip of east jetty at East Pass Inlet, Florida
