REPAIR, EVALUATION, MAINTENANCE, AND REHABILITATION RESEARCH PROGRAM

TECHNICAL REPORT REMR-CO-3

CASE HISTORIES OF CORPS BREAKWATER AND JETTY STRUCTURES

Report 6

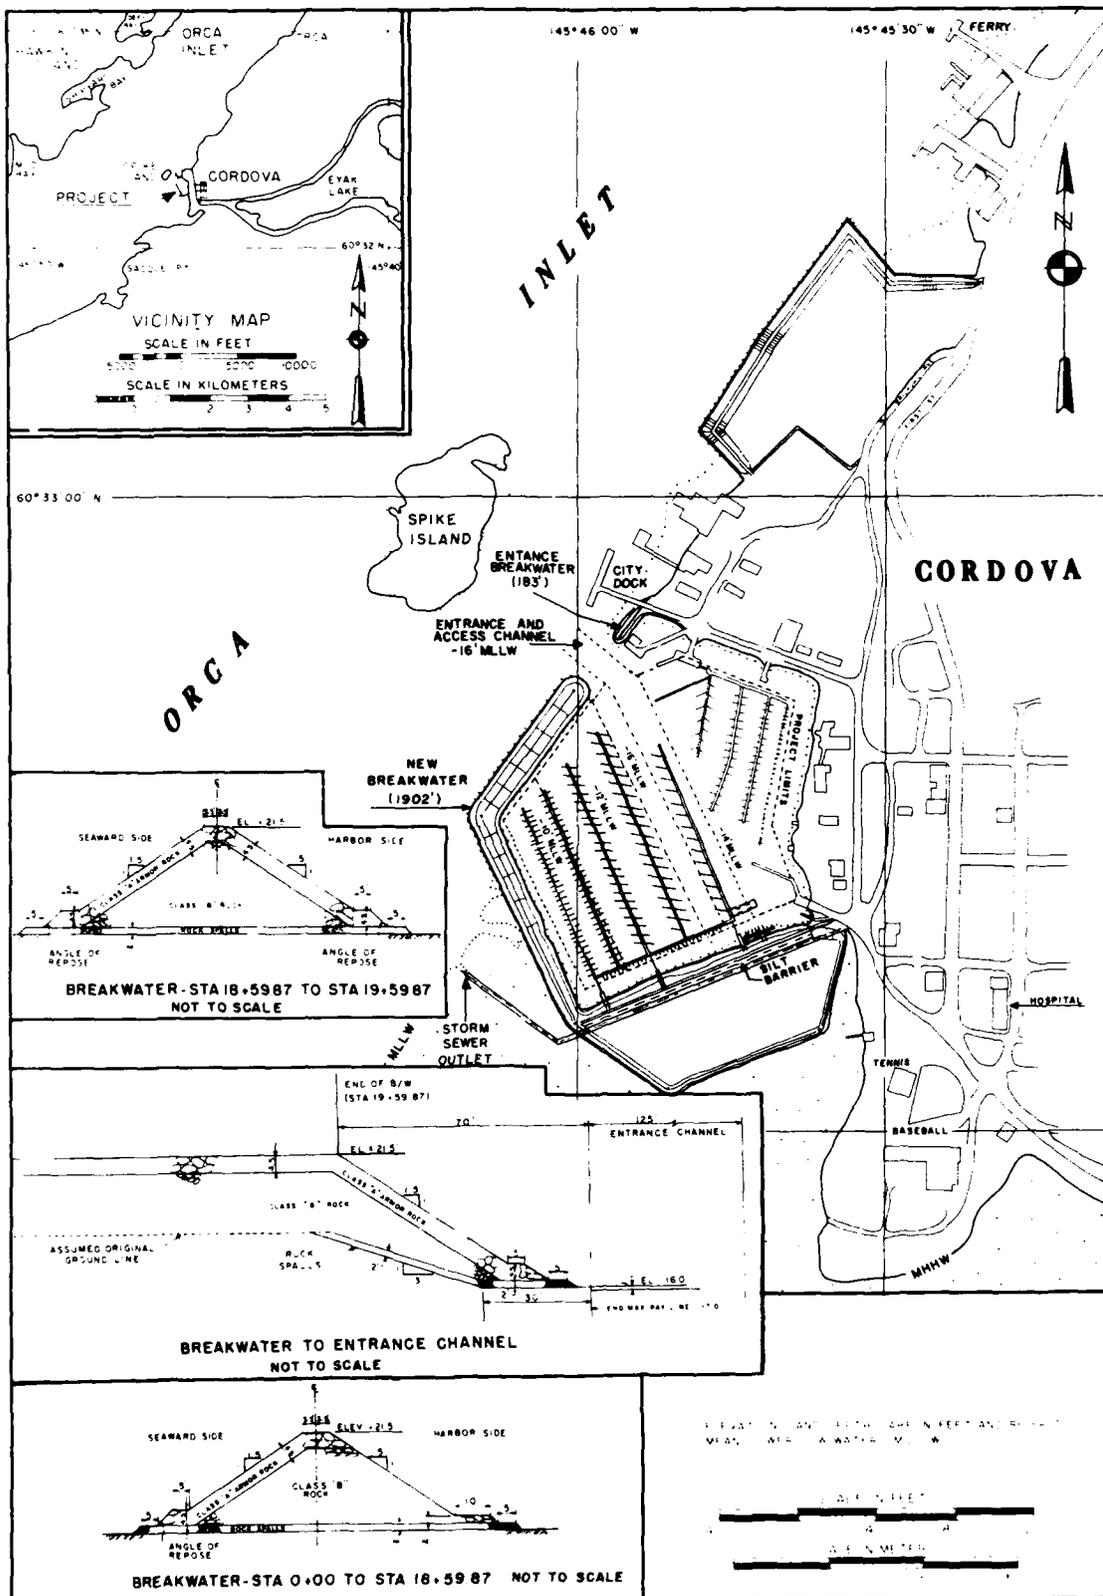
Figure 5. Site layout of Cordova Harbor, Alaska (revised 1985)

1985	The harbor is illustrated in Figure 5, and an aerial photograph of the harbor is presented in Figure 6. The breakwaters appear in good condition at this time.

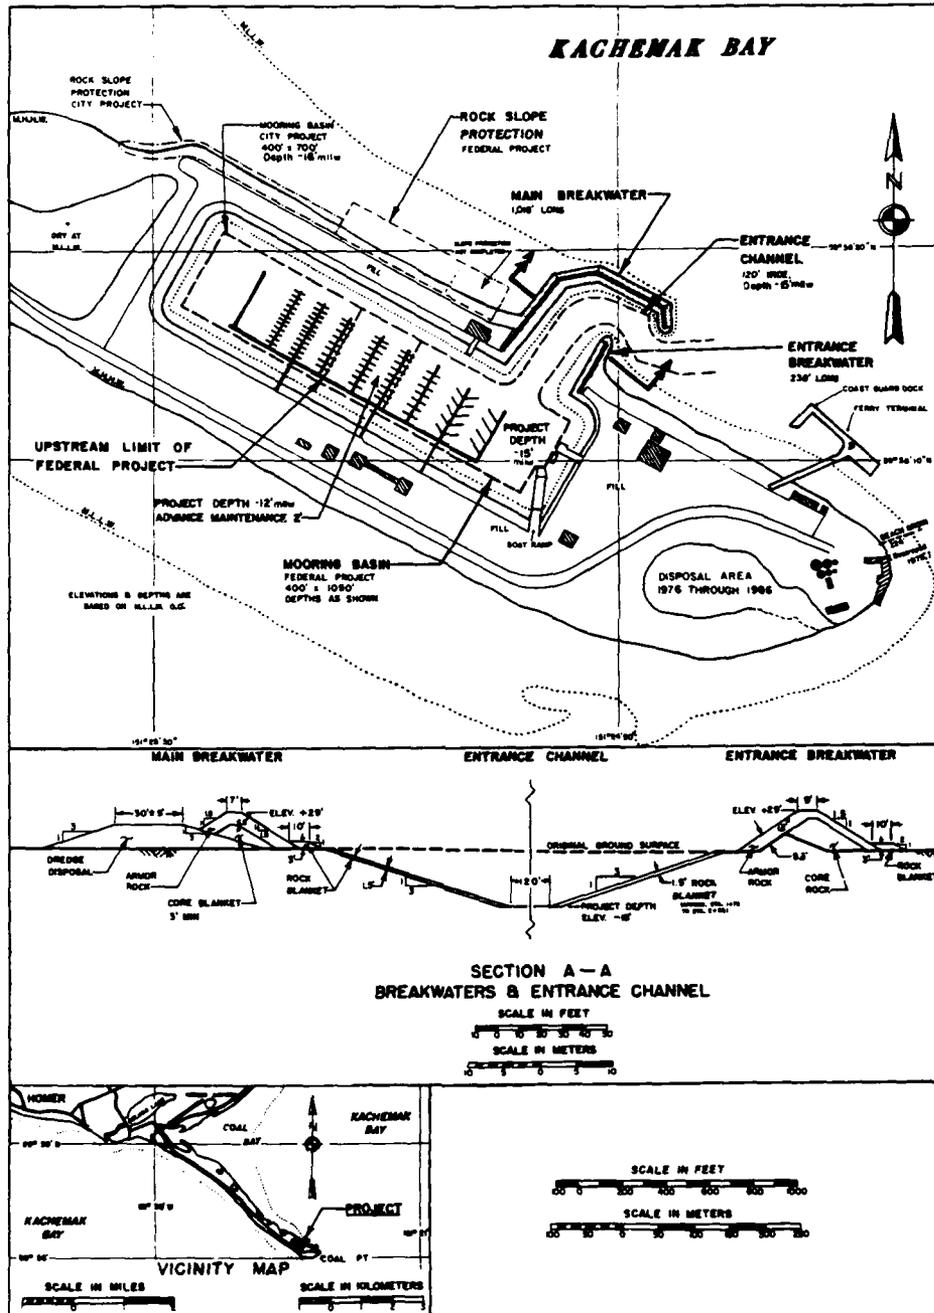
Figure 13. Site layout of Homer Harbor prior to expansion during 1984-1985 (revised 1978)

<u>Date(s)</u>	<u>Construction and Rehabilitation History</u>
1958	The original harbor plan was adopted.
1962	The original harbor was completed, including a 180- by 672-ft basin (2.8 acres), and a 1,260-ft rubble-mound breakwater.
1964	The original harbor was destroyed by earthquake, and the breakwater was severely damaged.
1965	The harbor was restored and relocated slightly to the northwest. The restored harbor included 2.75 acres at -12 ft mllw and 7.25 acres at -15 ft mllw, protected by a 1,018-ft main breakwater and a 238-ft entrance breakwater. Both breakwaters were constructed of a quarry-run core covered with an armor layer to crest elevation of +29 ft mllw with 1:1.5 side slopes. The main breakwater had a 7-ft crest width and was covered with a 5.5-ft layer of armor rock. The entrance breakwater had a 9-ft crest width and was covered with a 5.5-ft layer of armor rock on the entrance side and a 3-ft layer on the seaward side. The main breakwater had a rock blanket 3 ft thick extending 10 ft past the toe on the entrance side. The entrance breakwater had a 3-ft-thick rock blanket extending 10 ft past the toe on the seaward side. Armor rock was 700 to 1,100 lb. The entrance channel was dredged to -15 ft mllw and 120 ft wide at project depth, with 1:3 side slopes protected by a 1.5-ft-thick rock blanket. Cross sections of the breakwaters are shown in Figure 13.

1985 The breakwaters are in good condition at this time.

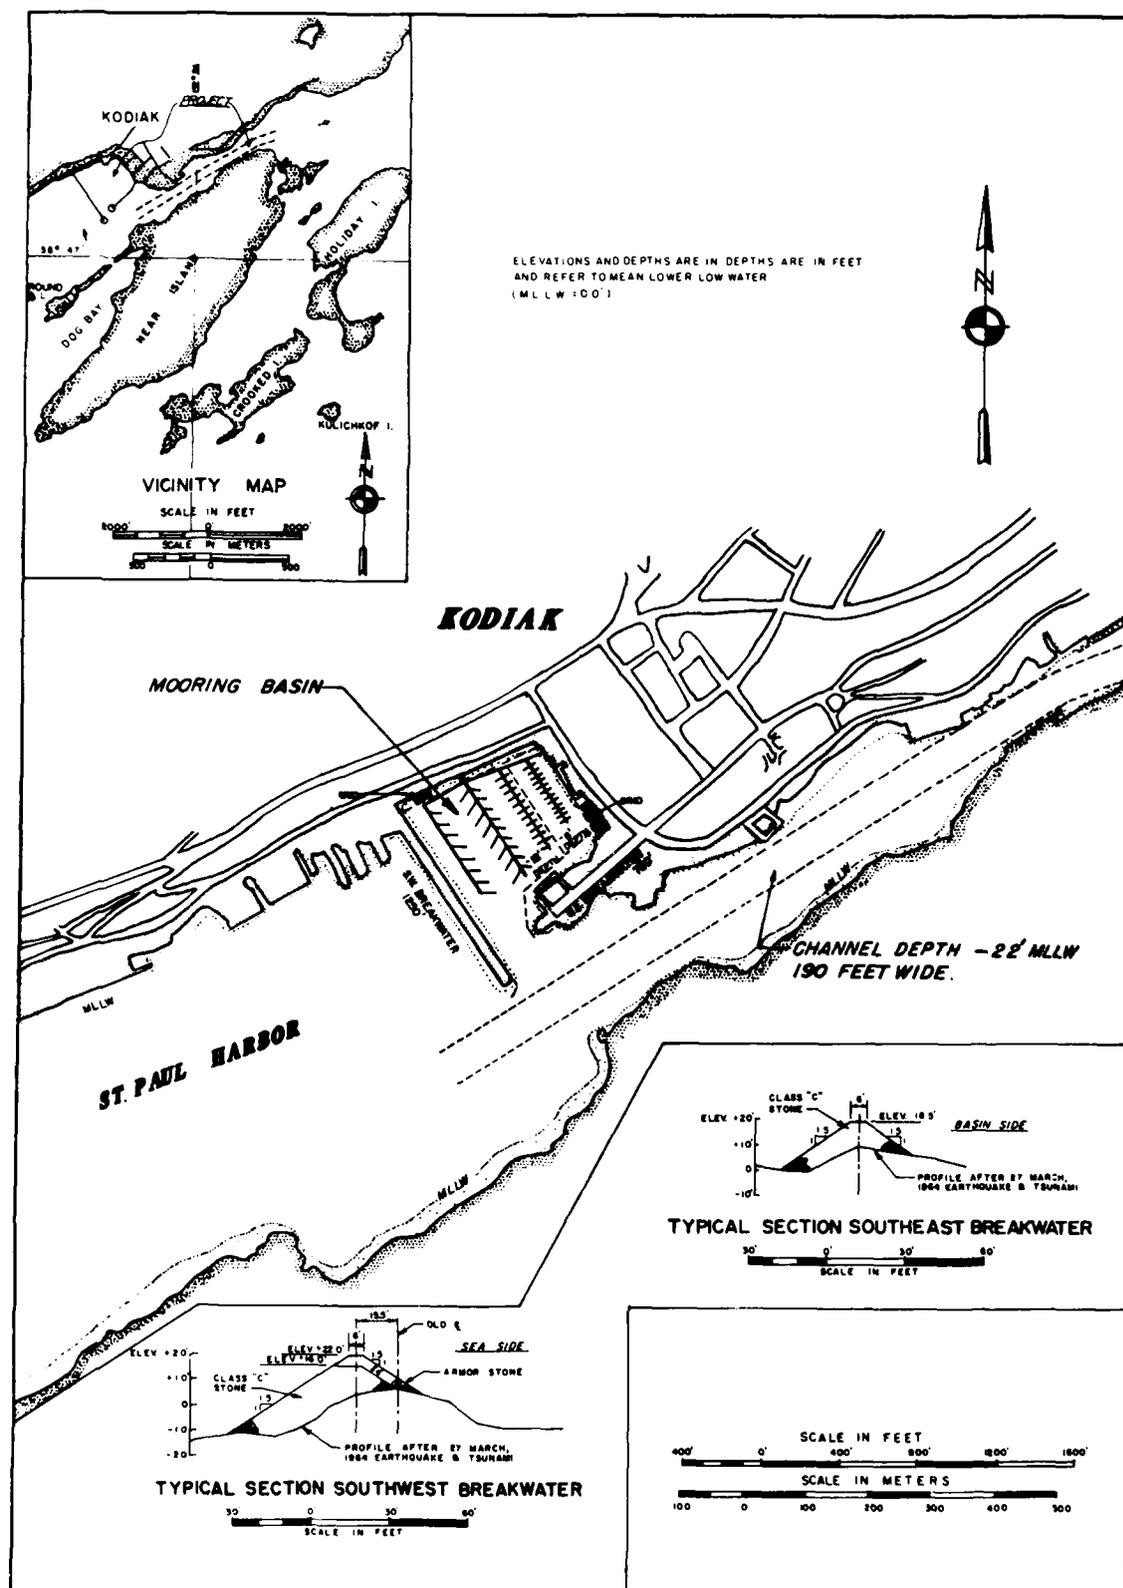
Figure 27. Site layout of Kodiak Harbor, Alaska (revised 1978)

<u>Date(s)</u>	<u>Construction and Rehabilitation History</u>
1935	A channel was authorized between Kodiak Island and Near Island to be 200 ft wide and later dredged to -22 ft mllw.
1954	The project was modified to include a small-boat basin.
1957	Construction of the breakwaters was initiated.
1958	A rock ledge was removed from the basin and channel. Construction of the breakwaters was completed. The southeast breakwater was constructed of a mound of Class "C" stone to an elevation of +18.5 ft mllw, a crest width of 6 ft, side slopes of 1:1.5, and length of 789 ft. The 1,250-ft-long southwest breakwater was constructed to an elevation of +22 ft mllw, a crest width of 6 ft, and side slopes of 1:1.5. The breakwater was constructed of a mound of Class "C" stone covered with a 6-ft layer of armor stone on the crest and a 4-ft layer of armor stone on the seaward side.
1964	The ground subsided 5 ft in an earthquake causing severe damage to the basin and breakwaters. The breakwaters were rebuilt with 70,000 tons of rock. Cross sections of the repaired breakwaters are shown in Figure 27.

1973	The tip of the southeast breakwater was repaired.
1985	The harbor is illustrated in Figure 27, and an aerial photograph of the harbor is presented in Figure 28. There have been no reports of needed repairs or rehabilitation since 1973.

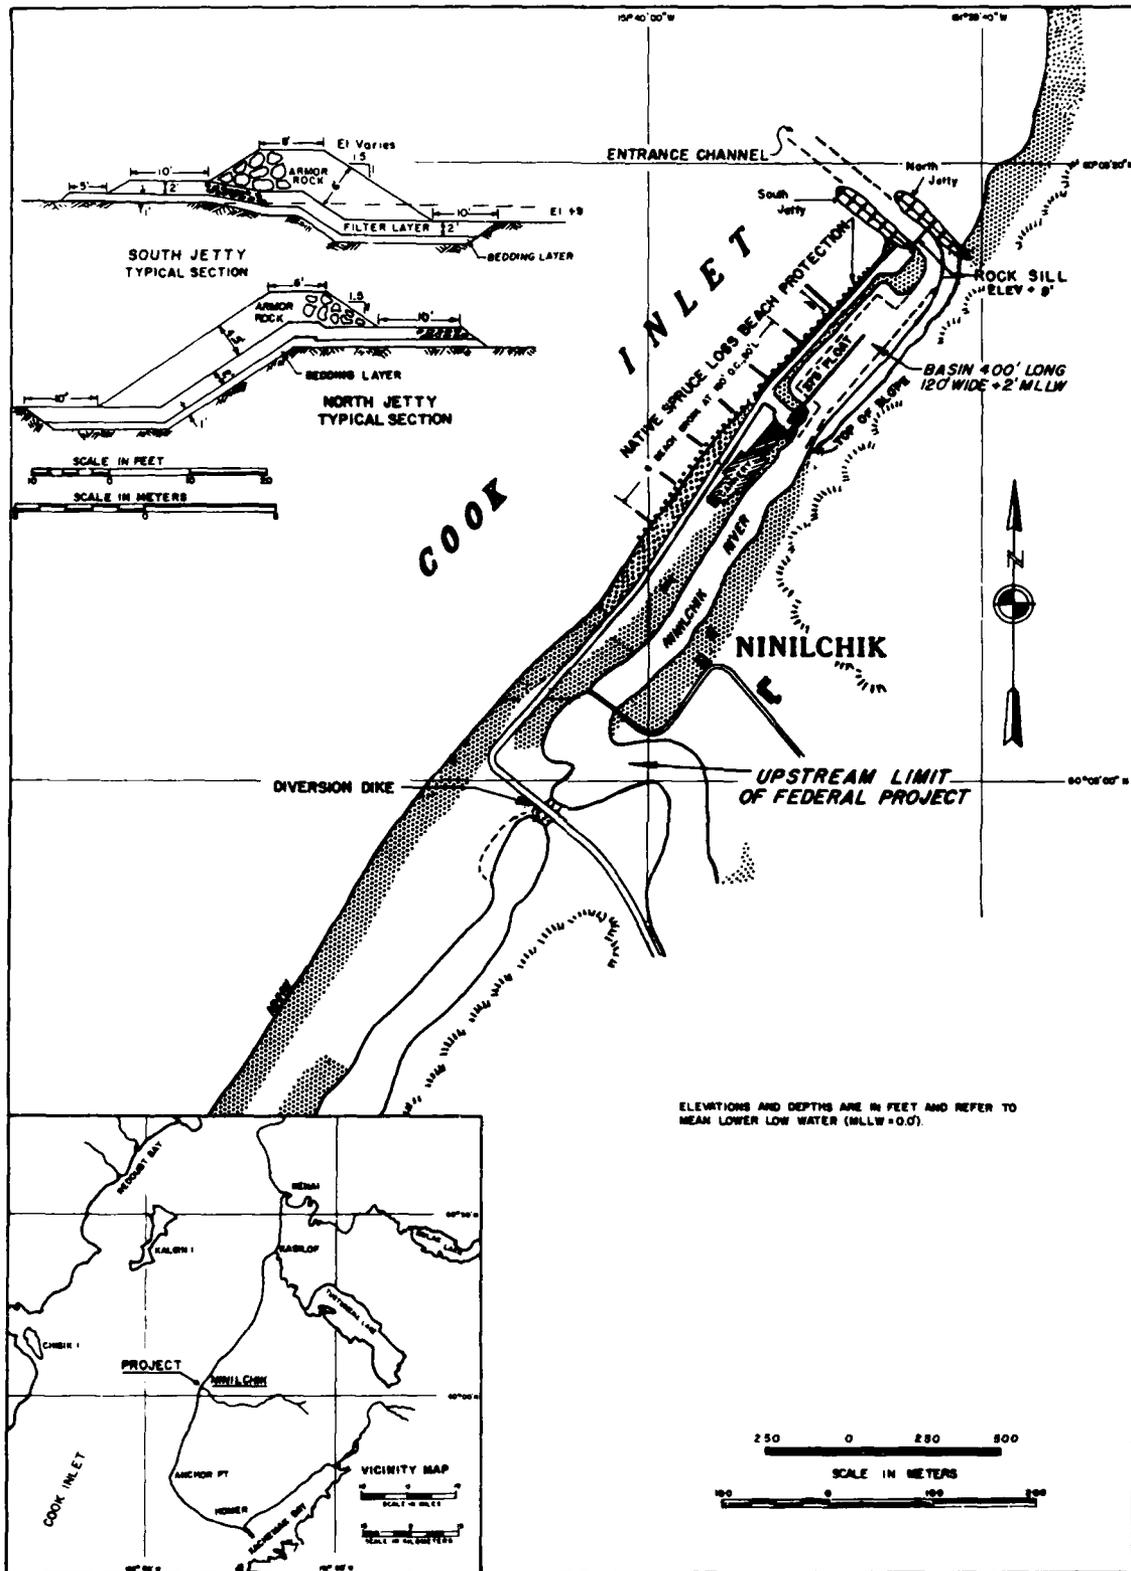
Figure 34. Layout of Ninilchik Harbor, Alaska (revised 1981)

1967	Major rehabilitation of the harbor was done. The Ninilchik River was diverted to its previous course south of the basin, and two short rubble-mound jetties were constructed at the river mouth. Jetty cross sections are shown in Figure 34.
1980	A study was authorized to determine the feasibility of harbor improvements.
1984	The study determined that improvements to the harbor would not be cost effective.
1985	The harbor is illustrated in Figure 34, and an aerial photograph of the harbor is presented in Figure 35. The harbor has required annual maintenance dredging and repairs since its construction.

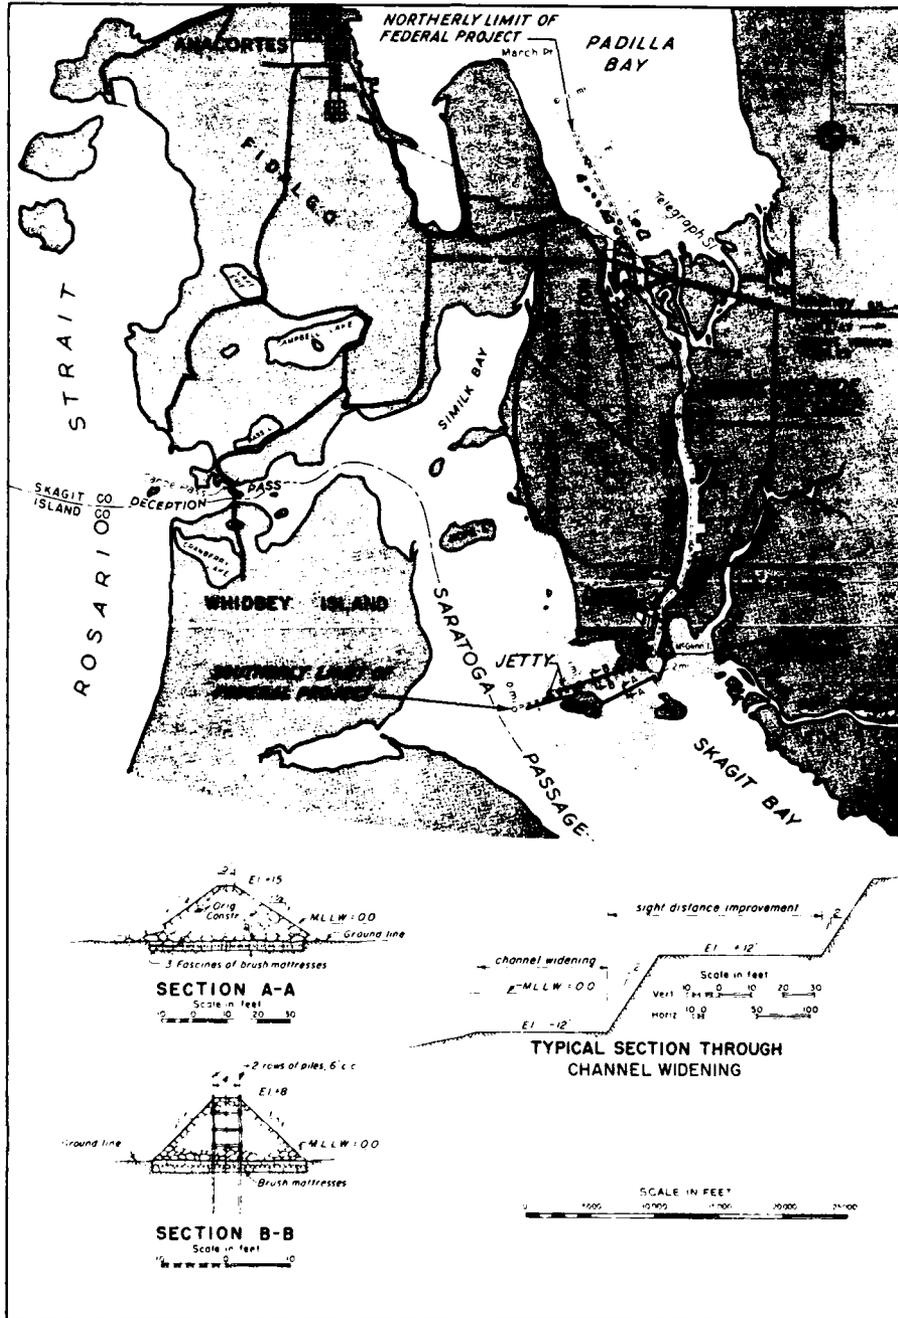
Figure 79. Site layout of Swinomish Channel, Washington (revised 1979)

1985 The jetty layout and cross sections of the jetties are illustrated in Figure 79. The north jetty shows obvious deterioration, and the south jetty and Goat-McGlinn Island jetty appear in good condition.

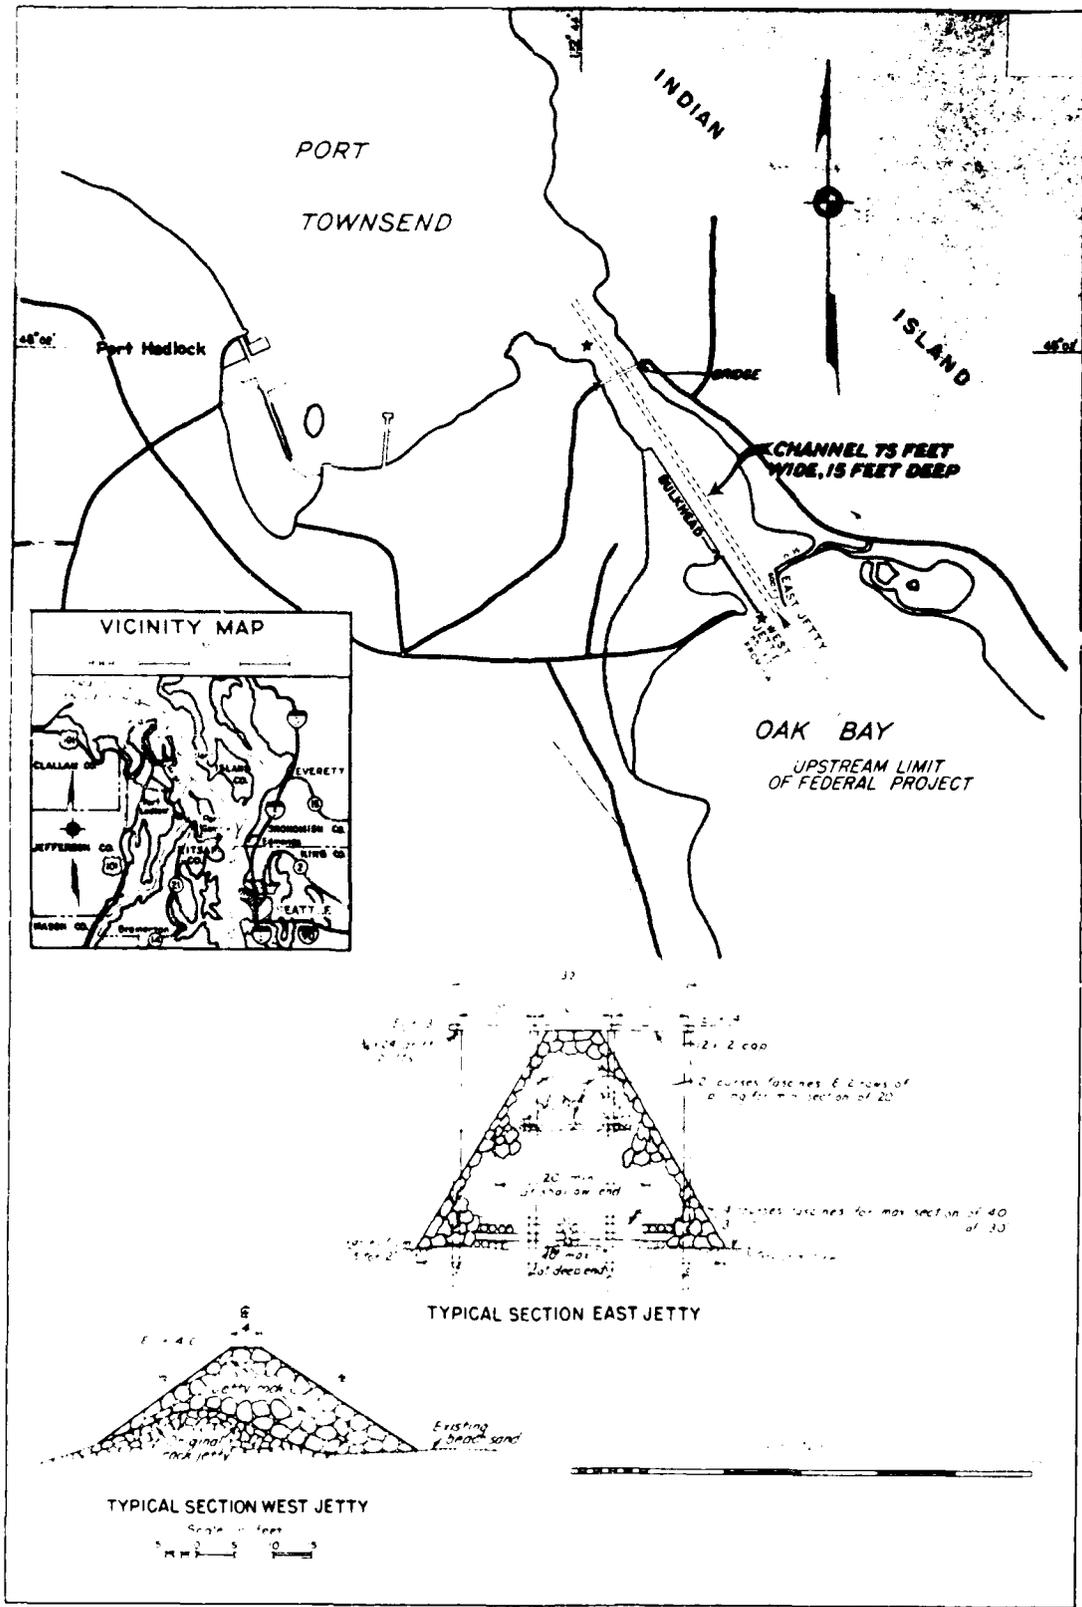
Figure 80. Site layout of waterway connecting Port Townsend and Oak Bay, Washington (revised 1979)

<u>Date(s)</u>	<u>Construction and Rehabilitation History</u>
1913	The project was adopted.
1915- 1916	The east jetty, west jetty, and bulkheads were constructed. The jetties were constructed of brush, pile, and stone with a 4-ft-wide crest and 1:1 side slopes. The west jetty was 550 ft long; the east jetty was 600 ft long. The bulkheads were constructed of brush, pile, and timber.
1925	The jetties and bulkheads were rehabilitated with 1,153 tons of rock.
1937	The rehabilitation work was performed on the east jetty by placing 393 tons of rock.
1961	The west jetty was rehabilitated with 12,173 tons of jetty rock to a crest elevation of +14 ft mllw, a crest width of 4 ft, and side slopes of 1:1.5.
1985	The jetty layout and cross sections are illustrated in Figure 80. There is no record of repairs or rehabilitation since 1961. The west jetty is in good condition. The east jetty shows some deterioration but is stable and functional.

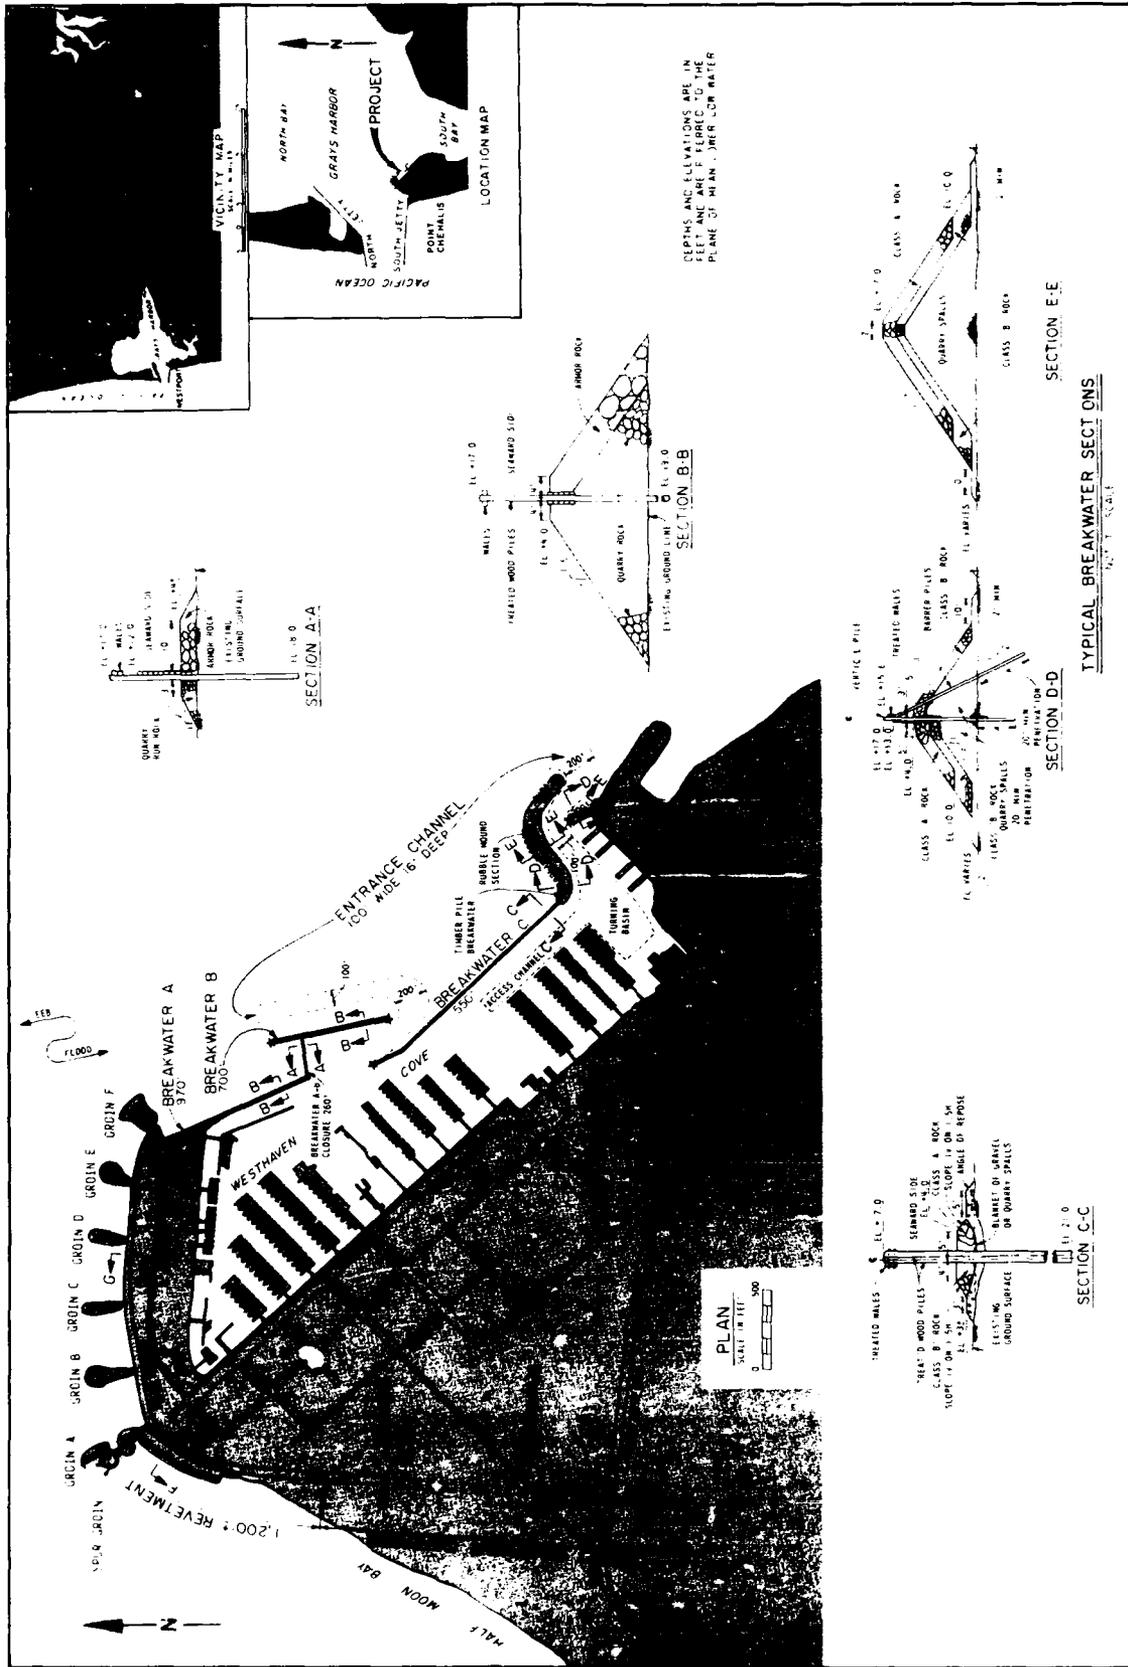
Figure 81. Site layout of Westhaven Cove Small-Boat Basin, Washington (revised 1979)

Date(s)	Construction and Rehabilitation History
1983	A detached breakwater at the southerly end of the basin was damaged by a storm. Some rock was displaced, and the decayed planking was damaged.
1984	The damaged breakwater was repaired.
1985	The basin layout and cross sections of the breakwaters are illustrated in Figure 81. Breakwaters are in reasonably good repair and appear to be functioning properly.

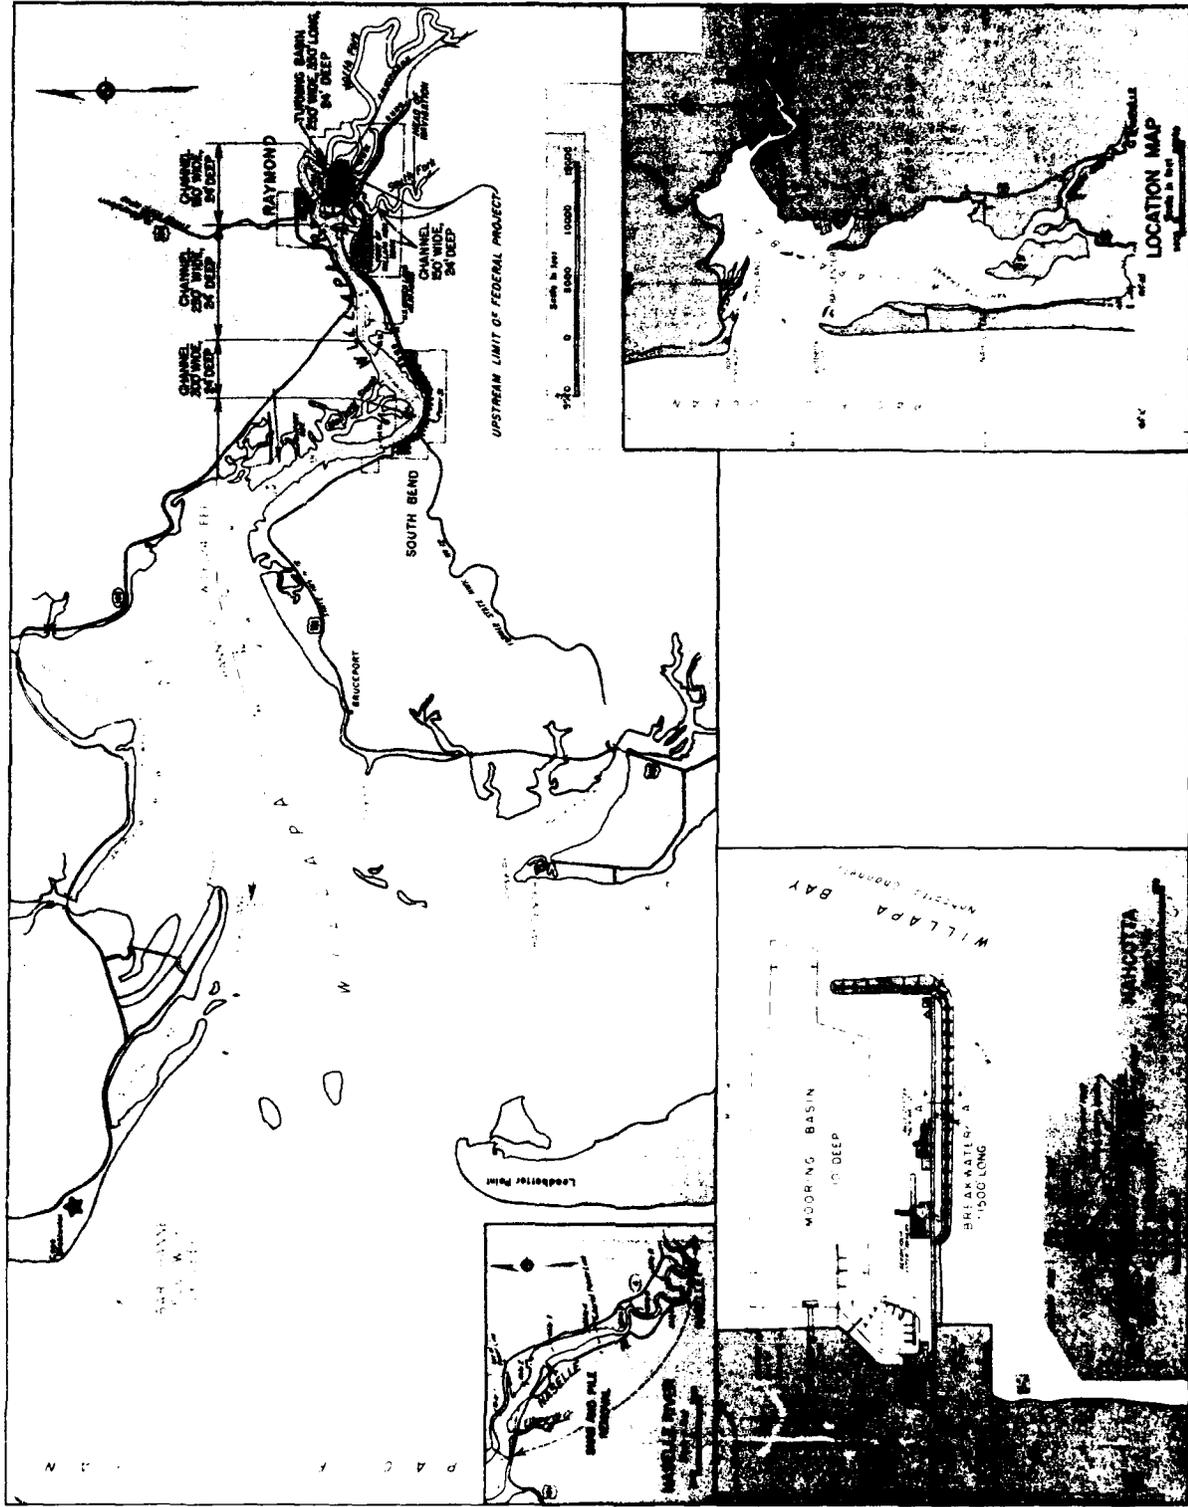
Figure 82. Site layout of Willapa River and Harbor and Naselle River, Washington (revised 1979)

Date(s)	Construction and Rehabilitation History
1916	Willapa River and Harbor project adopted.
1954	The Willapa River and Harbor project was modified to include the mooring basin and the breakwater at Nahcotta.
1957	The breakwater design at Nahcotta was modified to conform to requests by local interests.
1957- 1958	The Nahcotta breakwater was constructed. The 1,500-ft-long breakwater was of rubble-mound construction, with the crest at elevation +15 ft mllw, width of 6 ft, and side slopes of 1:1.5. The landward end tied into an existing oystershell mound at the landward end of Nahcotta Wharf. A 2-ft-thick layer of quarry spalls was extended 15 ft from the seaward toe on the channel side of the breakwater to protect against toe scour. The breakwater required 43,700 tons of rock to complete.
1958	The Nahcotta mooring basin and channels were dredged.
1985	The harbor layout and breakwater cross sections are illustrated in Figure 82. There are no reports of needed repairs or rehabilitation for the breakwater.
