Special Publication ARASM-SP-88003

ROOT CAUSE ANALYSIS, TANK FIRE PROBLEM,
M1A1 MAIN BATTLE TANK

MAJ John Dowalgo

February 1989

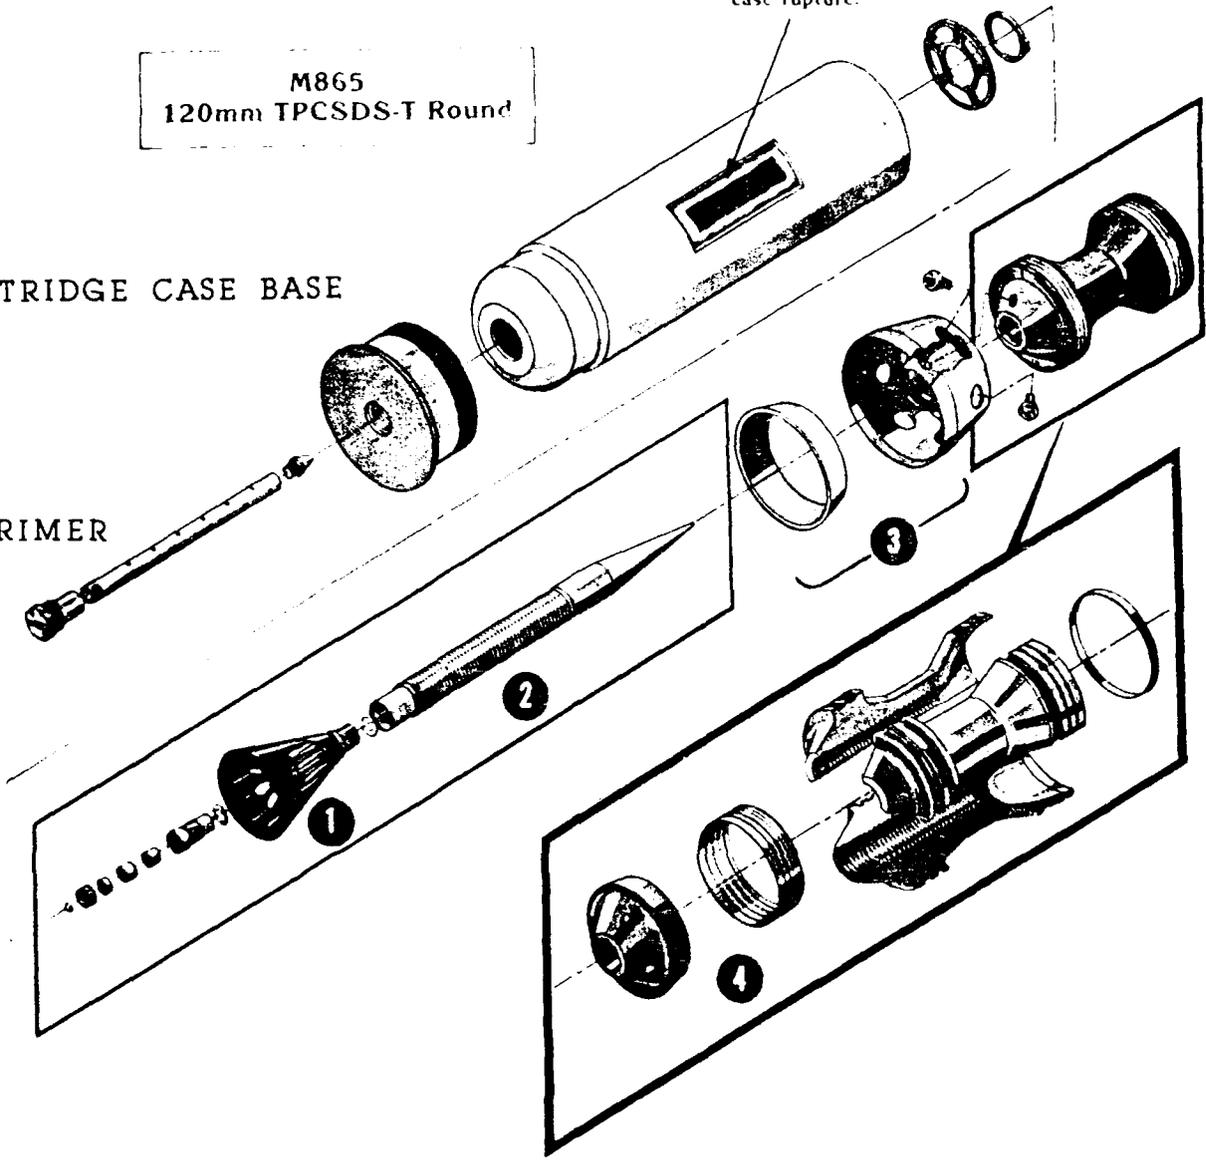
Figure 4. M865 cartridge exploded view

3. Strengthen the Combustible Cartridge Case The glued joint, where the case cover and cap assembly is attached to the combustible cartridge case (fig. 4), is suspect of separation and may have been a contributor to the 4 July 88 tank fire. Research to improve the joint is in progress. Efforts have addressed process controls, quality, testing, and improved strength. Additionally, researchers should evaluate the possibility of strengthening the propellant containment bag, especially where the bag is attached to the projectile.
