TECHNICAL REPORT REMR-CO-3

CASE HISTORIES OF CORPS BREAKWATER
AND JETTY STRUCTURES

Report 5

NORTH ATLANTIC DIVISION

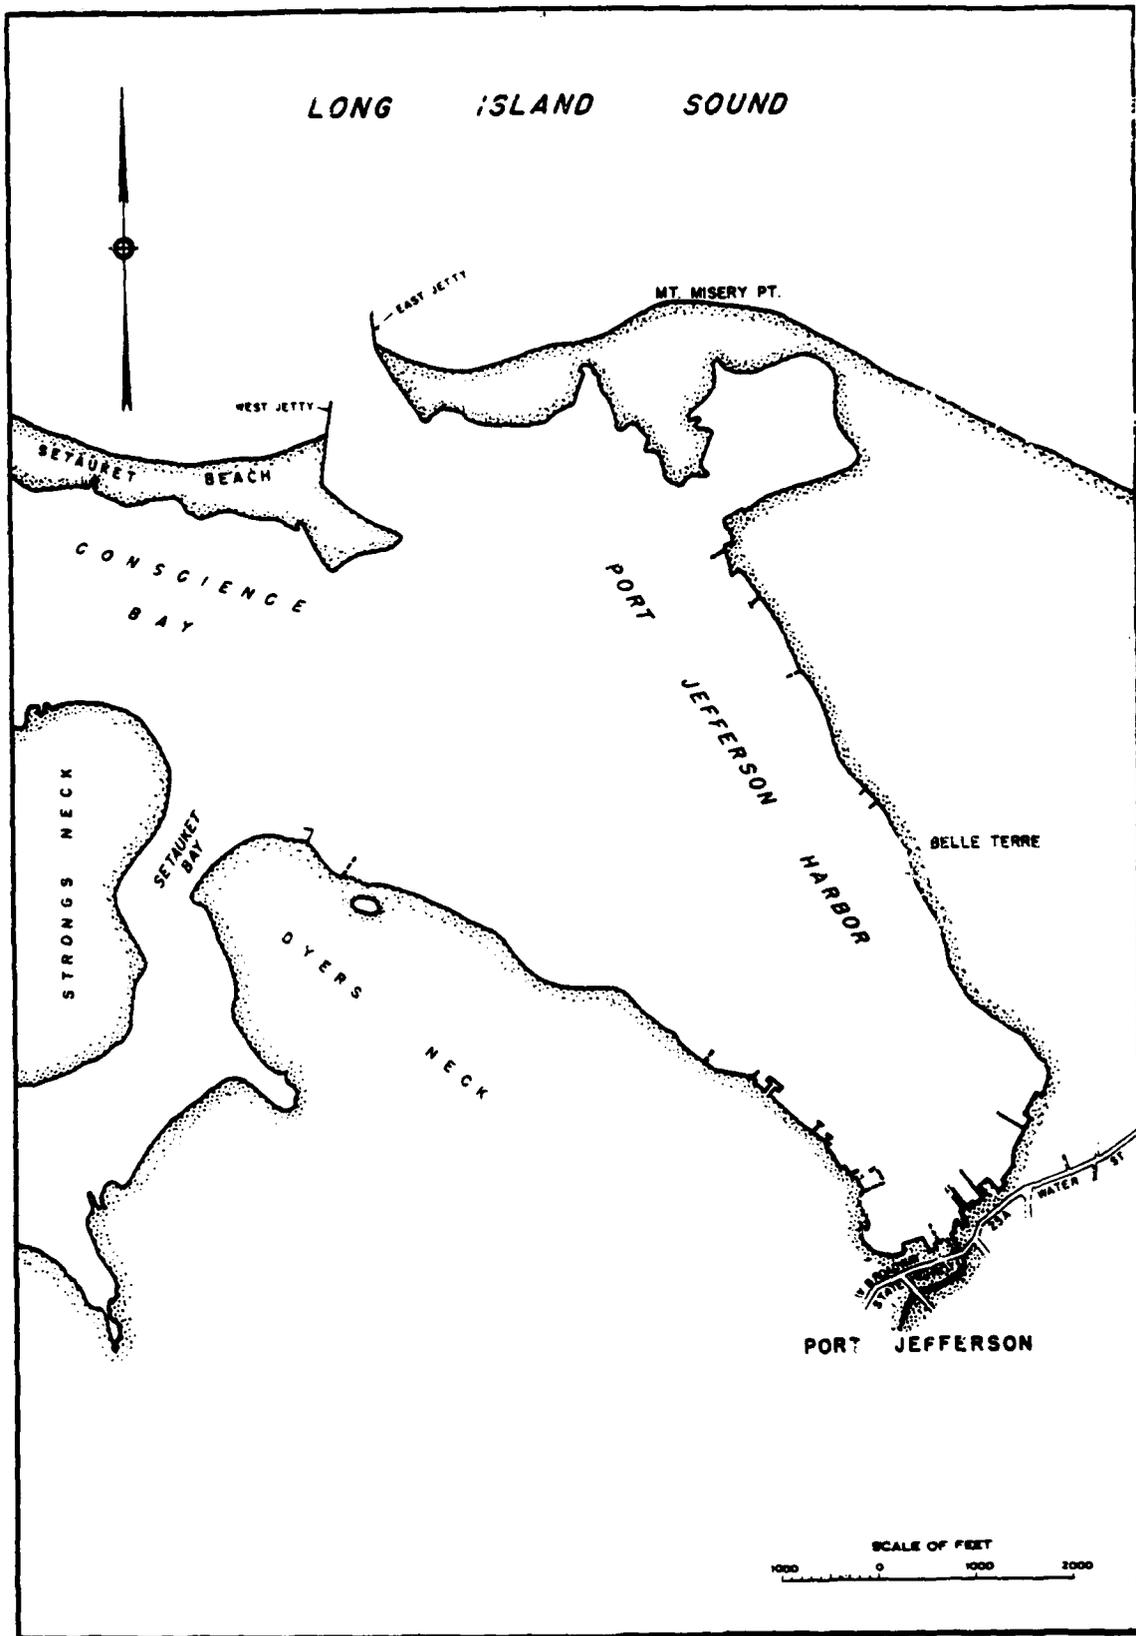
Figure 12. Port Jefferson Harbor, New York

1891	The east jetty was repaired over 600 ft with 1,464 tons of stone.
1908	The east jetty was extended to 1,550 ft (Figure 12).
1964	A survey indicated the jetties were in poor condition.
1986	No further repair or maintenance information has been found.

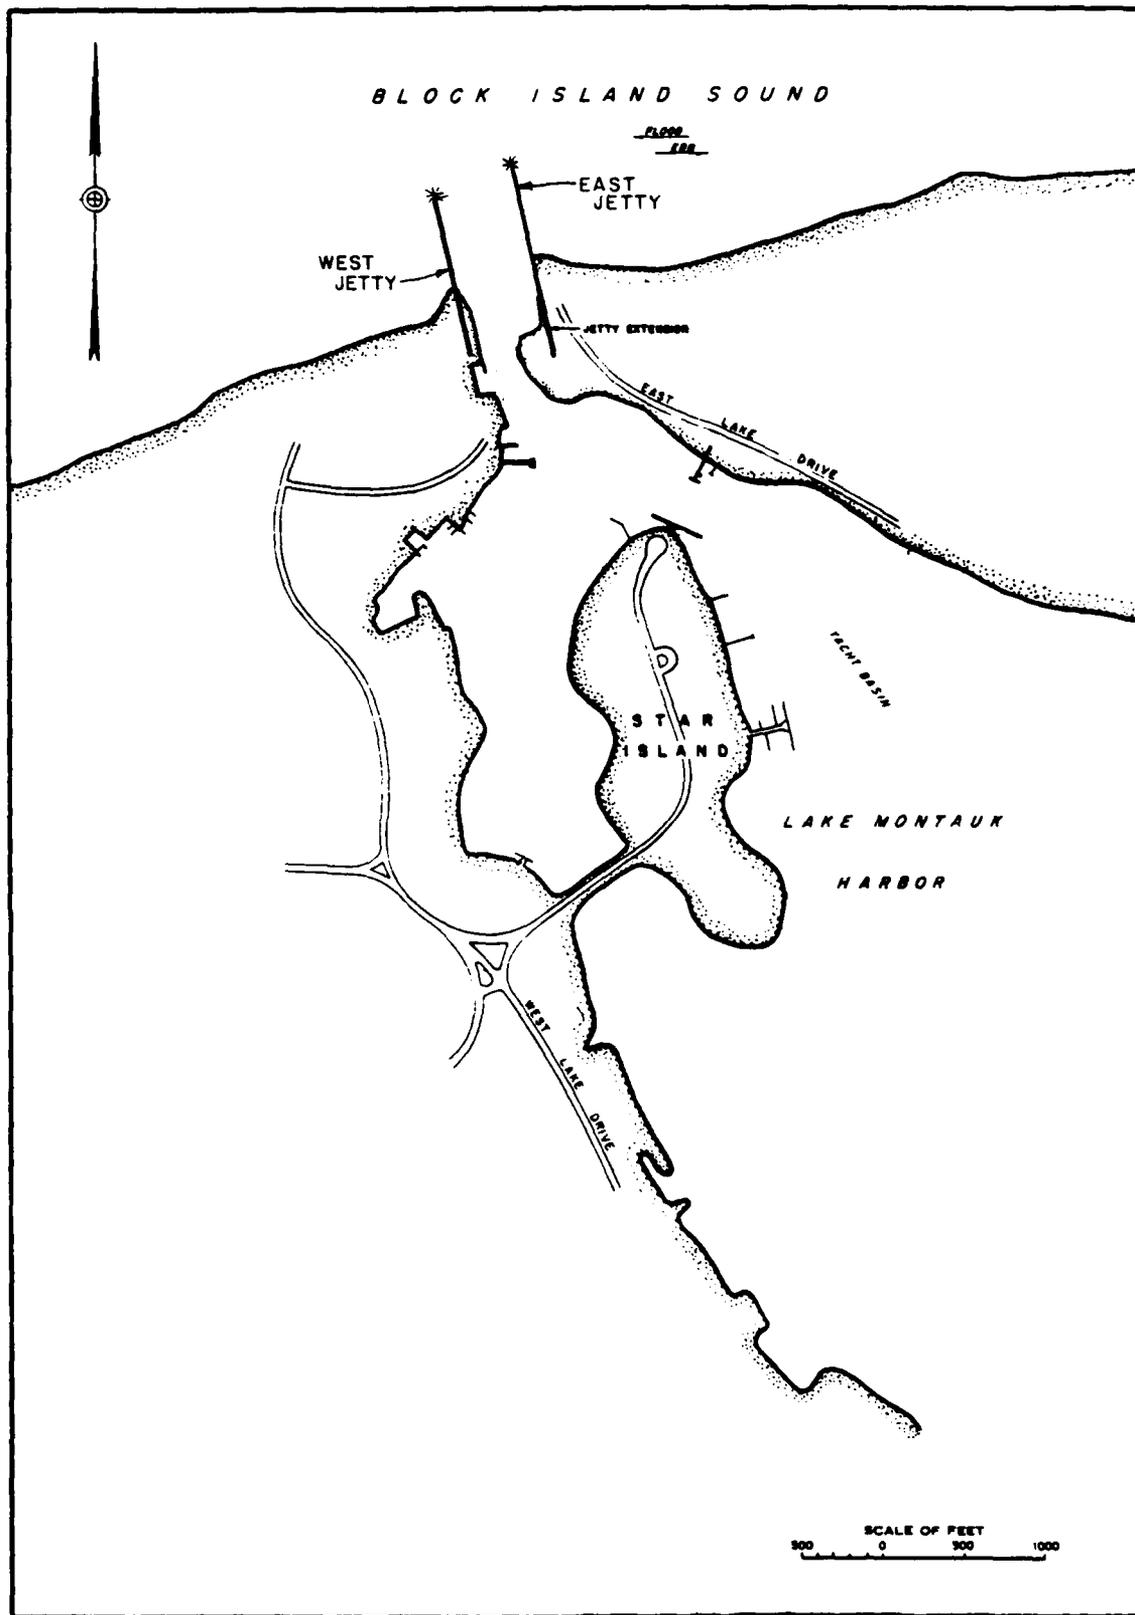
Figure 16. Lake Montauk Harbor, New York

<u>Date(s)</u>	<u>Construction and Rehabilitation History</u>
1926	Private interests constructed jetties east and west of the lake entrance. The east jetty was 750 ft long (Figure 16), and the west jetty was 981 ft long. Crest elevations were +6.0 ft and +8.0 ft mean low water (mlw) west and +8.0 ft mlw east. Crown width varied from 5.0 to 6.0 ft, and the side slopes were 1V:1.5H. One- to 4.0-ton stone was used and placed in random fashion.
1942	The west jetty was extended 231 ft shoreward at the request of the Department of the Navy using \$82,738 of Navy funds (Figure 16). Crest elevation of the extension was +8.0 ft mlw, crown width was 6.0 ft, and side slopes were 1V:1.5H. Cover stone used was 4.0 to 6.0 tons, and core stone was 8.0 to 6,000 lb.
1967	A survey indicated the jetty was in poor condition. Proposals were made to repair and extend the jetties using a design wave of 16.0 ft and 5.8 sec.

1968	The jetties were repaired, and the east jetty was extended 350 ft. The cost of repairs and the extension was \$526,600, and 18,400 tons of stone were used.
1986	No further repair or maintenance information has been found.

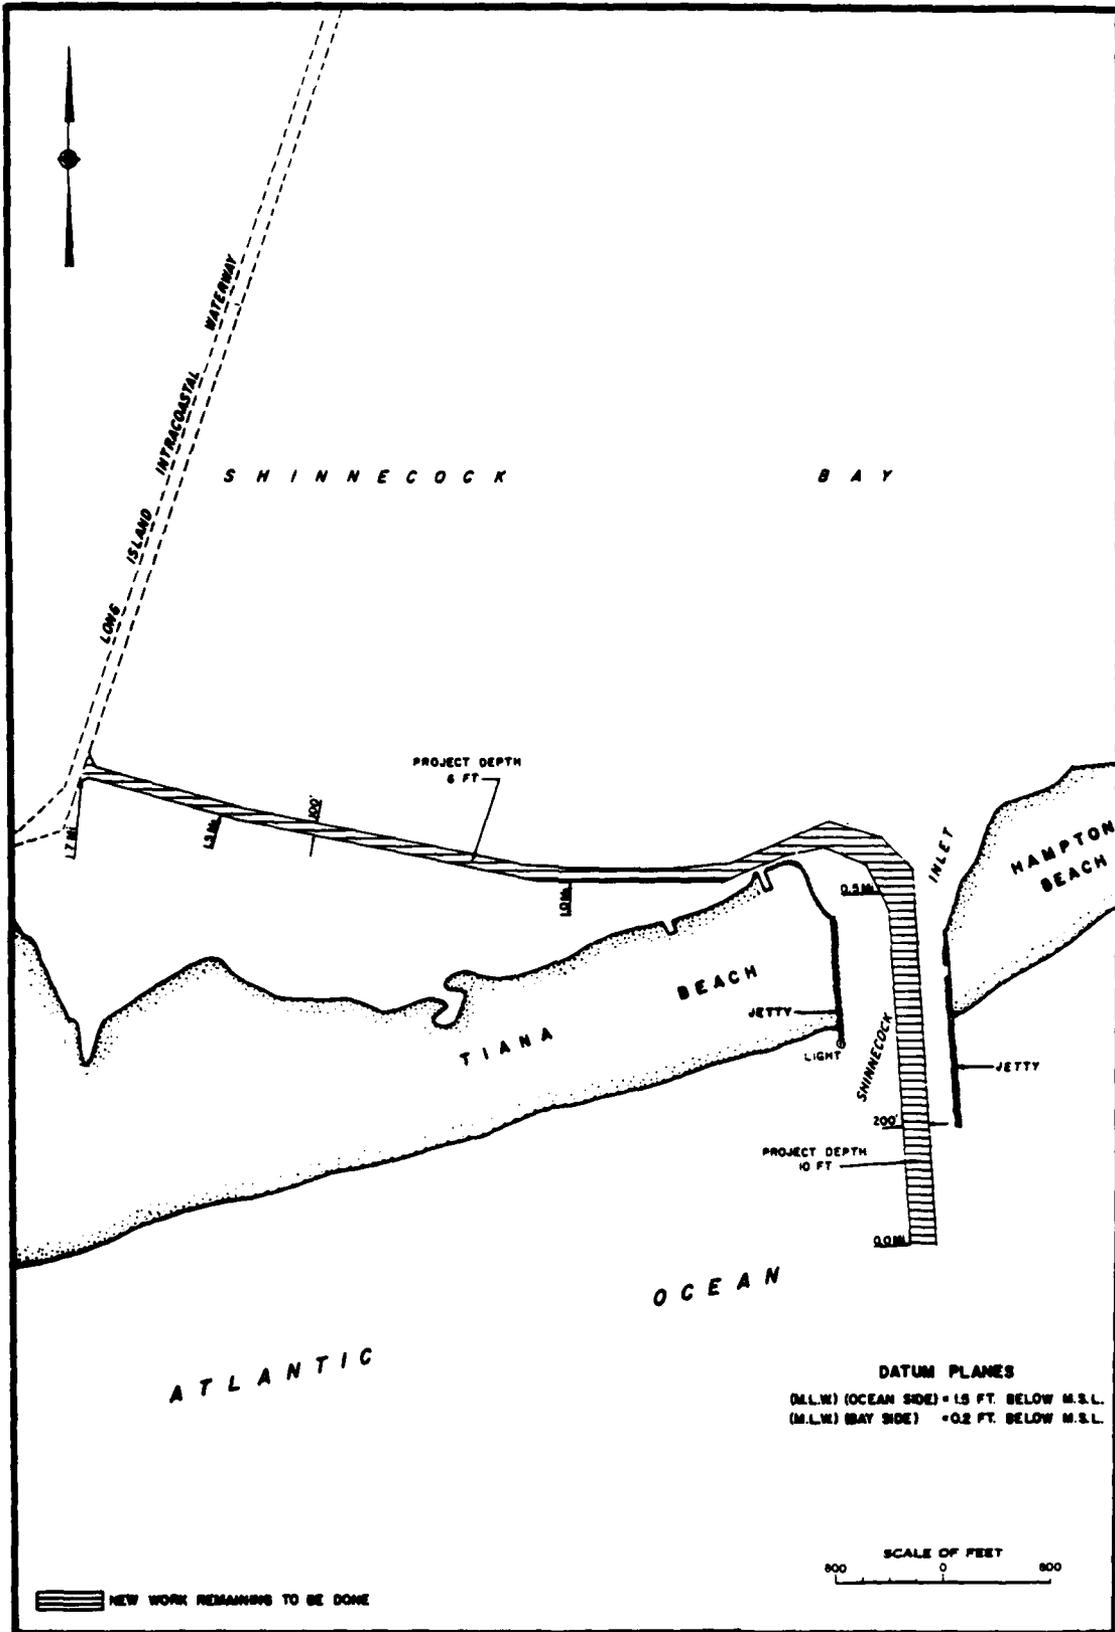
Figure 17. Shinnecock Inlet, New York

<u>Date(s)</u>	<u>Construction and Rehabilitation History</u>
1953	Local interests constructed two jetties for inlet stabilization at lengths of 1,363 ft east (Figure 17) and 850 ft west. The cost of construction was \$846,210 east and \$376,000 west. The design geometry of both jetties consisted of +9.0-ft mlw crest elevations, 12.0-ft crown widths, and 1V:1.5H side slopes. The jetties were constructed of one layer capstone, 4.0- to 10-ton stone on the landward 1,163 ft of the east jetty, and 6.0- to 12-ton stone elsewhere. Core stone used on the east jetty was 5.0 lb to 1.0 ton on the landward 1,163 ft and 5.0 lb to 2.0 tons elsewhere. Core stone used on the west jetty was 50 lb to 1.0 ton. A 2.0-ft-thick blanket and apron stone were placed using 5.0- to 500-lb stone.
1954	Local interests extended the west jetty 96 ft (Figure 17) at a cost of \$166,230. The extension was built at the same elevation and width as the original jetty. Side slopes were 1V:2H. Capstone was 6.0 to 12 tons, covering 10-lb to 2.0-ton core stone resting on a 2.0-ft-thick blanket and apron, consisting of 50- to 500-lb stone.

1956	A survey revealed that the east jetty had suffered severe damage. Capstones and slope stones had slipped and were disarranged in numerous spots. Core stones were washed out in several places. Capstones and core stones were washed out in four locations totaling 150 ft. The outer 250 ft of the jetty was partly washed out. Beach and dunes adjacent to the jetty eroded, and waves rode over the dunes and flanked the jetty. The west jetty was in fair condition with minor slips and disarrangement in five spots. The inlet was in a shoal condition. Most of the damage was due to a hurricane in 1954.
1982	The west jetty was reconstructed by resetting cap stones to original design geometry over 170 ft. A 1,470-ft-long pile crib revetment on the north end of the west jetty was replaced by a rubble-mound jetty. (Figure 18).
1985	A survey revealed that the reconstructed portion of the west jetty was in good condition. The seaward 200 ft of the west jetty had unraveled and capstones were scattered. The west jetty head had not maintained design configuration. Stones on the inlet side of the east jetty had sloughed in some sections, but stones on the beach side had retained their original position. Two areas on the northern end were completely deteriorated. Erosion of sand caused undermining of the east jetty with continual loss of sand undermining it further.

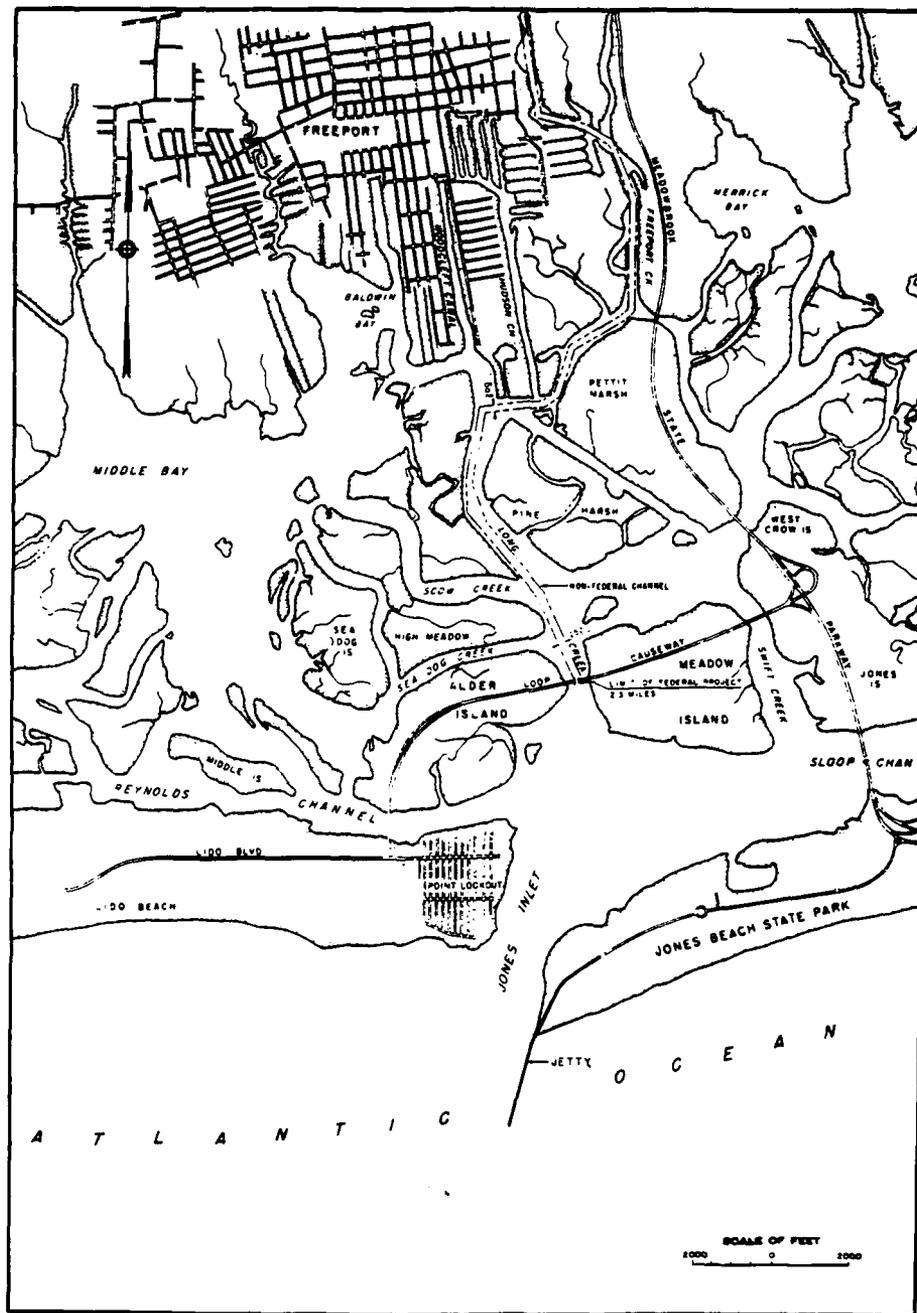
Figure 22. Jones Inlet, New York

1962	The Middle Atlantic coastal storm of 6-8 March 1962 damaged the jetty. The outer 200 ft was raveled and broken down to the high water level. A second layer of capstone was added to the outer 120 ft to restore the original design. The adjacent 1,080 ft shoreward was repaired by replacing armor stone and by adding stone. Armor stone was replaced on the adjacent 900 ft shoreward.
1985	The jetty had nearly reached impoundment. Sand was bypassing the jetty, mostly through large voids at the jetty-shoreline intersection. The apron had settled approximately 7.0 ft at the seaward end due to sand loss through voids in the apron.
1986	No further repair or maintenance information has been found.

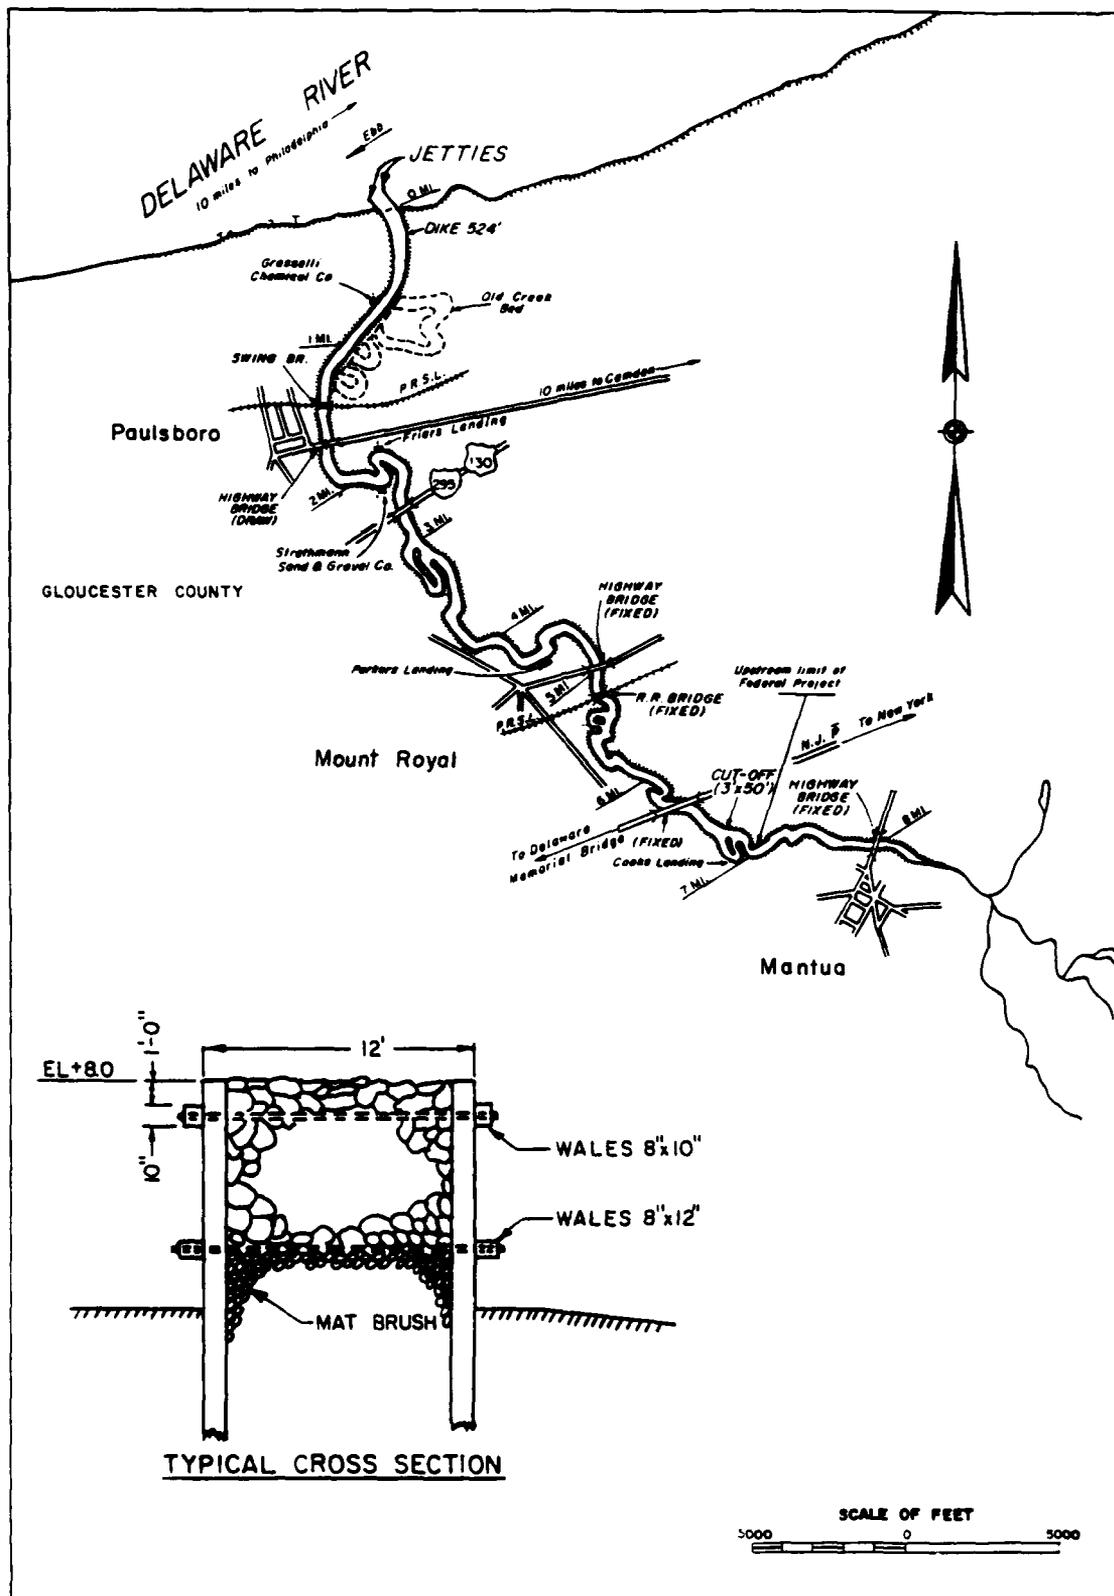
Figure 28. Mantua Creek, New Jersey

<u>Date(s)</u>	<u>Construction and Rehabilitation History</u>
1907	Two jetties were constructed to provide channel protection. Lengths were 754 ft and 580 ft east and west, respectively. The jetties were constructed of stone-filled timber cribs, with mat brush placed to support the stone (Figure 28). Top width and elevation were 12.0 ft and +8.0 ft mlw, respectively, for each jetty.
1912- 1913	The east jetty was extended to 1,577 ft, and the west jetty was extended to 1,456 ft (Figure 28).
1918	Repairs were made by the addition of stone.
1962	An investigation of the jetties revealed the jetties had settled an average of 2.0 ft. Approximately 100 ft of the offshore end of the east jetty had deteriorated, with most of the pilings gone, and stone had fallen out to below the waterline. Most of the walings had deteriorated and were missing. Piles were missing at intermediate locations along the jetties, but there was no significant loss of stone at those locations. Piles that remained were in good condition.

1963	The jetties were rehabilitated at a cost of \$136,895. A new row of piles was placed over approximately 100 ft at the offshore ends. Piles were placed 7.5 ft on either side of the center line of the jetties. Corestone was dumped between the piles to an elevation of +8.0 ft mlw (Figure 29). Missing piles were replaced, and new wales were provided along the remainder of the jetties. One row of capstone was placed on the inner sides of both cribs on top of the existing stone to +8.0 ft mlw. Core stone was filled between the capstones in the center of the jetties to +8.0 ft mlw (Figure 29). Crown width was 16.0 ft at the offshore ends and 12.0 ft on the remainder of the jetty. Design wave height was 4.2 ft.
1964	Repairs were made to the seaward end of the east jetty at a cost of \$4,864. The Corps was reimbursed later for this work.
1986	No further repair or maintenance information has been found.

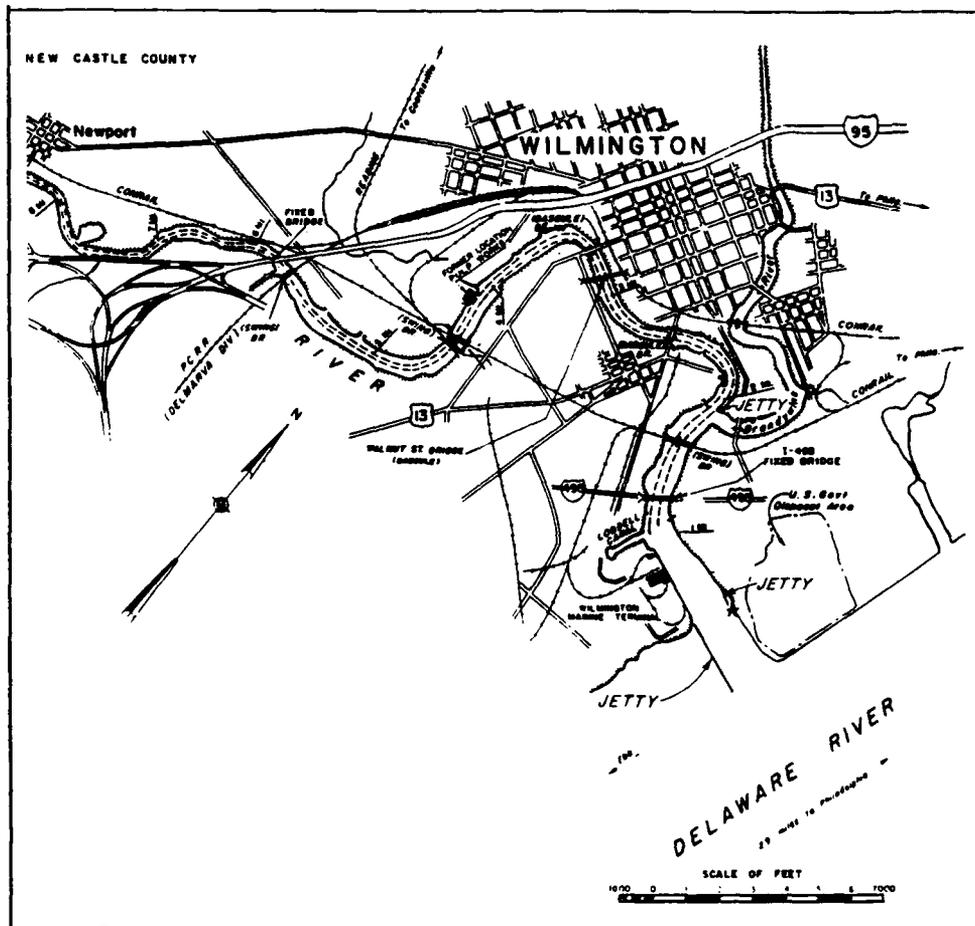
Figure 31. Wilmington Harbor, Delaware

Date(s)	Construction and Rehabilitation History
1937- 1939, 1948	Damages to the Christina south jetty, caused by ships colliding with it, were repaired each of these years at a total cost of \$90,000.
1961	The landward 500 ft of the Christina south jetty was removed to accommodate marine terminal expansion. The total length of the jetty was 1,800 ft.
1962	275 ft of buttressed steel sheet-pile wall failed during an extremely low tide and was eventually repaired.
1985	The Christina south jetty is in good condition.

<u>Date(s)</u>	<u>Construction and Rehabilitation History</u>
1883	A 1,740-ft-long curved stone-filled pile and timber crib jetty was constructed north of the Christina River mouth.
1884	The north jetty was raised 4.0 ft to a height above high water (no information on exact height).
1900	The north jetty was repaired and extended 313 ft. A terminal crib was also constructed. The total length of the north jetty was 2,150 ft. Jetties were constructed on the south side of the Christina River and at the mouth of the Brandywine River. The length of the south Christina River jetty was 1,515 ft and was built of pile and stone. A cross dike was built to connect the inner end of the jetty to the shore at high water. The Brandywine River jetty was V-shaped and was built of stone-filled pile and timber crib. The total length of this jetty was 690 ft, 430 ft on the Brandywine River side and 260 ft on the Christina River side (Figure 31).

1905	Repairs were made to the Brandywine River jetty and the north Christina River jetty. New wales were put on the Brandywine jetty, and face timber was replaced on the north Christina jetty. Stone was replaced where needed on both jetties.
1916	Repairs were made to the north Christina River jetty. Broken timber and piling was replaced with new material. Fender piles were placed along the channel face, and the interior of the crib was filled with stone where settling had occurred along the entire length of the jetty.
1925	The south jetty was removed, and a new jetty was to be built south of the Christina River.
1931	Approximately 1,200 ft of the north jetty was removed to improve the channel regime. The total length of the north jetty was 950 ft (Figure 31).
1936	A new jetty was completed south of the Christina River mouth. The jetty was 2,300 ft long (Figure 31) and consisted of 1,352 lin ft of steel sheet-pile wall, buttressed with 100-ft timber piles 12 ft on center, a 948-ft outboard section consisting of twelve 25.5-ft-diameter steel sheet-pile cells, and one 30.5-ft-diameter terminal cell with twelve 51-ft interconnecting fences. Crest elevation was +10 ft Corps of Engineers Datum (2.9 ft below mean sea level, 1929). The landward end of the jetty was connected to shore by a 120-ft steel sheet-pile anchor wall. The cost of construction was \$205,000.

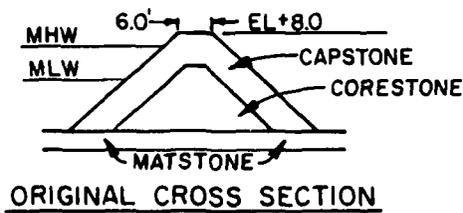
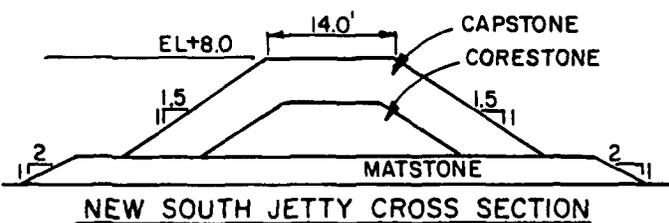
Figure 32. Delaware River and Chesapeake Bay Canal, Delaware

<u>Date(s)</u>	<u>Construction and Rehabilitation History</u>
1903	Construction of two rubble-mound jetties, north and south of the canal, was completed to provide channel protection. The length of each jetty was 725 ft, crest elevations were +8.0 ft mlw, crown widths were 6.0 ft, and side slopes were 1:1 (Figure 32).
1938	Each jetty was extended to 2,095 ft (Figure 32).
1960's	The south jetty was removed and replaced by a new jetty to increase the entrance size to accommodate larger vessels and to improve navigation safety. The new jetty had a crest elevation of +8.0 ft mlw and a 14.0-ft crown width (Figure 32). The design wave was 6.3 ft, 4.8 sec.
1985	The north jetty has subsided, lost stone, and the toe has scoured.

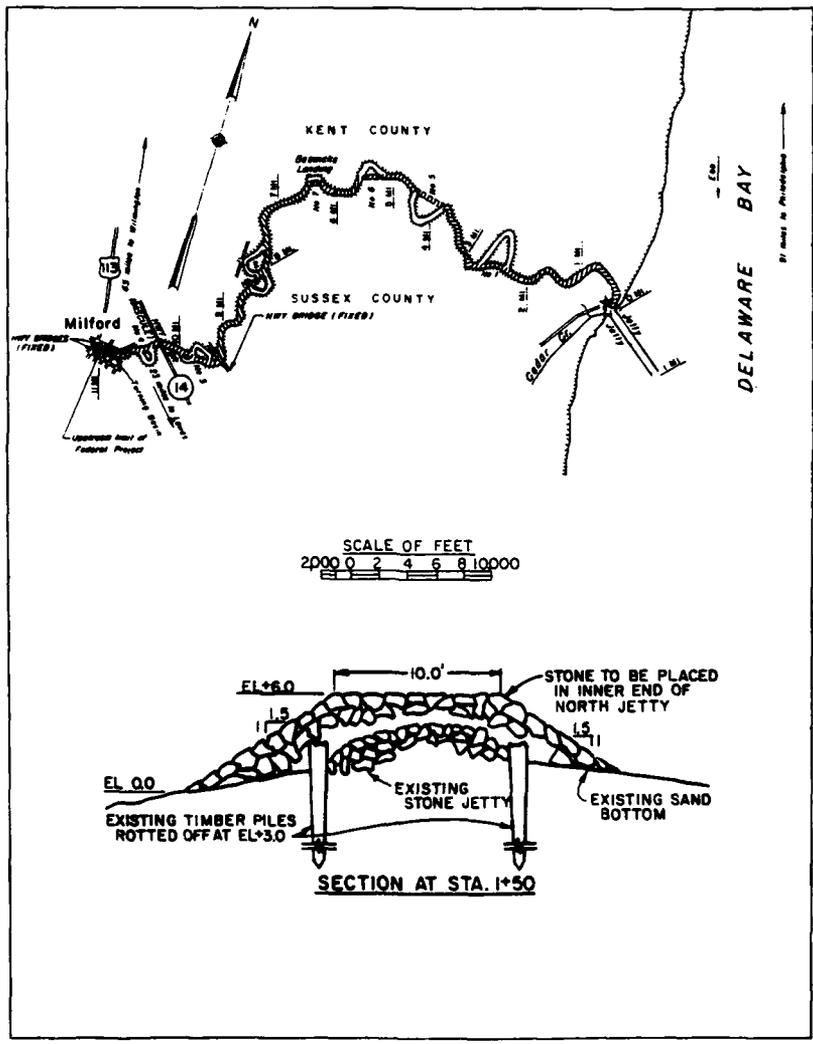
Figure 34. Mispillion River, Delaware

1944	Tops of piles were coated with tar on the north jetty near the river mouth at a cost of \$320.
1948	The north jetty was repaired beginning 708 ft from the shoreward end and extending 942 ft seaward. The original timber crib section was rehabilitated to a rubble-mound structure (Figure 34). The cost of repairs was \$51,493, and 4,870 tons of stone were used.
1963	A survey of the north jetty indicated there was no visible trace of the shoreward 708 ft. The total length of the existing jetty was 5,642 ft. The shoreward, rubble-mound, end had an average height of +6.2 ft mlw. The 1,200-ft-long timber crib structure adjacent to the rubble-mound section had deteriorated. Upper crib work was virtually nonexistent, and tops of piles were rotted or broken off. Stone had settled an average of 2.8 ft from design, was displaced, and had spilled out between piles. Piles, tie rods, and wales in the most seaward 3,500 ft appeared to be in good condition. Stone had settled an average of 1.5 ft in this section.

1964	Minor rehabilitation was done on the north jetty at a cost of \$377,848. The 1,200-ft-long deteriorated timber crib section was rehabilitated to a rubble-mound structure. The center line of the rubble-mound structure was placed north of the center line of the timber crib jetty to prevent failure of the jetty on the channel side due to lateral forces. The offset was 11.0 ft over a distance of 650 ft and 9.0 ft over a distance of 400 ft, shoreward and seaward ends of the section, respectively. Transition sections were on either end of the new structure and between the two offset sections. Crest elevation was +7.0 ft mlw, crown width was 10.0 ft, and side slopes were 1V:1.5H. Twenty-five ton minimum capstone was placed over 1- to 50-lb matstone. A layer of willow matting, compressed in

Date(s)	Construction and Rehabilitation History
1964 (Cont.)	place to 1.5 ft thick, was provided as a filter. Core stone, 25 to 500 lb, was placed on the channel side of the existing jetty at a slope of 1V:1H to 1V:1.5H to ensure stability of the rubble-mound structure. The 3,500-ft-long timber crib on the seaward end of the jetty was filled with core stone, 150 to 300 lb, to the original design elevation of +5.5 ft mlw. Cross sections of the rehabilitation are shown in Figure 35.
1985	The jetties are in good condition and have been effective in providing safe navigation and preventing channel shoaling.

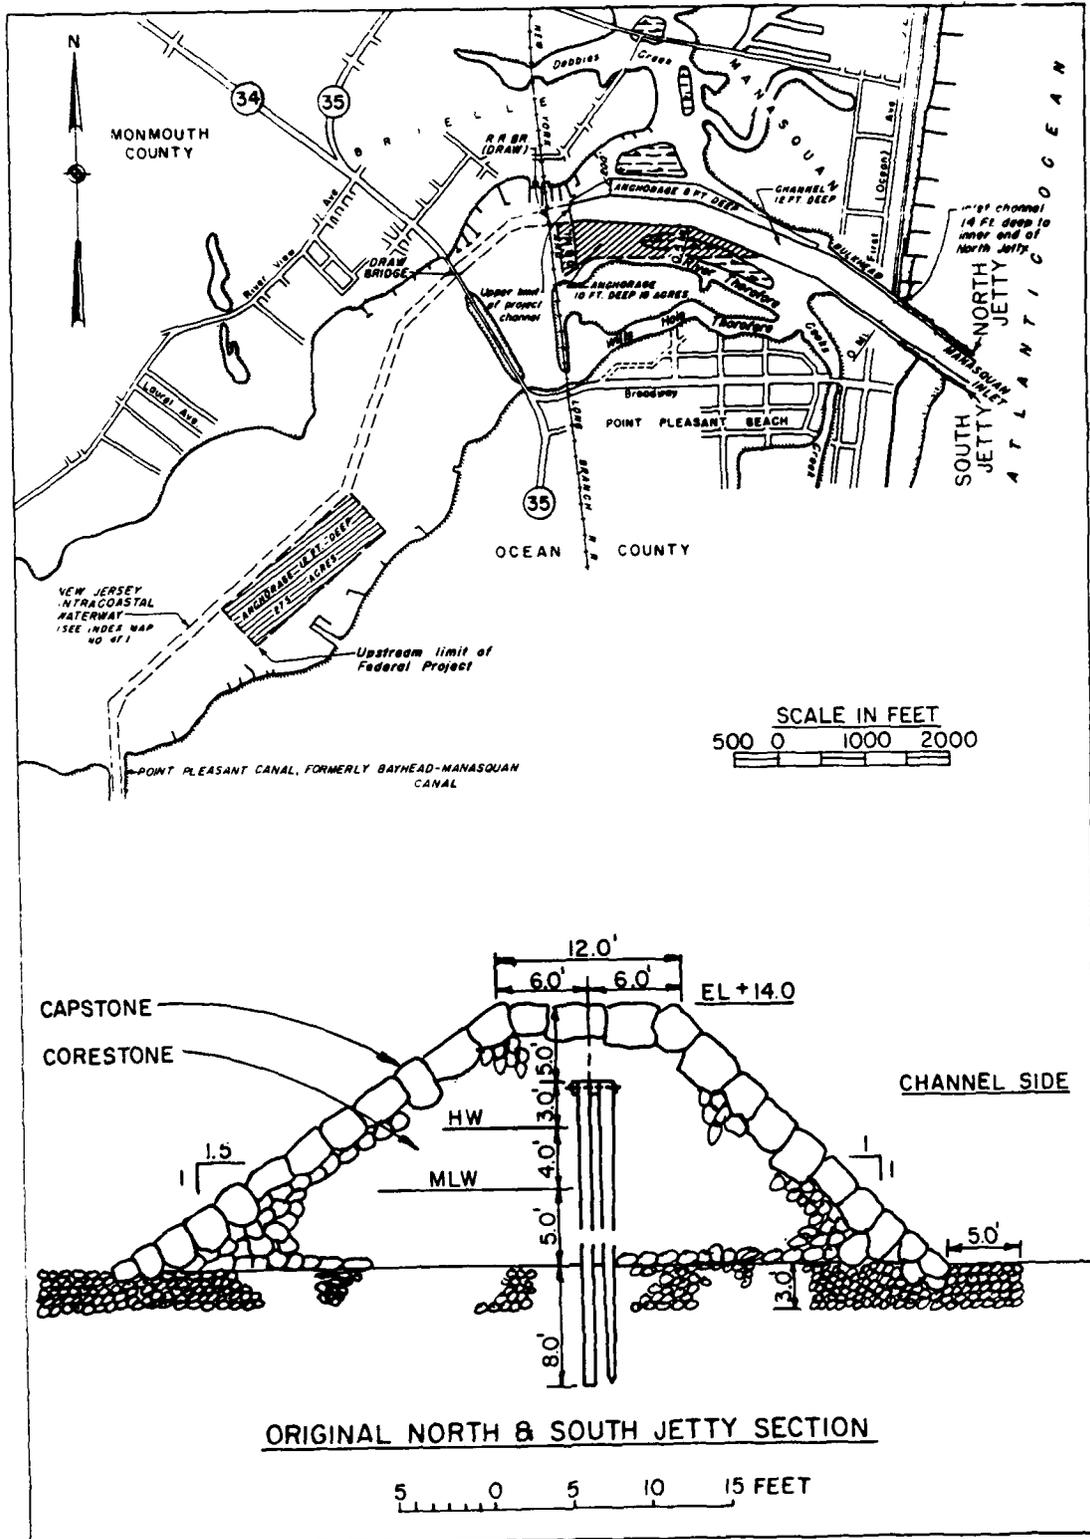
Figure 38. Manasquan River, New Jersey

<u>Date(s)</u>	<u>Construction and Rehabilitation History</u>
1882	A 1,515-ft-long timber jetty and dike was constructed north of the inlet.
1883	A timber jetty was constructed south of the inlet to a length of approximately 500 ft.
1886	The south jetty was flanked, and use of the inlet was seriously impaired.
1922	New timber jetties were constructed.
1924	The jetties were in a state of disrepair.
1930- 1931	Two rubble-mound jetties were constructed north and south of the inlet to replace the timber jetties and provide channel protection. The north jetty was 1,230 ft long, and the south jetty was 1,030 ft long. The jetties were spaced 400 ft apart and built to an elevation of +14 ft mlw, with a 12.0-ft crown width and side slopes of 1V:1.5H on the ocean side, and 1V:1H on the channel side (Figure 38). Capstone was 2.0 ton, and core stone ranged from 100 to 500 lb.
1946	Both jetties were rehabilitated using 5,190 tons of capstone, 2,886 tons of corestone, and 628 cu yd of grout. The cost of rehabilitation was \$56,778.

1955	The north jetty was rehabilitated using 5,400 tons of stone at a cost of \$128,597.
1959	The south jetty was rehabilitated using 12.0-ton capstone at a cost of \$67,048.
1977	The seaward 100 ft and 60 ft of the north and south jetties, respectively, were destroyed through continued displacement of armor stone and loss of structural integrity. The south jetty was damaged from the seaward end to 700 ft shoreward. Sand passed from the south jetty fillet through and over the jetty into the inlet.
1979- 1982	Both jetties were rehabilitated using dolosse. Sand and displaced stone were excavated and reshaped to design configuration before dolosse placement. Sixteen-ton dolosse were placed along the seaward 400 ft on the north side of the south jetty, around the jetty head, and along the seaward 50 ft on the south side. The dolosse extended to -10 ft mlw on the channel side, with side slopes of 1V:2H, and front slopes of 1V:3H. The seaward 400 ft was concrete capped, 20 ft wide, and was built at an elevation of +14 ft mlw. Sixteen-ton dolosse were placed along the seaward 250 ft on the north side of the north jetty, around the jetty head, and along the seaward 90 ft on

Date(s)	Construction and Rehabilitation History
1979- 1982 (Cont.)	the south side. The seaward 240 ft was concrete capped, 35 ft wide at the seaward end and 20 ft wide elsewhere. Capstone was placed shoreward of the dolosse section, 375 ft on the north side and crest, and 90 ft on the south side. Capstone size decreased in the shoreward direction from 12.0 to 3.0 to 5.0 tons. Design wave height was 25.0 ft. An aerial photograph of the rehabilitation is shown in Figure 39.
1985	The jetties were subjected to several storms after the 1982 rehabilitation, including a design level storm in March 1984. Photogrammetric monitoring of the structures under the Monitoring of Completed Coastal Projects (MCCP) Program indicated the last rehabilitation of the jetties has been fully successful to date.

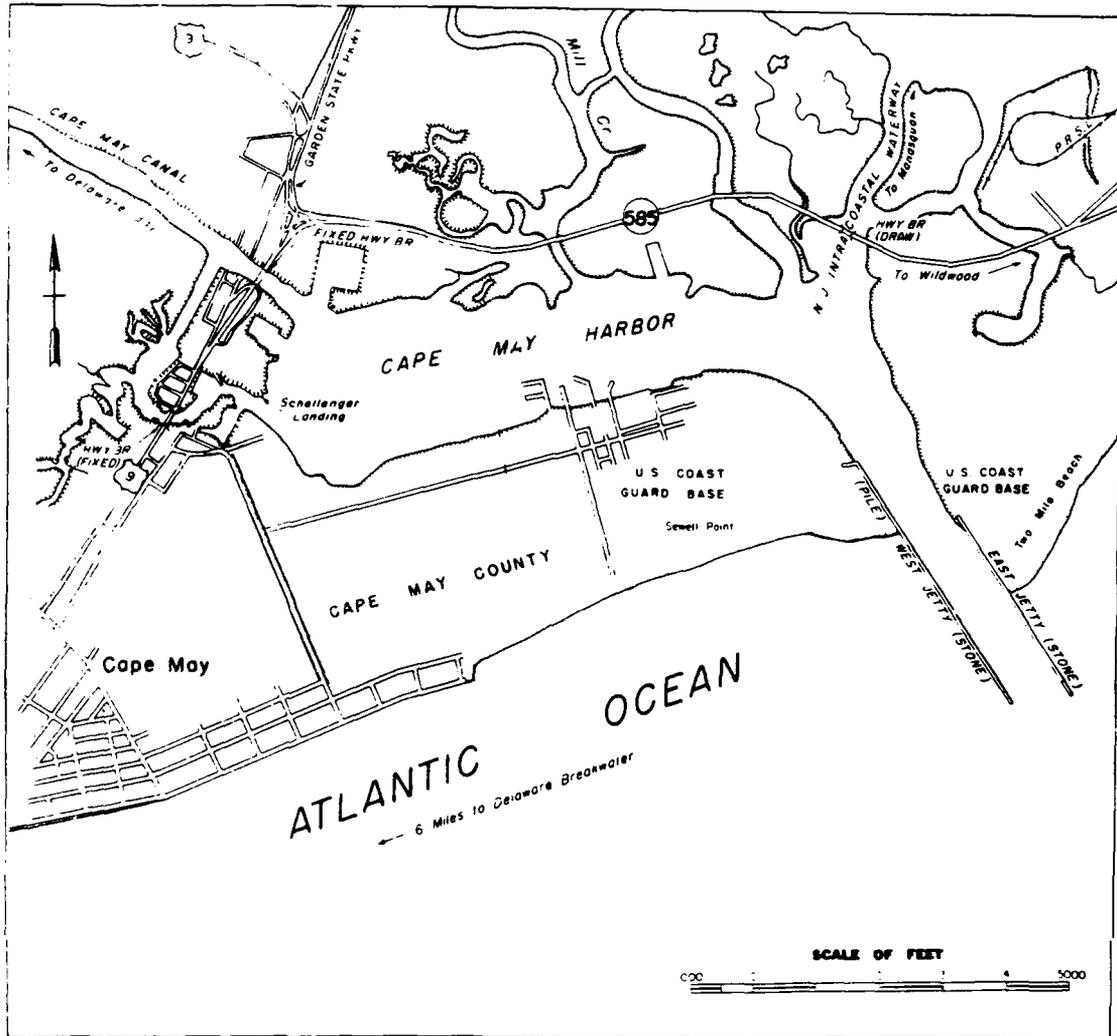
Figure 46. Cold Spring Inlet, New Jersey

<u>Date(s)</u>	<u>Construction and Rehabilitation History</u>
1911	Construction was completed on two parallel jetties 850 ft apart, on the east and west sides of the inlet. Lengths were approximately 4,548 ft and 4,410 ft east and west, respectively (Figure 46). Crest elevations were +10 ft mlw, crown widths varied from 6.0 to 15.0 ft, and side slopes were generally 1V:1.5H. A total of 326,049 tons of stone was used. Shoreward wing lengths were 750 ft and 297 ft east and west, respectively. Wings of both jetties and the shoreward 2,000 ft of the west jetty were constructed of stone-filled pile and timber. The remainder of the west jetty and the entire east jetty were rubble mound.
1915	Repairs were made by placing 8,497 tons of stone at a cost of \$24,810.
1916	Repairs were made by placing 9,023 tons of stone at a cost of \$31,816.
1917	Repairs were made by placing 1,500 tons of stone.
1922	An unknown quantity of stone was placed at a cost of \$5,410.

1923	The seaward 368 ft of the west jetty was repaired with concrete blocks and stone. The shoreward 1,572 ft of the west jetty was grout-sealed.
1927	Repairs were made by placing 10,424 tons of stone at a cost of \$63,884.
1946	Repairs were made by placing 519 tons of stone at a cost of \$12,072.
1948	Dolphin and jetty repairs were made at a cost of \$6,204.
1949	Repairs were made by placing 235 tons of stone at a cost of \$3,416.
1964	Jetties were rehabilitated at a cost of \$174,879.
1979	Jetties were rehabilitated at a cost of \$197,891.
1986	No further repair information is available. Figure 47 is an aerial photograph of the jetties in 1982.

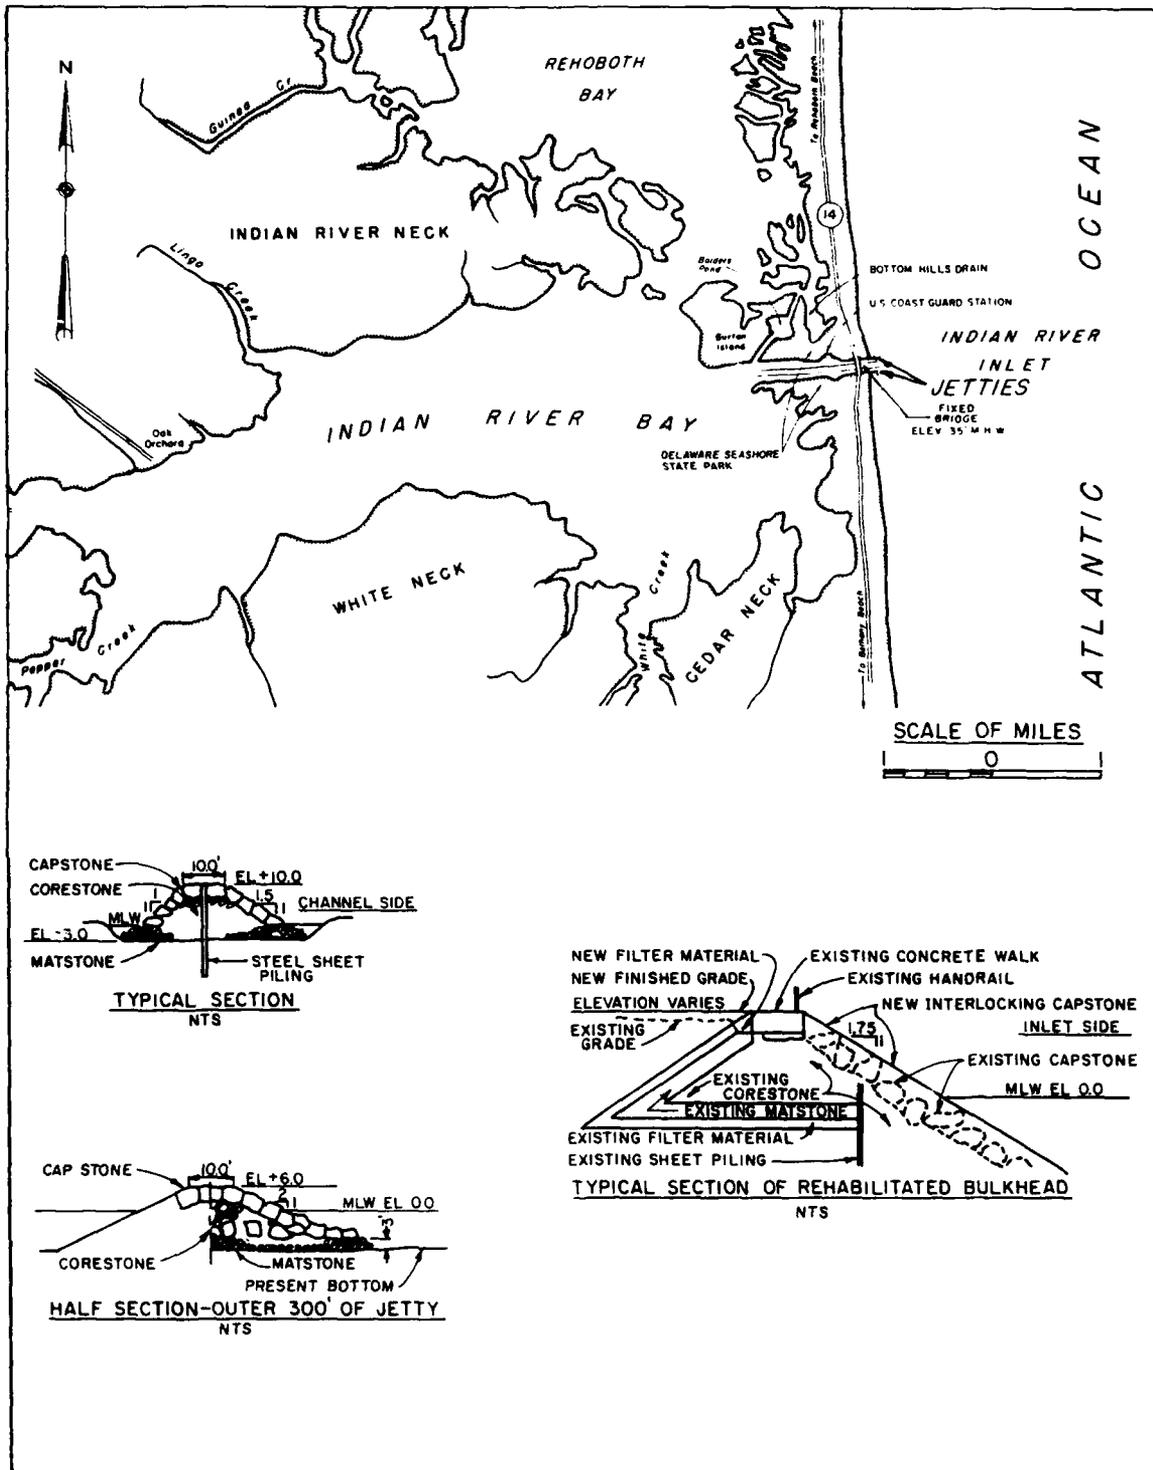
Figure 49. Indian River Inlet, Delaware

<u>Date(s)</u>	<u>Construction and Rehabilitation History</u>
1939	Two parallel jetties were completed to provide inlet protection. The jetties were 1,566 ft long and 500 ft apart. The shoreward 904 ft and 890 ft of the north and south jetties, respectively, were constructed of steel sheet pile, and the seaward portions were constructed of stone. The stone jetties had a crest elevation of +6.0 ft mlw, a crown width of 10.0 ft, and side slopes of 1V:1.5H (Figure 49).
1956	Storm damages to the south jetty were repaired.
1957	The north jetty was repaired because of storm damages and was extended shoreward 320 ft because of shoreline recession and deterioration of the sheet pile (Figure 49).
1985	The jetty heads are in poor condition because of slope failure, subsidence, and toe scour. Repair alternatives have been proposed, and the use of dolosse has been suggested. Figure 50 is an aerial photograph of the jetties taken in 1985.

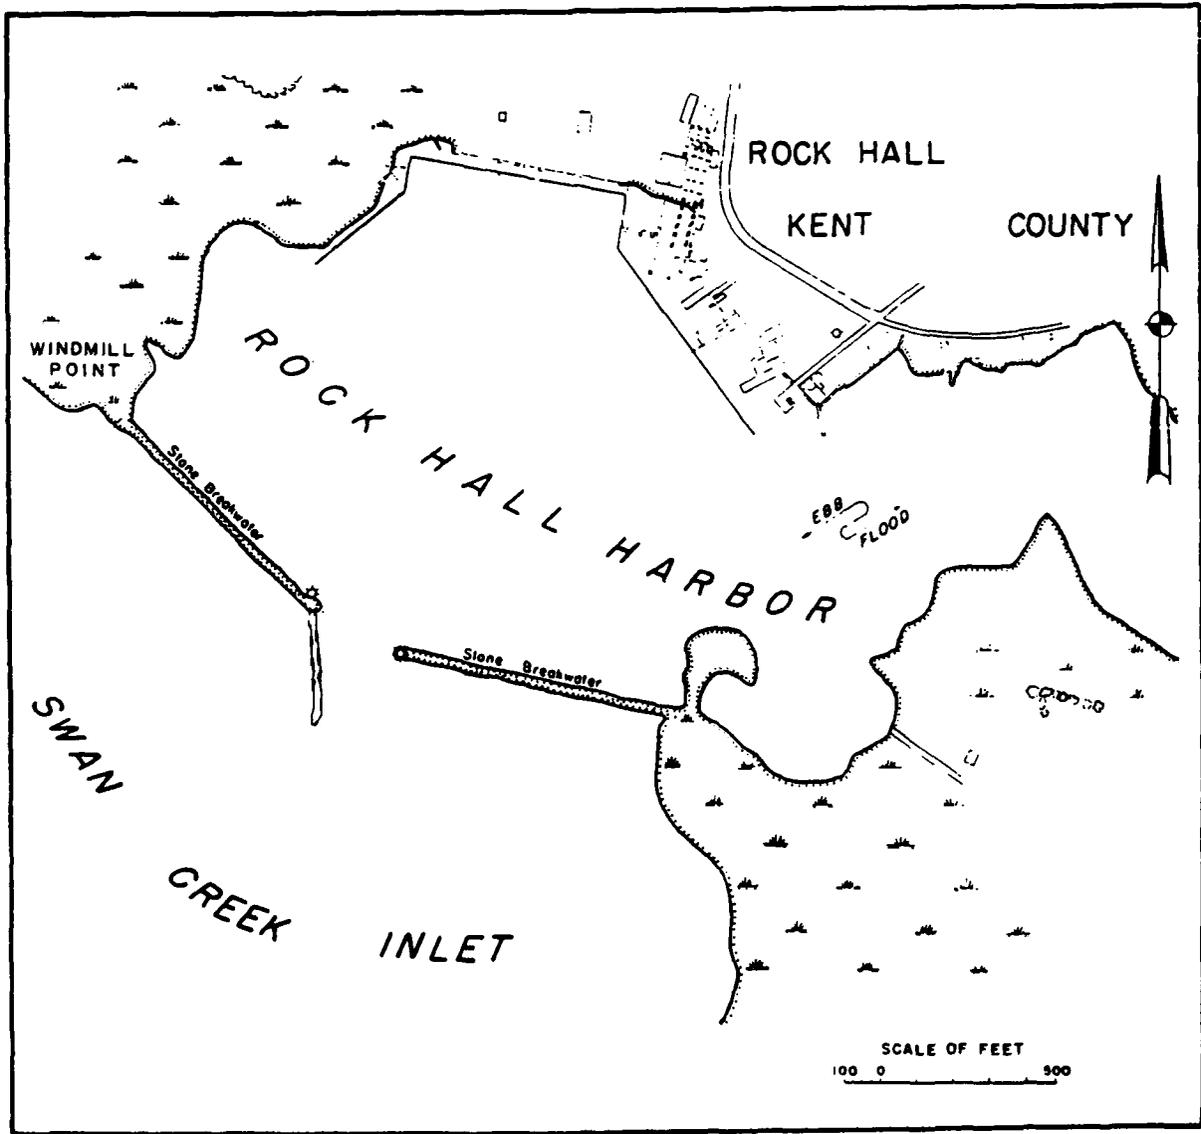
Figure 51. Rock Hall Harbor, Maryland

<u>Date(s)</u>	<u>Construction and Rehabilitation History</u>
1939	Two breakwaters were constructed with 8,400 tons of stone. Lengths of the breakwaters were 850 ft and 700 ft east and west, respectively (Figure 51). Elevations of the breakwaters were +4.0 ft mlw, with a single capstone, crown width of 4.0 ft, and side slopes of 1V:1.5H.
1964	Repairs were made on both breakwaters to restore them to original design geometry. The east breakwater was in good condition with crest subsidence of less than 0.5 ft. The majority of the repairs were made on the west breakwater. The landward 80 ft had subsided up to 2.0 ft, the seaward 50 ft had subsided to mlw, and the adjacent 380 ft had subsided 1.0 to 2.5 ft. The landward ends of both breakwaters were repaired with 250- to 500-lb stone. A 40-ft extension was added to the west breakwater (Figure 51), and the outer 220 ft, including the extension, were repaired with 1,000 to 2,000-lb cover and core stone. The adjacent 260 ft were raised by filling the existing section with additional core stone.

1982	Extensive rehabilitation was done to both breakwaters due to wave transmission and overtopping causing excessive wave heights (greater than 4.0 ft) in the inner harbor. Estimated cost of the rehabilitation was \$1,800,000 and required over 27,000 tons of stone. Crown elevation was raised to +7.0 ft mlw, crown width was widened to 8.0 ft with three capstones, and side slopes remained 1V:1.5H requiring 12,400 tons of stone. The west breakwater was extended to 1,100 ft requiring 14,800 tons of stone. Cover stone used for rehabilitation ranged from 2,300 lb at the trunk to 2,800 lb at the head. Cross sections and location of the rehabilitation are shown in Figure 52.
1986	No further repair or maintenance information has been found.
