TECHNICAL REPORT REMR-CO-3

CASE HISTORIES OF CORPS BREAKWATER
AND JETTY STRUCTURES

Report 5

NORTH ATLANTIC DIVISION

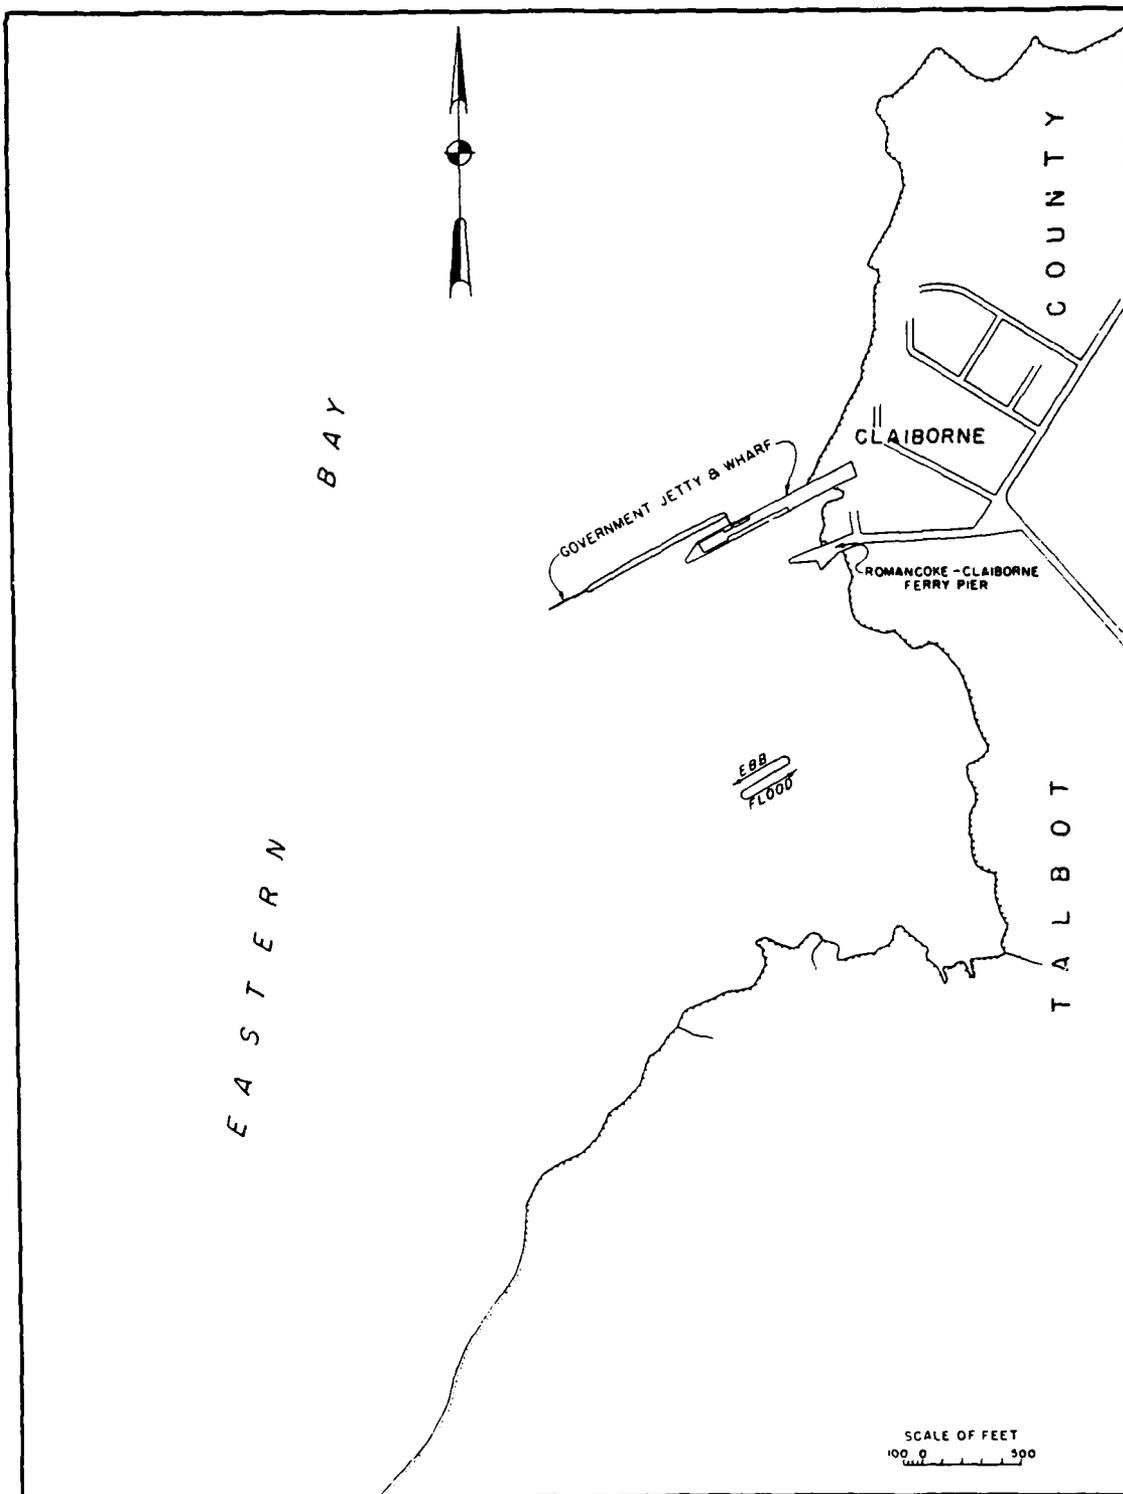
Figure 53. Claiborne Harbor, Maryland

<u>Date(s)</u>	<u>Construction and Rehabilitation History</u>
1888	A 750-ft-long slag jetty was constructed by a railway company at Claiborne Harbor.
1912	The jetty was extended 250 ft seaward as part of the federal project and was constructed of timber piles (Figure 53).
1928	The timber pile extension was in poor condition and was missing a seaward section.
1970's	The jetty was repaired, and revetment was placed around the jetty and wharf area of the harbor by non-Federal interests.
1978	A report recommended removal of deteriorated timber piles.
1981	A survey indicated the jetty was in excellent condition.
1986	Plans are complete for jetty rehabilitation. No details are available.

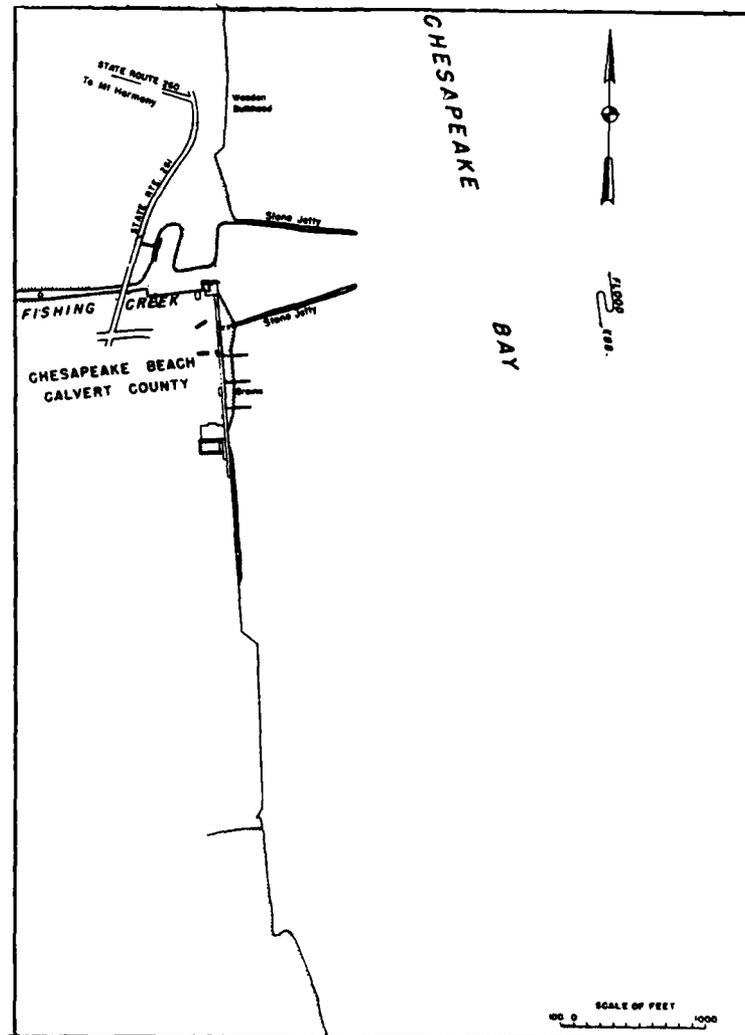
Figure 56. Fishing Creek, Maryland

<u>Date(s)</u>	<u>Construction and Rehabilitation History</u>
1941-1942	Two converging stone jetties were constructed to lengths of 1,050 and 1,100 ft north and south, respectively (Figure 56). Crown elevation was +4.0 ft mlw, crown width was 4.0 ft, and side slopes were 1V:1.5H.
1981	A survey revealed that both jetties were in good condition with minor settlement and some displaced stone.
1985	Plans call for sand tightening of the jetties with 2,100 to 3,500 lb of cover stone, 20 to 100 lb of core stone, and 1.0 to 20 lb of bedding stone.

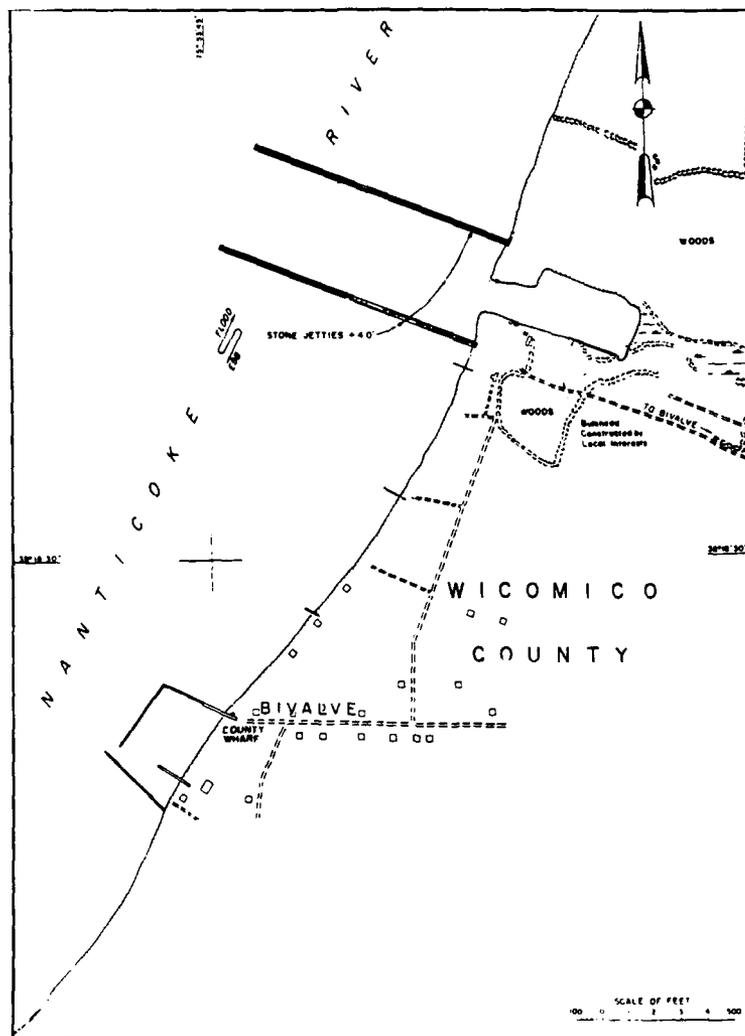
Figure 58. Nanticoke River at Bivalve, Maryland

<u>Date(s)</u>	<u>Construction and Rehabilitation History</u>
1960	Two jetties were constructed at lengths of 1,050 ft each and spaced 400 ft apart (Figure 58). Crown elevation was +4.0 ft mlw, crown width was 4.0 ft with a single capstone, and side slopes were 1V:2H. Minimum coverstone weight was 1.5 tons, and corestone ranged from 15 to 500 lb with a 1.0-ft-thick bedding layer. Design wave height was 7.0 ft.
1985	Both jetties are in excellent condition; however, present shoaling in the channel may be due to sand passing through the jetties.

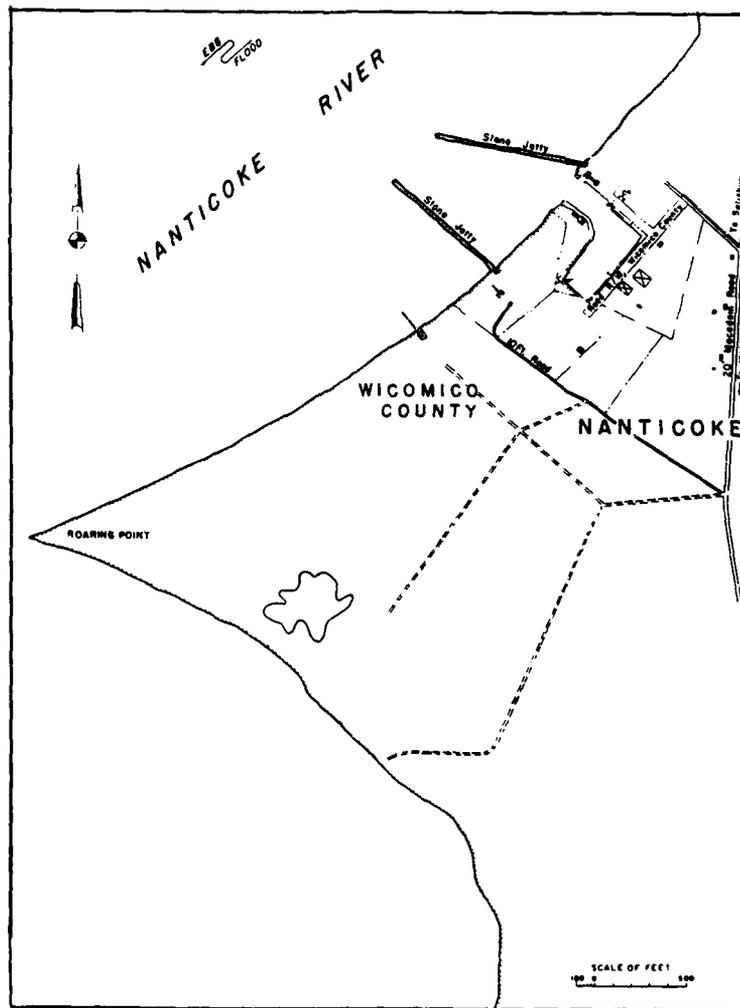
Figure 59. Nanticoke River at Nanticoke, Maryland

<u>Date(s)</u>	<u>Construction and Rehabilitation History</u>
1938	Two converging stone jetties were constructed at lengths of 850 ft and 750 ft north and south, respectively (Figure 59). Crown elevation was +5.0 ft mlw, crown width was 4.0 ft, with a single capstone, and side slopes were 1V:1.5H. A post-construction survey showed little deviation from the design elevation.
1944	A survey of the jetties indicated little change in crown elevation.
1981	A survey indicated both jetties were in excellent condition.
1986	No further repair or maintenance information has been found.

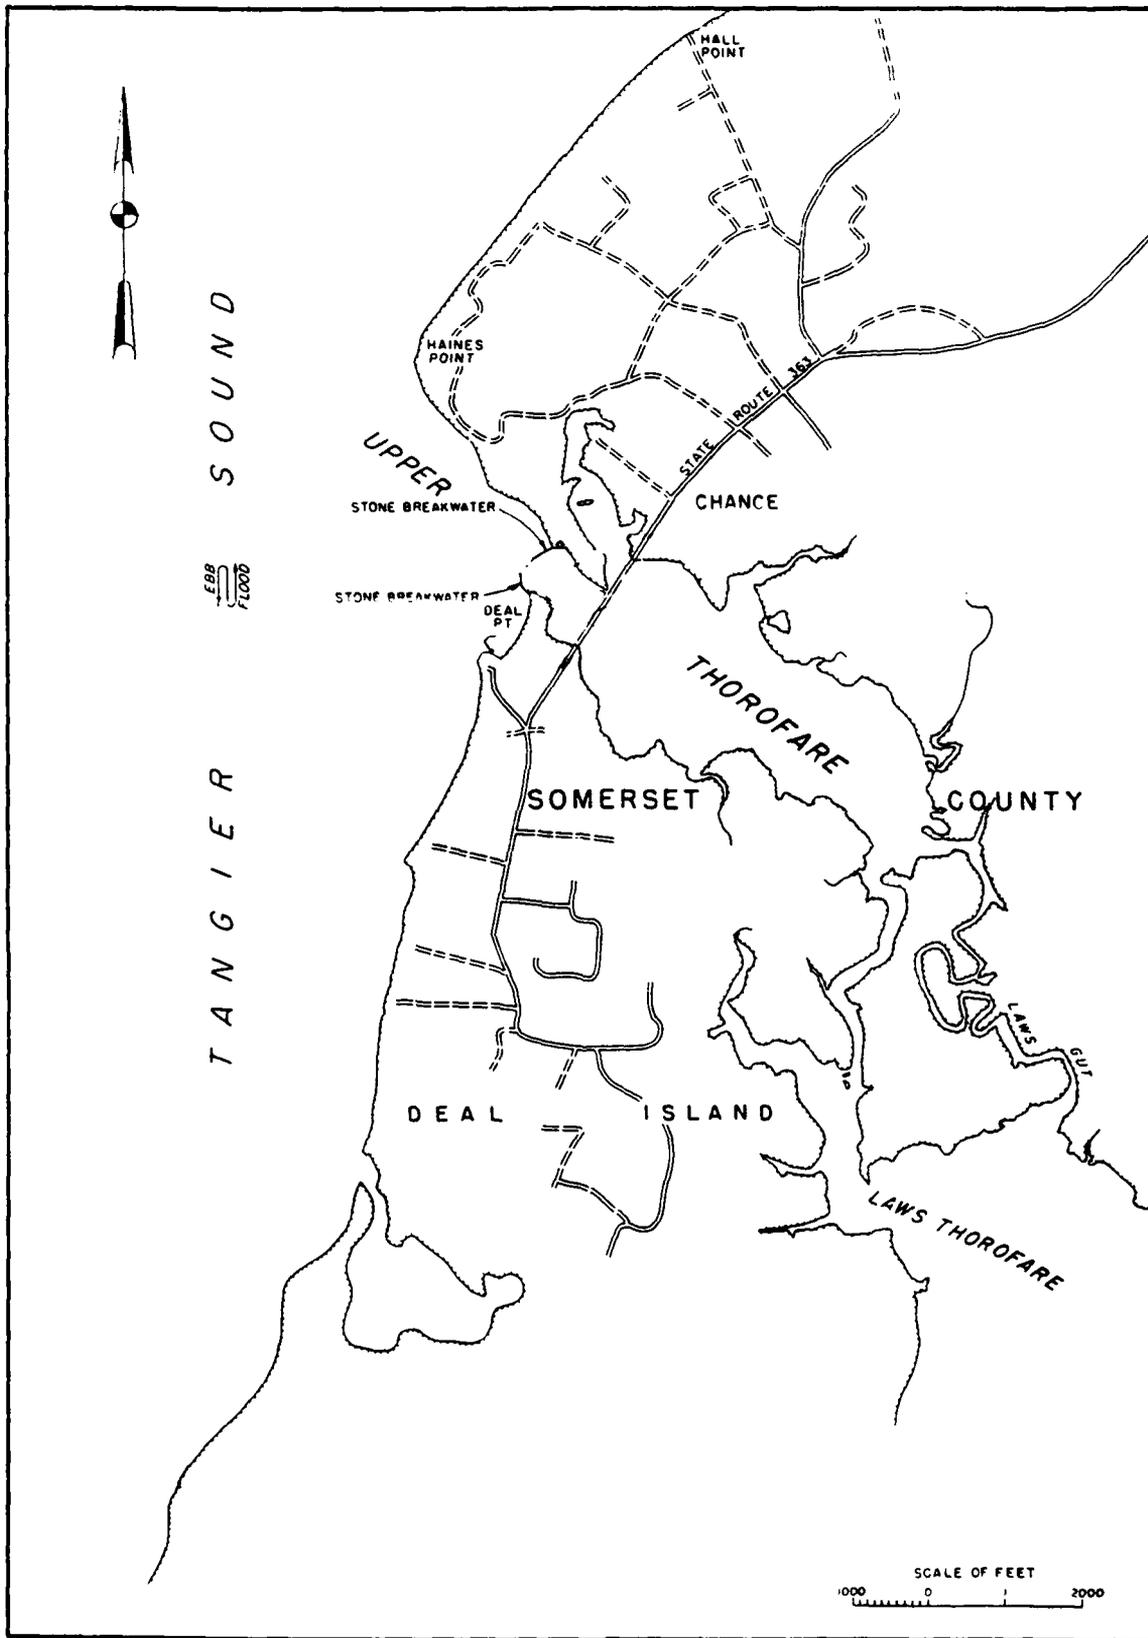
Figure 60. Upper Thorofare, Maryland

<u>Date(s)</u>	<u>Construction and Rehabilitation History</u>
1934	Two stone breakwaters were constructed with 3,650 tons of stone at an estimated cost of \$9,000. The north breakwater was 410 ft long. The south breakwater was 310 ft long. The seaward ends were 180 ft apart (Figure 60). Crest elevations were +7.0 ft mlw, except the landward 142 ft of the south breakwater which was from +5.0 to +6.5 mlw. Crown width was 4.0 ft, and side slopes were 1:1.
1966	Sand had accumulated around one-half to two-thirds of the landward end of the north breakwater. The south breakwater had an average subsidence of 2.0 ft and was repaired to raise the elevation to +7.0 ft mlw. Crown width was 4.0 ft, and side slopes were 1V:1.5H.
1981	A survey indicated the south breakwater was in excellent condition, although the midsection appeared to have subsided 1.0 ft. The north breakwater was almost completely surrounded by sand, and future shoaling of the channel was foreseen. The north breakwater appeared to have subsided 1.0 ft from the original design elevation.

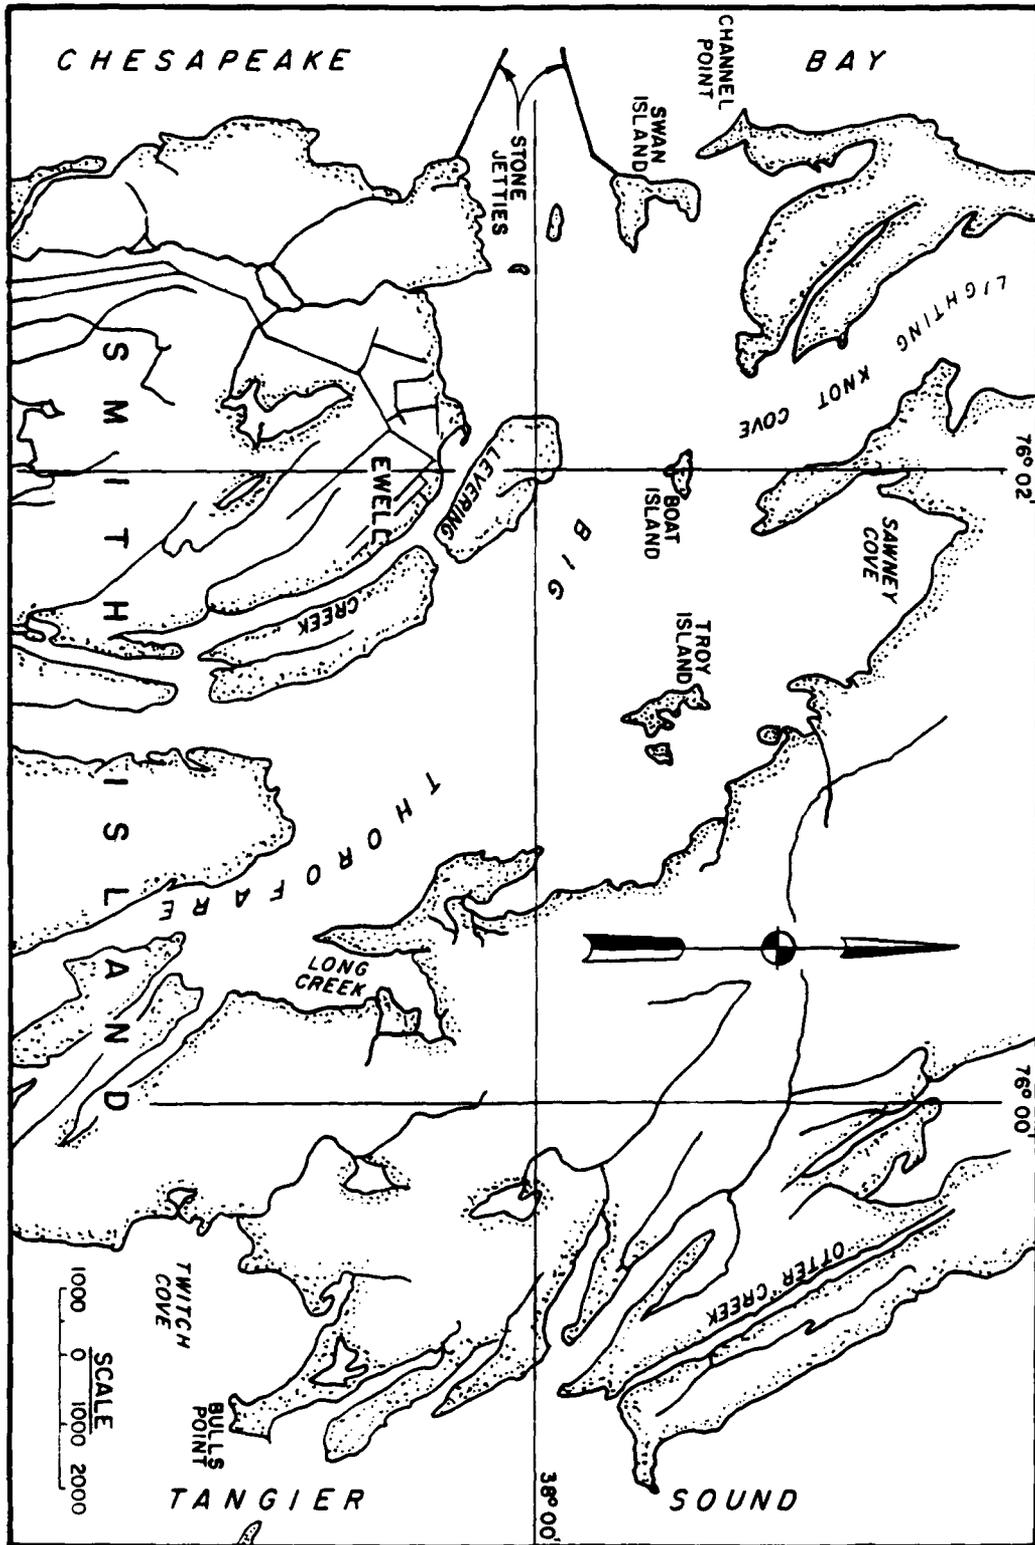
Figure 61. Twitch Cove and Big Thorofare River, Maryland

<u>Date(s)</u>	<u>Construction and Rehabilitation History</u>
1940	Two converging stone jetties were constructed with 23,000 tons of stone at a cost of \$112,000 (Figure 61). The north jetty was 2,070 ft long, and the south jetty was 1,800 ft long. The design section included a crown elevation of +4.0 ft mlw, a crown width of 2.0 ft with the exception of the seaward 120 ft of the north jetty which was 4.0 ft, and side slopes of 1V:2H, except for the bay side of the north jetty which was designed for 1:1 along the landward 1,950 ft. No stone size details were given; however, a 1981 survey indicated the side slope stone was approximately 1.5 tons, and the core was of similar stone. The survey also revealed the single cap-stone ranged from 2.0 to 3.0 tons. No apron or bedding was placed during construction or subsequent repairs.
1945	A condition survey was performed which indicated the north jetty was in a severe state of deterioration. The seaward 1,300 ft of this jetty had a typical subsidence of 0.5 ft below the original elevation, and the seaward 300 ft of this section had a range of subsidence of 2.0 to 4.0 ft. The south jetty was flanked, and the seaward 400 ft of the south jetty had subsided 0.5 to 1.5 ft. The seaward end of this section had subsided below mlw. Toe areas had scoured from -5.0 to -7.0 ft mlw.

1952	A condition survey was made on the north jetty. The seaward 570 ft had a range of subsidence from 2.0 to 5.0 ft, and 700 ft landward of this section had subsided 1.0 to 2.0 ft. Jetty cross sections indicated most of the subsidence occurred on the bay side. Repairs were made to the seaward 1,030 ft of the north jetty using original design geometry to raise the crest elevation to +3.0 ft mlw. The cost of the repairs and dredging was \$33,000.
1955- 1956	A condition survey performed on the south jetty indicated an average subsidence of 0.5 ft over the entire length. The seaward 300 ft had subsided 2.0 to 4.0 ft, and a length of 80 ft had subsided near the landward end. Areas of subsidence were typically 1.0 to 2.0 ft below adjacent sections. Repair work began in 1956 to raise the crest elevation to +3.5 ft mlw using original design geometry. Approximately 1,000 tons of stone were used at a cost of about \$35,000 which included dredging. Toe areas had scoured to -9.0 ft mlw.

1962	Both jetties were surveyed and repaired with 2,200 tons of stone for approximately \$64,500. The north jetty had been flanked on the landward end, and elevations of the seaward 520 ft ranged from +1.0 to +3.0 ft mlw. The seaward 180 ft of the south jetty had elevations ranging from 0.0 to +4.0 ft mlw. The above sections were repaired to

Date(s)	Construction and Rehabilitation History
1962 (Cont.)	a crown elevation of +4.0 ft mlw, with a 2.0-ft crown width, except the seaward 70 ft of the north jetty was 4.0 ft. The side slopes were 1V:2H. The landward end of the north jetty was extended 120 ft. Voids along the remainder of the jetties were repaired by placing and resetting existing stone at existing section elevations. The depth at the toes of the jetties ranged from 10.0 to 12.0 ft mlw.
1981	<p>A survey report indicates both jetties are in "poor" condition. The seaward end of the north jetty and the landward ends of both jetties were flanked, and there were numerous areas of subsidence along their lengths. It is believed that scour is the reason for their deterioration for the following reasons:</p> <ul style="list-style-type: none"> -- Existence of a homogeneous cross section (no smaller core placed). -- No bedding stone or apron stone being placed during original construction or during repairs. -- Increase in depth from a range of 5.0 to 6.0 ft to a range of 10.0 to 12.0 ft mlw at the seaward ends. -- Landward ends of the jetties being flanked at present. Each has been flanked once and repaired since original construction. -- General susidence along the entire lengths of the jetties of 0.5 to 1.0 ft. -- Numerous voids or gaps where capstones were missing.

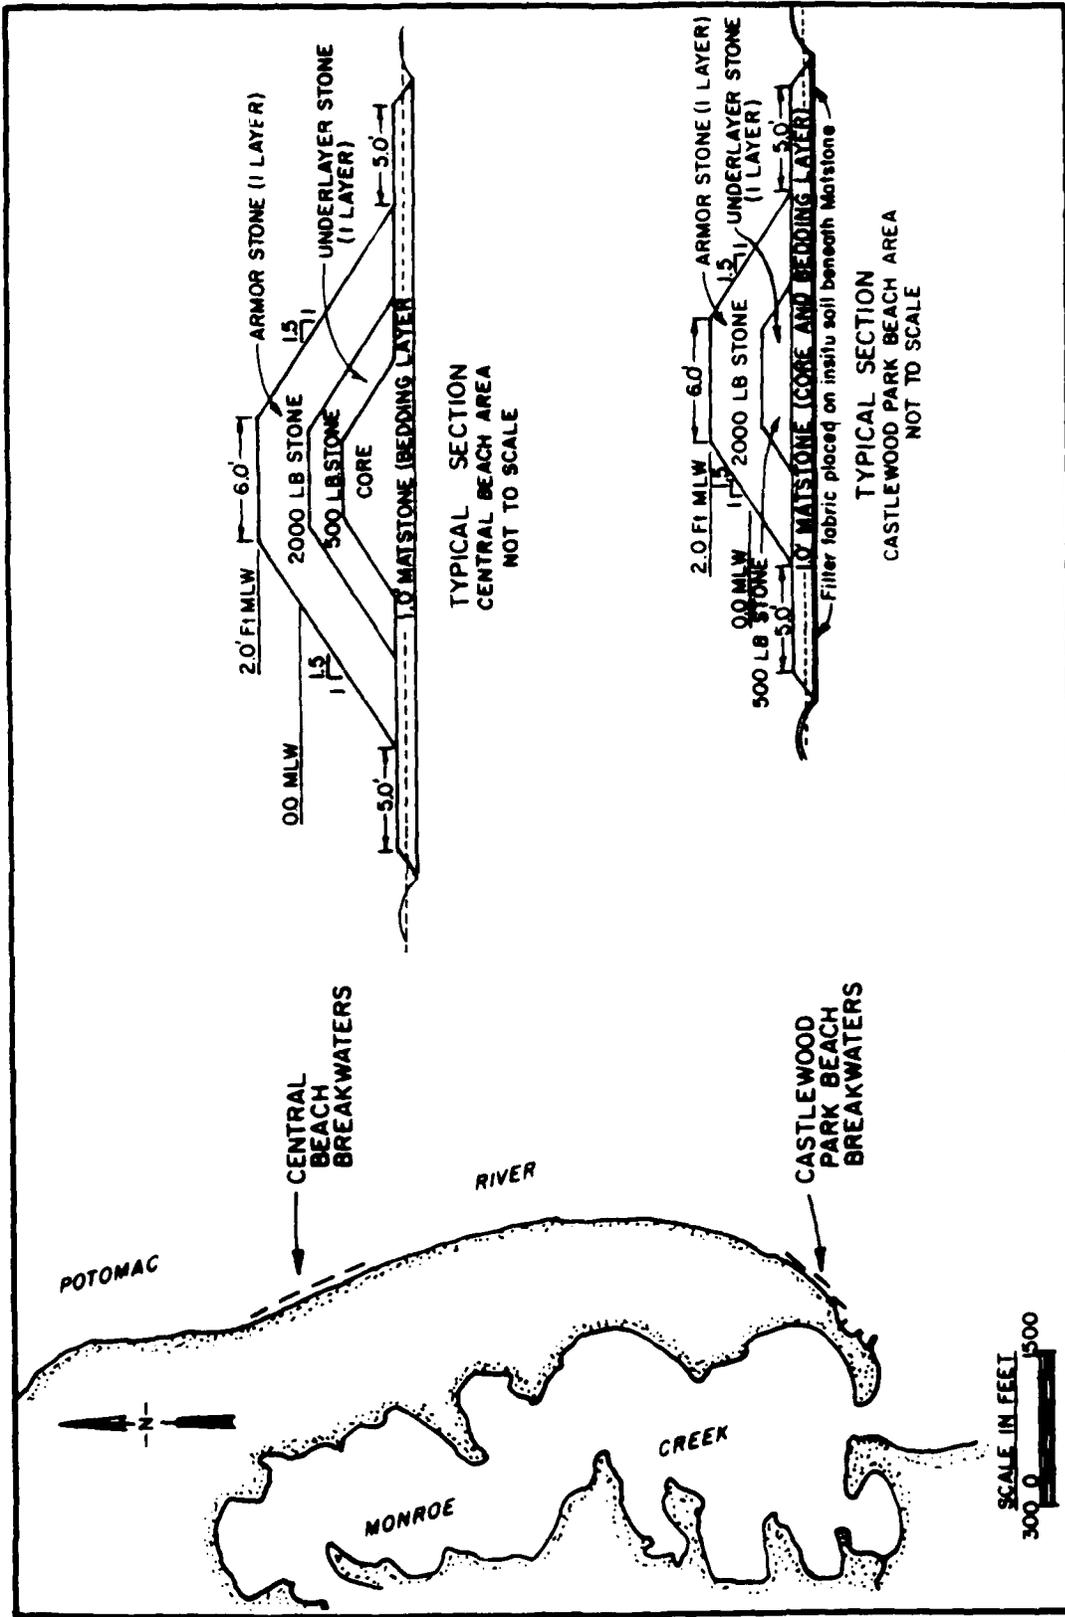
Figure 63. Colonial Beach, Virginia

<u>Date(s)</u>	<u>Construction and Rehabilitation History</u>
1982	Seven offshore breakwaters were constructed as part of a beach restoration project for approximately \$447,000, using over 9,000 tons of stone (Figure 63). One 300-ft breakwater and two 200-ft breakwaters were placed at Castlewood Beach, and four 200-ft breakwaters were placed at Central Beach. All were placed parallel to the shoreline and approximately 100 ft offshore, and they were separated by 150-ft gaps. Crest elevations were +3.0 ft mlw but allowed for settlement to +2.0 ft mlw. Crown widths were 6.0 ft, and side slopes were 1V:1.5H. One layer of 2,000-lb cover stone was placed over one layer of 500-lb underlayer resting on a core and 1 ft bedding layer. Design wave height was 6.0 ft.
1985	The breakwaters are in excellent condition and serving their intended function.

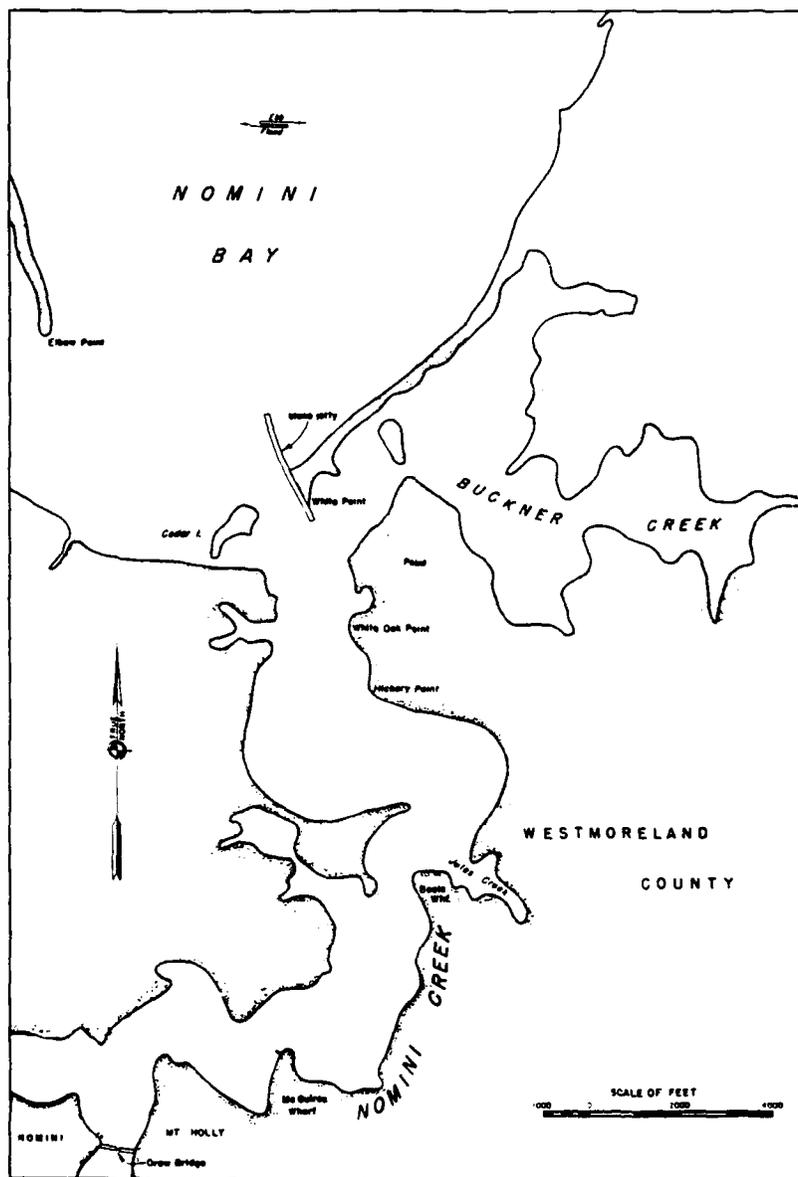
Figure 64. Nomini Bay and Creek, Virginia

<u>Date(s)</u>	<u>Construction and Rehabilitation History</u>
1912	A 2,410-ft-long stone jetty was completed (Figure 64).
1981	A survey indicated the jetty was in good condition.
1986	No further repair or maintenance information has been found.

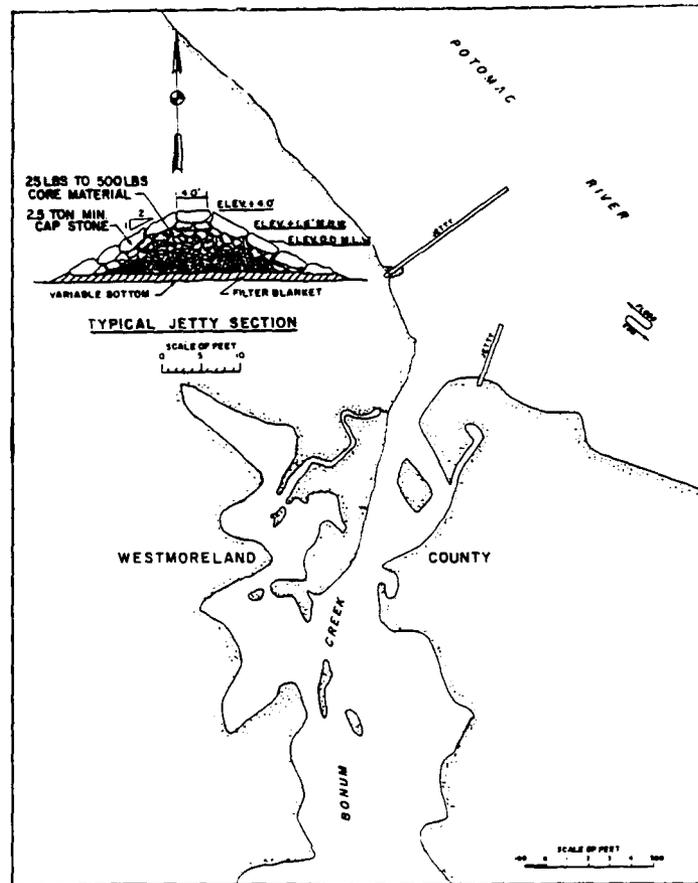
Figure 65. Bonum Creek, Virginia

<u>Date(s)</u>	<u>Construction and Rehabilitation History</u>
1968	Construction was completed on two stone jetties at an estimated cost of \$221,000 using 8,000 tons of stone. The north jetty was 800 ft long, and the south jetty was 300 ft long (Figure 65). Crown elevation was +4.0 ft mlw, crown width was 4.0 ft with a single capstone, and side slopes were 1V:2H. Cover stone used was 2.5 tons, and core stone ranged from 25 to 500 lb. Design wave height was 9.0 ft.
1981	A condition survey revealed that the jetties had undergone some settlement but were in good condition.
1986	No further repair or maintenance information has been found.

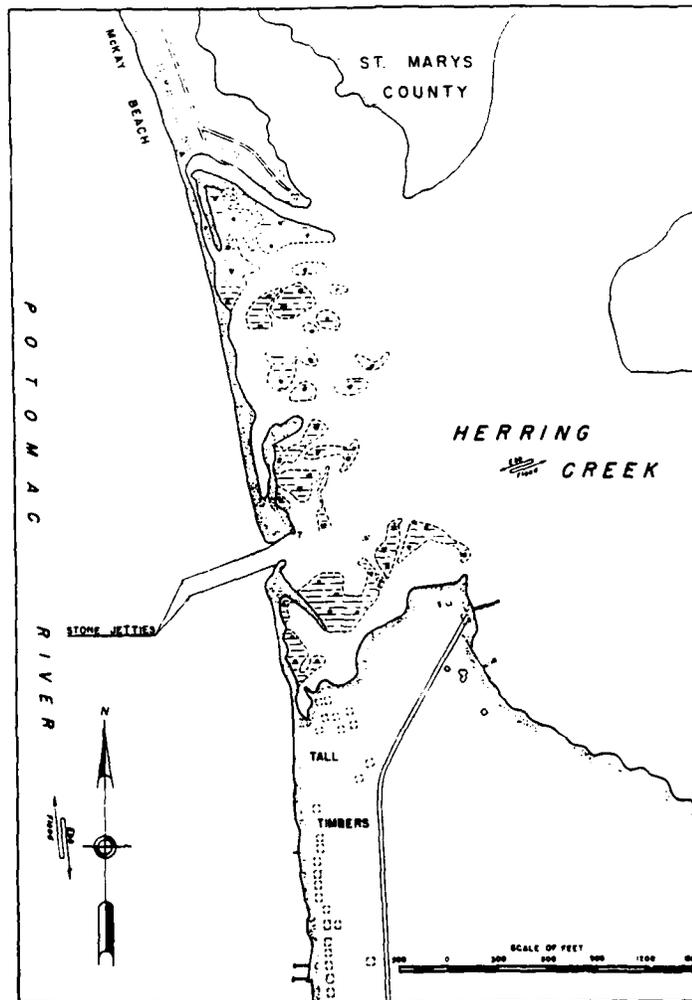
Figure 66. Herring Creek, Maryland

<u>Date(s)</u>	<u>Construction and Rehabilitation History</u>
1960-1961	Two jetties were constructed to 750- and 700-ft lengths north and south, respectively (Figure 66). Crown elevation was +4.5 ft mhw, crown width was 4.0 ft, and side slopes were 1V:2.5H. A 1.0-ft-thick bedding layer was placed, and a 1.0-ft-thick by 10.0-ft-wide apron was placed along both jetty toes.
1981	A survey indicated the jetties were in good condition with only minor settlement.
1986	No further repair or maintenance information has been found.

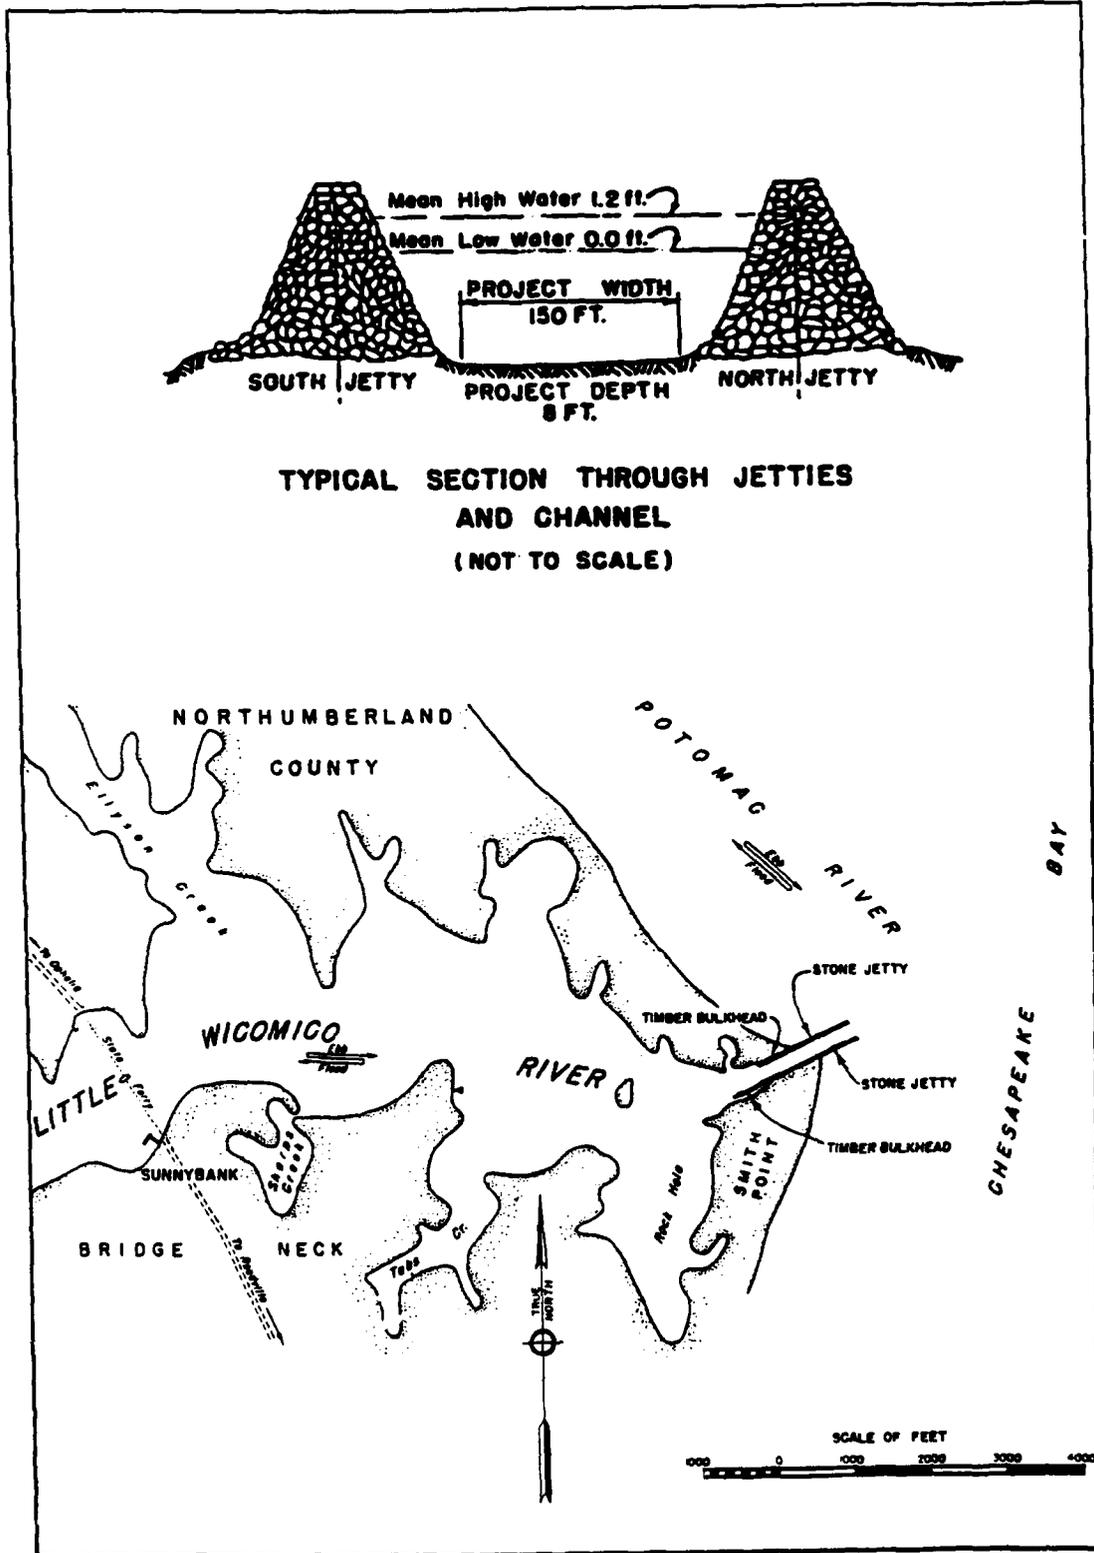
Figure 67. Little Wicomico River, Virginia

<u>Date(s)</u>	<u>Construction and Rehabilitation History</u>
1937	Two stone jetties were constructed to lengths of 1,000 and 1,300 ft north and south, respectively (Figure 67). Timber pile jetties were also placed at the landward ends of the stone jetties. Lengths of the timber piles were 357 ft north and 650 ft south.
1970	The north timber pile jetty was repaired at a cost of \$51,822.
1981	Survey of the jetties indicated the seaward 300 ft of each jetty had crown elevations ranging from -2.0 to +6.0 ft and no semblance of a crown width.
1985	The jetties were to be rehabilitated to minimize shoaling of the federal channel. The seaward 290 ft of each jetty was to be made sand tight by placing core stone and cover stone on the outer face at a 1-V:1.5-H slope. Crown elevation was to be +4.0 ft mlw, with a crown width up to 15.0 ft along the sections with crown elevations below +4.0 ft mlw. Toe protection was to be provided by a 2.0-ft-thick by 5.0-ft-wide extension of the core stone. A double layer of 1.0-ton cover stone was to be used. It is not known if the work was done.

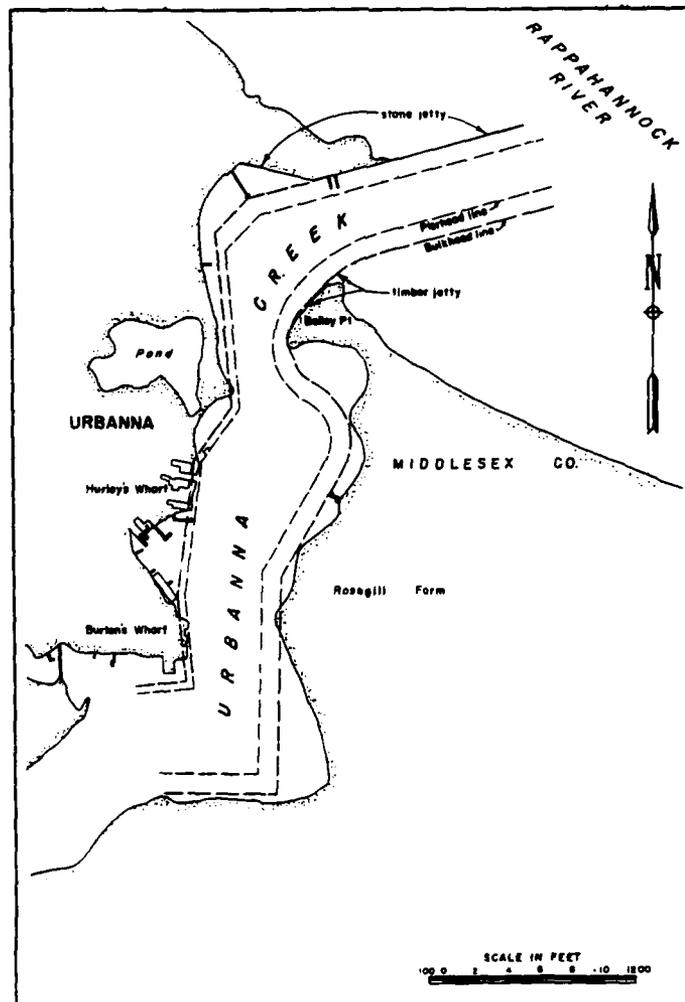
Figure 68. Urbanna Creek, Virginia

<u>Date(s)</u>	<u>Construction and Rehabilitation History</u>
1956	Two jetties were constructed for channel control. The north jetty, 1,895 ft long, was rubble mound. The 717-ft-long south jetty was built of timber (Figure 68).
1962	The north jetty was rehabilitated.
1986	No further repair or maintenance information has been found.

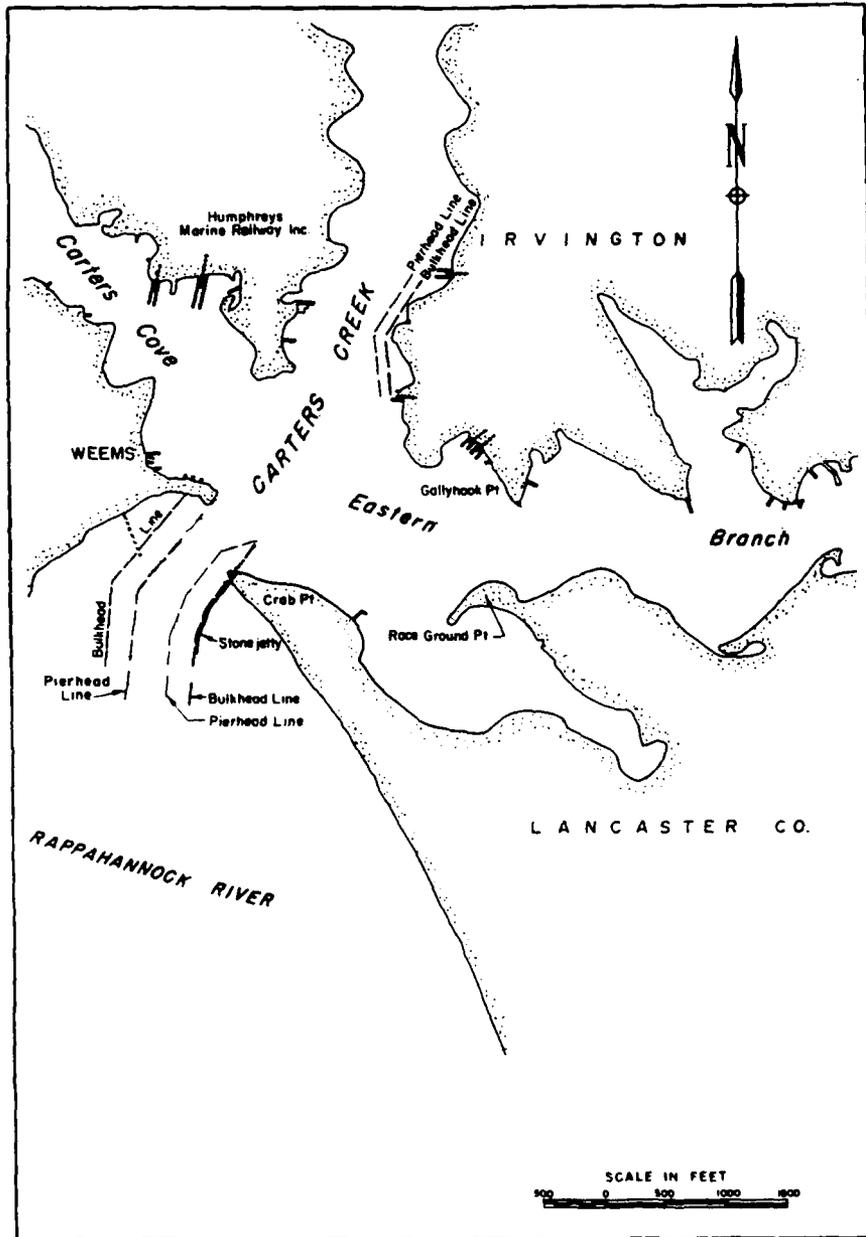
Figure 69. Carters Creek, Virginia

<u>Date(s)</u>	<u>Construction and Rehabilitation History</u>
1902-1906	A 742-ft-long rubble-mound jetty was built to provide channel control (Figure 69).
1986	No further repair or maintenance information has been found.

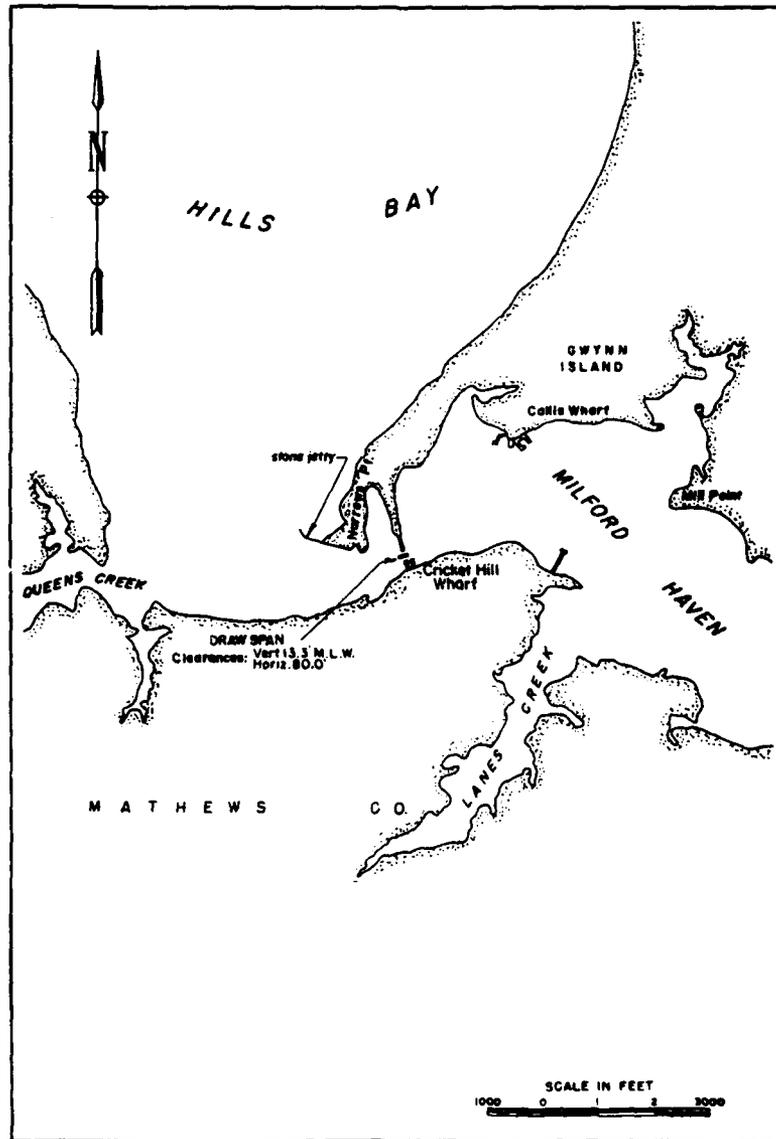
Figure 70. Milford Haven, Virginia

<u>Date(s)</u>	<u>Construction and Rehabilitation History</u>
1913	A 1,183-ft-long rubble-mound jetty was constructed to provide channel control (Figure 70).
1986	No further repair or maintenance information has been found.

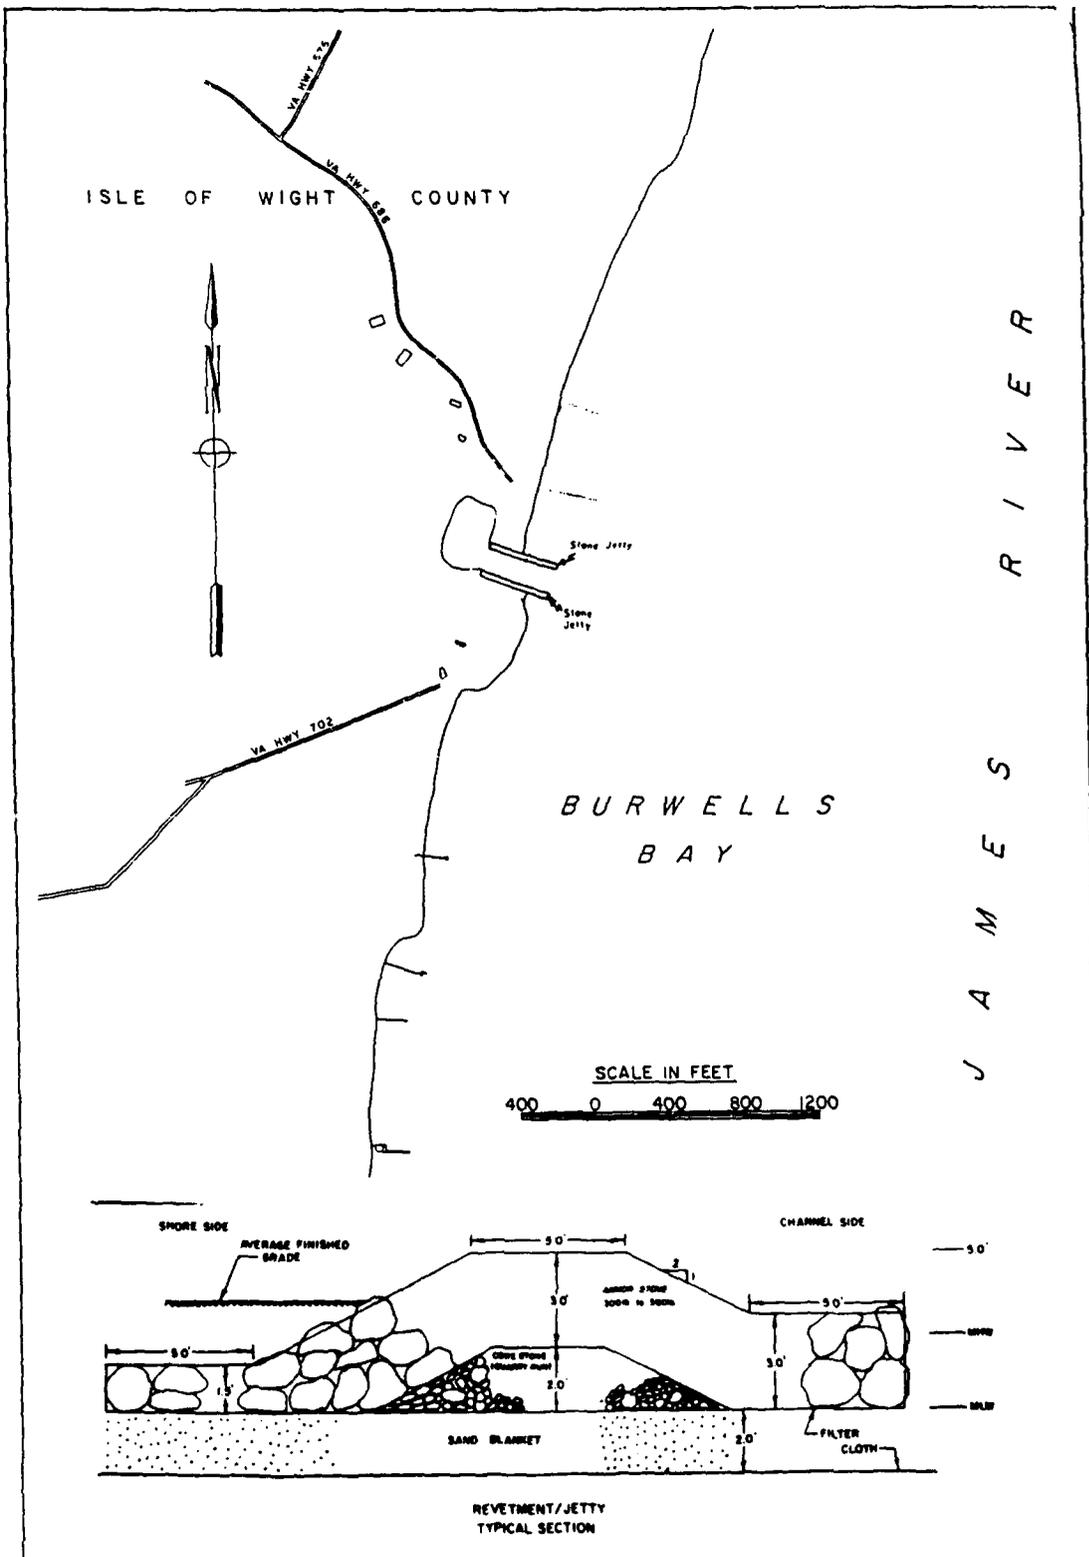
Figure 71. Tylers Beach, Virginia

<u>Date(s)</u>	<u>Construction and Rehabilitation History</u>
1981	Two parallel rubble-mound jetties were constructed to provide channel control. Both jetties were 370 ft in length and spaced 120 ft apart (Figure 71). Crest elevation was +5.0 ft mlw but allowed for 0.5 to 1.0 settlement; crown width was 5.0 ft; and side slopes were 1V:2H. One layer of armor stone, 300 to 500 lb, was placed over one layer of core stone, 3.0 to 40 lb. The jetties rested on a 2.0-ft-thick sand blanket. The sand was encased by filter fabric. A 5.0-ft-wide, 1.5-ft-thick apron and a 5.0-ft-wide, 3.0-ft-thick apron were placed on the shore and channel sides, respectively (Figure 71). A 6.0-sec, 4.1-ft design wave was used. Estimated cost of construction was \$245,000.
1986	No further repair or maintenance information has been found.
