HISTORIC STANDING STRUCTURE  
INVESTIGATION OF THE SOURIS RIVER  
BASIN PROJECT RURAL IMPROVEMENTS

HISTORICAL RESEARCH ASSOCIATES

FINAL REPORT

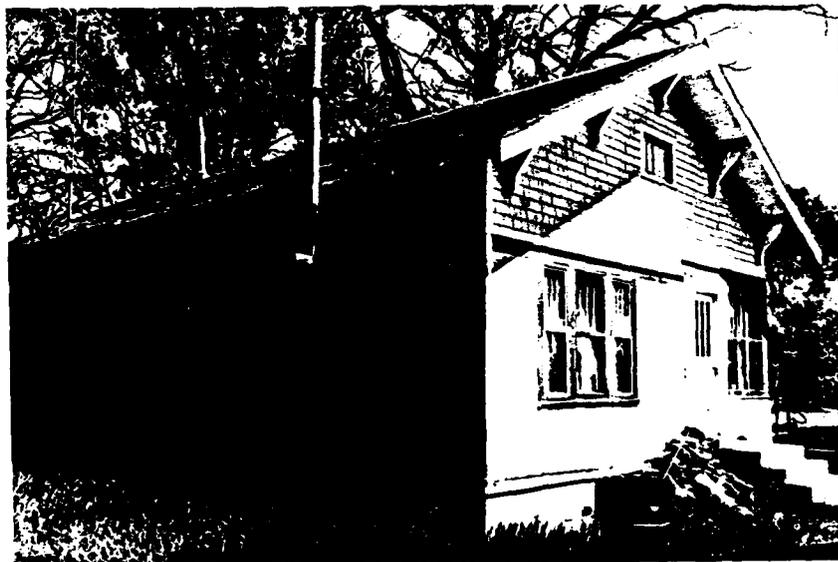
Feature 1 is a one story dwelling with a gable roof, wood shingles, and concrete foundation (Figure 9). Exterior siding materials are stucco on the lower two-thirds of the sides, and wood shingles on the remaining one-third. There is a metal stovepipe near the northern end in the center of the roof, and a metal woodstove pipe that exits near the southwest corner on the west exterior wall. On the west elevation are one 3/1 double-hung window, two three-lite fixed-pane windows, and one 3/1 double-hung window. The main entrance on south elevation has a single-entry door. On the west side of the door are three 3/1 double-hung windows and east of the door are two 3/1 double-hung windows. The east elevation of the structure has five 3/1 double-hung windows and one small 3/1 double-hung window. The north elevation has a single-entry door and two 3/1 double-hung windows. The feature was moved onto the site in the early 1970s. Thus, it has no integrity of association.

Figure 9. Looking northeast at Feature 1 of 32MH32 (HRA 121).

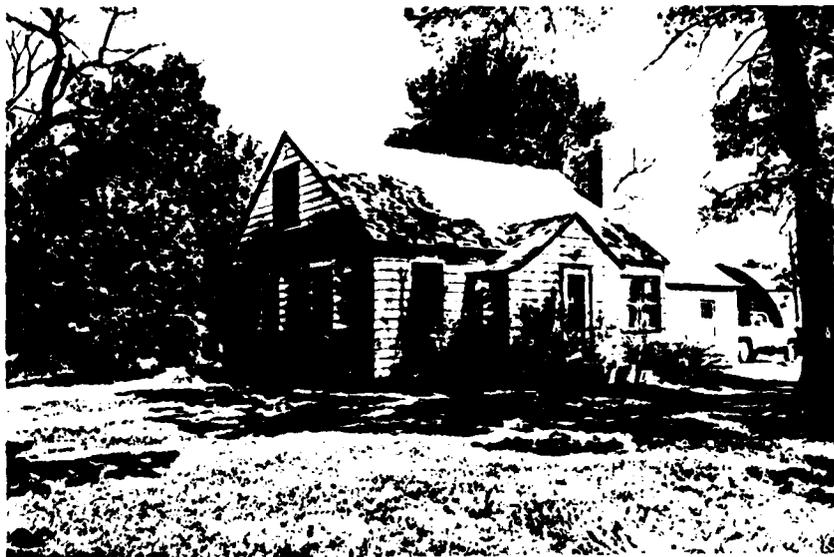
Feature 2 is a one and one-half story, gable-roofed residence with asphalt shingles and a one story gable-roofed addition on the east elevation (Figure 10). There is also a gable-roofed entry on the south elevation. The sides are covered with aluminum siding. Windows are 6/1 double-hung, with two on the west and three on the south elevations. There also is a single-entry door on the south elevation. There are two 6/1 double-hung windows on the east elevation of the main structure and two 6/6 double-hung windows on the south elevation of the addition. There is a single-entry door on the east elevation of the addition. There are two 6/6 double-hung windows on the north elevation of the addition and one 6/1 double-hung window on the north corner of the east elevation of the main structure. The south elevation of the main structure has two 6/1, one 1/1, and one 6/6 double-hung windows. The feature sits on a concrete pad foundation. Feature 2 was constructed in the early 1950s and has been extensively altered. Thus, it lacks integrity of association and does not meet the age requirements for listing on the National Register of Historic Places.

Figure 10. Looking northeast at Feature 2 of 32MH32 (HRA 121).

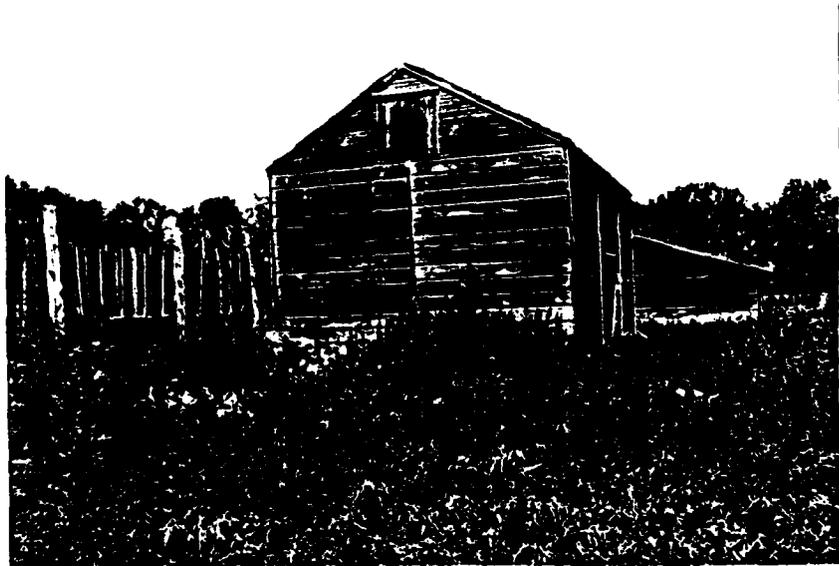
Feature 7 is a one and one-half story, frame granary (Figure 11). It has 1x4 tongue and groove siding and wood shingles on the roof. There is no foundation. There is a loading door on the south elevation near the top. Recently, a single-entry door on the east has been cut into the side. The feature is not architecturally significant.

Figure 11. Looking north at Feature 7 of 32MH32 (HRA 121).

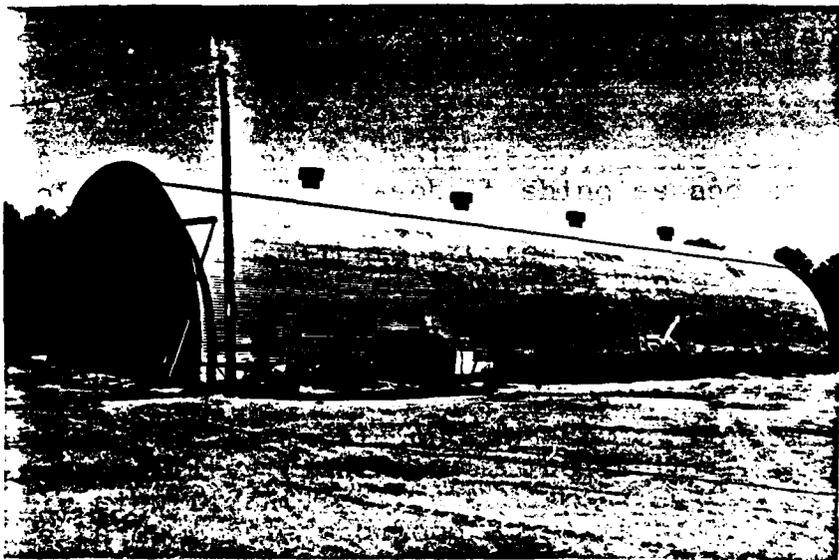
Feature 9 is a long, metal, quonset-style, equipment storage and maintenance facility (Figure 12). The feature is not architecturally significant.

Figure 12. Looking northeast at Feature 9 of 32MH32 (HRA 121).

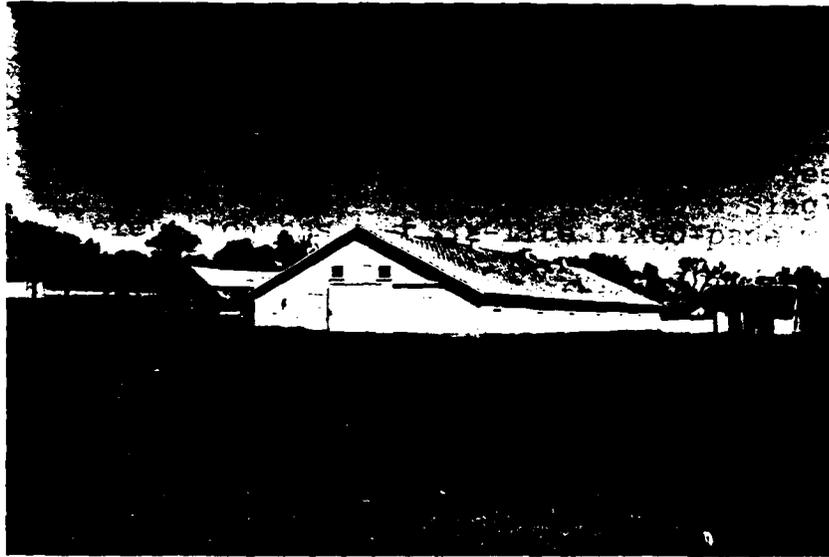
Feature 21 is a long, one and one-half story, gable-roofed barn on a concrete foundation (Figure 17). The roof is covered with asphalt shingles and has four metal ventilators on the crest. The walls are sided with 1x4 tongue and groove siding. There are two six-lite fixed-pane windows on the south elevation, as well as a double entry with a sliding door. The east elevation has seven six-lite fixed-pane windows. The west elevation has six six-lite fixed-pane windows and a single-entry door. The north elevation has two six-lite fixed-pane windows and a double entry with a sliding door. The barn probably was built around 1930-1945 and is in good condition. The addition of other features that are less than fifty years old has compromised the integrity of this feature.

Figure 17. Looking northwest at Feature 21 of 32MH33 (HRA 195-199).

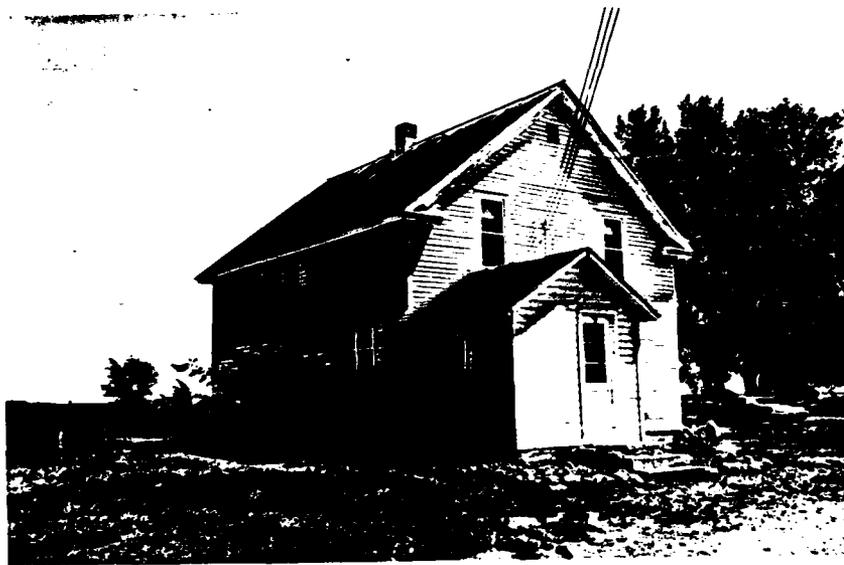
Feature 1 is a two story, frame, gable-roofed residence (Figure 21). It is sided with 1x2 clapboard and the roofing material is asphalt shingles. There is a cinder block chimney in the center of the roof and the structure has a concrete foundation. A new redwood deck is located on the east elevation. A gable-roofed, one story, mud room addition has been added on the west elevation. The addition has a wood shingle roof and 1x4 tongue and groove siding. The east elevation has two 1/1 double-hung windows on the upper floor, one 1/1 double-hung window on the lower floor, and one sliding glass door onto the deck. The south elevation has two 1/1 double-hung windows with aluminum 1/1 storms, and one single-entry metal door. The west elevation has two 1/1 double-hung windows on the upper floor, one 1/1 double-

Figure 21. Looking southeast at Feature 1 of 32MH44 (HRA 232).

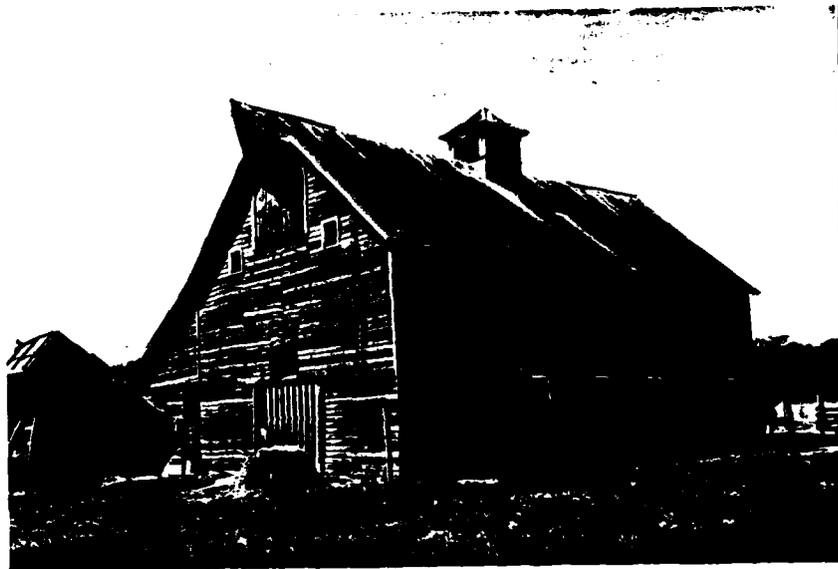
Feature 4 is a two and one-half story, frame, gable-roofed barn on a concrete foundation (Figure 22). The roof is covered with wood shingles and in the center of the roof is a center-set wooden vent. Siding is 1x4 tongue and groove. There is a shed-roofed addition running the full length of the west elevation. On the east elevation are five window openings on the first floor. There is one opening for loading/unloading hay on the second floor. The south elevation has doors on all openings. The door in the hay mow is hinged on the bottom, the door on the second floor is hinged on one side, and the two on the lower floor are sliding doors. The north elevation has a small, windowless opening on the upper floor. The shed addition on the west elevation is open for animal entry from the ground to halfway up the north elevation. There is a double entry on the main portion, with no door. The feature is in poor condition and the lack of maintenance has resulted in deterioration of the building, thus compromising its integrity. The feature is not architecturally significant.

Figure 22. Looking northwest at Feature 4 of 32MH44 (HRA 232).

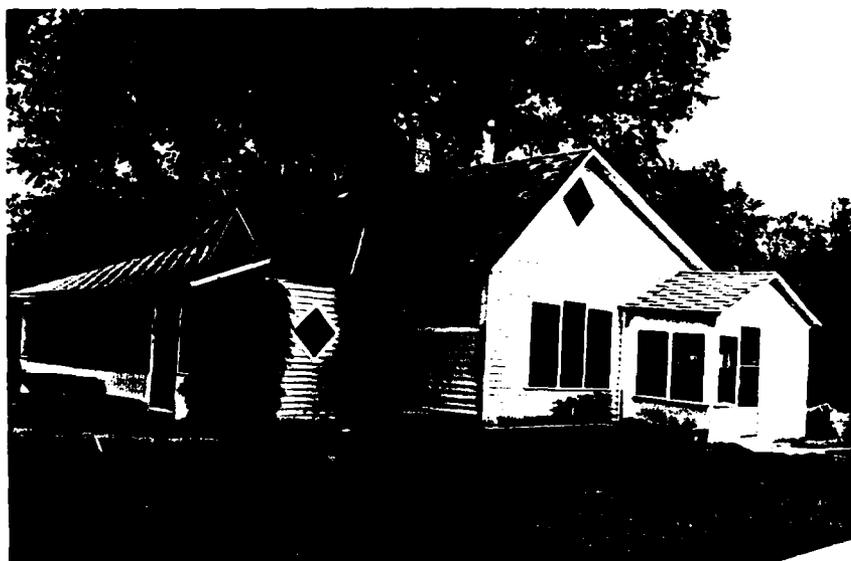
Figure 25. Looking southeast at Feature 2 of 32MH36 (HRA 320).

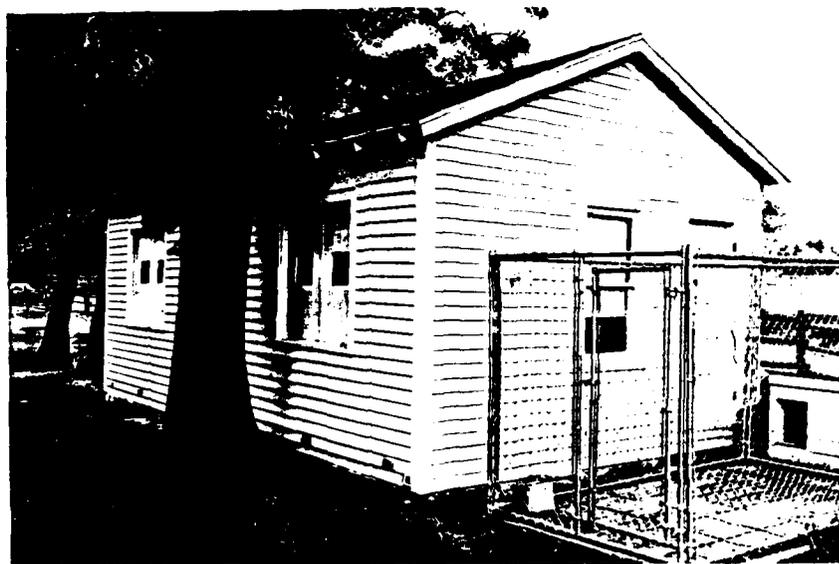
Figure 26. Looking northwest at Feature 5 of 32MH36 (HRA 320).

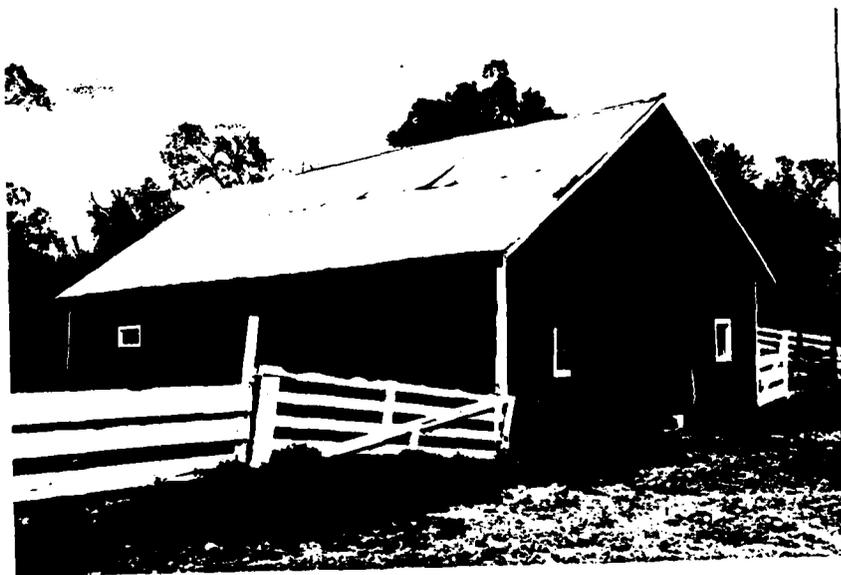
Figure 27. Looking northwest at Feature 6 of 32MH36 (HRA 320).

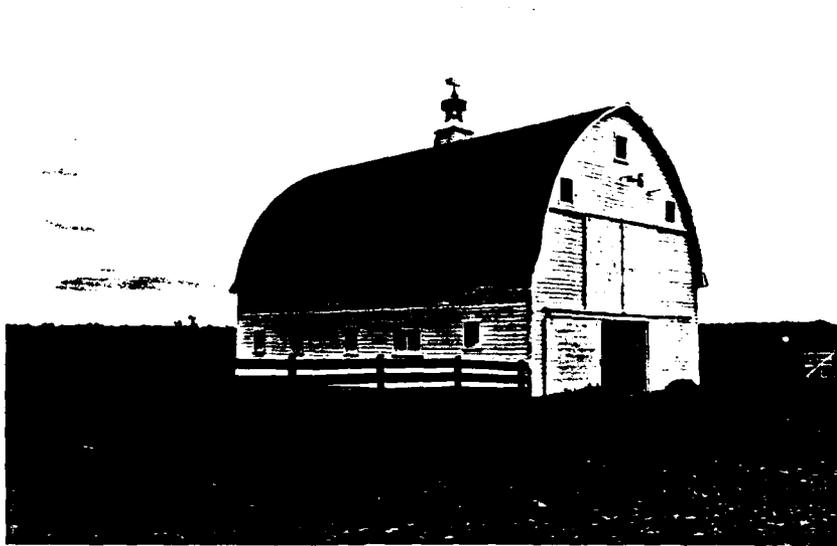
Feature 7 is a three story, wood frame barn with a vaulted, bellcast roof (Figure 28). There is a frame hip-roofed vent in the center of the roof. The building has asphalt shingles on the roof, 1x4 tongue and groove siding, and rests on concrete footers. There are two four-lite fixed-pane windows and a double-entry doorway with a sliding wooden door on the north elevation. The east elevation has seven four-lite fixed-pane windows. The west elevation has six four-lite fixed-pane windows. There are three four-lite fixed-pane windows on the upper floor of the south elevation, a large hay loading entry with two sliding doors on the middle floor, and a single vehicle entry with a sliding door on the ground level. The barn was probably built between 1915-1930 and is in good condition. The addition of other features that are less than fifty years old has compromised the integrity of this feature.

Figure 28. Looking southwest at Feature 7 of 32MH36 (HRA 320).

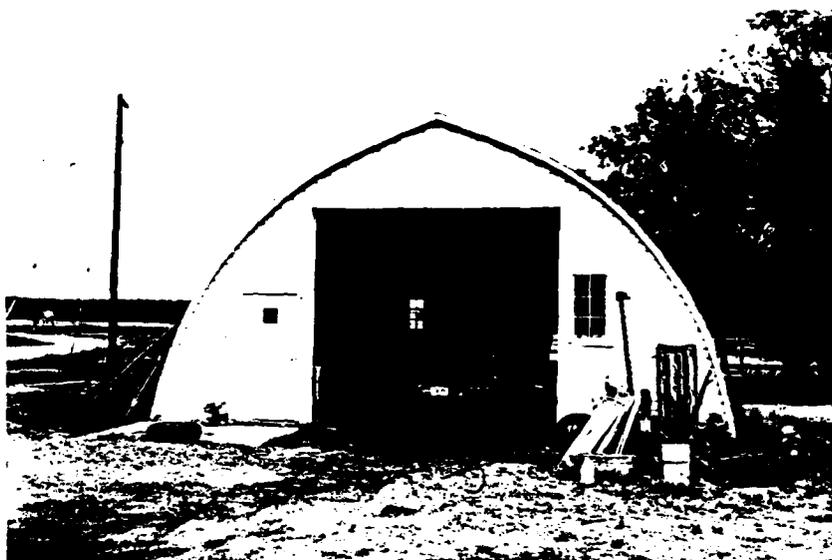
Figure 30. Looking east at Feature 9 of 32MH36 (HRA 320).

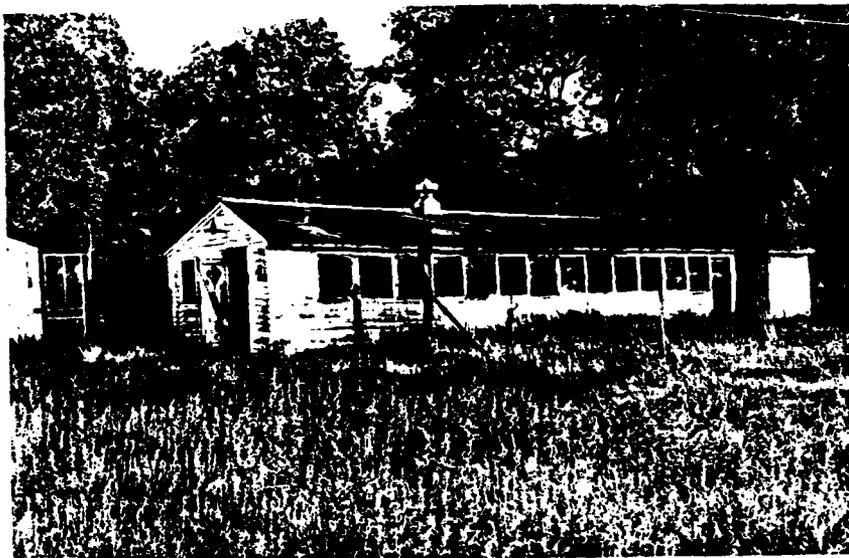
Figure 33. Looking northeast at Feature 3 of 32MH37 (HRA 420).

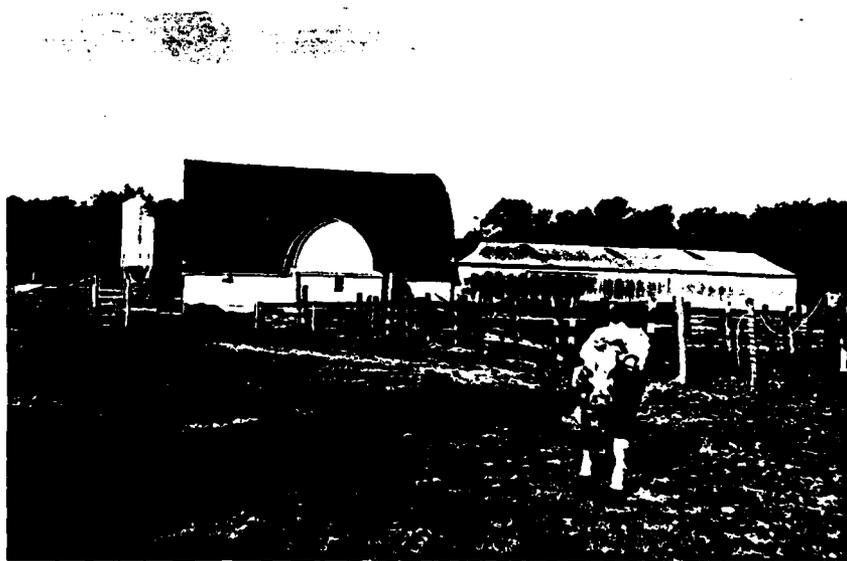
Feature 5 is a three story barn with a vaulted or arched roof (Figure 34). On the east elevation is a two story addition with a vaulted or arched roof. A one story shed-roofed addition

Figure 34. Looking west at Feature 5 of 32MH37 (HRA 420).

is attached to the east elevation of the two story addition. There is a long, two story, corrugated metal, machine shed attached to the north elevation of the feature. With the exception of the metal machine shed, the roofing material used throughout the feature is asphalt shingles, and the exterior siding is 1x4 tongue and groove. The foundation is concrete. The south elevation of the original part of the feature has two six-lite fixed-pane windows flanking the barn door on the first level. Immediately over the barn door is a hay opening. Two window openings are located above the hay opening. On the south elevation of the additions is a single-entry door and two 4/1 double-hung windows. A 1/1 double-hung window is located on the east elevation of the feature's one story addition. The north elevation has 20 four-lite fixed-pane windows. Located on the west elevation of the original part of the feature are five six-lite fixed-pane windows, a single-entry door, and a boarded up window opening. The metal shed addition has a wide metal door on its west elevation. The feature is in good condition. The feature has been extensively altered and no longer maintains integrity of association.

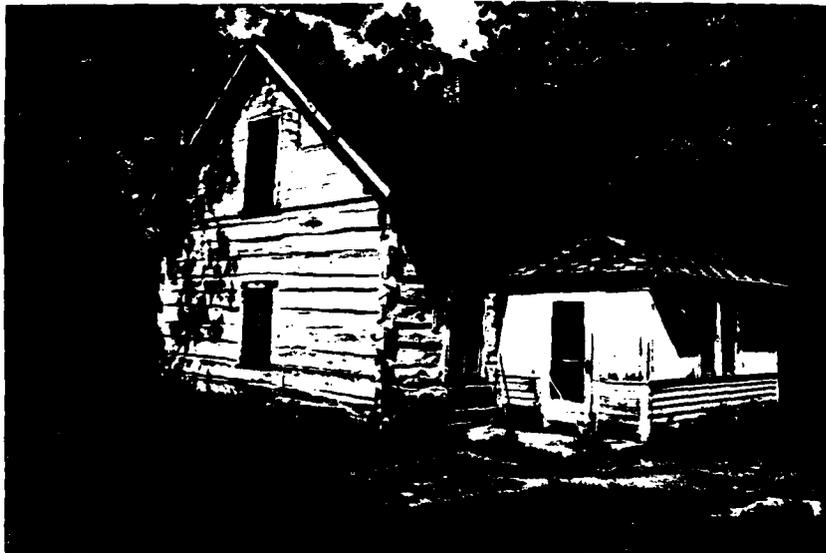
Figure 37. Looking west at Feature 1 of 32MH43 (HRA 430).

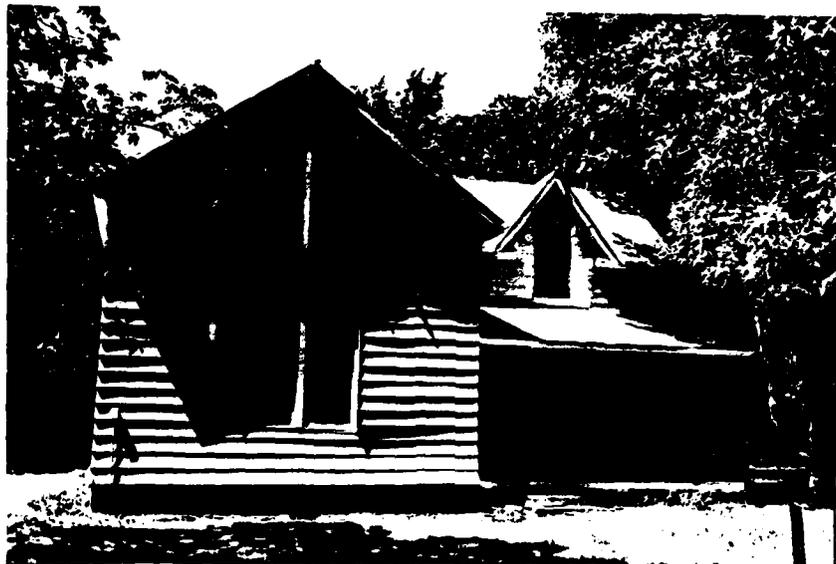
Figure 41. Looking west at Feature 1 of 32MH34 (HRA 451).

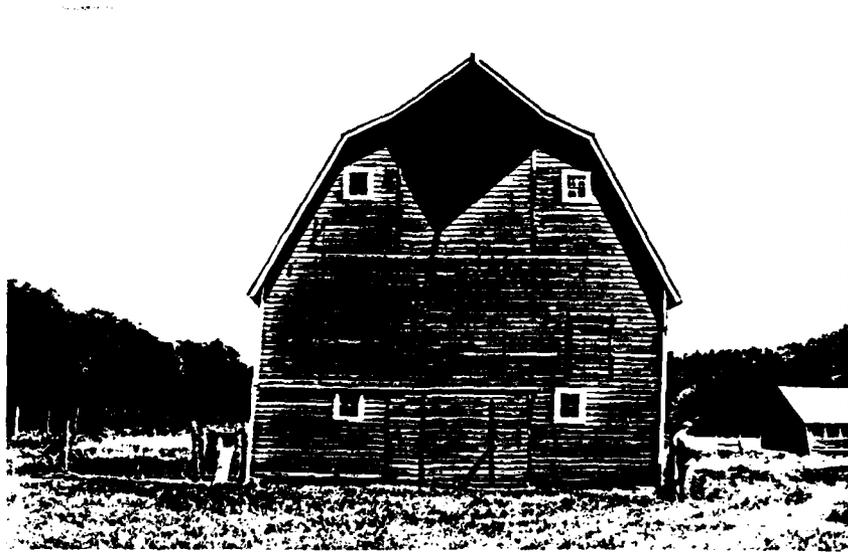
Figure 43. Looking north at Feature 4 of 32MH34 (HRA 451).

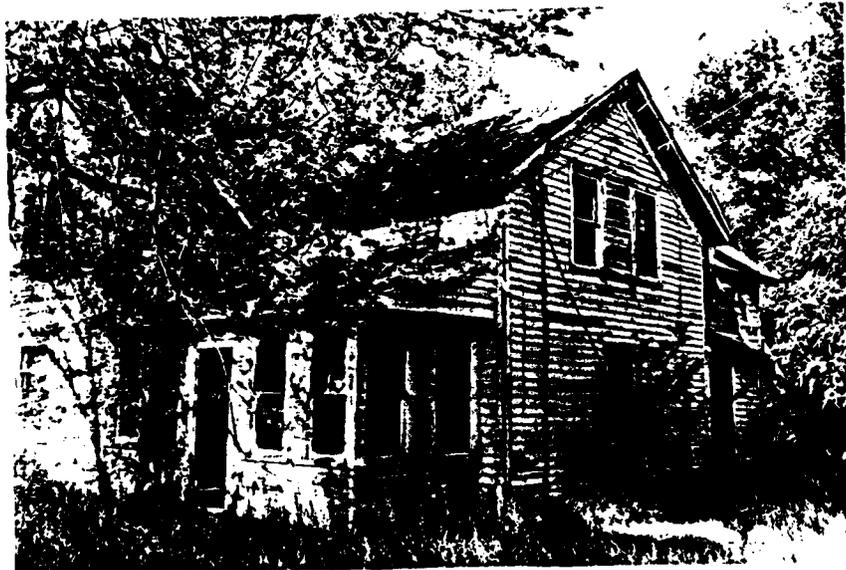
Figure 47. Looking southwest at Feature 4 of 32MH42 (HRA 452).

Feature 4 is a two story, wood frame, gable-roofed dwelling with numerous additions (Figure 47). It is roofed with wood shingles, built with 1x4 shiplap siding, and rests on a concrete foundation. There are brick chimneys near the southeast and southwest corners of the house. The original portion of the structure is rectangular, with gables on the east and west elevations. The gables display decorative shingles. The west elevation of this portion has one 2/2 and one 1/1 double-hung window on the second floor and a 1/1 double-hung window centered on the ground floor. The south elevation has two 1/1 double-hung windows on the ground floor only. The east elevation has two 1/1 double-hung windows on the second floor and a three-lite fixed-pane window on the ground floor. There is a two story addition on the north elevation, with gabled roof, two 1/1 double-hung windows on the second floor, and a two-lite fixed-pane window on the ground floor. The west and east elevations are adjoined by a second two story addition and a shed-roofed addition, respectively. The second two story addition has a gable but no windows or doors on the west elevation, a gabled 1/1 double-hung window on the second floor of the south elevation, two 2/2 double-hung windows on the ground floor, and a gabled 1/1 double-hung window on the second floor of the north elevation. There is a shed-roofed addition on a porch foundation in the southeast corner, with a single-entry door and four 1/1 double-hung windows on the east elevation and two 1/1 double-hung windows on the south elevation. A smaller shed-roofed addition on the north elevation has a single-entry doorway with an aluminum screen door. The house was built apparently between 1915 and 1930, and is now vacant. The feature has been extensively altered and no longer maintains integrity of association. The feature is in poor condition and the lack of maintenance has resulted in deterioration of the building, thus compromising its integrity.

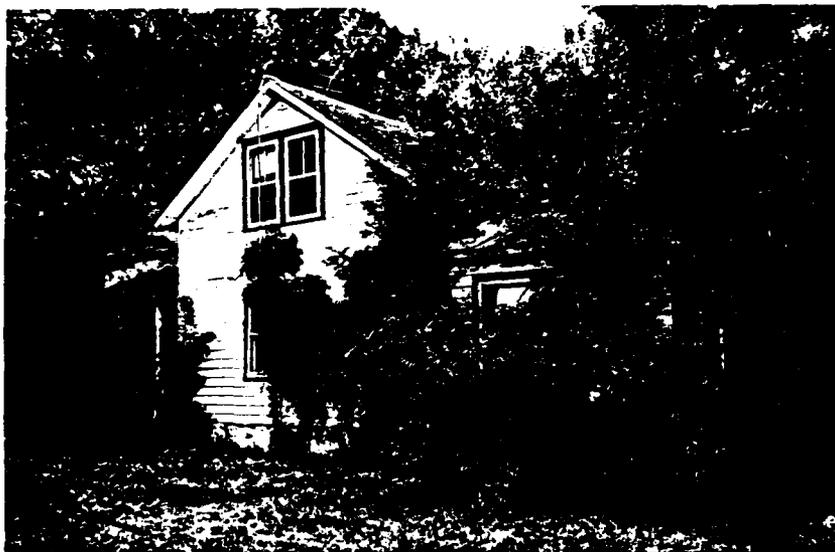
Figure 51. Looking northwest at Feature 1 of 32MH35 (HRA 454).

Feature 1 is a gable-roofed, two story residence with an east/west orientation, and a north/south addition on the east elevation (Figure 51). The west elevation has an open porch with

a shed roof and the east elevation has an enclosed porch with a shed roof, which was made into a kitchen. The main roof is constructed of wood shingles, while the shed roofs have asphalt shingles. The house has a rock and mortar foundation, a center-set brick chimney in the main portion, and another brick chimney in the shed-roofed addition. The main portion was built with logs in 1904, but the exterior is currently covered with decorative metal siding. The north elevation has three 2/2 double-hung windows with four-lite fixed-pane storm windows on each, and a single-entry door into the shed-roofed addition. The east elevation has one 2/2 double-hung window with a four-lite fixed-pane storm window and a single-entry door. The south elevation has a large one-lite picture window in the shed-roofed addition, four 2/2 double-hung windows in the main north/south-oriented addition, and one single-entry door and a 2/2 double-hung window in the east/west-oriented portion. The west elevation has two 2/2 double-hung windows. The building is in fair condition. The feature has been extensively altered and no longer maintains integrity of association.

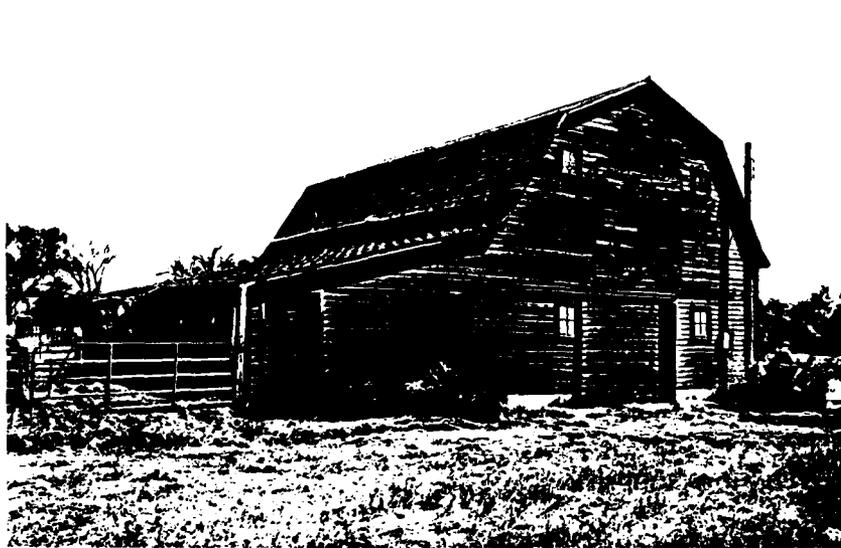
Figure 52. Looking northeast at Feature 6 of 32MH35 (HRA 454).

Feature 6 is a two and one-half story, gambrel-roofed barn with a large, shed-roofed addition on the west elevation (Figure 52). The barn is a wood frame structure with tongue and groove siding. It rests on a concrete foundation. There is a vehicle entry with a sliding door on the ground level of the south elevation, and an opening with two hinged doors for loading hay on the second floor. There are four four-lite fixed-pane windows on the main wall of the south elevation and a single-entry door in the shed-roofed addition. The north elevation of the barn is identical to the south elevation. There are no windows or doors in the east elevation. The shed-roofed addition on the west elevation is half open. The barn was built in the 1930s. It is in good condition. The feature was moved onto the site in 1961 or 1962 and therefore lacks integrity of association.

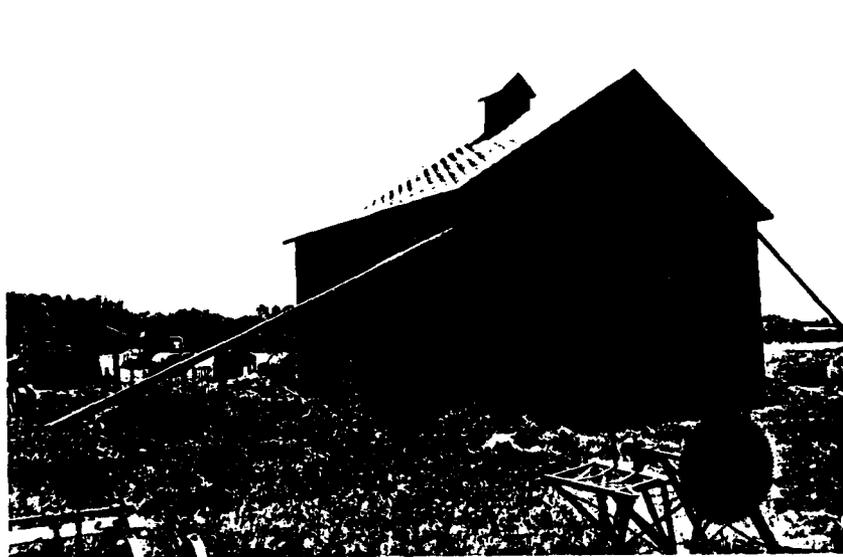
Figure 53. Looking southwest at Feature 9 of 32MH35 (HRA 454).

Feature 9 is a two story, quonset-roofed, metal frame work shop on a concrete foundation (Figure 53). The south elevation has an equipment entrance, six fixed-pane windows, and a single-entry door. The building is of recent construction, and is in good condition. The feature is less than fifty years old and does not maintain historic association.

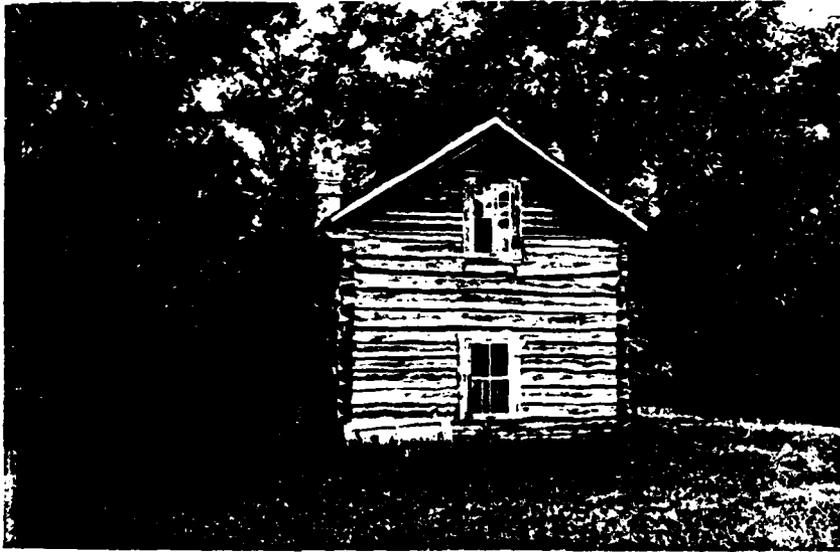
Figure 61. Looking west at Feature 2 of 32MH39 (HRA 485).

Feature 2 is a two story log cabin with a gable roof (Figure 61). The roofing material is wood shingles. There is a brick chimney on the southwest corner of the roof. The exterior walls consist of logs, fourteen courses high, that were fitted by dovetail notching. The chinking is mostly gone and only some mortar remains. The foundation is stone. There are no windows or doors on the north elevation. On the east elevation there are two window openings. The windows were apparently 6/6 double-hung with four-lite fixed-pane storms. Most of the glass is missing on the windows and the storm windows. There is a single-entry door on the south elevation. On the second floor of the west elevation is one small window opening with no glass. On the first floor of the west elevation is a window opening similar to the window frames on the east elevation. The feature is in fair condition. The addition of other features that are less than fifty years old has compromised the integrity of this feature.

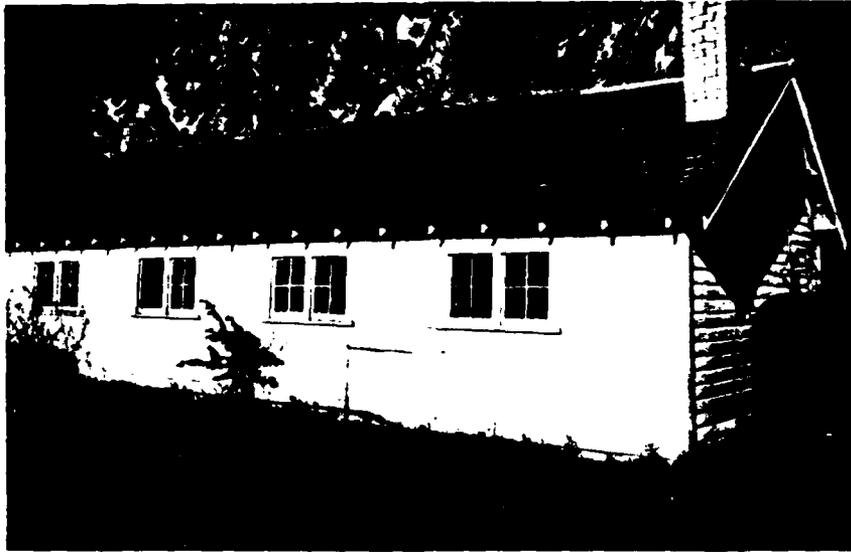
Figure 65. Looking southwest at Feature 2 of 32MH38 (HRA 525).

Feature 2 is a one story, wood frame, gable-roofed garage on a concrete foundation (Figure 65). The garage has wooden shingle roofing and 1x4 tongue and groove siding. There is a brick chimney in the north elevation of the roof. The south elevation has a single vehicle opening with no door, and the east elevation has eight four-lite fixed-pane windows. The garage was built in the 1920s and was moved to the site around 1940. It is in good condition. The feature is not architecturally significant.

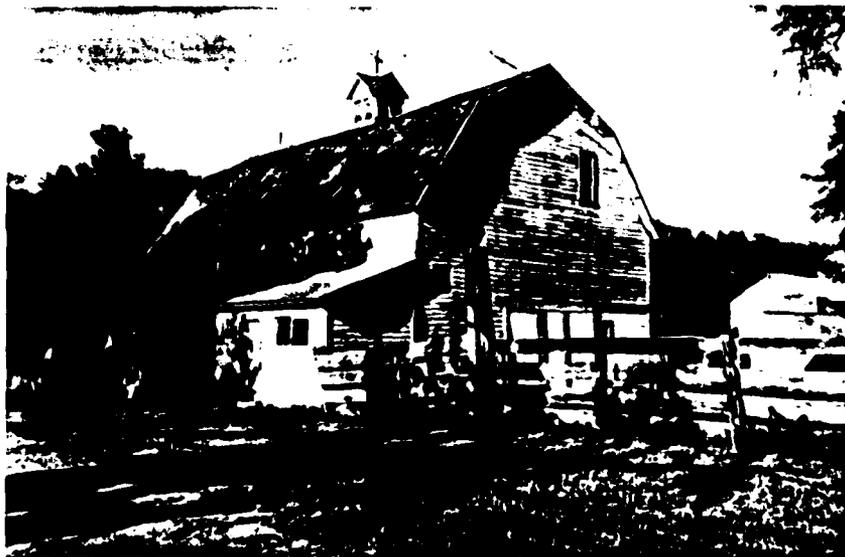
Figure 66. Looking southwest at Feature 5 of 32MH38 (HRA 525).

Feature 5 is a two and one-half story, wood frame barn with a gambrel roof (Figure 66). The roofing is asphalt shingles and the walls have 1x4 tongue and groove siding. There is no visible foundation. The barn has two shed-roofed additions on the east elevation, the older one extending three-quarters of the length of the building and the narrower, more recent one covering the rest. Both additions have corrugated metal roofs and stand on a concrete pad. There is a hip-roofed wooden vent on the top of the barn. The west elevation of the building has a single-entry door, two four-lite fixed-pane windows, and two window apertures without windows. The south elevation has two 4/4 double-hung windows on the uppermost half story, a double hay loading door with two sliding doors on the second floor, and a double door with one sliding door on the ground level. The shed-roofed addition has a double entry with a sliding door on its south elevation, and a single-entry door and five fixed-pane windows (four four-lite and one one-lite) on the east elevation. The north elevation of the barn has two 4/4 double-hung windows on the uppermost half story. On the ground level are a single-entry doorway with sliding door, and two window openings, one boarded up and one with a four-lite fixed-pane window. The barn was built in 1925, and is in fair condition. The addition of other features that are less than fifty years old has compromised the integrity of this feature.

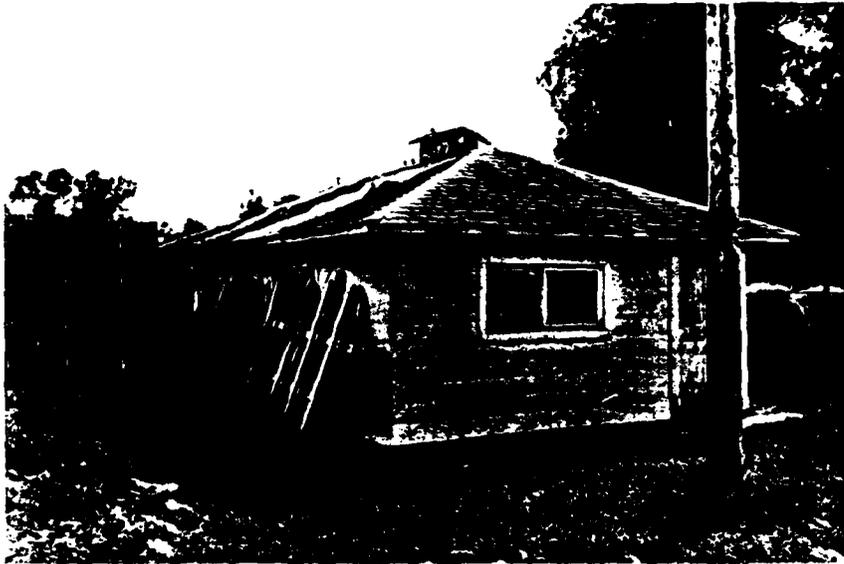
Figure 70. Looking southwest at Feature 6 of 32MH41 (HRA 580).

Feature 6 is a one story, frame, milk house with a hip roof (Figure 70). It was built in 1920. The roofing material is wood shingles. The exterior siding is metal with a "fake block" design. The feature is located on a concrete pad. A one-lite window and a two-lite window are located on the west elevation. A single-entry door and a two-lite fixed-pane window are located on the north elevation. A two-lite fixed-pane window is located on the east elevation. There is a single-entry door on the south elevation. The feature is in fair condition. The addition of other features that are less than fifty years old has compromised the integrity of this feature.

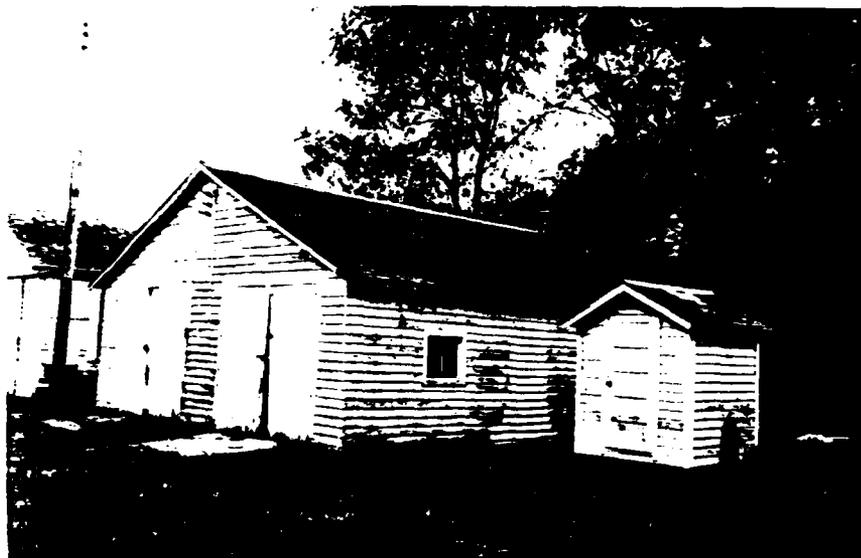
Figure 72. Looking southwest at Feature 9 (right) and 10 (center) of 32MH41 (HRA 580).

Feature 9 is a one story, frame, pump house with a gable roof (Figure 72). The roofing material is asphalt shingles. The exterior siding is tongue and groove. The foundation is concrete. On the east elevation is a single-entry door. There is a four-lite fixed-pane window on both the south and west elevations. The feature is in good condition. The addition of other features that are less than fifty years old has compromised the integrity of this feature.

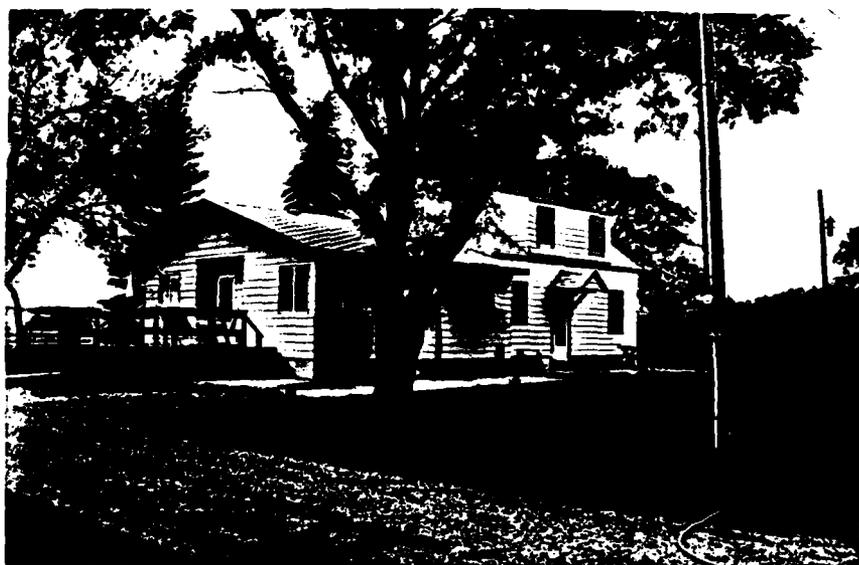
Figure 79. Looking southwest at Feature 2 of 32WD55 (HRA 1130).

Feature 2 is a two story, wood frame, gable-roofed residence on a concrete foundation (Figure 79). Roofing material is asphalt shingles. The building has a dormer on the south and north sides of the roof. There is a one story, hip-roofed

addition and a wooden deck on the east elevation. The addition has aluminum siding. The south elevation of Feature 2 has three 3/1 double-hung windows and a single-entry door that opens into a 1x1 meter porch. The dormer has four 3/1 double-hung windows with aluminum storms. The south elevation of the addition has two two-lite Anderson windows. The west elevation of Feature 2 has one 3/1 double-hung window with an aluminum storm on the upper story, and two 3/1 double-hung windows with aluminum storms on the first floor. The north elevation has two 3/1 double-hung windows with aluminum storms and one single-entry door on the first level. The dormer has two 3/1 double-hung windows with aluminum storms. The north elevation of the addition has a 2/1-lite and a 1/1-lite Anderson window. The east elevation of the addition has two two-lite Anderson windows and a single-entry doorway inset into the east elevation. The feature has been extensively altered and no longer maintains integrity of association.
