TECHNICAL REPORT REMR-CS-21

IN SITU REPAIR OF DETERIORATED CONCRETE  
IN HYDRAULIC STRUCTURES:  
A FIELD STUDY

April 1989  
Final Report

Prepared for DEPARTMENT OF THE ARMY  
US Army Corps of Engineers  
Washington, DC 20314-1000

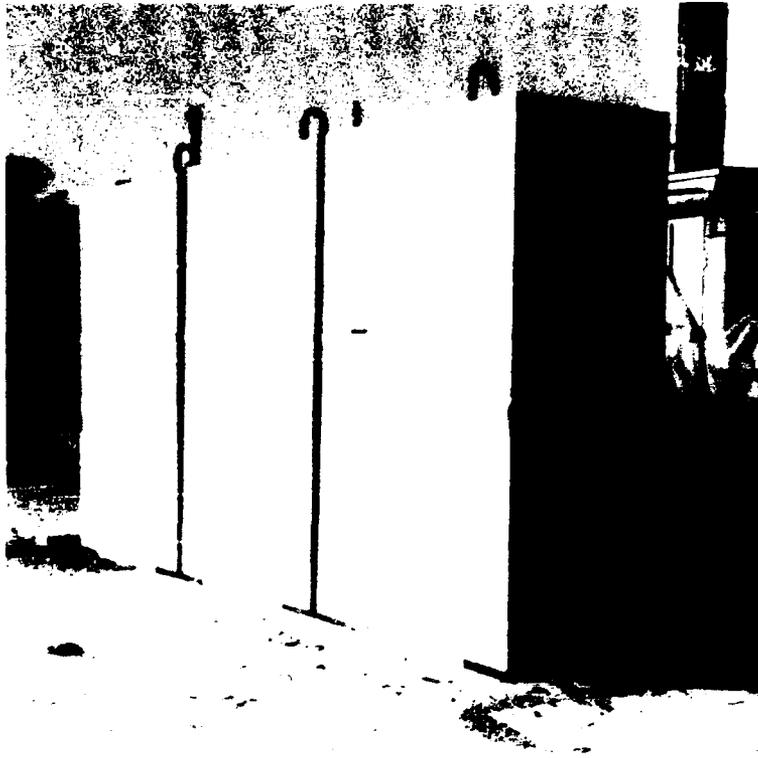
Figure 1. Concrete shielding blocks

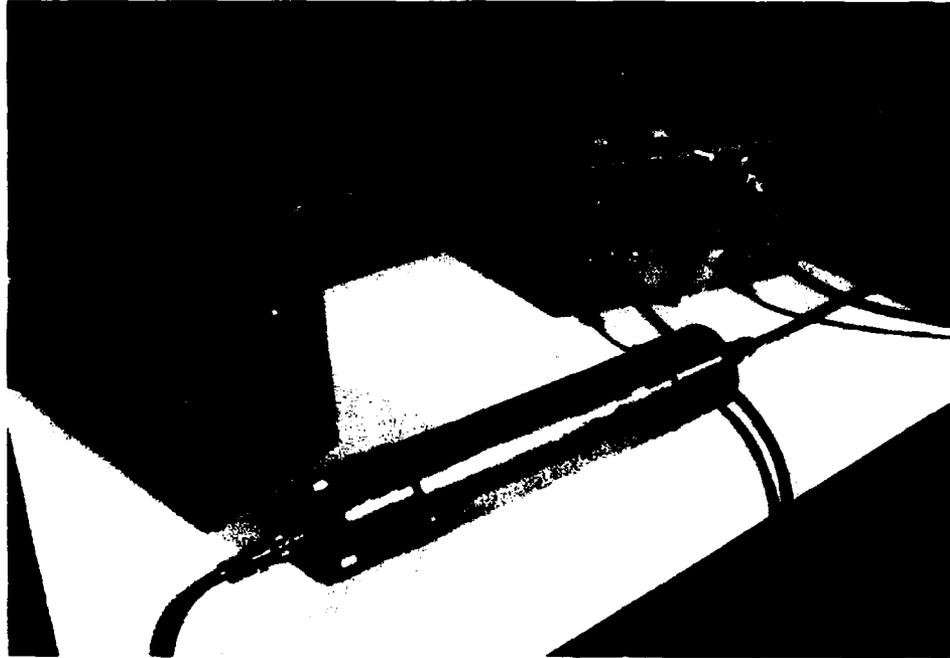
13. Preliminary measurements of ultrasonic pulse velocity were made with a portable Pundit Ultrasonic Tester (Figure 3). Readings were taken before starting repair work to obtain an accurate indication of the condition of each structure. All readings were taken with the indirect or surface transmission method.

Figure 3. Pundit Ultrasonic Tester

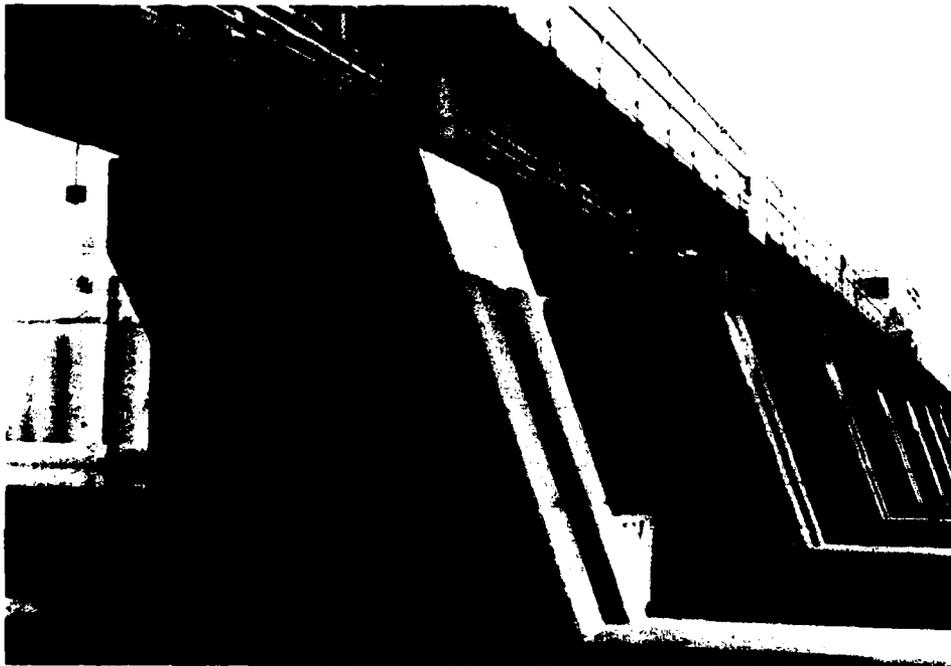
34. After completion of the large-scale laboratory tests, a small-scale field test was performed on Pier No. 27 at Lock and Dam No. 20, Canton, MO, 17-25 Aug 1987 (Figure 8). The objectives were to demonstrate, under field conditions, the procedures developed in the laboratory and to evaluate the effectiveness of the materials and equipment selected for use.

35. Lock and Dam No. 20 is located at river mile 343.2 on the Mississippi River, Canton, MO. The structure, operated by the US Army Corps of Engineers (USACE), was placed into service in 1936 and is a part of the 9-ft Channel Navigation Project. Over the years, periodic inspections revealed cracks in many of the 42 concrete pier stems that support the dam service bridge. The condition of the concrete ranges from good (high compressive strength and no deterioration) to severely deteriorated (D-cracking, leaching, drummy with a loss of strength) (US Army Engineer District, Rock Island 1985).

Figure 8. Pier No. 27 (in foreground)

36. Damage to the pier stems is most significant in the top 11 ft, the area from el 490 to the top of the pier at el 501.\* The damage is attributed to stresses developed by a lack of slip between the service bridge sole plates and the anchored bearing seats in the tops of the stems. Water allowed to pond because of the recessed bearing seats gains access to the pier stem interior through cracks caused by the anchor forces and accelerates deterioration of the concrete. Cracking in this area of the pier stems has been observed since 1939.

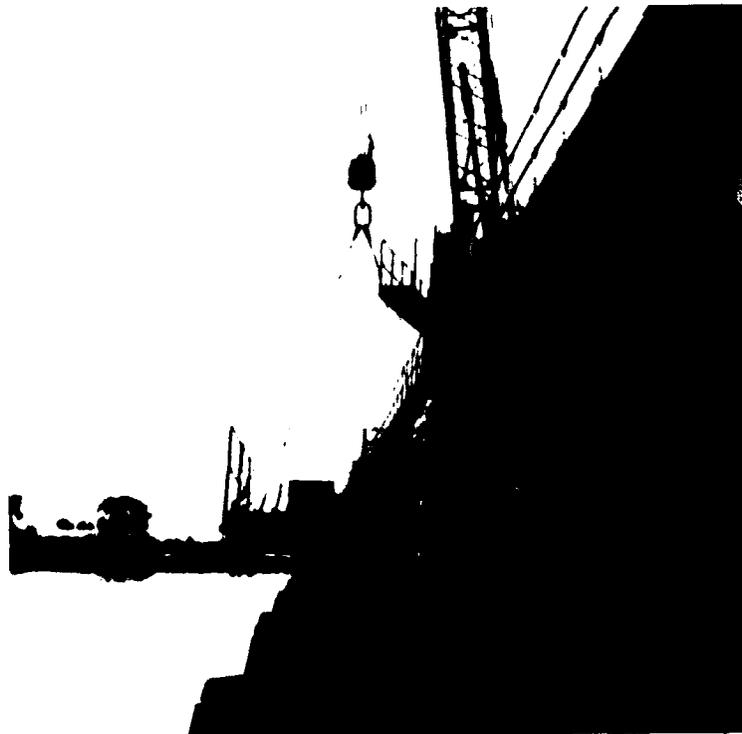
40. Access to the upstream and downstream faces was provided by an existing work platform suspended over the sides of the dam from the service bridge crane (Figure 16).

Figure 16. Work platform suspended from service bridge crane

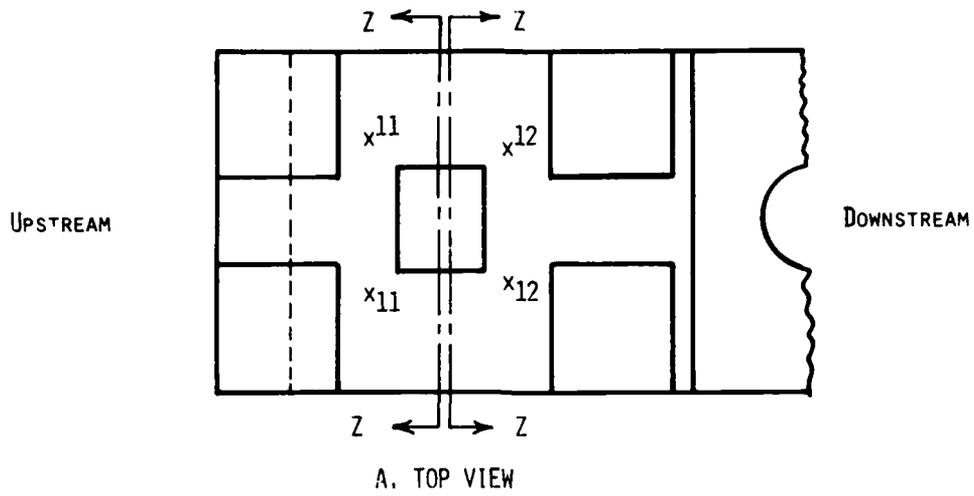
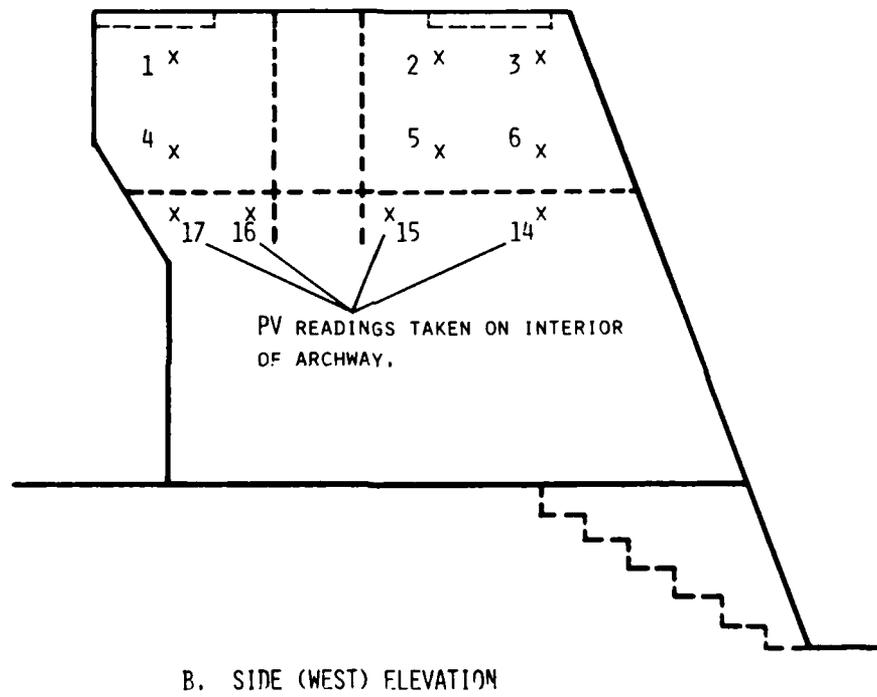
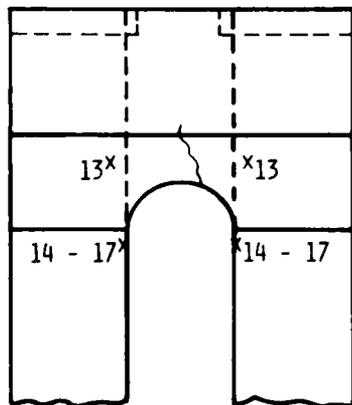
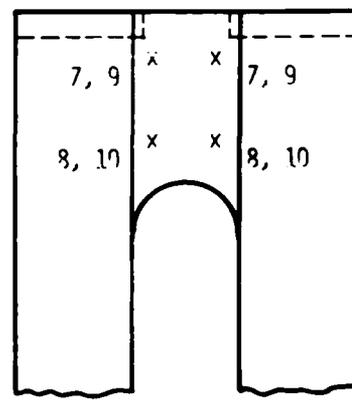
41. Preliminary ultrasonic pulse velocity data were taken between opposite points at six locations on the Illinois and Missouri faces of the pier stem using the direct transmission method. Readings also were taken between selected points on the faces of the stairwell, the top of the pier stem, the upstream face of the pier stem and the archway ceiling using the indirect transmission method. However, these readings were used only to supplement the data obtained from the direct transmission method, since the indirect method generally is considered less accurate than the direct method.\* Primary emphasis was based upon the pulse velocity values obtained using the direct transmission method. The general locations of the pulse velocity readings are illustrated in Figure 17, and the readings are summarized in Table 1.

Figure 17. Locations of ultrasonic pulse velocity measurements

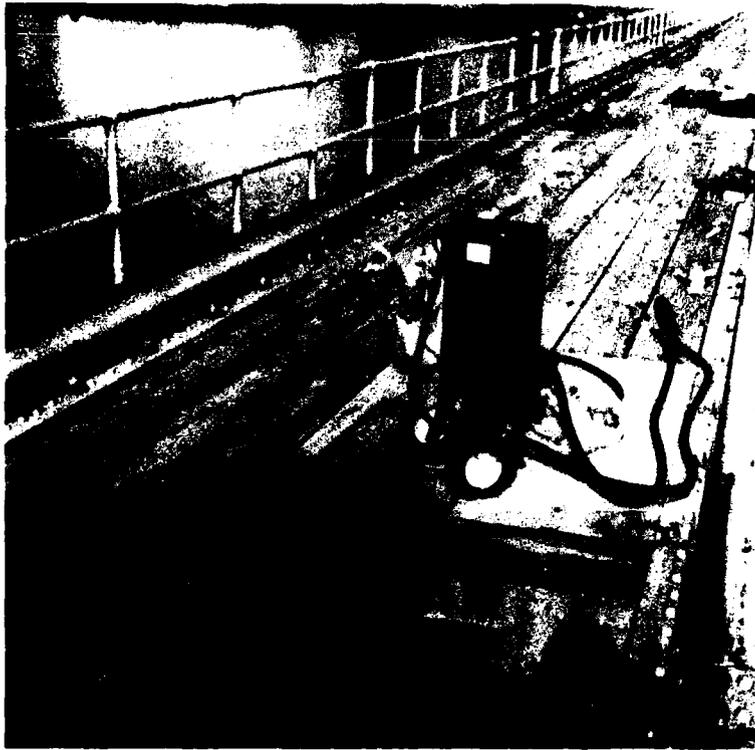
44. The pier stem was sandblasted using a small portable unit (Sandy Jet Pressure Blaster, Model F-110) (Figure 18), which was operated off a 100-cfm portable air compressor. A total of 640 lb of No. 460 sandblasting sand (94-percent passing a No. 30 sieve) cleaned a surface area of approximately 350 sq ft.

Figure 18. Portable sandblasting unit

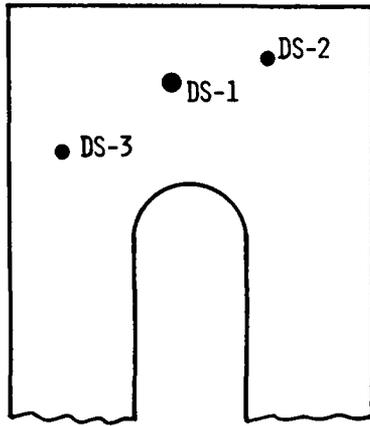
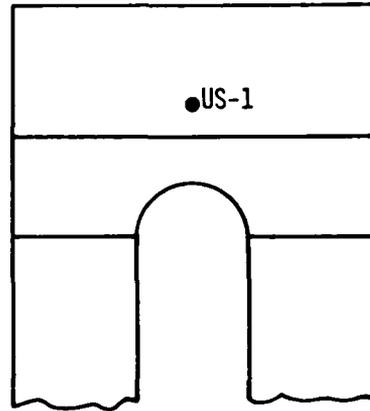
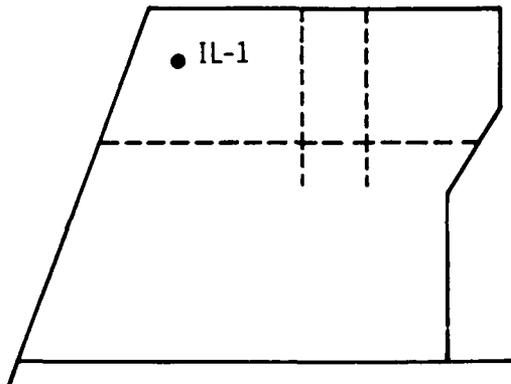
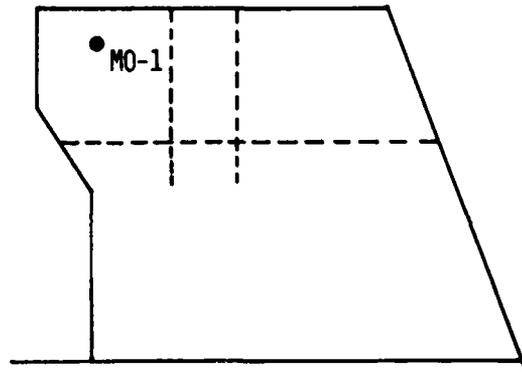
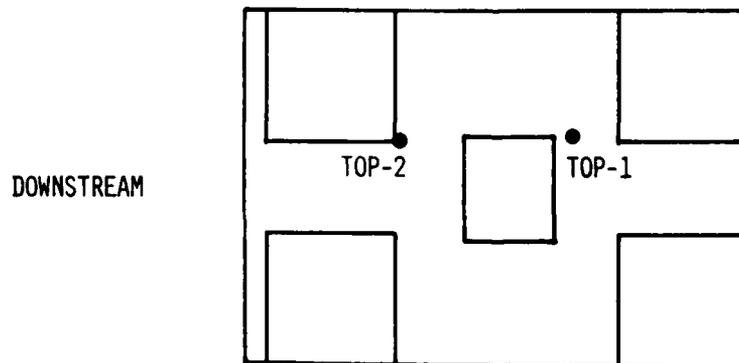
Figure 24. Locations of concrete cores

4-in.-diam cores and one 6-in.-diam core were removed from Pier No. 27 by personnel from the US Army Engineer District, Rock Island. The core locations are shown in Figure 24, and the drilling logs are presented in Appendix A.
