DEM-TR-89-01

NONCONVENTIONAL ROOF SYSTEMS FOR IN-HOUSE INSTALLATION AT AIR FORCE BASES

W.B. ROSE
D.M. BAILEY

JULY 1989
FINAL REPORT

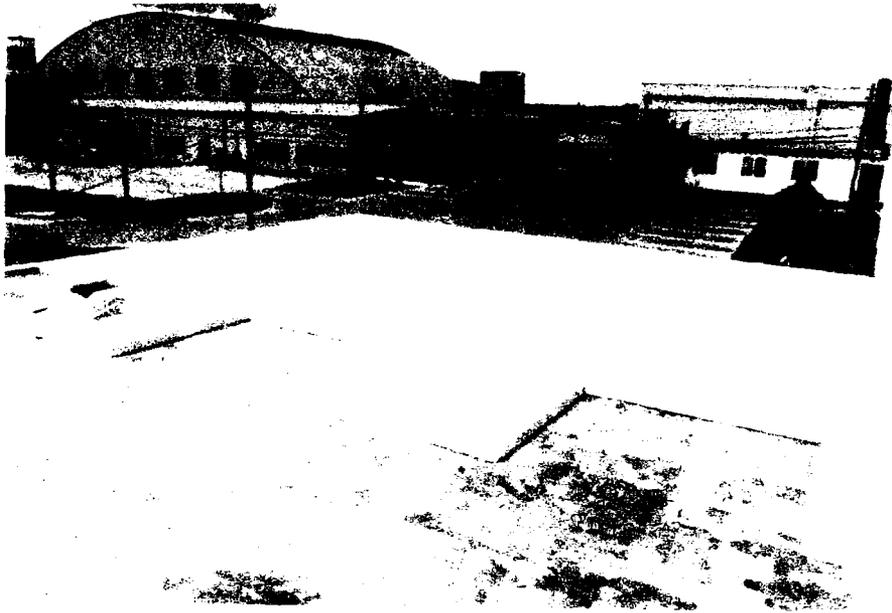
were nailed to the 2 by 4s (Figure 13). Rigid foam insulation panels 2 in. thick were laid on the cleaned deck (Figure 14). They were not fastened in place because the weight of the ballast provides the uplift resistance for the entire system.

Figure 14. Rigid foam insulation laid in place.

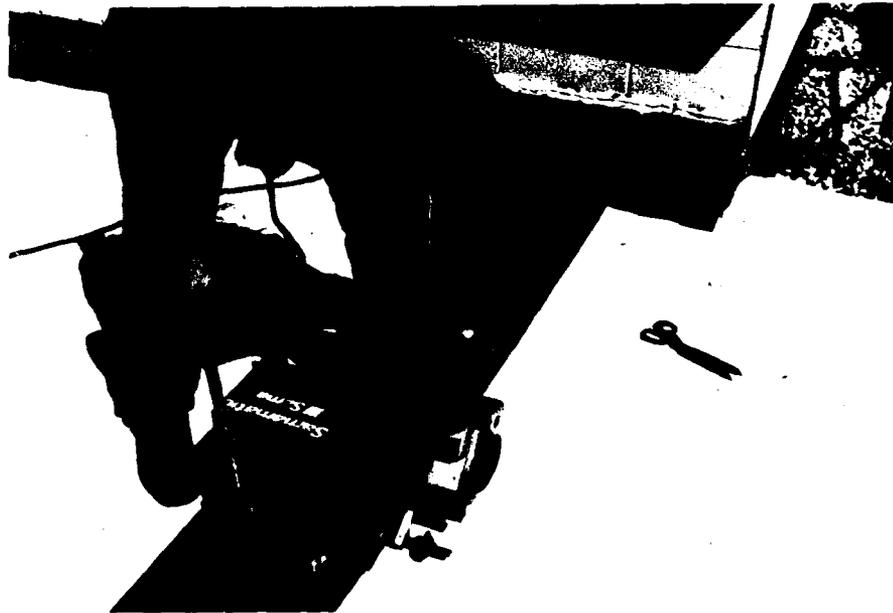
Figure 21. The seaming machine must be regulated for speed and temperature.

Because some of the lap seams could be pried apart, the temperature and speed of the machine seamer were adjusted so that the seams were more tightly welded. The completed seams were reinforced with membrane strips at the suggestion of the roof engineer.

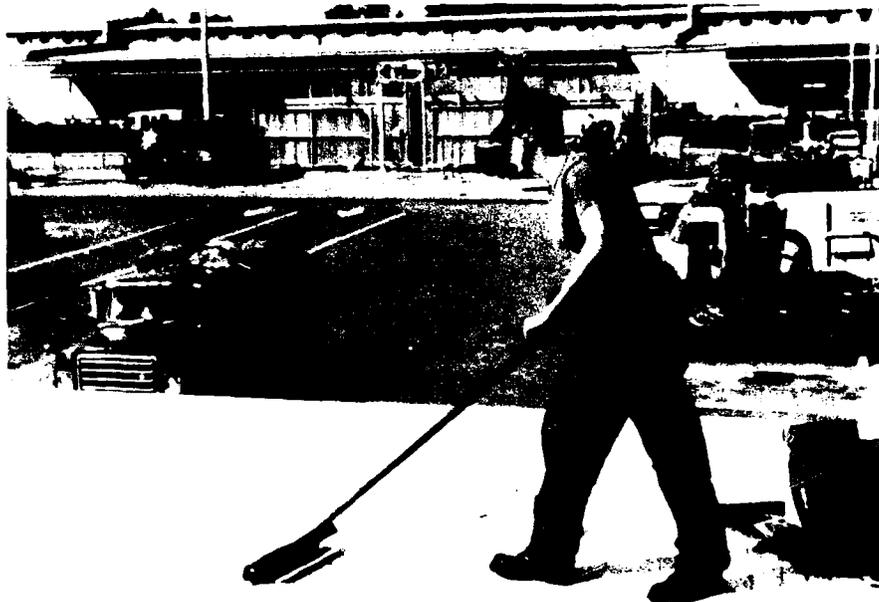
Full adhesion at the seam and adhesion of the membrane to the deck was obtained by rolling with a small roller (Figure 38). The person who pushed the roller also gathered the torn-off sections of release paper and disposed of them.

Figure 38. A small roller is applied to increase the membrane's adhesion to the deck.

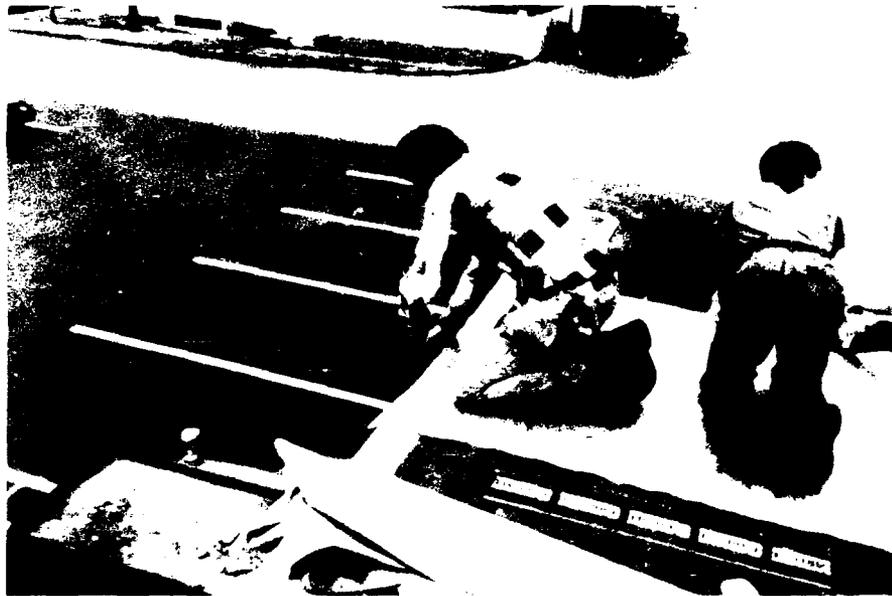
A recover board of medium density fiberboard was applied over the existing BUR with large fasteners that went through the membrane into the wood deck (Figure 59). Some of the fasteners had been carelessly installed with the washers upside down so that sharp edges were in contact with the membrane. The fasteners were removed and the washers were turned around.

Figure 59. Mechanical fasteners are long screws that penetrate through the recover-board to wood deck beneath.
