REPAIR, EVALUATION, MAINTENANCE, AND REHABILITATION RESEARCH PROGRAM

TECHNICAL REPORT REMR-CS-22

MONOLITH JOINT REPAIRS: CASE HISTORIES

Structures Laboratory

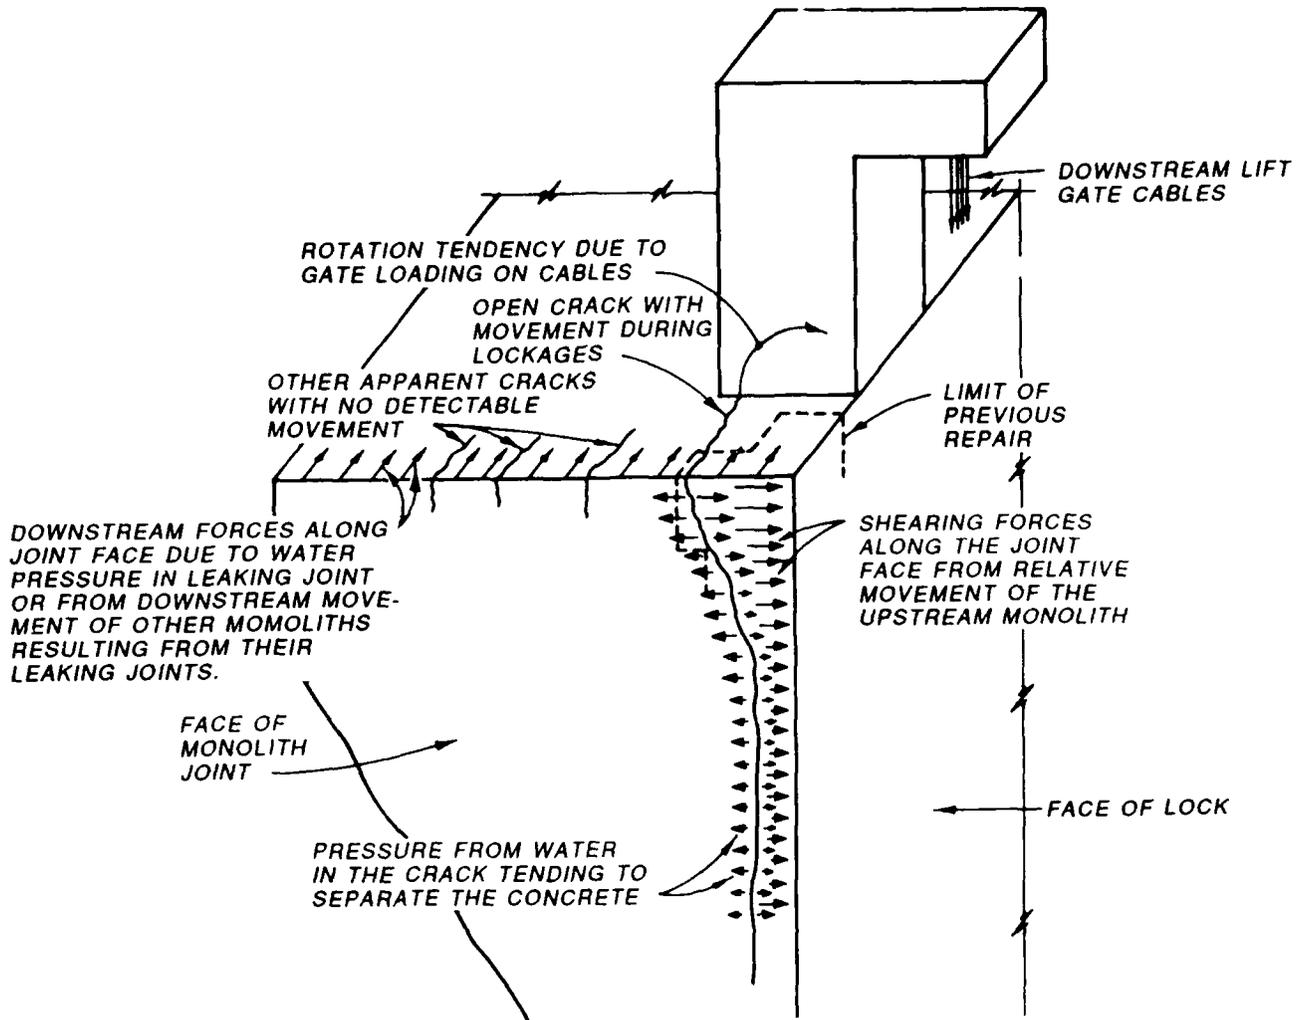
10. Periodic Inspection Reports No. 4 (USAED, Walla Walla, 1973) and No. 5 (USAED, Walla Walla, 1975), documented the continued deterioration of the concrete adjacent to these joints. The deterioration extended from el 420* to 460 on monolith 26 and el 480 to 537 on monolith 28. The cause of the deterioration (Figure 3) was described in Periodic Inspection Report No. 5 (USAED, Walla Walla, 1975) as follows:

Figure 3. Forces acting on gate monolith, Lower Monumental Lock and Dam

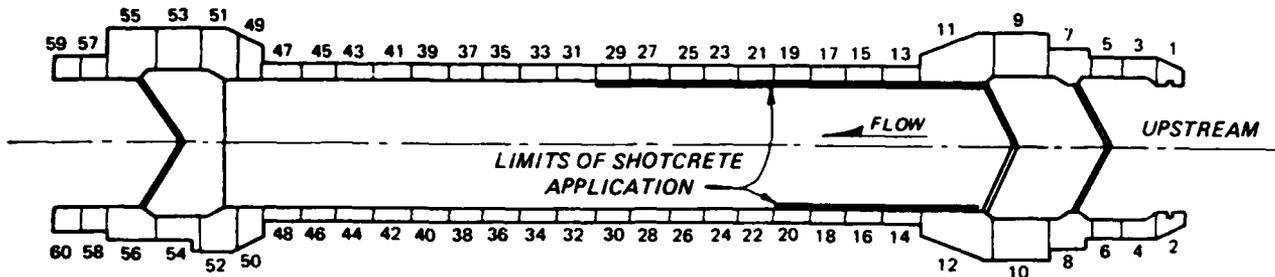
Figure 11. Limits of 1954 repair, Dresden Island Lock and Dam

the monolith joints where some spalling had occurred. The original structure did not contain expansion joints, but expansion joint material was incorporated in the relatively thin resurfaced section during 1954 rehabilitation. Because this material could not function as a joint but could absorb water, it probably contributed to the damage from cycles of freezing and thawing. The lock wall monoliths that had not been resurfaced were deteriorated an average depth of 7 in. Severe erosion was also noted at the monolith joints in the upper and lower guide walls.

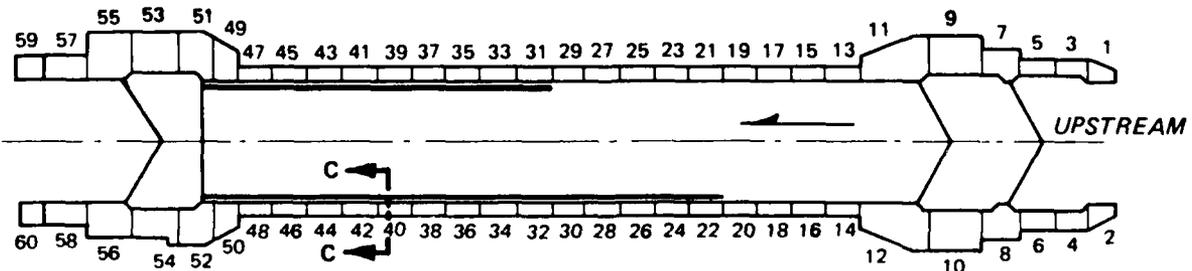
Figure 12. Limits of 1978 repair, Dresden Island Lock and Dam

17. The downstream lock walls were completely refaced (Figure 12). This repair is described in detail in Technical Report REMR-CS-13 (McDonald

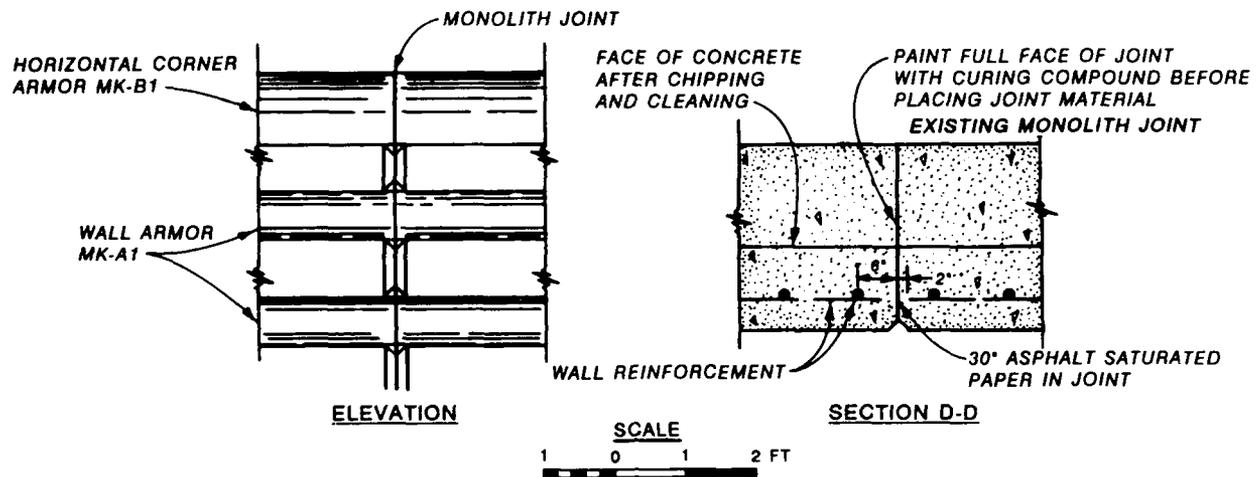
Figure 13. Monolith joint details for the 1978 repair, Dresden Island Lock and Dam

1987). Because existing monolith joints were tight, only 30-lb asphalt-saturated felt paper was used in the monolith joints to serve as a bond

breaker. Each monolith joint had a 2- by 2-in. chamfer on each side. The full face of the joint was covered with curing compound before the joint material was placed (Figure 13).

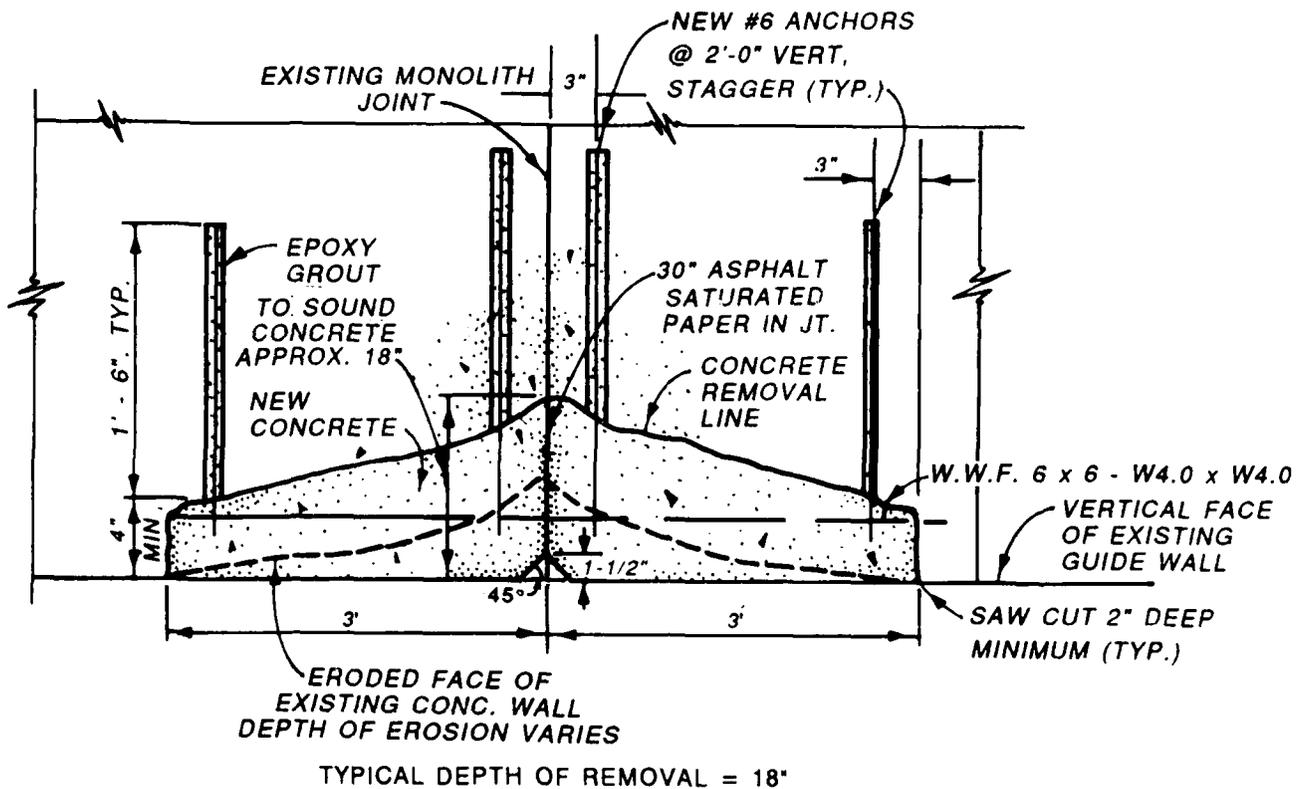
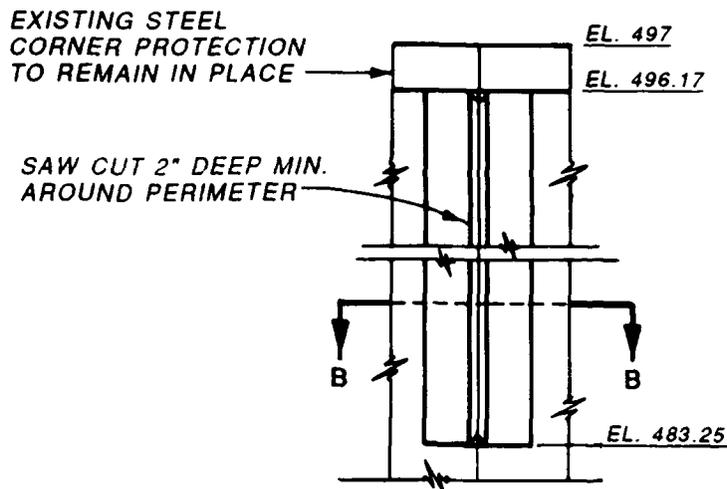
Figure 17. Monolith joint repair details for the lower guide wall, Dresden Island Lock and Dam

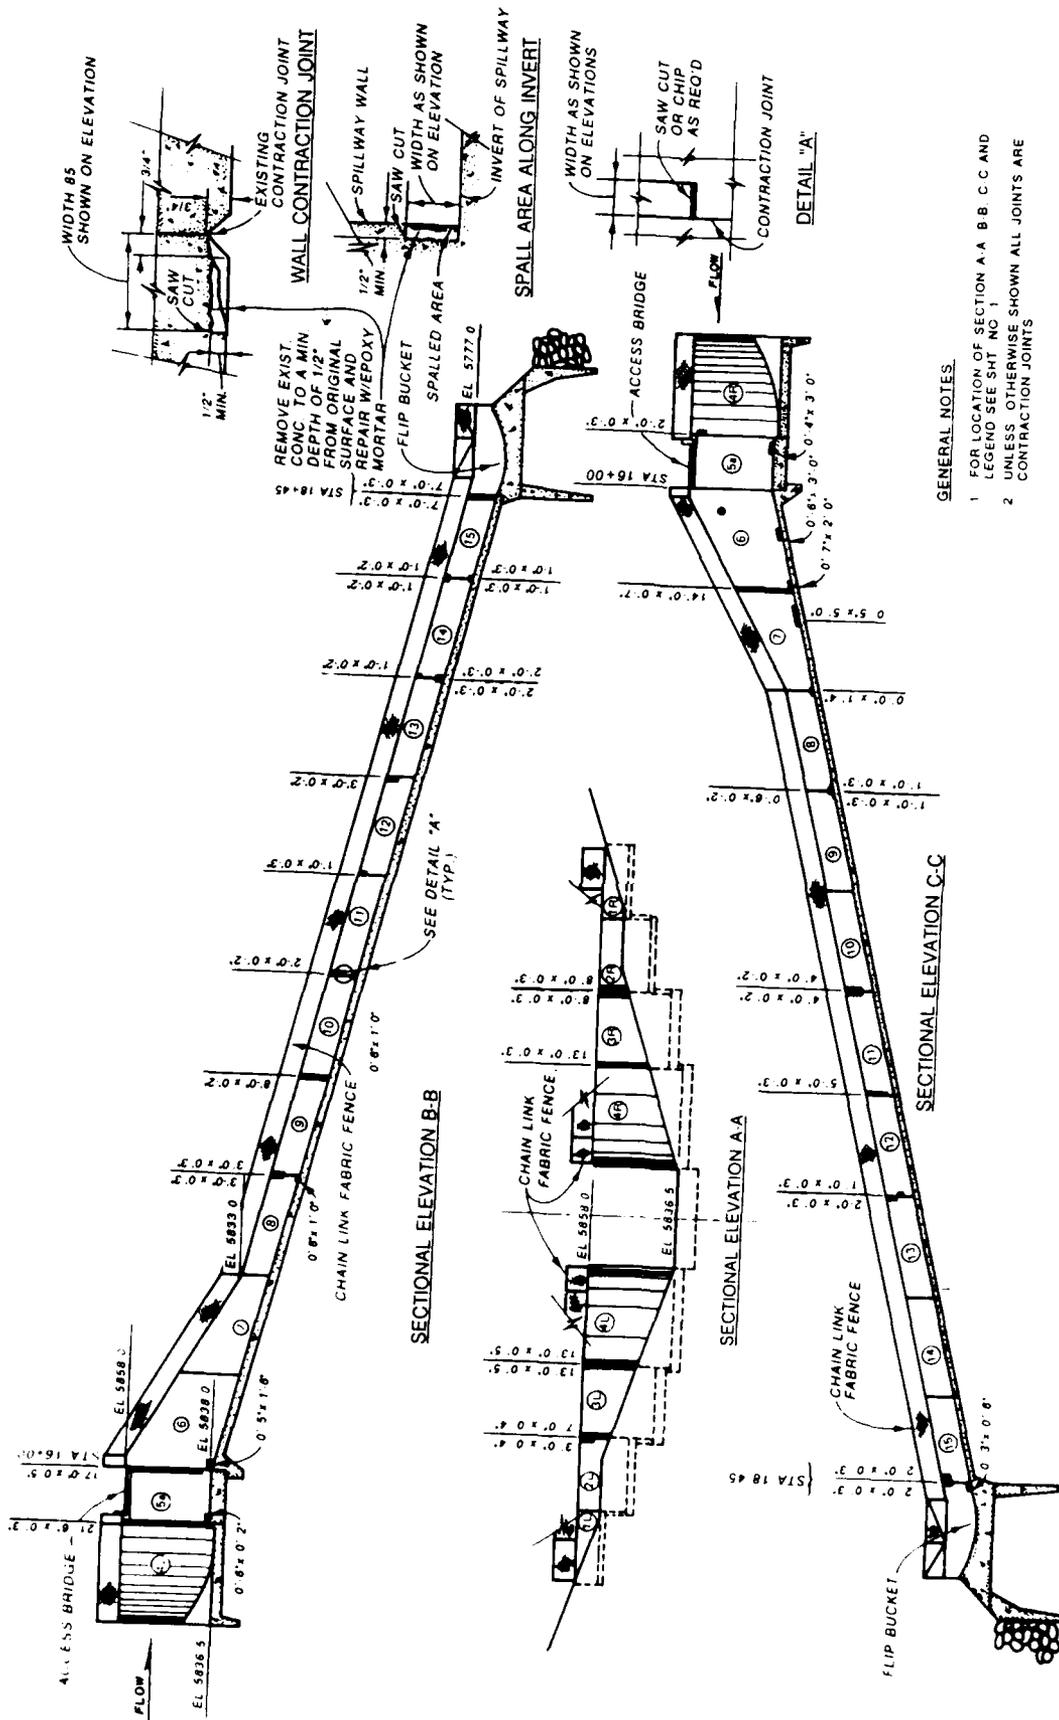
Figure 19. Joint repair details, Martis Creek Lake Dam

22. The epoxy mortar repairs were made by Adhesive Engineering Company. These repairs consisted of saw cutting the area around the spalls and removing the damaged concrete (Figure 19). The surface was then prepared to ensure a clean, dry surface, free of all loose material (Figure 20). The specifications required sandblasting or a high-pressure water jet. The repair area was primed with a thin coat of epoxy prior to the placement of the epoxy mortar. The epoxy, Coneresive 1315, consisted of two components which were thoroughly mixed for 3 to 5 min with a mechanical mixer. Care had to be taken to ensure that no more epoxy was mixed than could be used before the pot life expired.

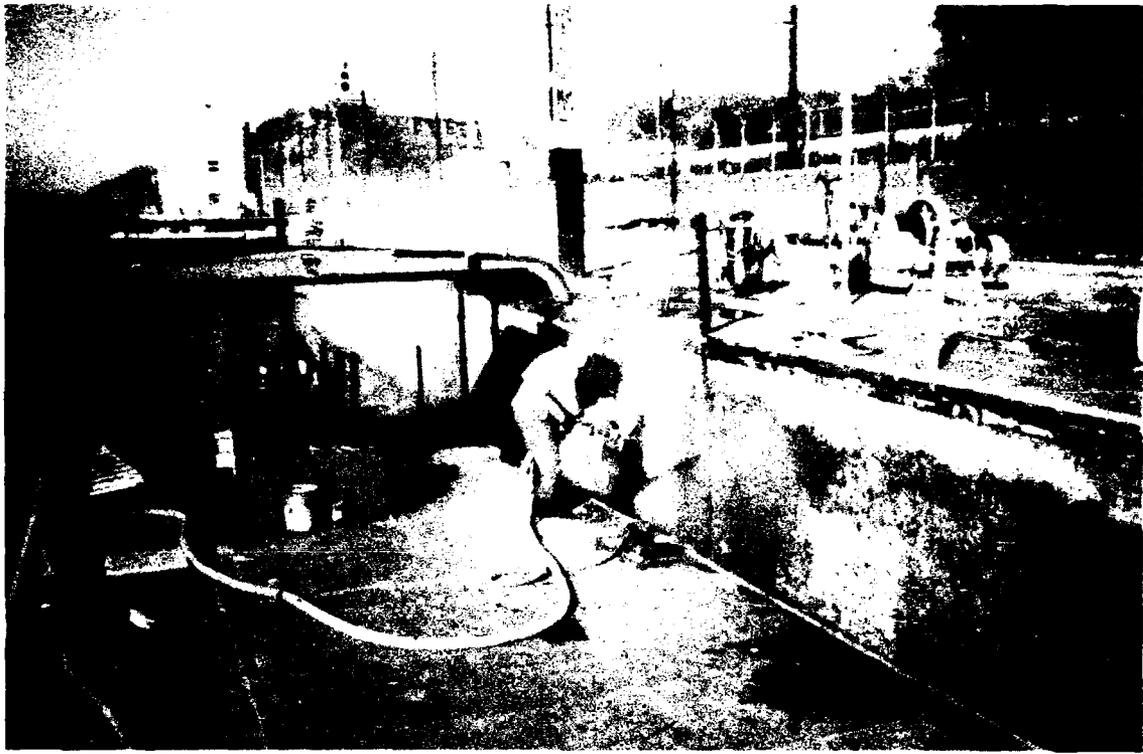
Figure 32. Fibercrete test section, November 1980, Emsworth Locks

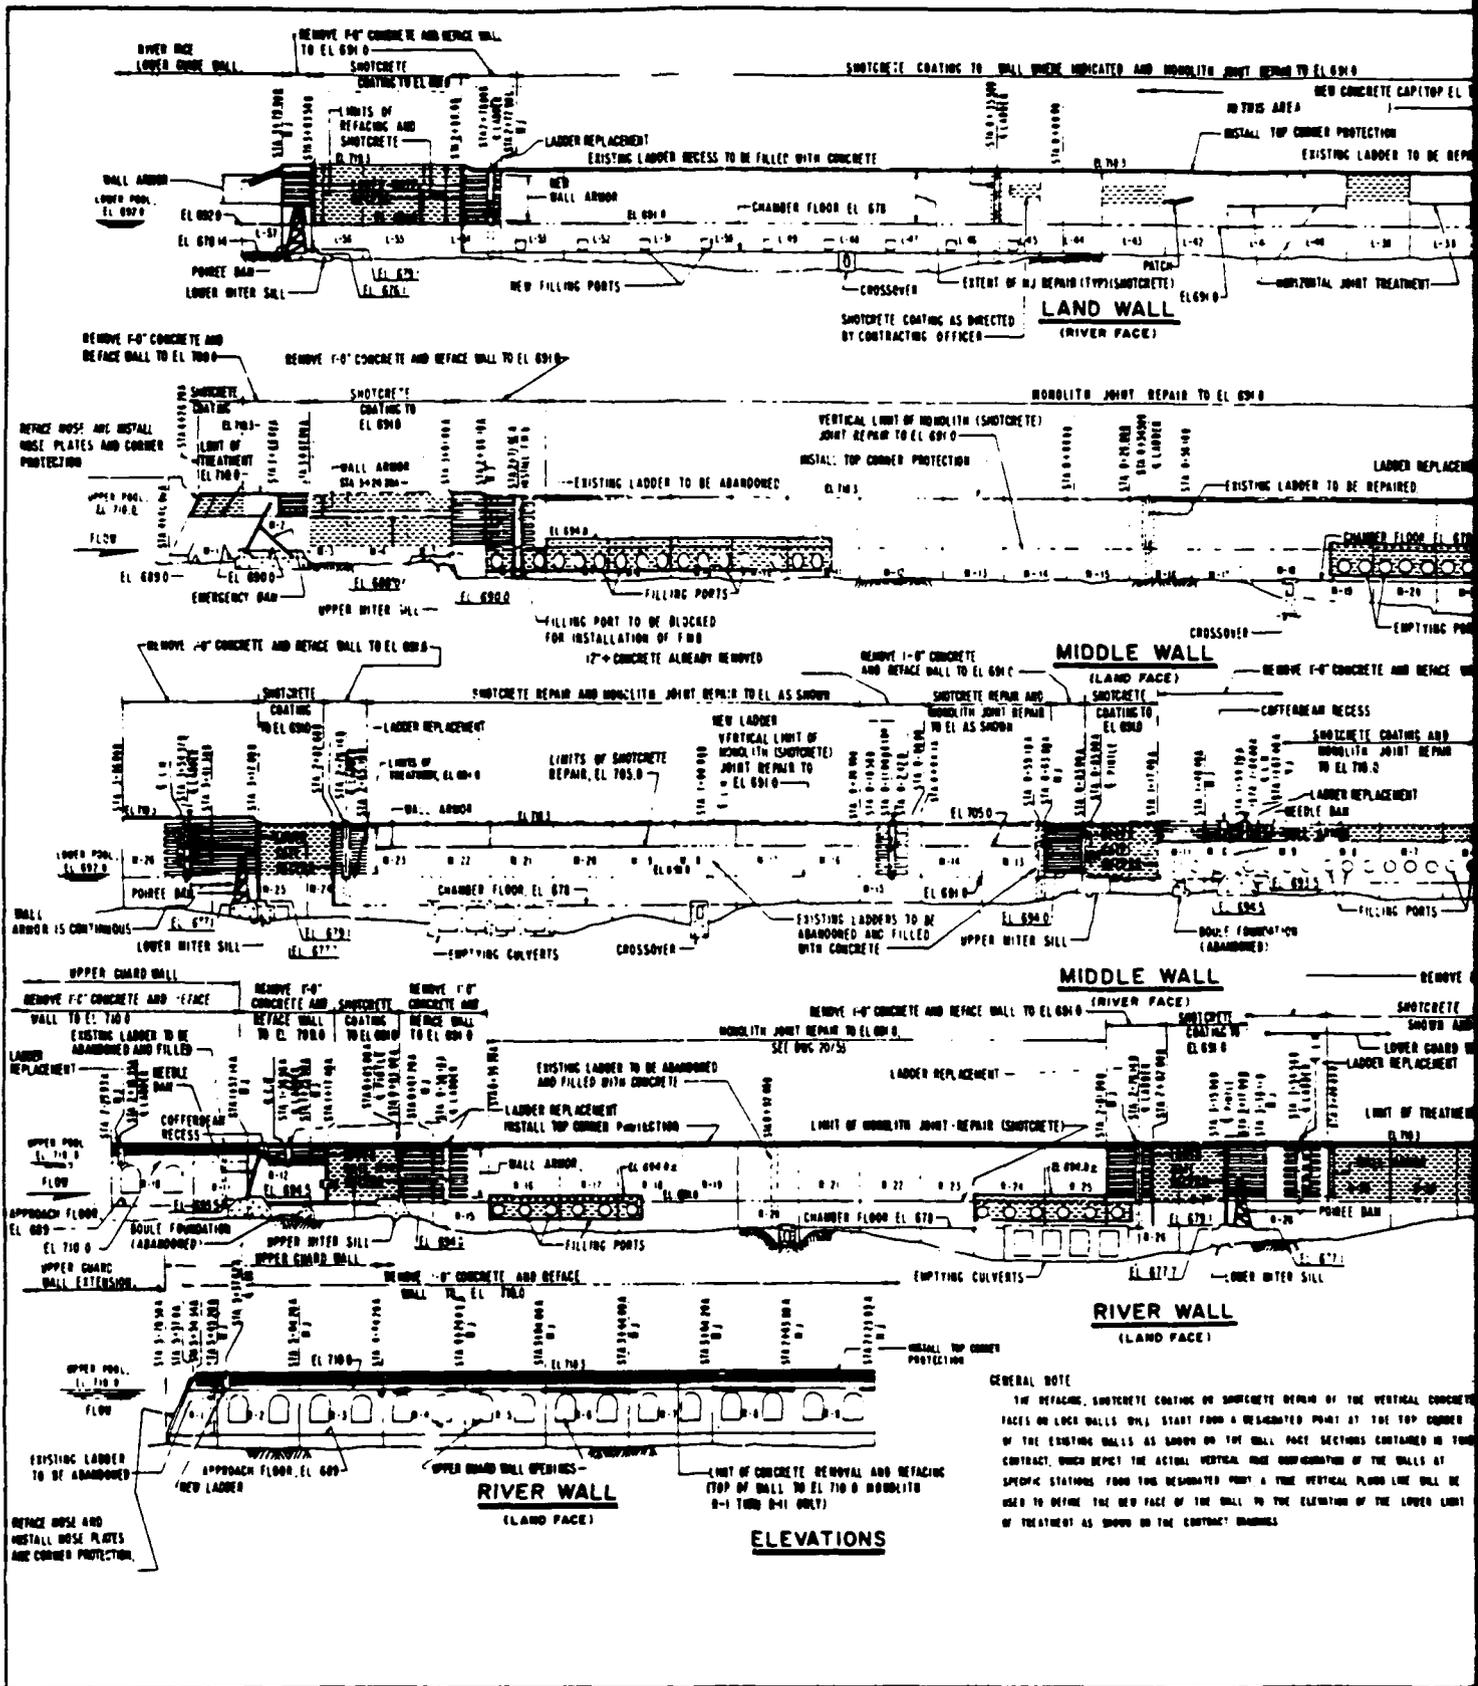
Figure 33. Elevations, lock chamber wall refacing,

34. Navigation traffic through the locks was maintained during the rehabilitation: work on the river chamber was completed before work on the land chamber was begun. Because the land chamber was the primary chamber by virtue of its size, work which would have interrupted navigation traffic was limited to two 30-day periods. The lock walls were refaced with conventional concrete, resurfaced with shotcrete, or coated with shotcrete depending upon the degree of damage in a particular area (Figure 33). The repair extended from 1 ft below the lower pool elevation to the top of the wall.

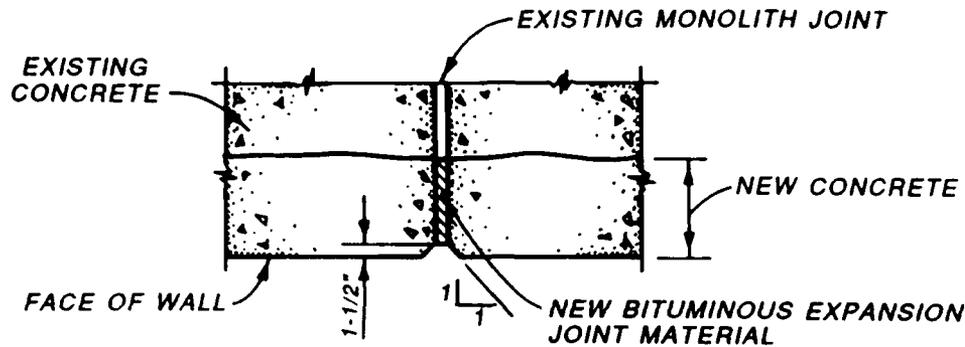
Figure 34. Conventional concrete-refacing monolith joint repair details, Emsworth Locks

35. The conventional concrete-refacing repairs began with the use of explosives to remove the deteriorated concrete to a depth of 1 ft. This repair technique is described in detail in Technical Report REMR-CS-13 (McDonald 1987) and summarized here. The reinforced concrete was designed to have a compressive strength of 3,000 psi at 28 days, a maximum water-cement ratio of 0.50, and a 1-1/2-in. maximum size coarse aggregate. The only special treatment given to the monolith joints during the concrete repairs was the addition of a bituminous expansion joint material and a 45-deg chamfer on each side of the 1-1/8-in.-deep joint (Figure 34).

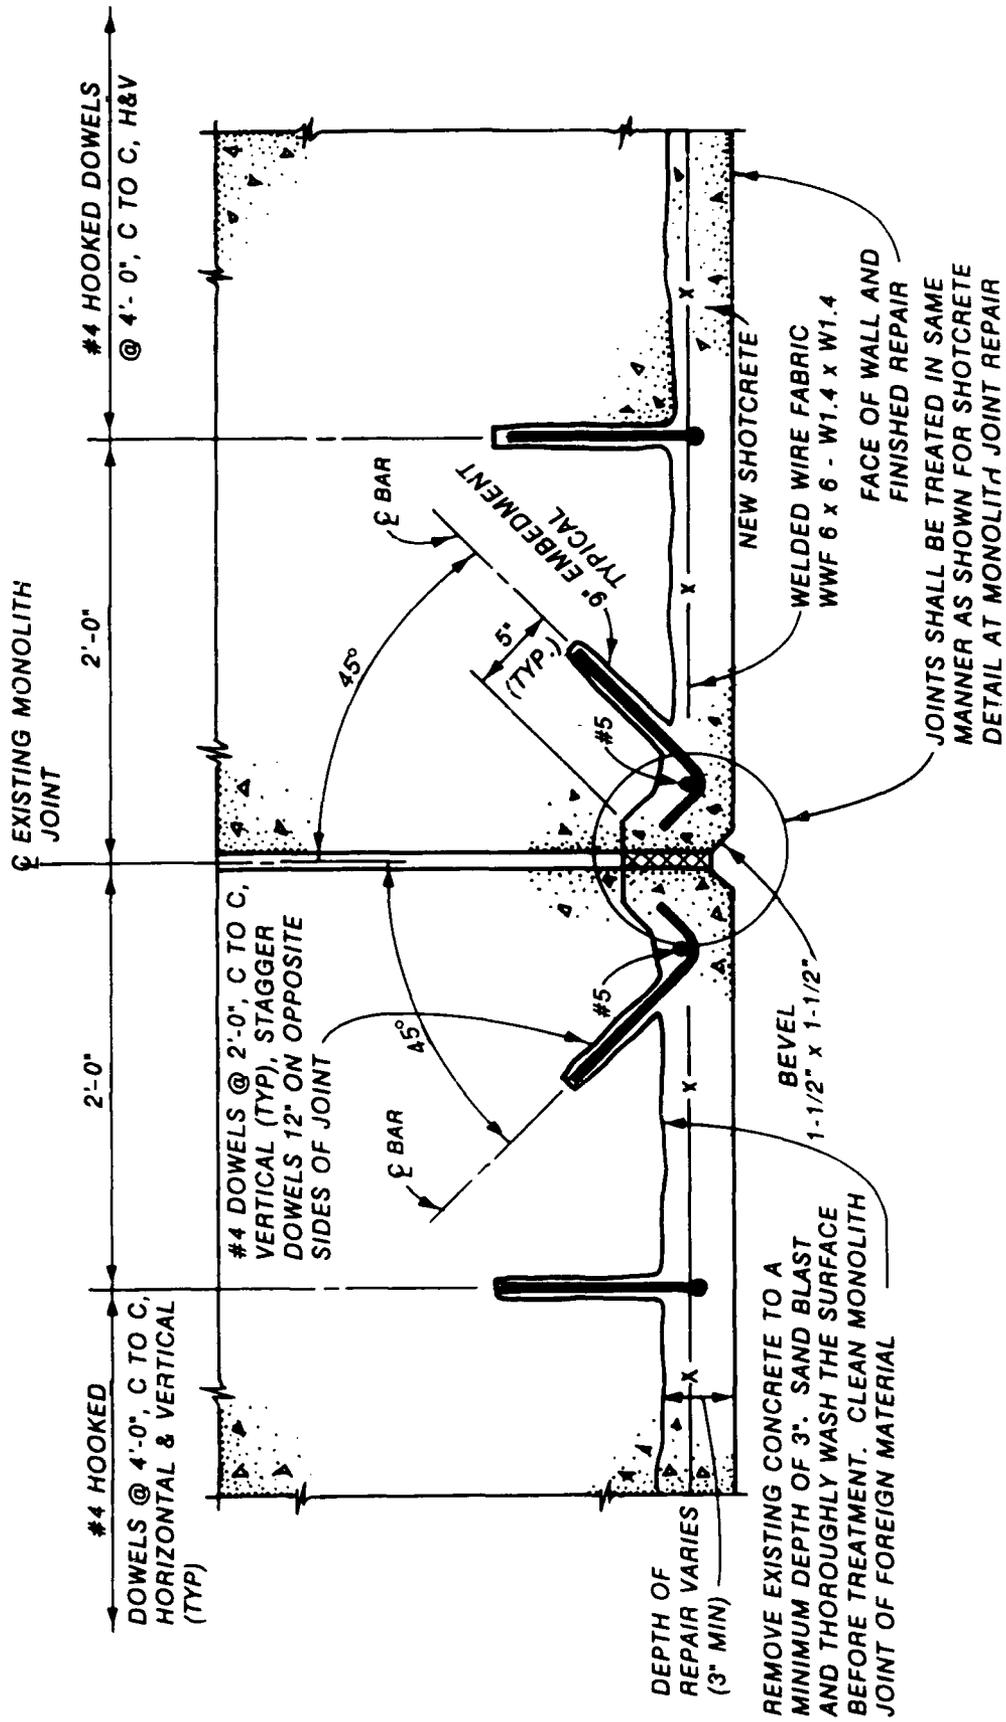
Figure 35. Shotcrete resurfacing monolith joint repair details, Emsworth Locks

accelerator was used to minimize sagging. Hooked dowels were installed on both sides of the monolith joint. A bituminous expansion joint material was placed at the joint and the corners were beveled (Figure 35).

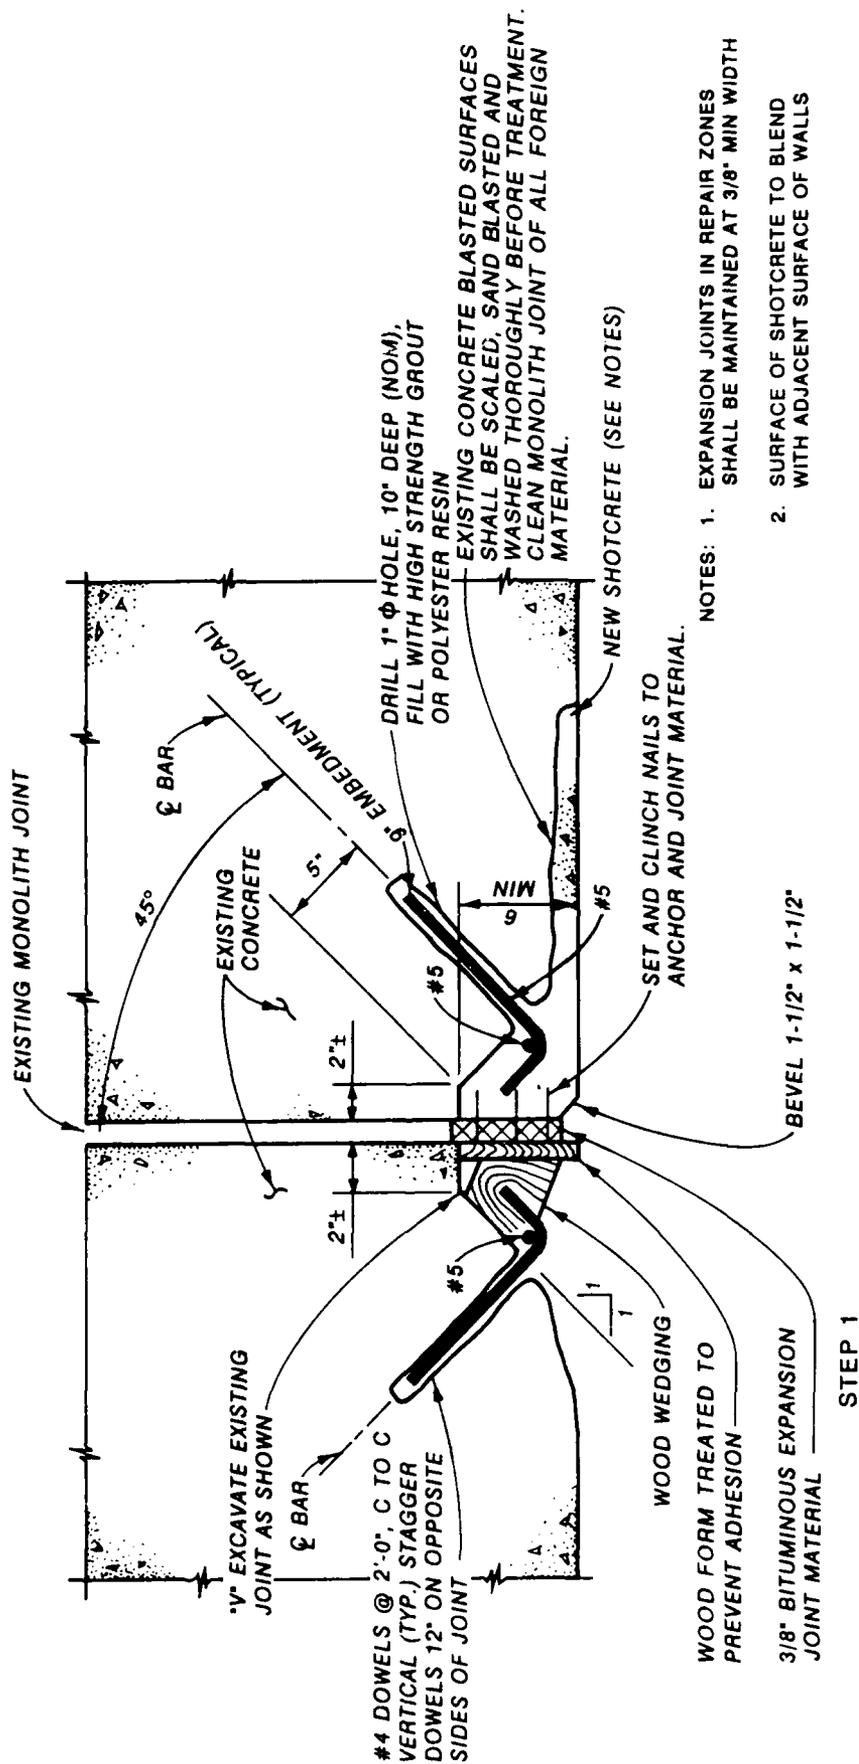
Figure 36. Shotcrete monolith joint repair details, Emsworth Locks

37. Some areas received a shotcrete 3/4-in.-thick coating, while other areas had only the monolith joints repaired. At these monolith joints, 6 in. was the minimum removal depth (Figure 36). Hooked dowels were grouted on both sides of the joint with polyester resin. Expansion joint material was installed and the joint was filled leaving a 45-deg bevel, 1-1/8-in. deep on both sides of the joint (Figure 37).

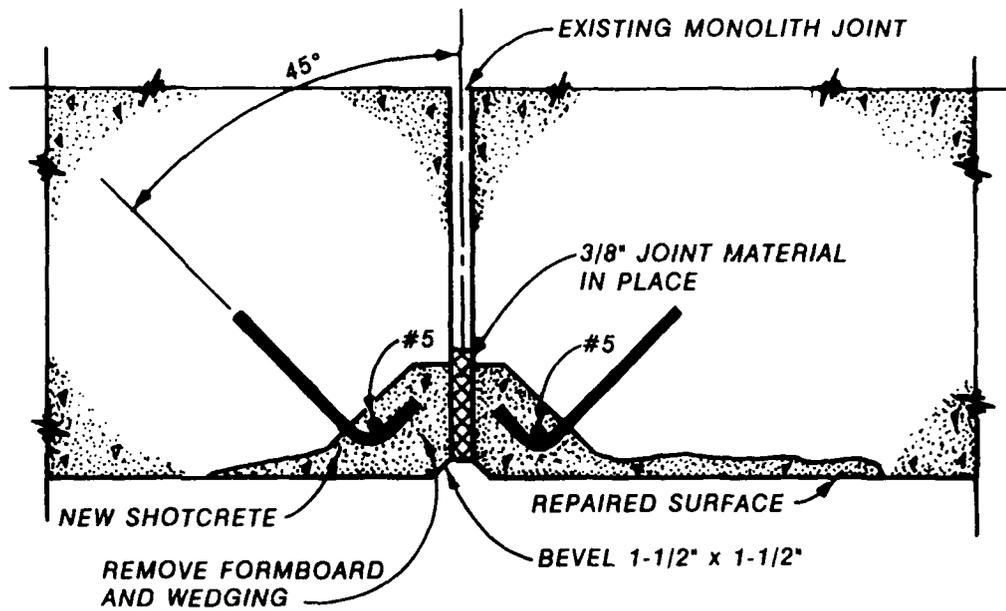
Figure 37. Shotcrete monolith joint repair details,
Emsworth Locks

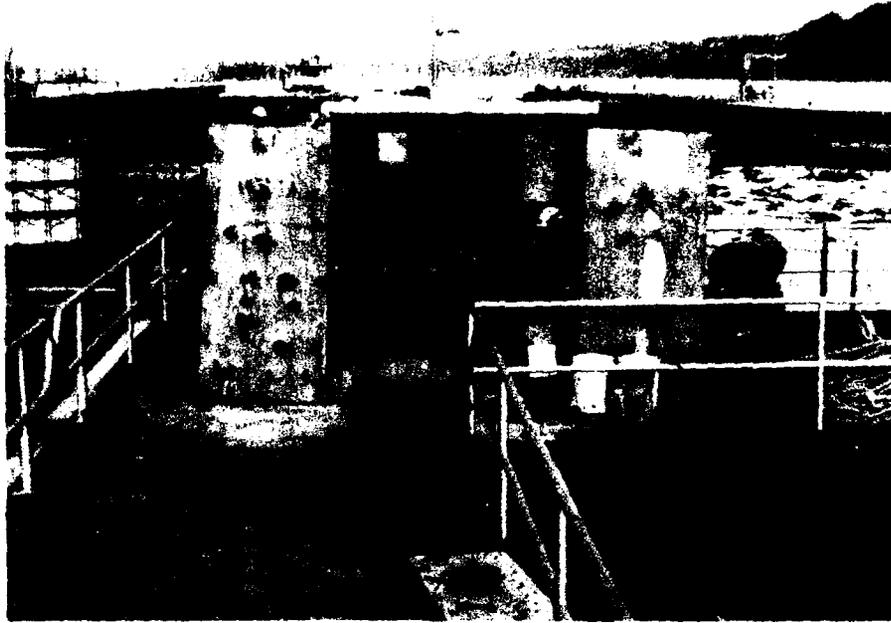
Figure 44. Heated concrete-mixing shelter,
Lock and Dam No. 2

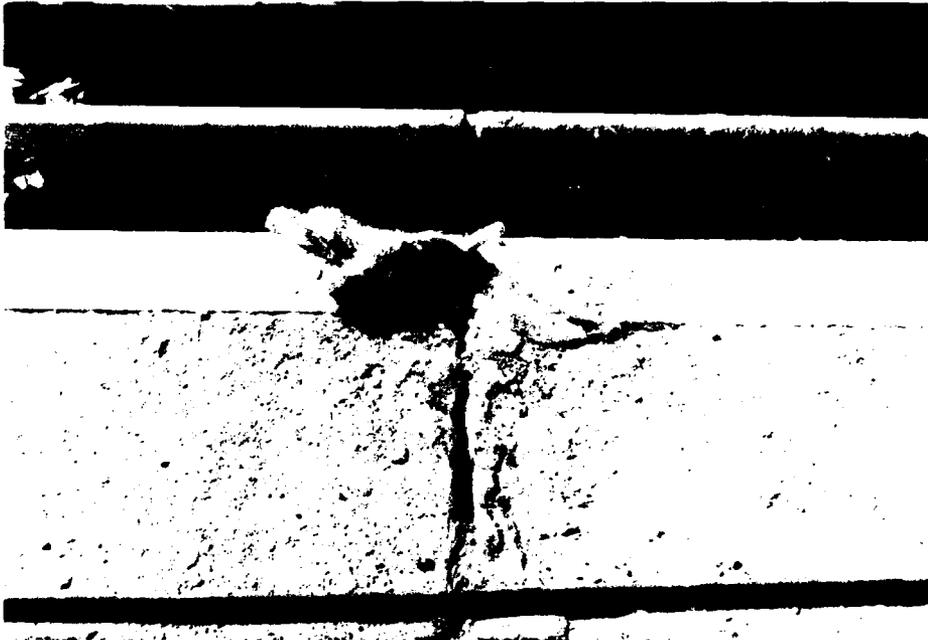
Figure 48. Backing material and oakum in place before
grouting, Lock and Dam No. 2

the gatorboard to be removed, the soft styrofoam center was removed and the plastic faces, previously coated with form oil, released easily. The expansion joint was filled with a water-activated polyurethane foam grout and sealed with a polyurethane joint sealant (Figures 48 through 50).

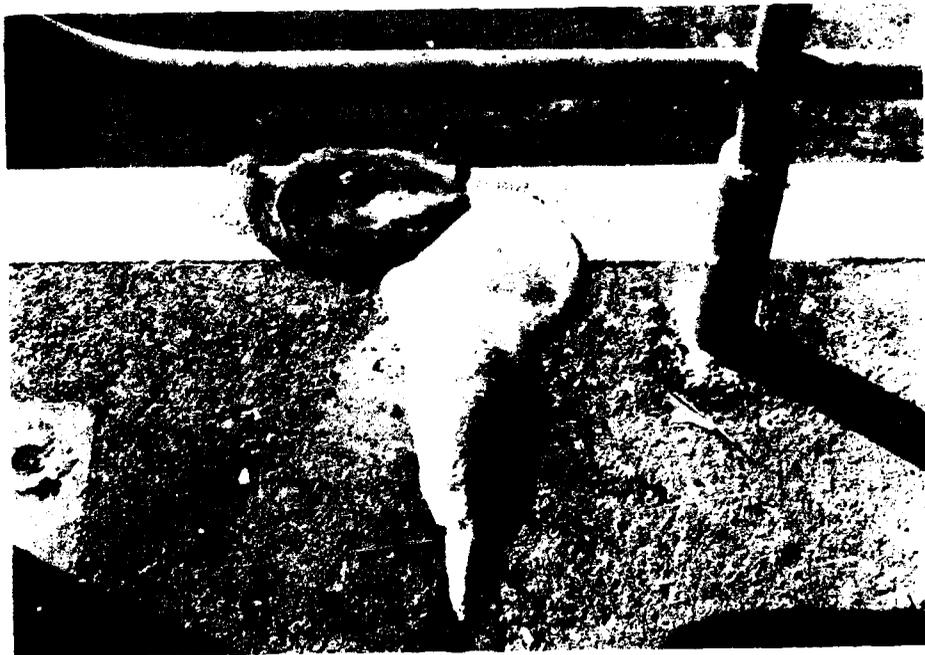
Figure 50. Expanded grout, Lock and Dam No. 2

43. These FRAPMC joint repairs continue to perform well. The same technique and material was used by the USAED, St. Paul, to repair similar spalling at Lock and Dam No. 3 during the 1987-1988 winter.

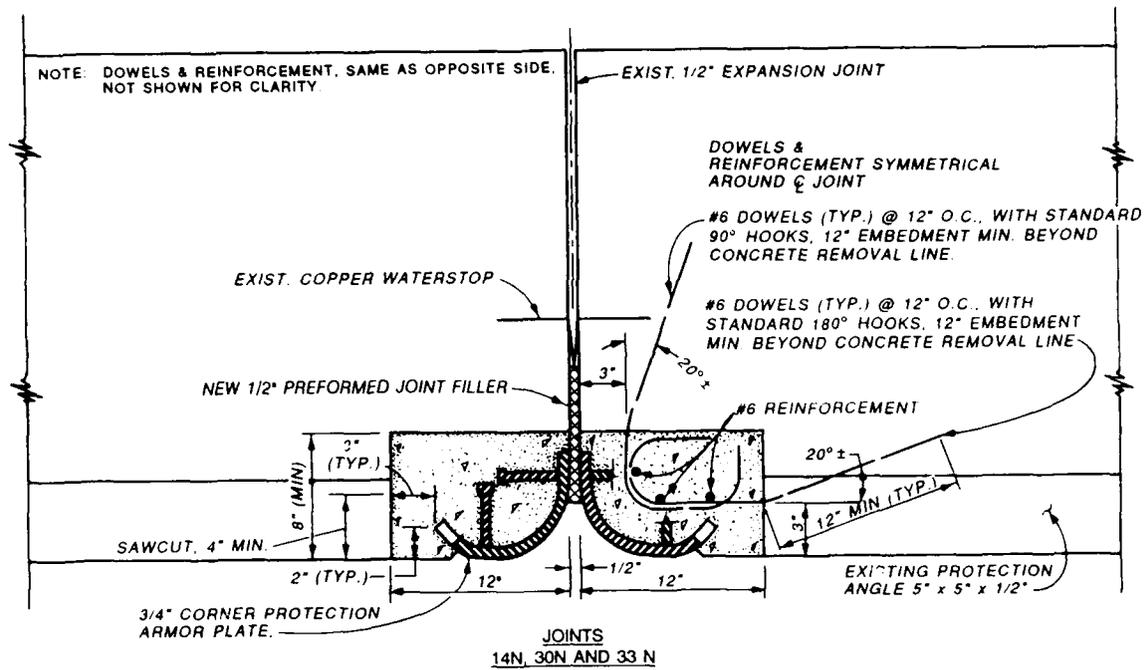
Figure 53. Monolith joint repair details for joints 14N, 30N, 33N, Algiers Lock

47. The first method of joint repair consisted of a modified version of the conventional armor system (Headquarters, Department of the Army, 1979). This system was used on joints 14N, 30N, and 33N. The second repair method consisted of the installation of an ultra-high-molecular weight polyethylene liner to protect the joint. This system was used on joints 15N, 31N, and 34N. Ultra-high-molecular weight polyethylene is a material with excellent impact and abrasion resistance and is not adversely affected by water, temperature changes, ultraviolet rays, or chemical action. It is not subject to corrosion, but if damaged can be easily replaced. This material is currently

48. The procedure for the first repair method began with the removal of the deteriorated concrete around the joint. The contractor used a system of scaffolding hung over the side of the lock as well as scaffolding mounted on a pontoon barge to gain access to the work area. A minimum 4-in.-deep saw cut was made 12 in. on each side of the joint. Concrete was removed a minimum depth of 8 in. with jackhammers. A final removal surface tolerance of plus or minus 1/2 in. was required. Two No. 6 dowels were installed on 12-in. vertical centers on both sides of the joint (Figure 53). One dowel had a standard 90-deg hook and the other had a standard 180-deg hook. All dowels were installed with an epoxy grout. Three No. 6 dowels were installed vertically the entire height of the repair. The concrete surface was prepared by wet sandblasting. No bonding agent was used. Next, the 1/2-in. preformed joint filler was installed. This step was followed by the installation of the 3/4-in.-thick armor with stud anchors along with the formwork. A 3-in. polyvinyl chloride tremie was used to place the new concrete in one continuous 20-ft lift. The concrete was designed to have a 0.45-water-cement ratio and a 90-day compressive strength of 3,000 psi. The 90-day strength requirement was based on the contractor's use of fly ash. After the initial strength had been developed, the formwork was stripped and the concrete was moist cured for 7 days. The armor was coated with a coal tar epoxy paint, and the joint sealant was installed.

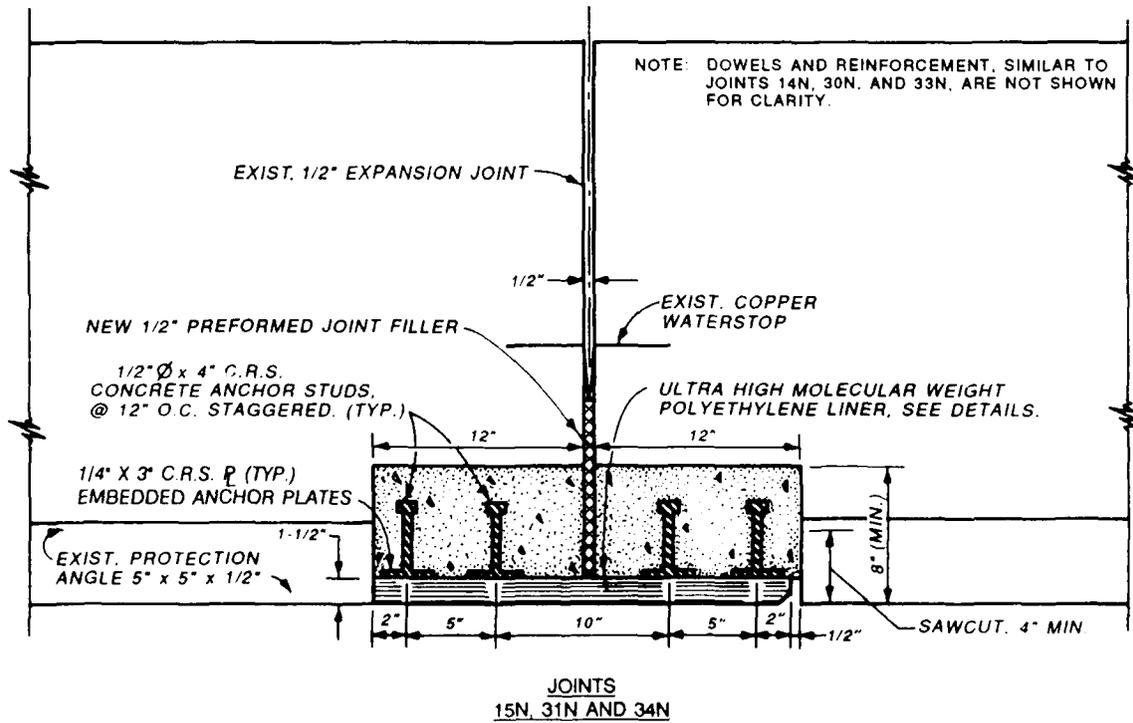
Figure 54. Monolith joint repair details for joints 15N, 31N, and 34N, Algiers Lock

49. The second repair technique used the same procedures for removing concrete and surface preparation. After the surface was prepared, the 1/2-in. preformed joint filler was installed. The ultra-high-molecular weight polyethylene liner was then coated with form-release oil and installed on the inside of the formwork. Simultaneously, the stainless steel studs which had been welded to the concrete anchor plates were placed on 12-in. vertical centers (Figure 54). Again a tremie was used to place the new concrete in one 20-ft lift. After the forms were stripped, the new concrete was moist cured for 7 days. The liner was fixed on one side and free on the other side to compensate for thermal expansion and contraction (Figure 55).

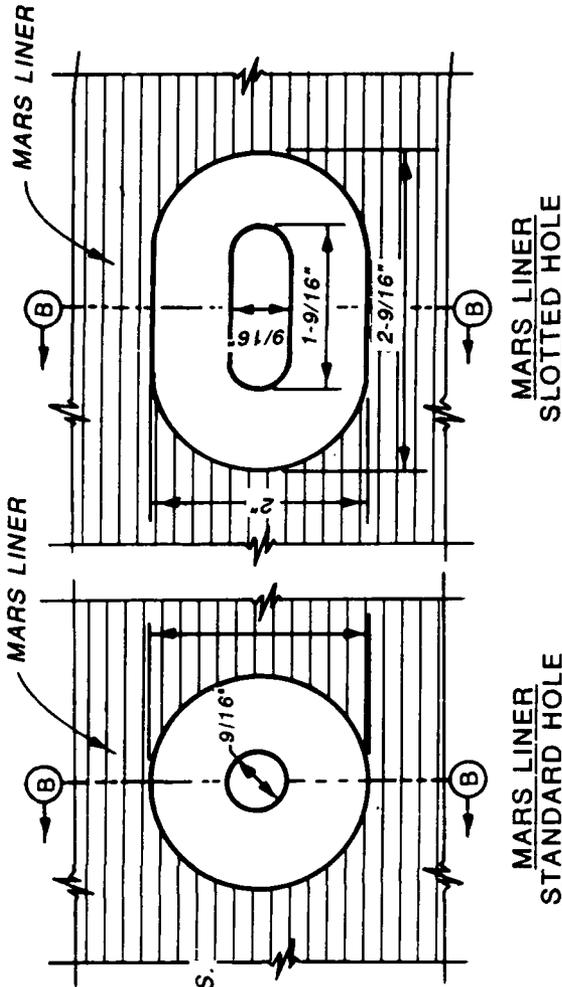
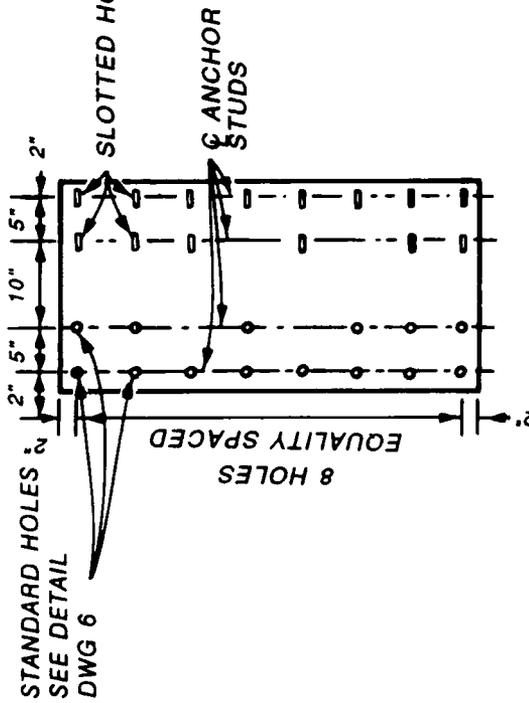
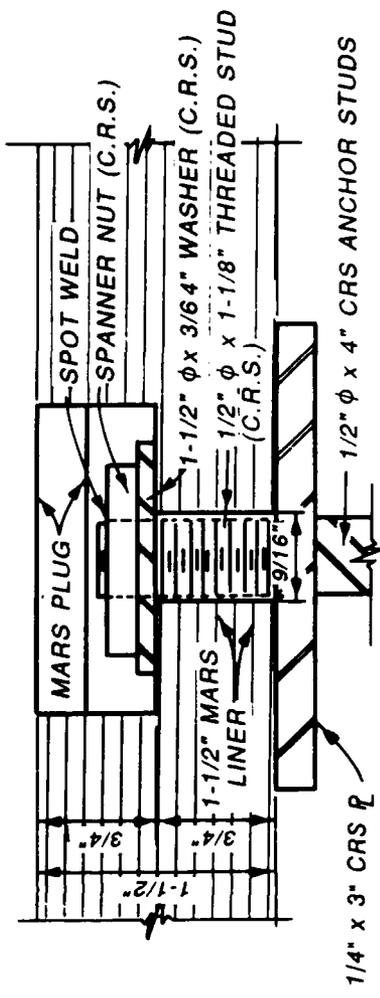
Figure 55. Ultra-high-molecular weight polyethylene liner details, Algiers Lock

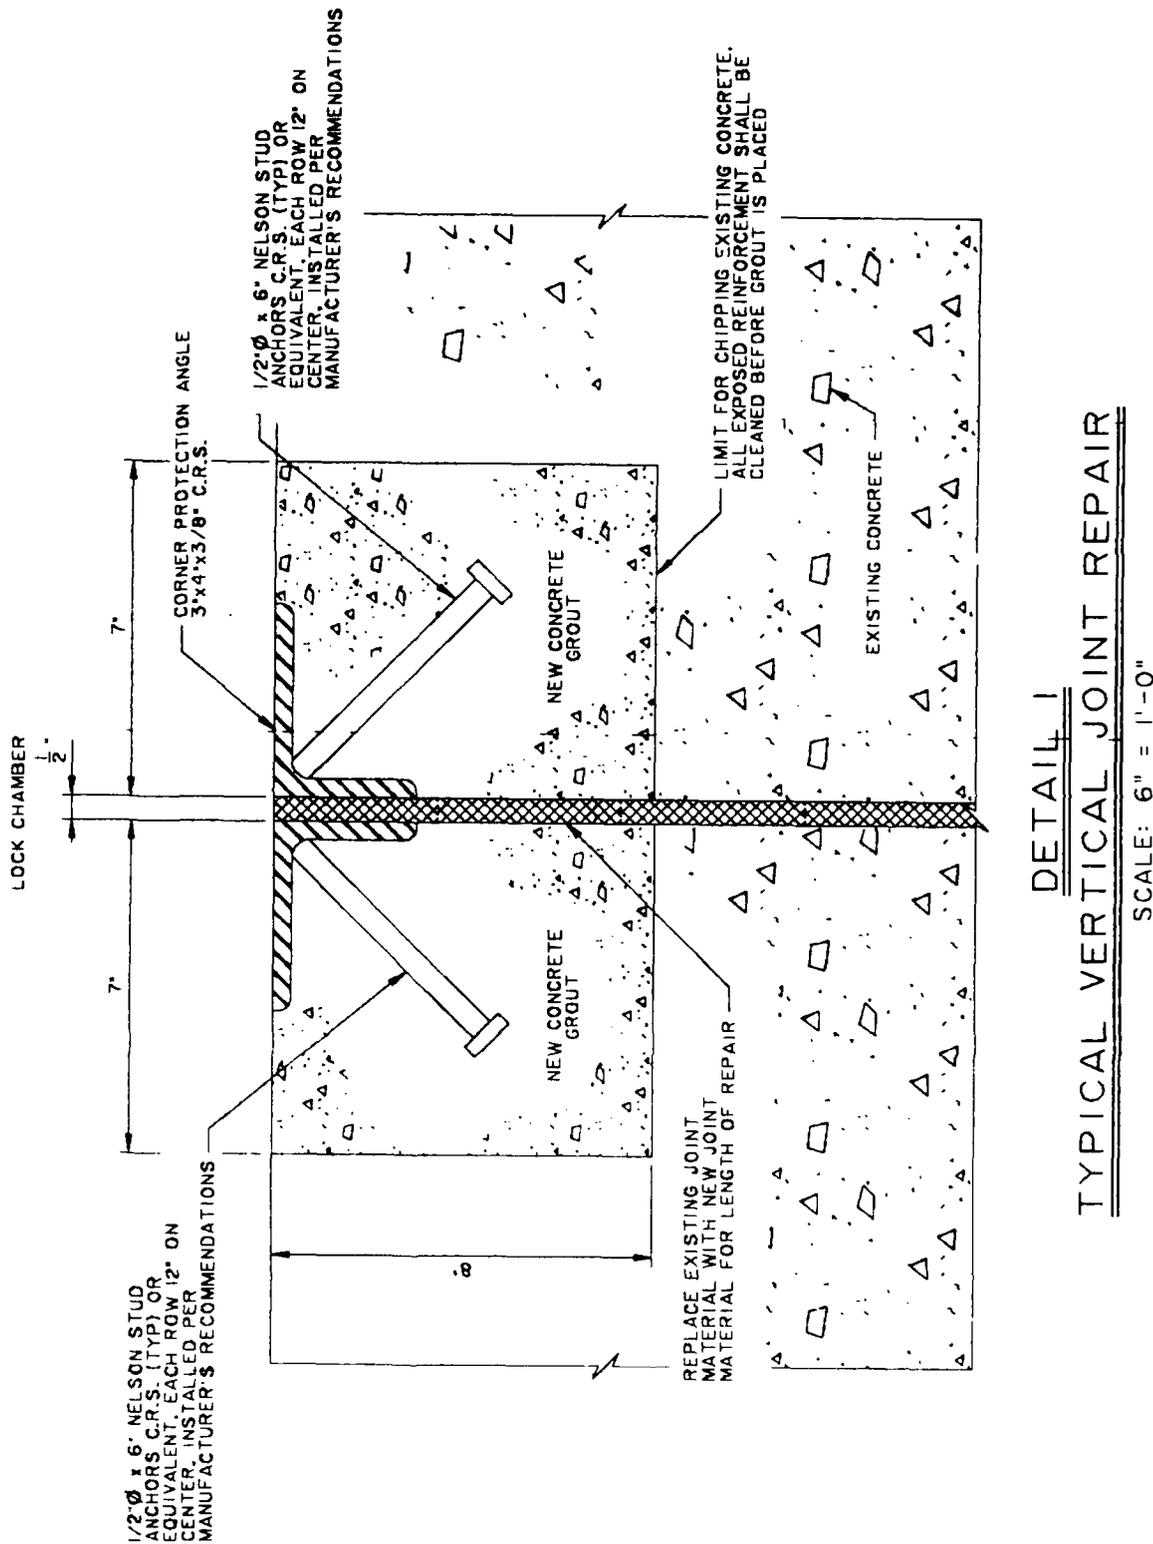
Figure 58. Monolith joint repair details (not final), Bayou Sorrel Lock

53. The repair technique for the monolith joints consists of removing the deteriorated concrete a minimum depth of 8 in. (Figure 58) and then preparing the surface. The formwork would be installed with corner protection angles and Nelson stud anchors attached. New joint filler would be installed the length of the repair, and the repair material would be placed and cured.
