Aircraft Structures Technical Memorandum 515

**FLUTTER INVESTIGATIONS ON A TRANSAVIA PL12/T-400 AIRCRAFT (U)**

A. Goldman, C.D. Rider and P. Piperias

An isolated flutter incident was reported in 1986 involving violent oscillations of the rudder and tail boom. This report details the subsequent activity to find a solution to the problem, and the tests conducted to verify the effectiveness of the solution.

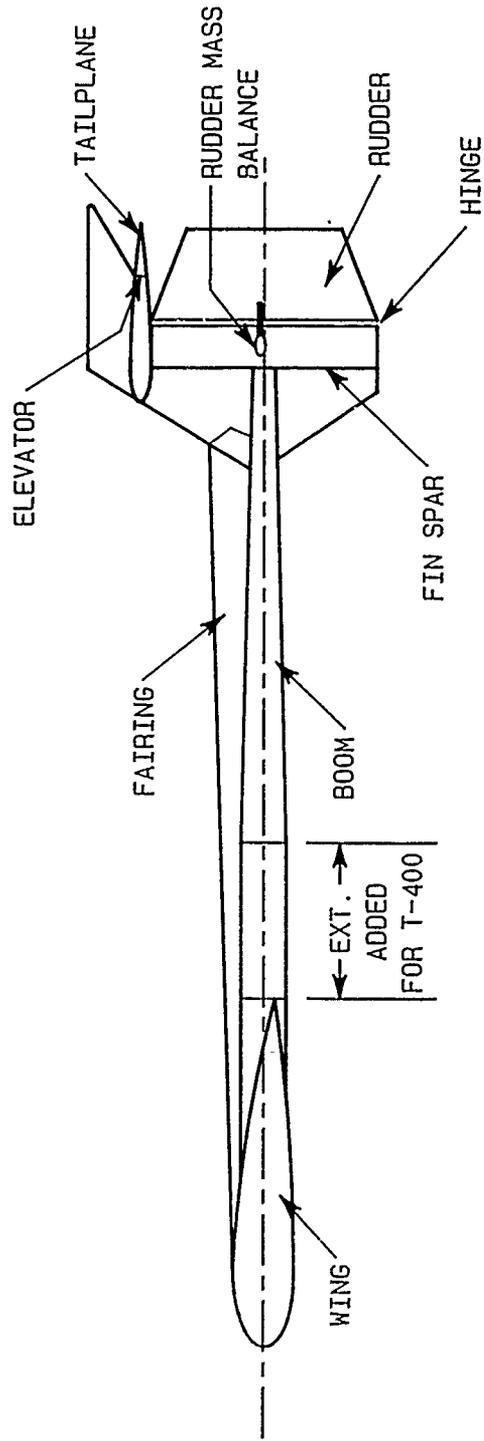
FIG 1. LAYOUT OF WING-BOOM-TAIL OF T-400

Figure 1 shows the layout of the tail boom of the T-400 aircraft. The T-400 aircraft was first flown in 1984 and flutter clearance testing was completed that year (Ref. 1). During the flutter clearance programme, the aircraft was flown up to a speed of 160 knots and shown to be free from flutter, using what were considered at the time to be adequate means of excitation in flight.

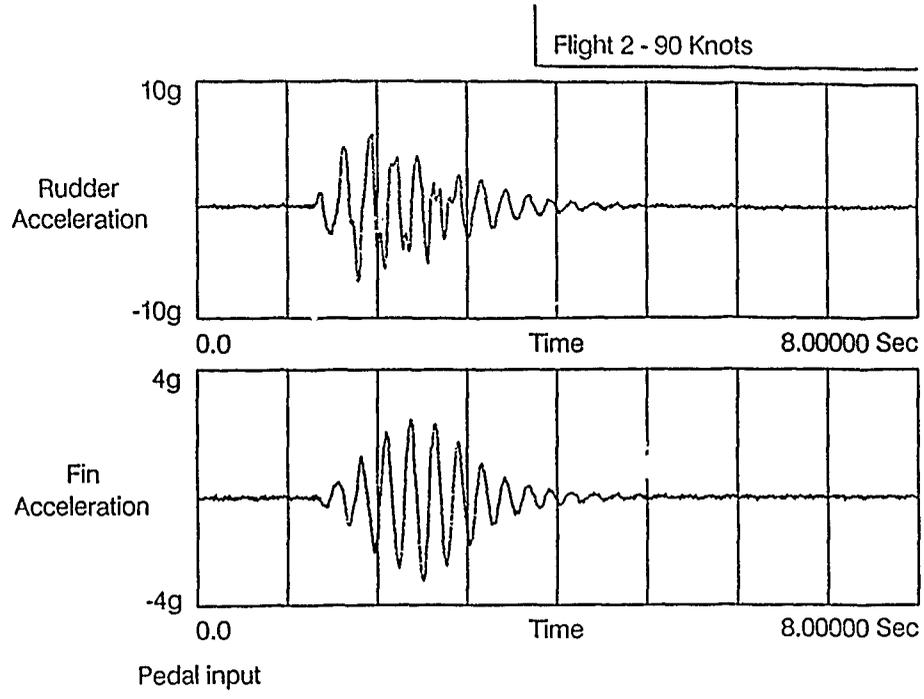
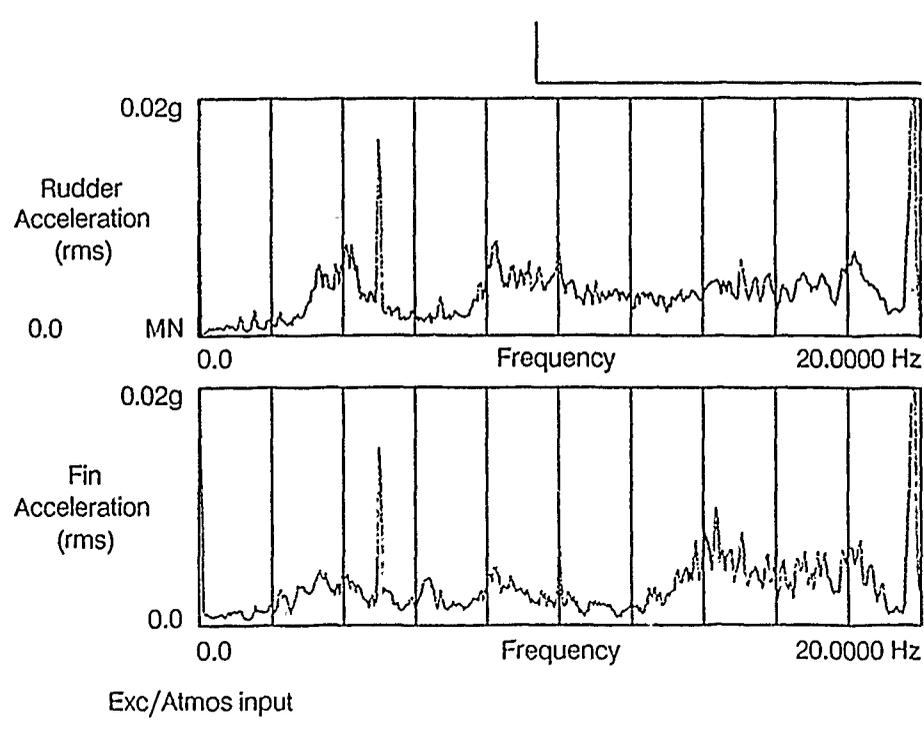
FIG 8a. FLIGHT 2 - 90 KNOTS

Following the fitting of adequate mass balance to the rudder, it will be seen from Figures 7 to 11 that it was not possible to excite this mode of flutter with rudder oscillations up to 800 mm in amplitude. These amplitudes, of course, are in absolute terms and include the fin motion.

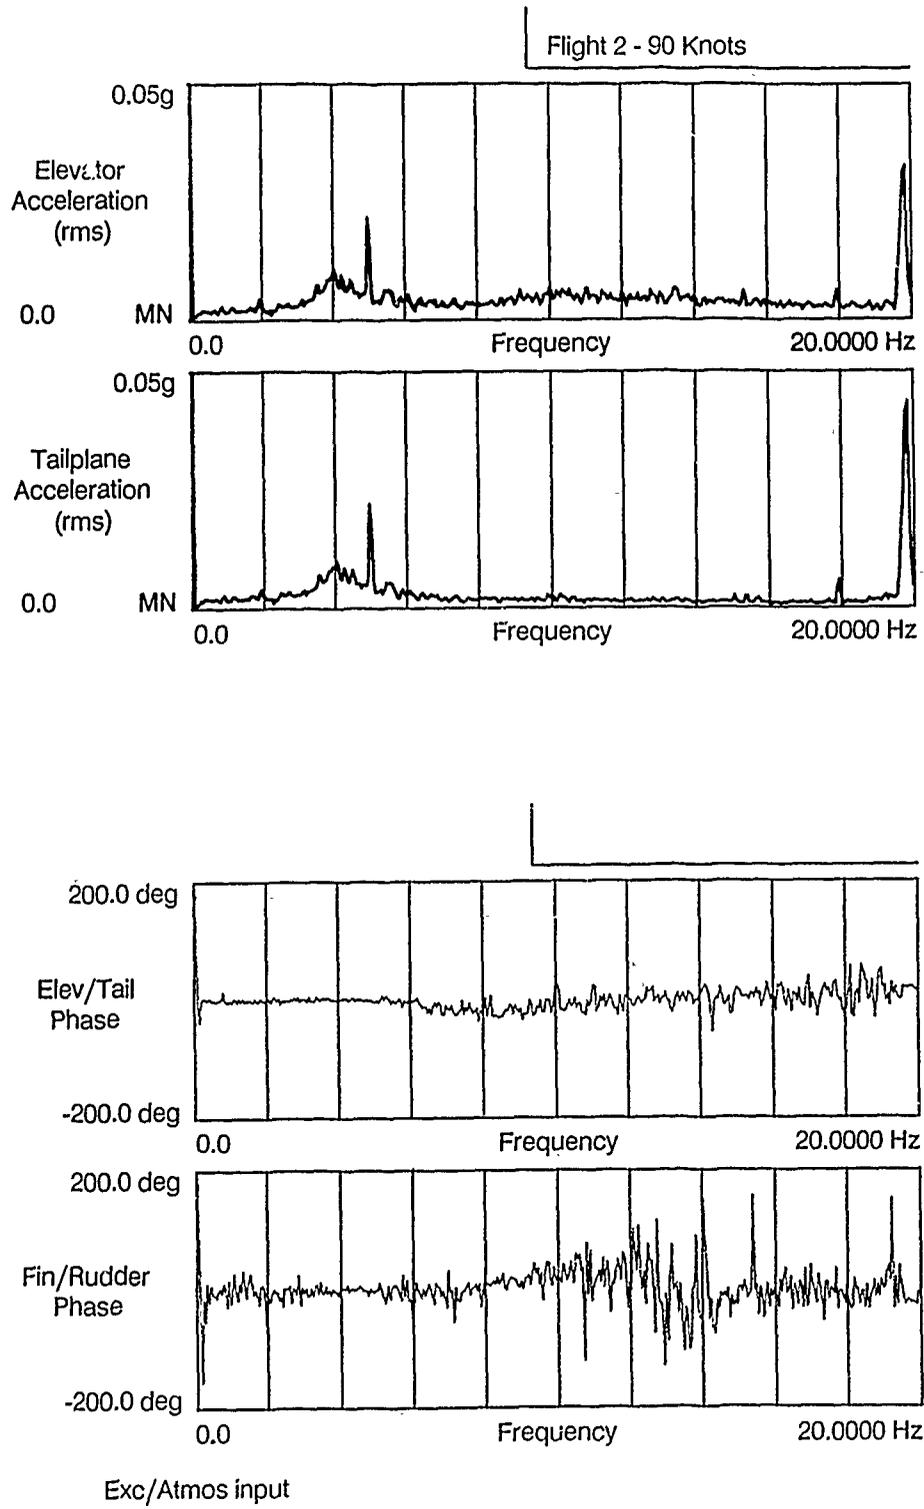
FIG 8b. FLIGHT 2 - 90 KNOTS

Figure 7 to 15 also show the results of FFT frequency analysis of the fin/rudder and tailplane/elevator combinations. The elevator and tailplane locations were included to ensure that no problems had been introduced in the vertical plane by the addition of the rudder mass balance system.
