NASA Technical Memorandum 102681  
USAAVSCOM Technical Report 90-B-003

# Behavior of Composite/Metal Aircraft Structural Elements and Components Under Crash Type Loads--What Are They Telling Us?

Huey D. Carden, Richard L. Boitnott, and Edwin L. Fasanella

May 1990

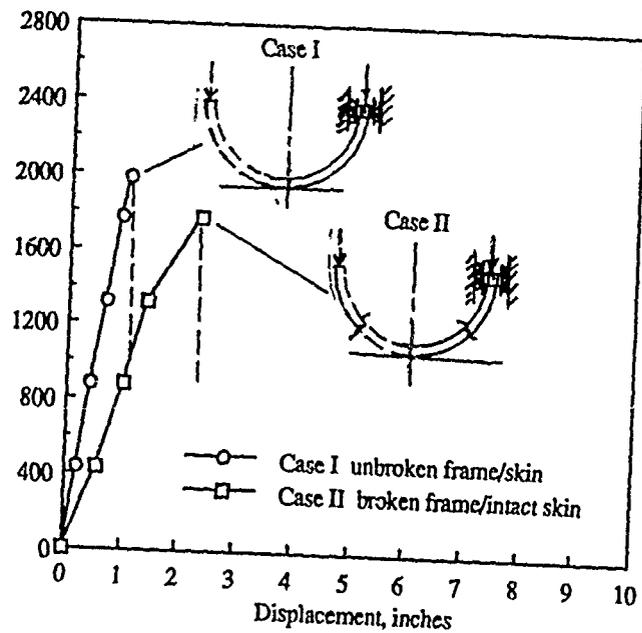
(a) Load-displacement.

Furthermore, a comparison of the analytical cases (figure 12(a)) with the actual static load-deflection of the Z-section (figure 11(b)) indicates very similar load-deflection behavior patterns as discussed above. Although the Z-frame had no skin, if the ends jam together (as they did in several cases), the boundary is effectively between the skin stiffened case and a guided boundary. Thus, the predicted maximum moment location in the simple beam-frame model at about 50 degrees (See figure 12(b)) agrees well with the 54 and 58 degree failure locations in the experiment with the Z-section frame.

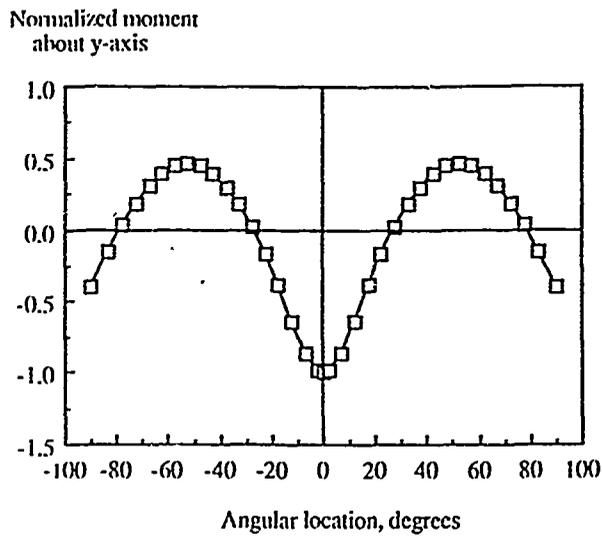
(b) Case I---Normalized moment (Prior to failure).

An examination of the normalized distribution of the bending moment on the frame shown in figure 12(b) provides insight and a better understanding of the failure/behavior. Maximum moments are indicated (just prior to failure) to be at the 0 degree location and between  $\pm 50-60$  degrees from the bottom contact area. The locations correlate well with the failure locations in the experiment with the Z-frame.

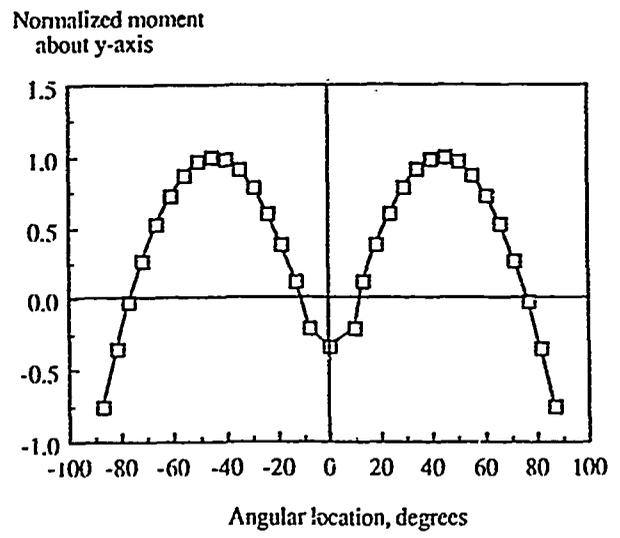
(c) Case II---Normalized moment (Broken frame-intact skin).

Normalized bending moment distribution on the broken frame is presented in Figure 12(c). As may be noted, the distribution is quite similar to the initial model results in figure 12(b). The failure location is at the maximum bending moment location predicted to be about  $\pm 45$  degrees which is somewhat lower than the same location shown in the initial model of the unbroken frame. The agreement between the predicted behavior by the two models, however, is still considered good. The effect of diameter on the moment distribution of the frame was assessed with a model having a 75 inch diameter (twice the initial diameter). The distribution was identical to the smaller diameter results, however, the loads producing the moments differed between the two models (as expected). Moment in terms of geometry and load for a point loaded ring<sup>28</sup> shows that the maximum moment will occur at the same angle for different values of diameter.

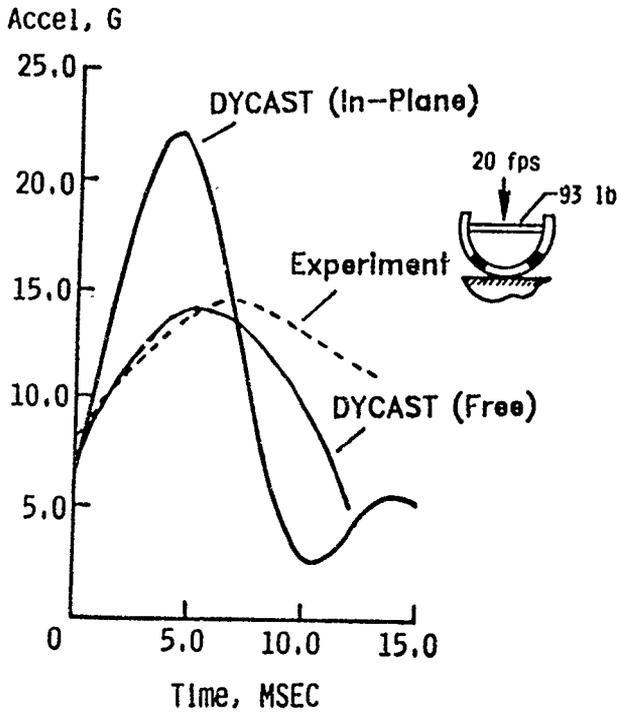
(c) Experimental and analytical accelerations.

**Dynamics analytical studies.**- Experimental and analytical model results for the composite Z-frame subjected to a 20 ft/s impact are shown in Figure 13(c). The first 15 milliseconds of the experimental acceleration of the floor and analytical predictions are shown. In one analysis, in-plane deformations were constrained to the plane of the frame whereas in the other, the frame was free to twist and bend out-of-plane. As noted in the figure, agreement between the "free" model and the experiment is good for the initial peak load. Later the agreement is less because the backstop and clear fence in the experiment, which was not modeled, began to provide support to the twisting and bending frame. The in-plane model results are about 60% higher when compared to the experiment and the free model results. Such results emphasize the importance of knowing and modeling the experimental boundary conditions to understand the dynamic and static behavior of structures under crash loadings. Unfortunately, mixed boundary conditions often exist or occur in the experiment.

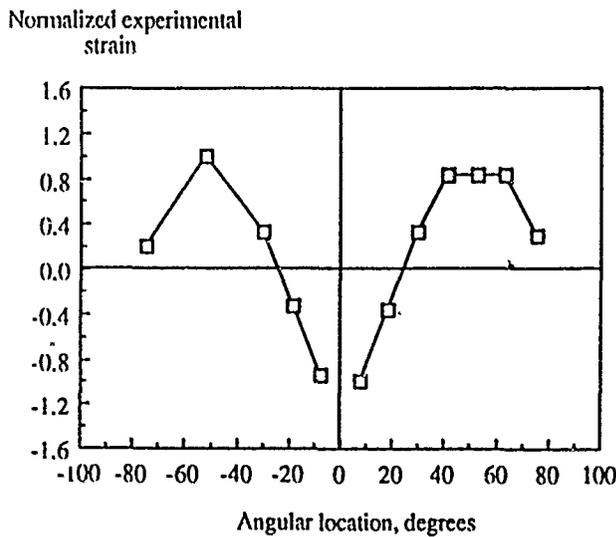
(c) Normalized circumferential strain distribution.

**Dynamic tests.**- A photograph of a skeleton subfloor after an impact test onto a concrete surface at 20 feet per second is shown in Figure 15. In the dynamic test of the skeleton subfloor, fractures were produced at notches in the frames (Figure 15(a)). The locations, shown in figure 15(b), were also near the point of impact (about 11 degrees because of the splice plate) and at three other locations up the circumference of the frames (55 degrees and 78 degrees) totalling 15 fractures for all three frames. The impact energy exceeded the energy absorbed by the local fractures and the floor bottomed out during the impact. The normalized circumferential strain distribution measured on the flange of the front frame during the dynamic test just before first failure is shown in Figure 15(c). A comparison of the measured distribution to the predicted moment distribution of Figure 12(b) and (c) shows essentially identical shape between the single frame and skeleton frame distributions. Maximum values at 0 degrees and at approximately 50 to 55 degrees for the experiment agree well with the analytically predicted locations on the frame.

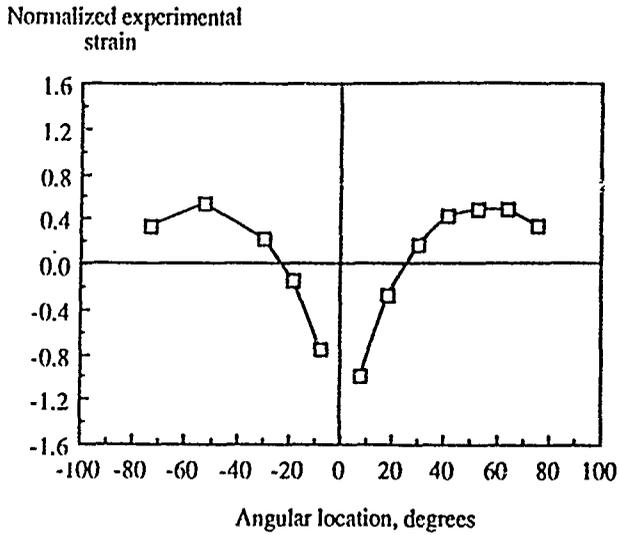
(c) Normalized circumferential strain distribution.

Impact results for the subfloor with skin after an impact of 20 feet per second are shown in Figure 16. A photograph of the subfloor specimen after the test is shown in Figure 16(a). Points of failure of the frames in this specimen are indicated in figure 16(b). Again the points of failure are at or near the impact point (within 12 degrees) and circumferentially at about 56 degrees up both sides of the frame on the middle and back frame and 45, 12 and 22.5 degrees on the front frame. It was observed that the subfloor impacted first on the front area which possibly explains the 12 and 22.5 degree fractures being different from the other locations. Again all three frames were involved in the failures. Some delamination of the frames from the skin was evident but the skin remained intact. Normalized strain distribution (just prior to first failure) measured on the skin at the location of the front frame during the dynamic test showed essentially identical shape as the single frame and skeleton frame distributions. As was the case for the skeleton subfloor maximums at 0 degrees and at approximately 50 to 55 degrees for the experiment agree well with the analytically predicted locations on the frame.

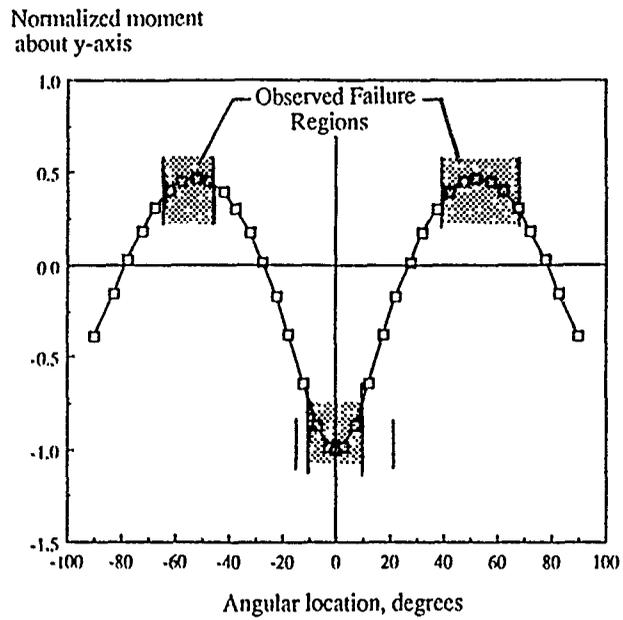
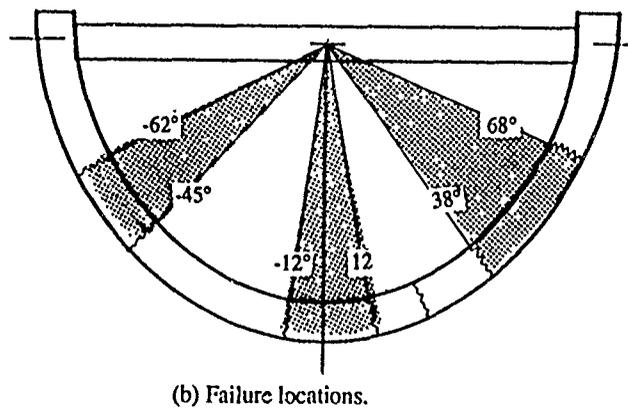
Figure 18. - Comparison of non-dimensional analytical moment distribution predicted by finite element frame model and observed failure locations on metal and composite fuselage components and structures.

The response behavior determined during the studies of full-scale aircraft sections, fuselage frames, and subfloors are summarized in figure 18. Normalized moment distribution on a representative frame of the various specimens are shown in Figure 18(a). Figure 18(b) shows the failure locations which were noted from static and dynamic tests. The visual impression is quite striking among the various specimens. The structures all share in common the generally circular or cylindrical shape, the normal loading situations, and what appears to be a similar pattern of failure behavior. Analytical models of frame structures under vertical loads have moment distributions which have maximums at the point of loading and at approximately 45 to 50 degrees (depending on boundary conditions) around the circumference from the ground contact point. Failures of the structures were noted at these same locations. Such observations may help dynamists gain a clearer understanding of what to expect from such structures in crash loading situations, may guide designers of new structures to account for the vertical crash loads, and allow increased energy absorption to be included in the new designs. Additionally, the observations may help analysts to model the aircraft structures more adequately for predicting the failure responses and behavior under crash situations. The latter task is a difficult and challenging one, not only for composite structures but for metal structures as well. Studies are currently underway to improve the analysis capabilities of current codes and to add composite elements to finite element libraries such as the DYCAST program. In addition, new analysis approaches are being explored through grants to universities as an extension of NASA Langley Research Center's in-house efforts.

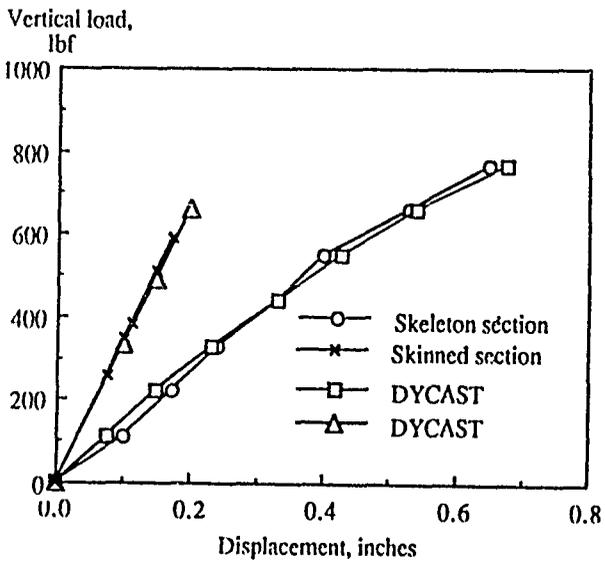
Figure 17. - Comparison of experimental and analytical stiffness of composite skeleton and skinned subfloors.

Analytical studies.-The contribution of the skin to the stiffness of the section with the nonsymmetrical frames is illustrated in figure 17. Static load-deflection data for the unskinned subfloor and the skinned subfloor along with the DYCAST predictions are shown in the figure. It can be noted that the subfloor stiffness (with skin) is approximately three times the stiffness of the skeleton subfloor, thus the skin's contribution to the structure is to maintain in-plane deflections of the non-symmetrical Z-section and prevent any substantial twisting of the frames. Out-of-plane bending and twist were allowed in the skeleton subfloor predictions.
