REPAIR, EVALUATION, MAINTENANCE, AND
REHABILITATION RESEARCH PROGRAM

TECHNICAL REPORT REMR-CO-15

FIELD EVALUATION OF PORT EVERGLADES,
FLORIDA, REHABILITATION OF SOUTH JETTY
BY VOID SEALING

Coastal Engineering Research Center

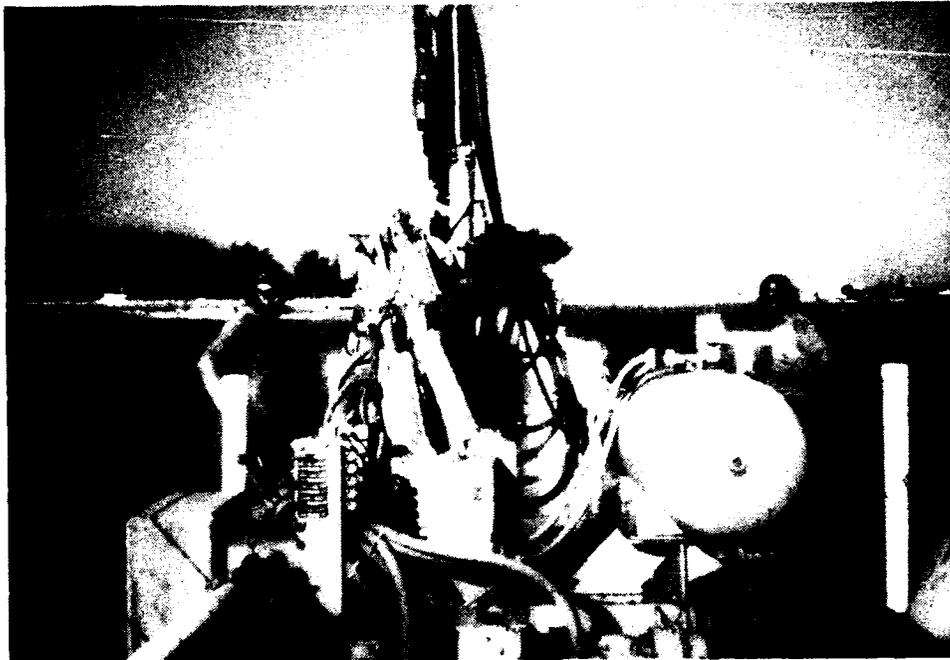
Figure 8. Drilling south jetty at entrance to Port Everglades, Florida

12. The state-of-the-art procedures and material characteristics for sealing coastal structures with cementitious and chemical grout sealants for this project are discussed in detail by Simpson* and Simpson and Thomas.** The 3-1/2-in.-diam sealant holes at 3-ft spacings along the center line of the structure were drilled to previously specified elevations beneath the bed of the structure. The asphalt fishing walkway provided an ideal foundation from which to operate the drilling and sealing operation. Initially, every other hole (primary) was sealed with sodium silicate-cement sealant, which began to "set up" in 70 to 80 sec. After the primary holes were sufficiently strengthened (approximately 24 hr), secondary holes between the primary holes were sealed with the sodium silicate-cement sealant. Usually the quantity of sealant required for the secondary holes was on the order of only 10 percent of the adjacent primary hole quantity. It was expected that this procedure would result in a 4-ft-wide sealant curtain longitudinally within the structure.

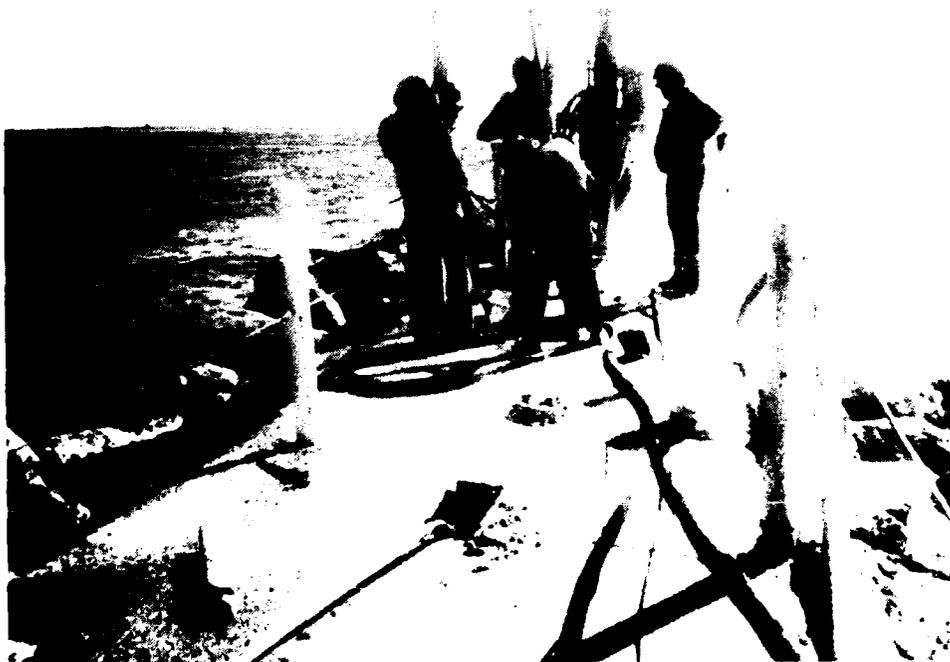
Figure 9. Placing sealant into south jetty at entrance to Port Everglades, Florida

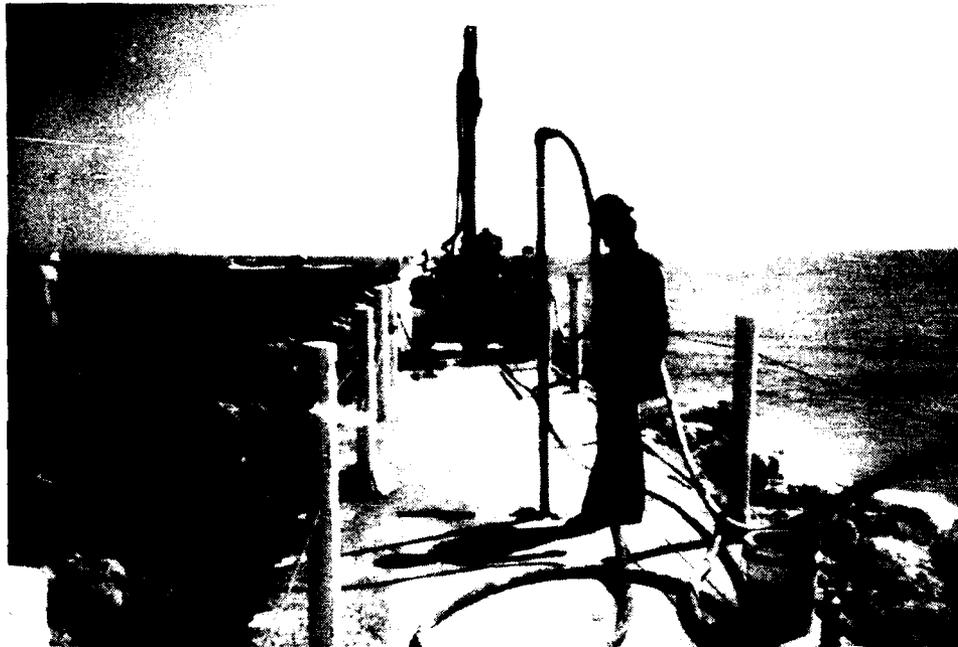
Figure 10. Monitoring sealant level in south jetty
at entrance to Port Everglades, Florida
