WEAR ANALYSIS OF DIESEL ENGINE FUEL INJECTION PUMPS FROM MILITARY GROUND EQUIPMENT FUELED WITH JET A-1

**INTERIM REPORT
BFLRF No. 272**

**Belvoir Fuels and Lubricants Research Facility (SwRI)
Southwest Research Institute
San Antonio, Texas**

**U.S. Army Belvoir Research, Development
and Engineering Center
Materials, Fuels and Lubricants Laboratory
Fort Belvoir, Virginia**

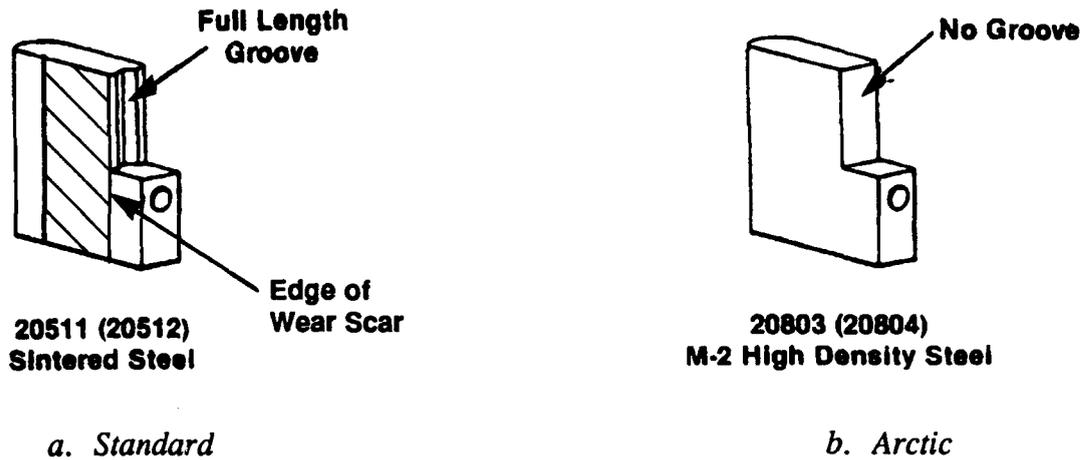
The DB and DC series pumps are designed to operate on low-viscosity/lubricity fuels. Critical components within the pumps have an improved metallurgy, corresponding to the "arctic" conversion for the standard DB2 pump. The upgraded components include the transfer pump liner and blades, the drive tang, and the governor thrust washer. The Rockwell hardness of a number of standard and arctic components is given in TABLE 1. The increased hardness of the arctic parts would be expected to decrease adhesive and abrasive wear, although its effect on corrosive wear is less well defined. Upgraded transfer pump parts may be distinguished from their standard counterparts, as shown in Fig. 1.

The transfer pump section was previously demonstrated to be particularly susceptible to wear.(3) As a result, the transfer pump was the subject of a more detailed study in the present work. A reciprocating motion is formed between the rotor and the transfer pump blade. This action forms a wear scar with a sharp step at the limit of the cycle, at the position shown in Fig. 1. The depth

Figure 1. Diagram of standard and arctic pump vanes
