DOT/FAA/RD-90/17

Analysis of Rotorwash Effects in Helicopter Mishaps

May 1991

Final Report

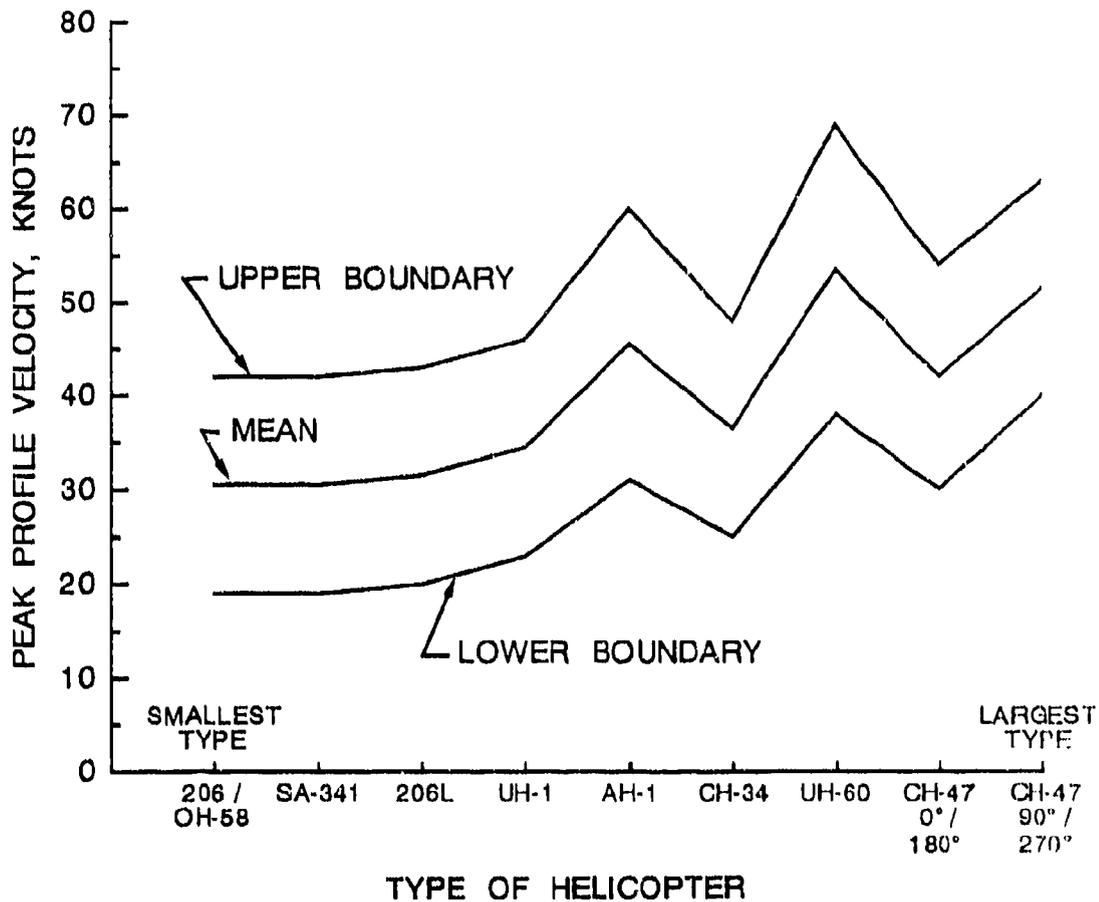
FIGURE 6 ESTIMATED THRESHOLD ROTORWASH VELOCITY MEAN VALUES AND RANGES FOR ALL HELICOPTER MISHAPS INVOLVING DOOR AND COWLING DAMAGE

The alternative analysis approach is to define a velocity range containing the unknown threshold value of rotorwash and assign a qualitative level of confidence to the range. An upper boundary defining the threshold velocity range can be estimated using figure 4 by connecting the maximum velocity values for the 9 knot data. A lower boundary can likewise be estimated by connecting the 4 foot velocity values for the 0 knot wind data. A set of mean values for each rotorcraft type can be calculated by adding these 2 values and dividing by 2. Results from the accomplishment of this task are presented in figure 6. The first observation obtained from these data is that threshold velocity ranges for 3 types of helicopters, the AH-1, UH-60, and CH-47 (at 90 degrees), are shifted toward higher velocities when compared with similar data from the remaining 6 helicopter types. A quick review of figure 4 data indicated that for a combined total of 28 mishaps, only 5 mishaps involved the AH-1, UH-60, and CH-47. The majority of these 5 mishap reports were also very poorly documented. Since use of these suspect data in the analysis would result in separation guidelines for small helicopters being quite close to those for large helicopters (intuitively wrong), one must conclude that too few data exist for a proper analysis of the AH-1, UH-60, and CH-47 (at 90 degrees). If these suspect data are dropped from the analysis, the modified velocity boundaries are as presented in figure 7.

One can assume in analyzing the figure 7 data that the probability of the threshold rotorwash value being near the lower boundary (mid gross weight, 4 foot height, 0 knot wind) is small because the wind is rarely calm. Also, the use of this boundary would result in the specification of large separation distances in the presence of ambient winds. These large separation distances would be highly restrictive to what presently appear to be very safe heliport operations. Likewise, the upper boundary (heavy gross weight, 9 knot wind) would appear not restrictive enough. This is because separation boundaries would be based on a large value of threshold velocity, the most liberal interpretation of available mishap data. Also, no proof exists that even the majority of the reported mishaps occurred in 9 knot crosswind conditions. Therefore, although based on data influenced by several key assumptions, a logical deduction is that the threshold rotorwash velocity

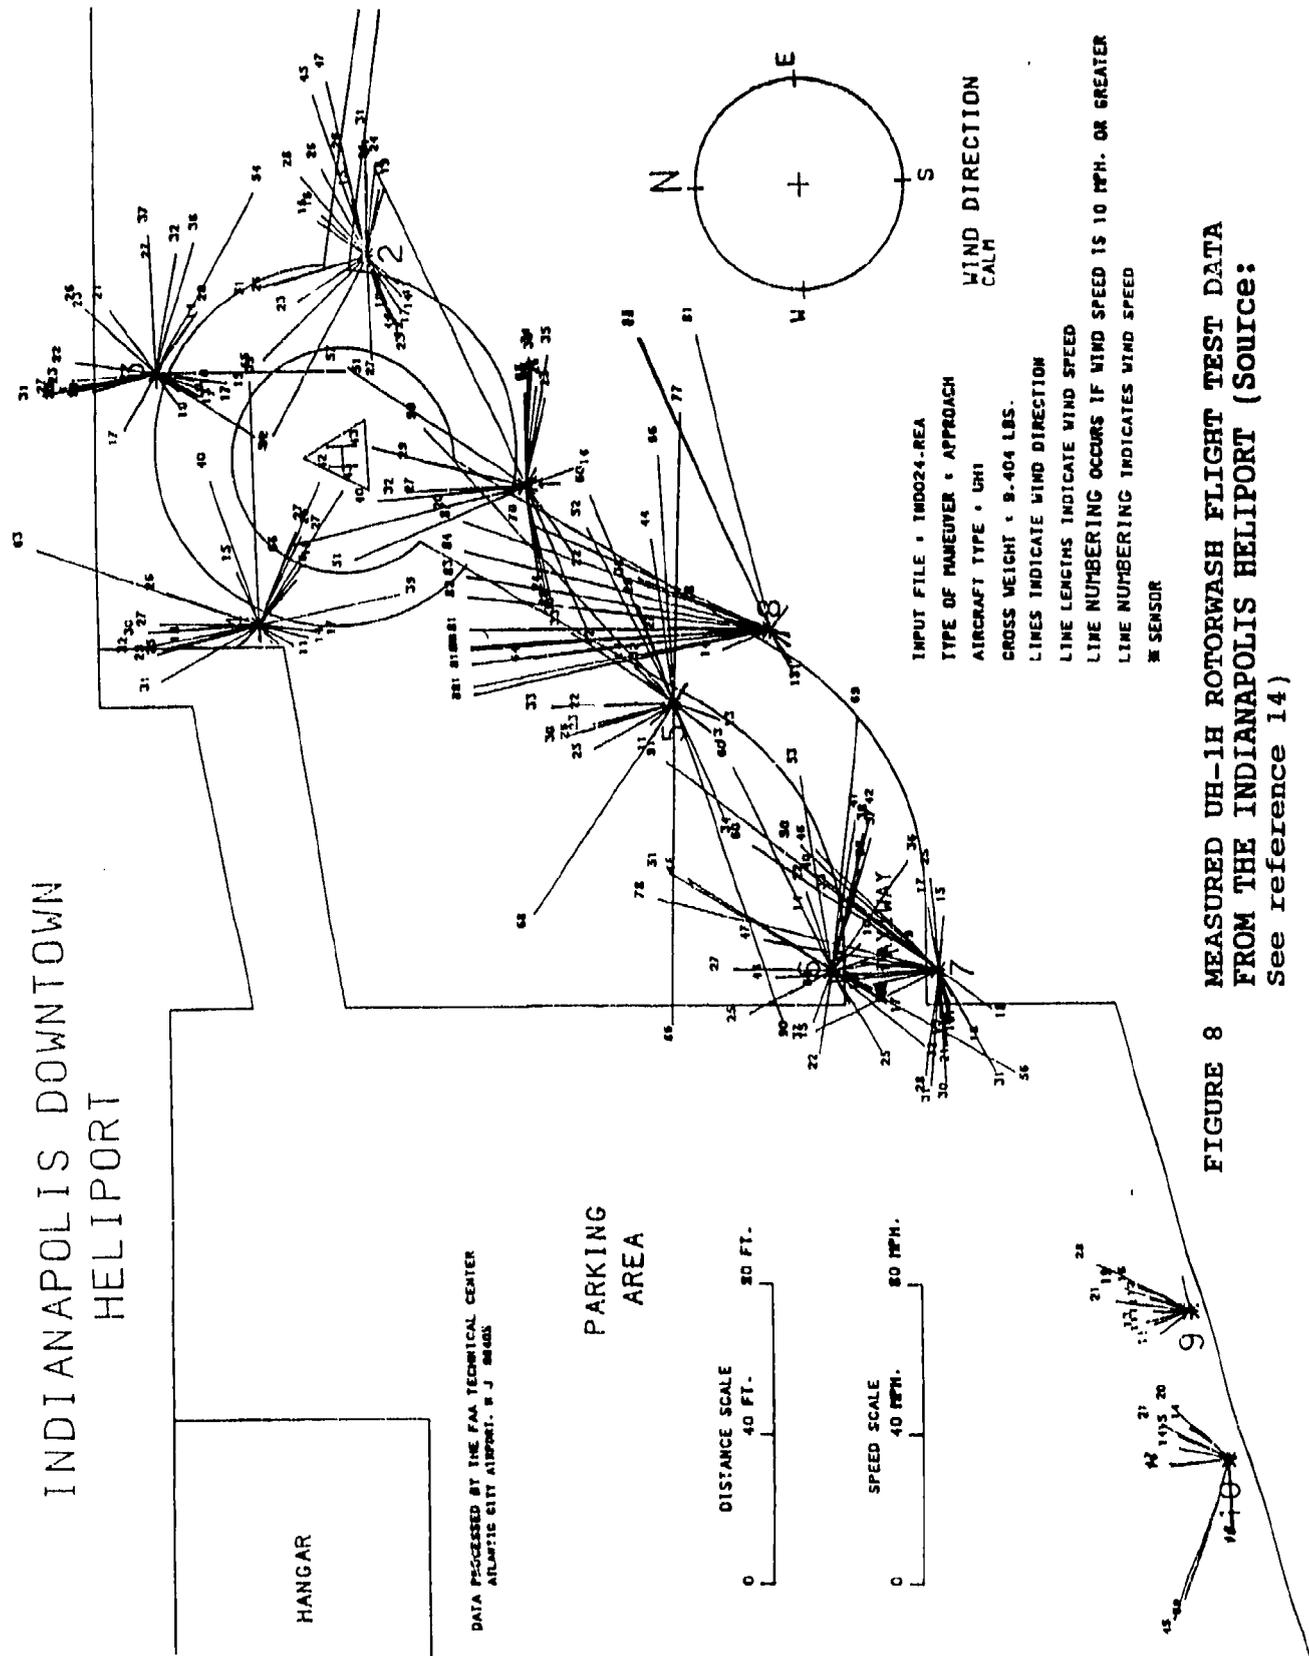
FIGURE 8 MEASURED UH-1H ROTORWASH FLIGHT TEST DATA
FROM THE INDIANAPOLIS HELIPORT (Source:
See reference 14)

Recorded velocity data for the Bell 206, 206L, and UH-1 models in calm winds at both heliports frequently exceeded 30 knots as the helicopters passed by the sensors. The magnitudes of some measured velocity data (for all three types of helicopters) occasionally even appeared to exceed the ROTWASH calculated peak velocities for 9 knots of wind. In some of these cases, the measured peak velocities momentarily exceeded 85 knots (approximately 100 miles per hour). As an example, a recorded movement of a UH-1 at the Indianapolis Heliport is presented as figure 8 (reproduced directly from reference 14). Reasons why these velocity values exceed peak calculated values could include effects due to maneuvering and density altitude as well as wind. It is generally accepted that peak rotorwash velocities directly in front of a helicopter during the final phase of a decelerating approach to hover are greater than those for the same helicopter after it is subsequently stabilized in hover. Also, when all other factors are held constant, peak rotorwash velocities increase with a decrease in atmospheric density (increase in density altitude). While these data do not necessarily provide specific insight into the reviewed mishaps, the data contained in reference 14 do help support many of the assumptions inherent to the analysis. This is

1. rotorwash peak velocities measured in an operational environment vary significantly in magnitude for the same type of helicopter. Reasons for this documented fact include pilot technique, gross weight, and atmospheric conditions (to name only a few).
2. typical rotorwash peak velocity levels in close proximity to the helicopters involved in the reported mishaps do significantly exceed the range in velocity which is expected to contain the threshold velocity value (if this observation was not confirmed by measured flight data, doubts would exist with respect to the quality of the ROTWASH calculated velocity data and the validity of the analysis approach).

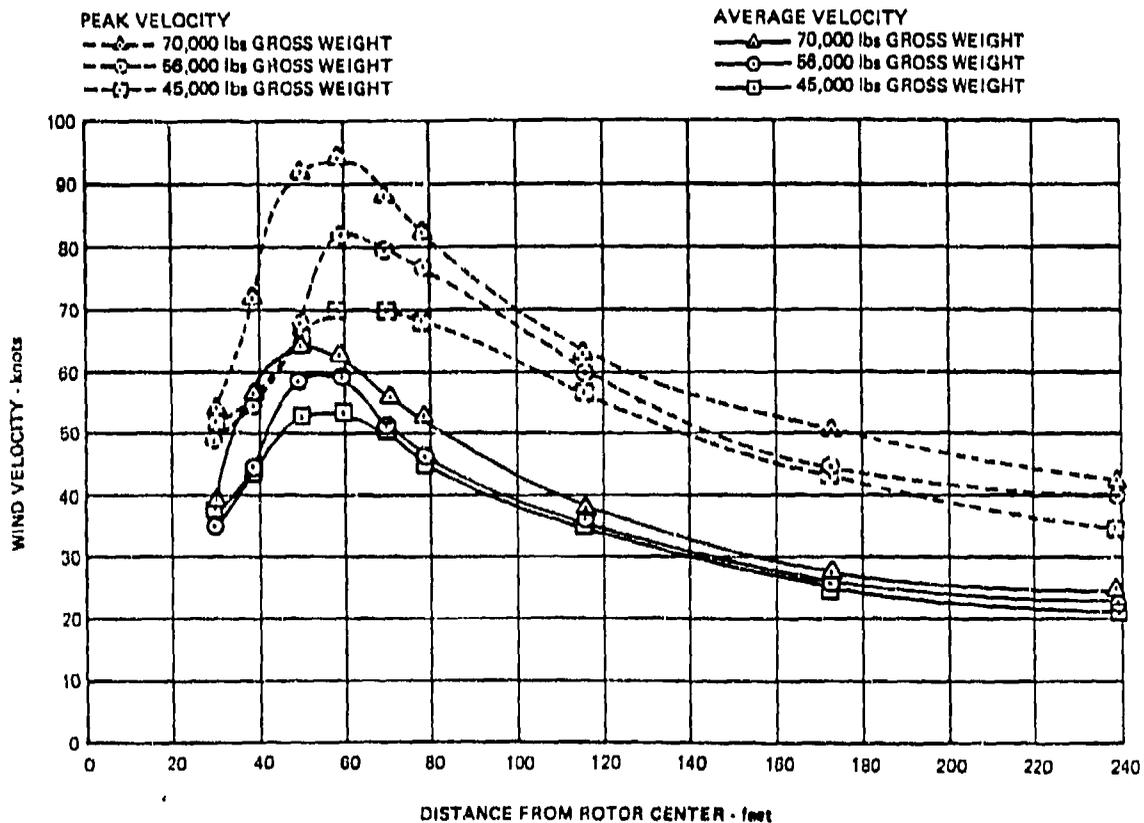
FIGURE 9 MEASURED CH-53E PEAK PROFILE VELOCITIES AS A FUNCTION OF DISTANCE FROM THE ROTOR CENTER AT A HEIGHT OF 3 FEET FOR A HOVER WHEEL HEIGHT OF 20 FEET (Source: See reference 11)

If the H-53 was at a very low airspeed and almost on the ground when it passed the Cessna, one might assume that the H-53 was approaching hover. This is probably the worst case scenario from a rotorwash estimation standpoint. In this instance, peak profile velocity flight test data from reference 11 can be used to estimate the rotorwash velocities involved. These velocity data are presented in figure 9 (reproduced directly from reference 11). If the Cessna was between 100 and 200 feet away (which is highly probable), peak velocity values may have been between 40 and 60 knots. If the H-53 was flying at a low airspeed, such as 30 knots, the rotorwash flowfield would have been composed

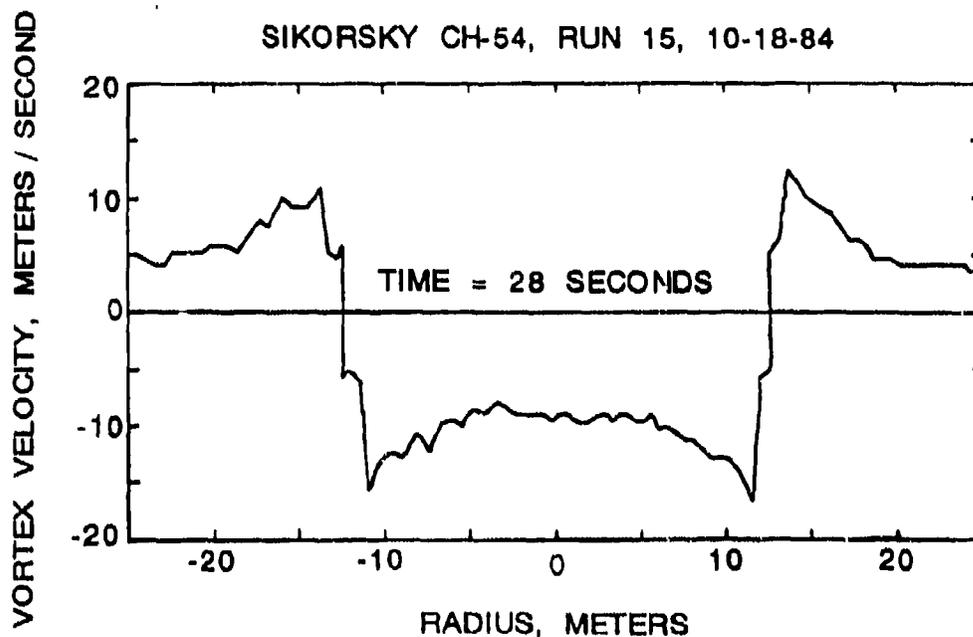
FIGURE 10 CH-54 TRAILING WAKE VELOCITY PROFILE AT AN AGE OF 28 SECONDS (Source: See reference 17)

of a trailing wake vortex structure. Data from reference 18 for a Sikorsky CH-54 (which has a rotor configuration almost identical to an H-53) are presented in figure 10 to provide insight into wake velocities contained within this type of flowfield. These presented data are for a gross weight of approximately 38,000 pounds at an airspeed of 30 knots. Peak velocities in this wake structure taken at 28 seconds behind the CH-54 are between 15 and 20 meters per second (29 and 39 knots). It is reasonable to assume that these velocities could be increased by as much as 50 percent if the gross weight of the H-53 was greater than 38,000 pounds

or if the wake data were measured within seconds after the helicopter passed by. In summary, if the Cessna 152 was struck by rotorwash flowfields of either type containing velocities of the estimated values, there is little doubt that the aircraft could have been turned over (as was actually the case). More discussion on the significance of these velocity magnitudes is presented in the following paragraphs.

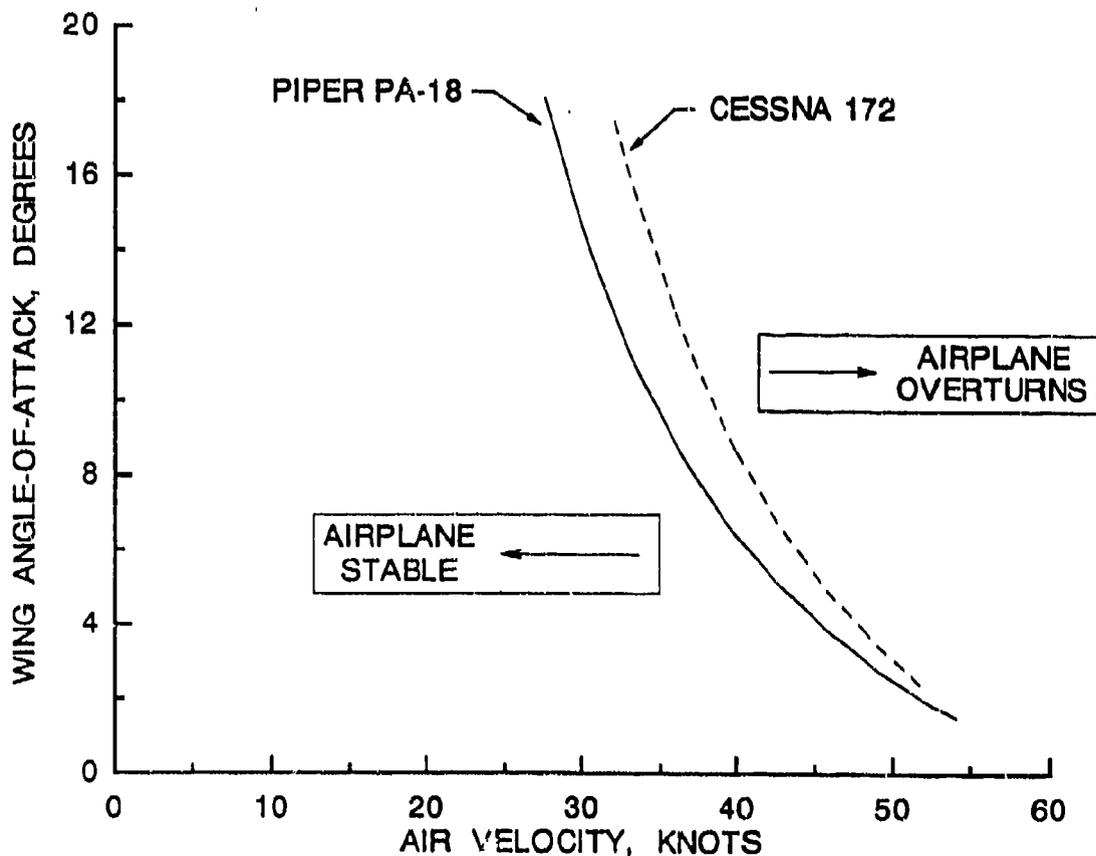
FIGURE 12 MINIMUM AIRSPEED/ANGLE-OF-ATTACK REQUIREMENTS FOR THE OVERTURNING OF LIGHT FIXED-WING AIRCRAFT

The data presented in figure 12 represent the estimated angle-of-attack values required to overturn a Piper PA-18 or Cessna 172 as a function of rotorwash peak velocity. Table 3 presents a summary of the input data values used to make these calculations. These results indicate that slightly lower values of rotorwash than were previously predicted in reference 8 may be capable of overturning light fixed-wing aircraft. At air velocities of approximately 40 knots, only 6 to 8 degrees of wing angle-of-attack are required to overturn the aircraft. Angle-of-attack values of this magnitude are frequently measured in hover rotorwash flowfields. This is because the flowfields have a tendency

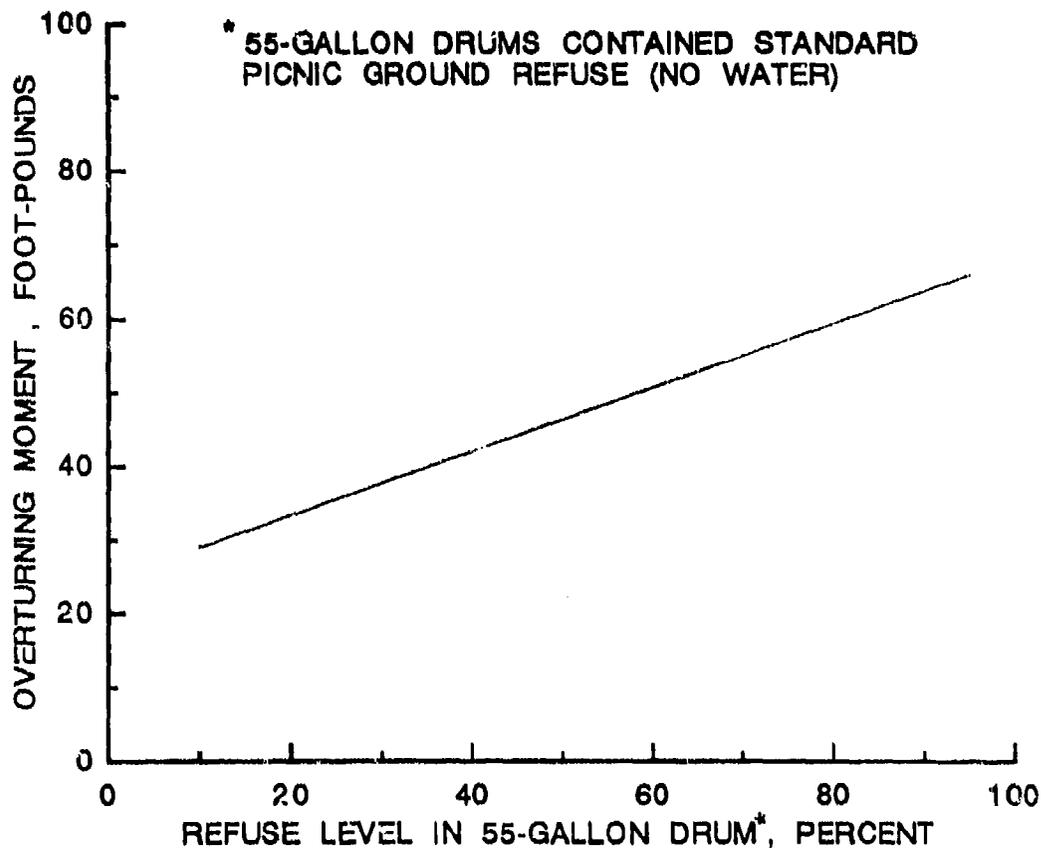
FIGURE 14 55-GALLON OIL DRUM OVERTURNING MOMENTS

The first task in the detailed analysis of these two mishaps was to acquire information on the amount of applied moment required to overturn an empty oil drum. Since information of this type was not found in any reference book or report, a simple experiment was conducted to measure the moment. The 55-gallon drums used in the experiment were located in a park on a grass surface and were being used as waste receptacles. The measured overturning force was applied to the top of the drum through a harness fitted around the drum. This force was measured with a calibrated spring force gauge and multiplied by the moment arm of 33 inches to obtain the overturning moment. Drums containing varying levels of refuse were measured, as well as empty drums; the results are presented in figure 14. However, several factors must be considered prior to use of these data. These factors are as follows:

1. it was apparent during the experiment that the weight of the refuse in the drums had a significant impact on the results,
2. drums which were more than one-half full sometimes tended to slide across the grass and were not inclined to overturn as easily, and
3. if water or oil had been contained in the bottom of the drums, which was not the case in this experiment, the fluid would have significantly increased the measured overturning moment. The drums would then be more likely to slide before overturning if they were not constrained along the bottom edge.

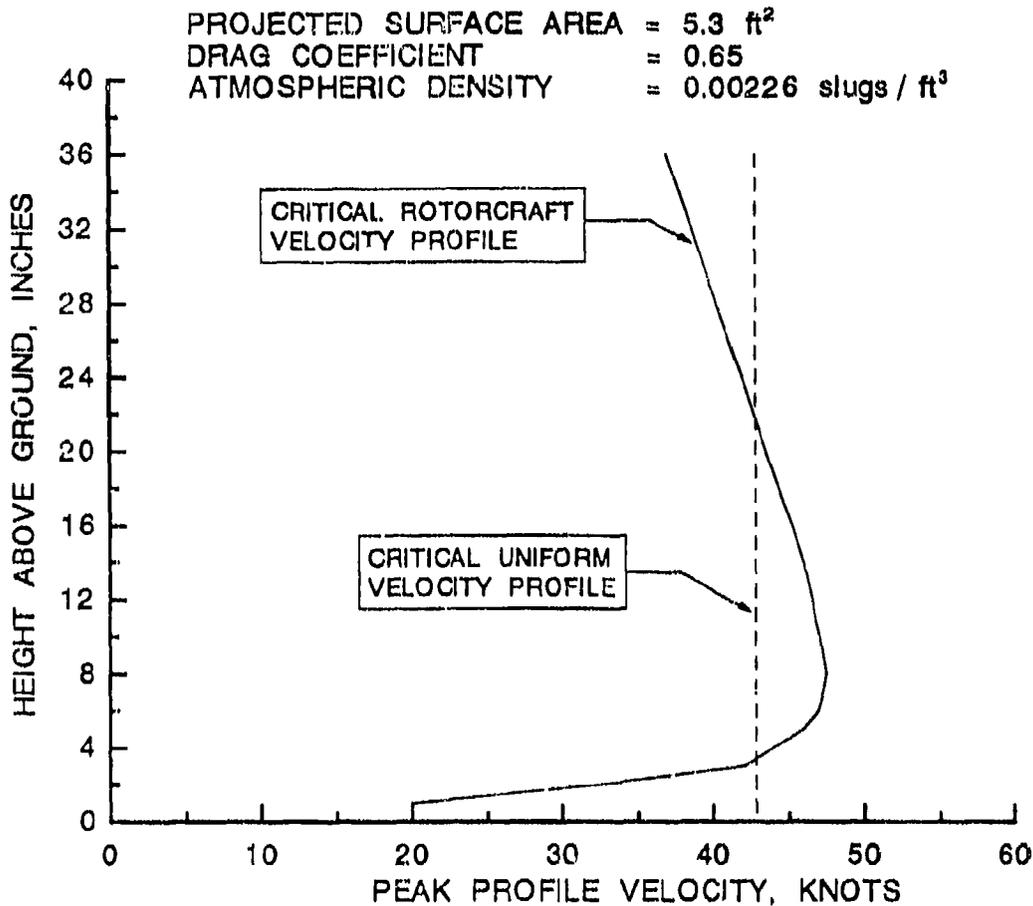
FIGURE 15 GENERIC VELOCITY PROFILE CREATING THE MOMENT REQUIRED TO OVERTURN A 55-GALLON OIL DRUM

foot-pounds. This task was accomplished by dividing the drum into 17 equal segments and iteratively integrating calculated UH-1H velocity profiles from 0 to 33.5 inches until the calculated overturning moment exceeded the critical value. The total projected drum surface area used in these calculations was approximately 5.3 square feet (this value was based on the maximum diameter of the drum and did not take into account the effect of the ridges along the side which slightly reduced the projected area). The coefficient of drag (C_D) was estimated as approximately 0.65 from reference 19. The air density used in the calculations was 95 percent of sea level standard day conditions. The approximate generic velocity profile found to produce the critical overturning moment value using the above values is presented in figure 15. The peak velocity in this profile is approximately 47 knots at a height of 8 to 10 inches off the ground and is reduced to approximately 38 knots at 33.5 inches. If a constant velocity profile is assumed for the sake of simplicity, the critical velocity is approximately 43 knots. With completion of this task, it was then possible to further analyze the two oil drum mishaps.
