MTL TR 92-26

# LAV ARMOR PLATE STUDY

MARTIN G. H. WELLS, REBECCA K. WEISS, and  
JONATHAN S. MONTGOMERY  
METALS RESEARCH BRANCH

April 1992

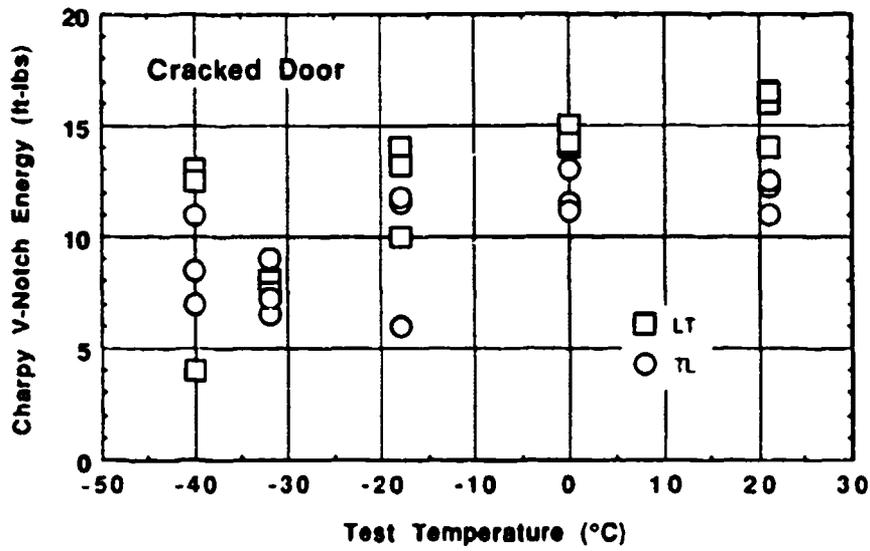
(3/4 size specimens) from room temperature (72°F) to -40°F. No sharp transition temperature was observed (see Figure 4). The shape of the curve is typical for very high strength steels.<sup>3</sup>

Figure 4. CVN energy (3/4-size specimens) versus test temperature; cracked door.

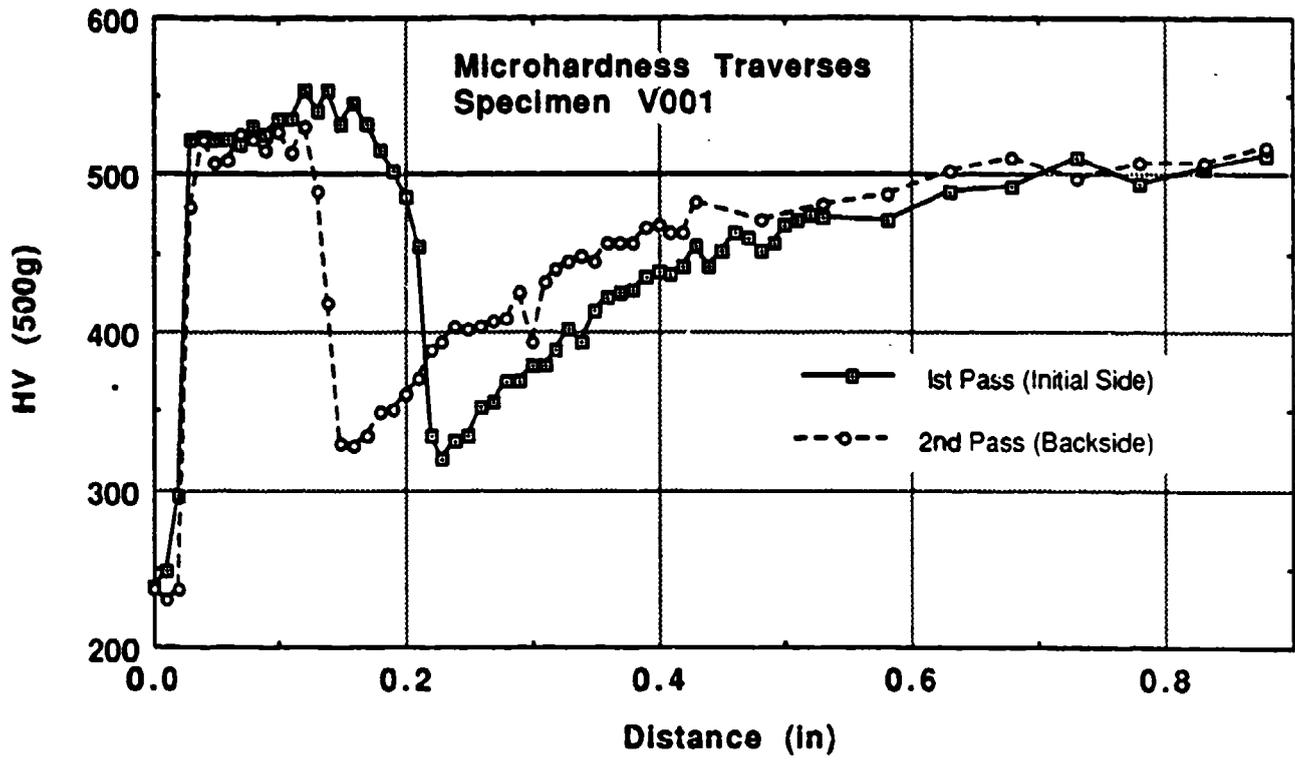
Figure 8. Microhardness traverses across a weld from dropped LAV.

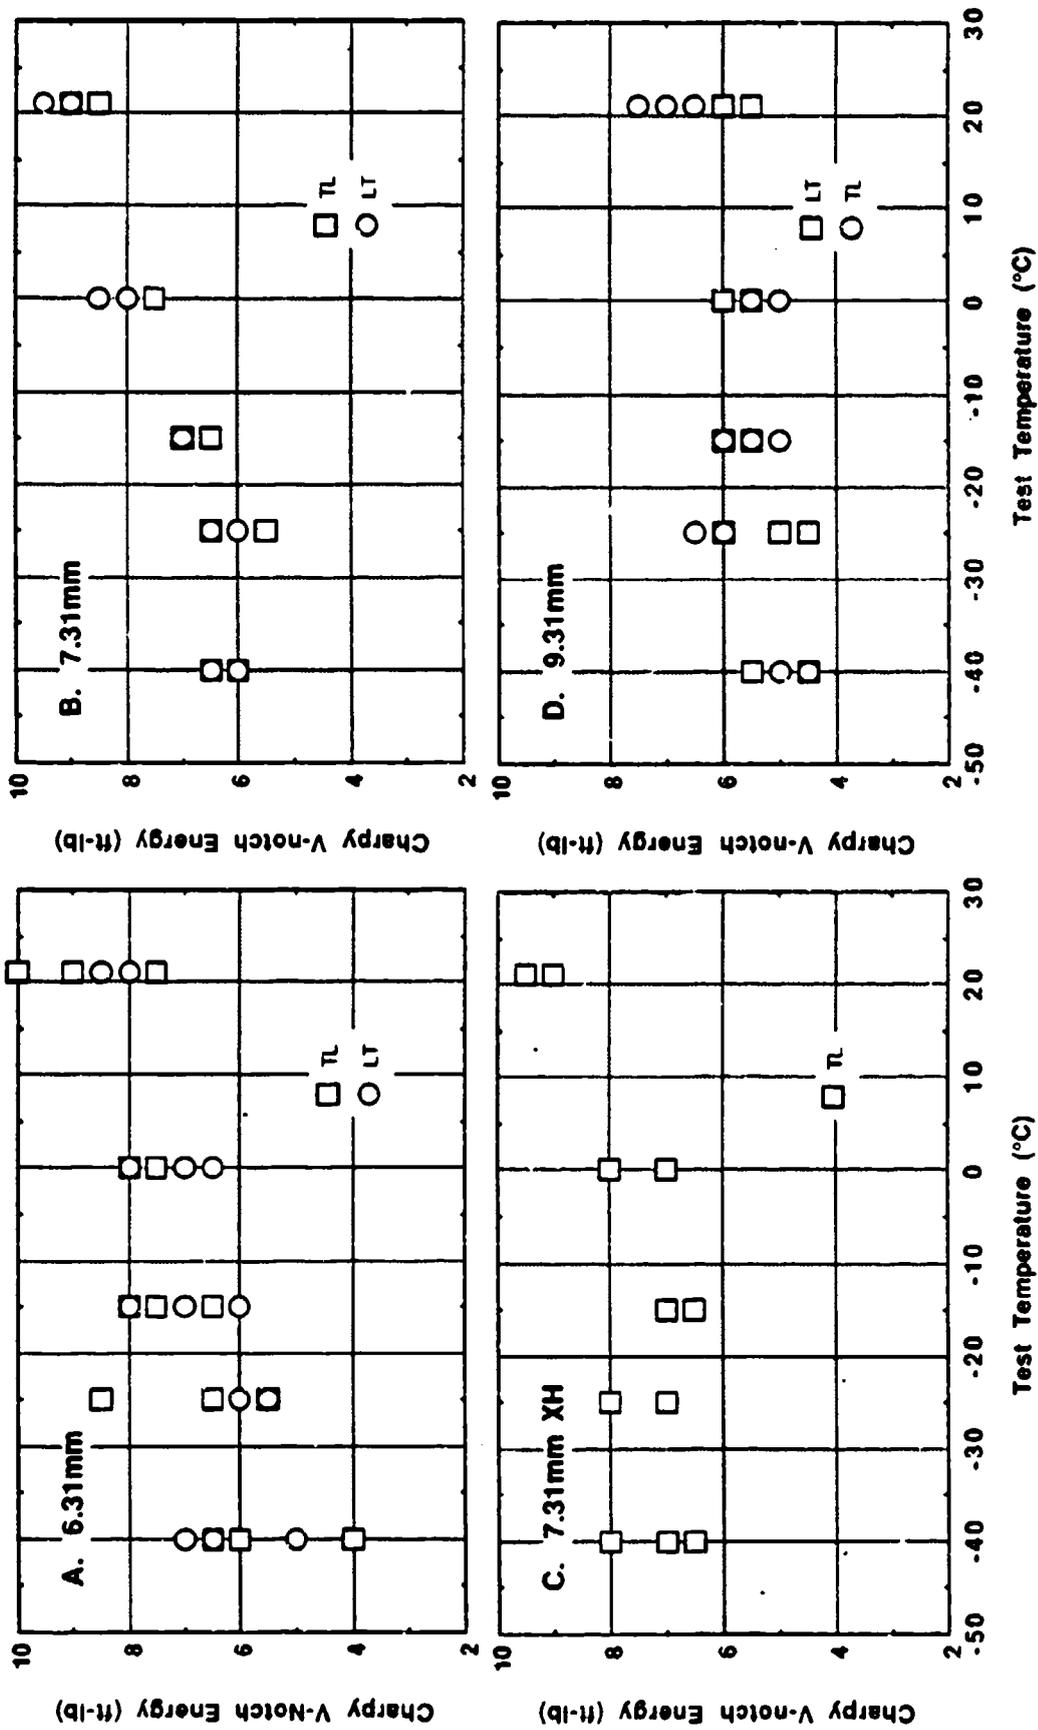
The Charpy impact toughness was measured on the four plates in both the longitudinal and transverse directions over a test temperature range from  $-40^{\circ}\text{F}$  to the room temperature of  $72^{\circ}\text{F}$ . The results are given in Figures 9a through 9d for the four plates tested. It should be noted that there is no abrupt change in toughness values at any point over this temperature range. The toughness decreases gradually from room temperature ( $72^{\circ}\text{F}$ ) to  $-40^{\circ}\text{F}$ . The Charpy values exceeded the requirements of MIL-A-46100 for three of the plates, while the 9.71-mm thick material had values slightly lower than specified; i.e., longitudinal 10 ft-lbs measured versus 12 ft-lbs specified, and transverse 9.5 ft-lbs measured versus 10 ft-lbs specified.

Figure 9. Charpy impact energy (1/2 size specimens) versus temperature for (a) 6.31-mm plate, (b) 7.31-mm plate, (c) 7.31-mm XH plate, and (d) 9.71-mm plate.
