1. AGENCY USE ONLY (Leave blank)		2. REPORT DATE Aug 1993		3. REPORT TYPE AND DATES COVERED
4. TITLE AND SUBTITLE M825A1 WHITE PHOSPHOROUS MALFUNCTION INVESTIGATION RELATED TO THE M739/M739A1 SAFING AND ARMING MODULE			5. FUNDING NUMBERS

6. AUTHOR(S) Saman F. Khoury				
7. PERFORMING ORGANIZATION NAME(S) AND ADDRESSES(S) ARDEC, AED Fuze Division (SMCAR-AEF-F) Picatinny Arsenal, NJ 07806-5000			8. PERFORMING ORGANIZATION REPORT NUMBER Technical Report ARAED-TR-92031

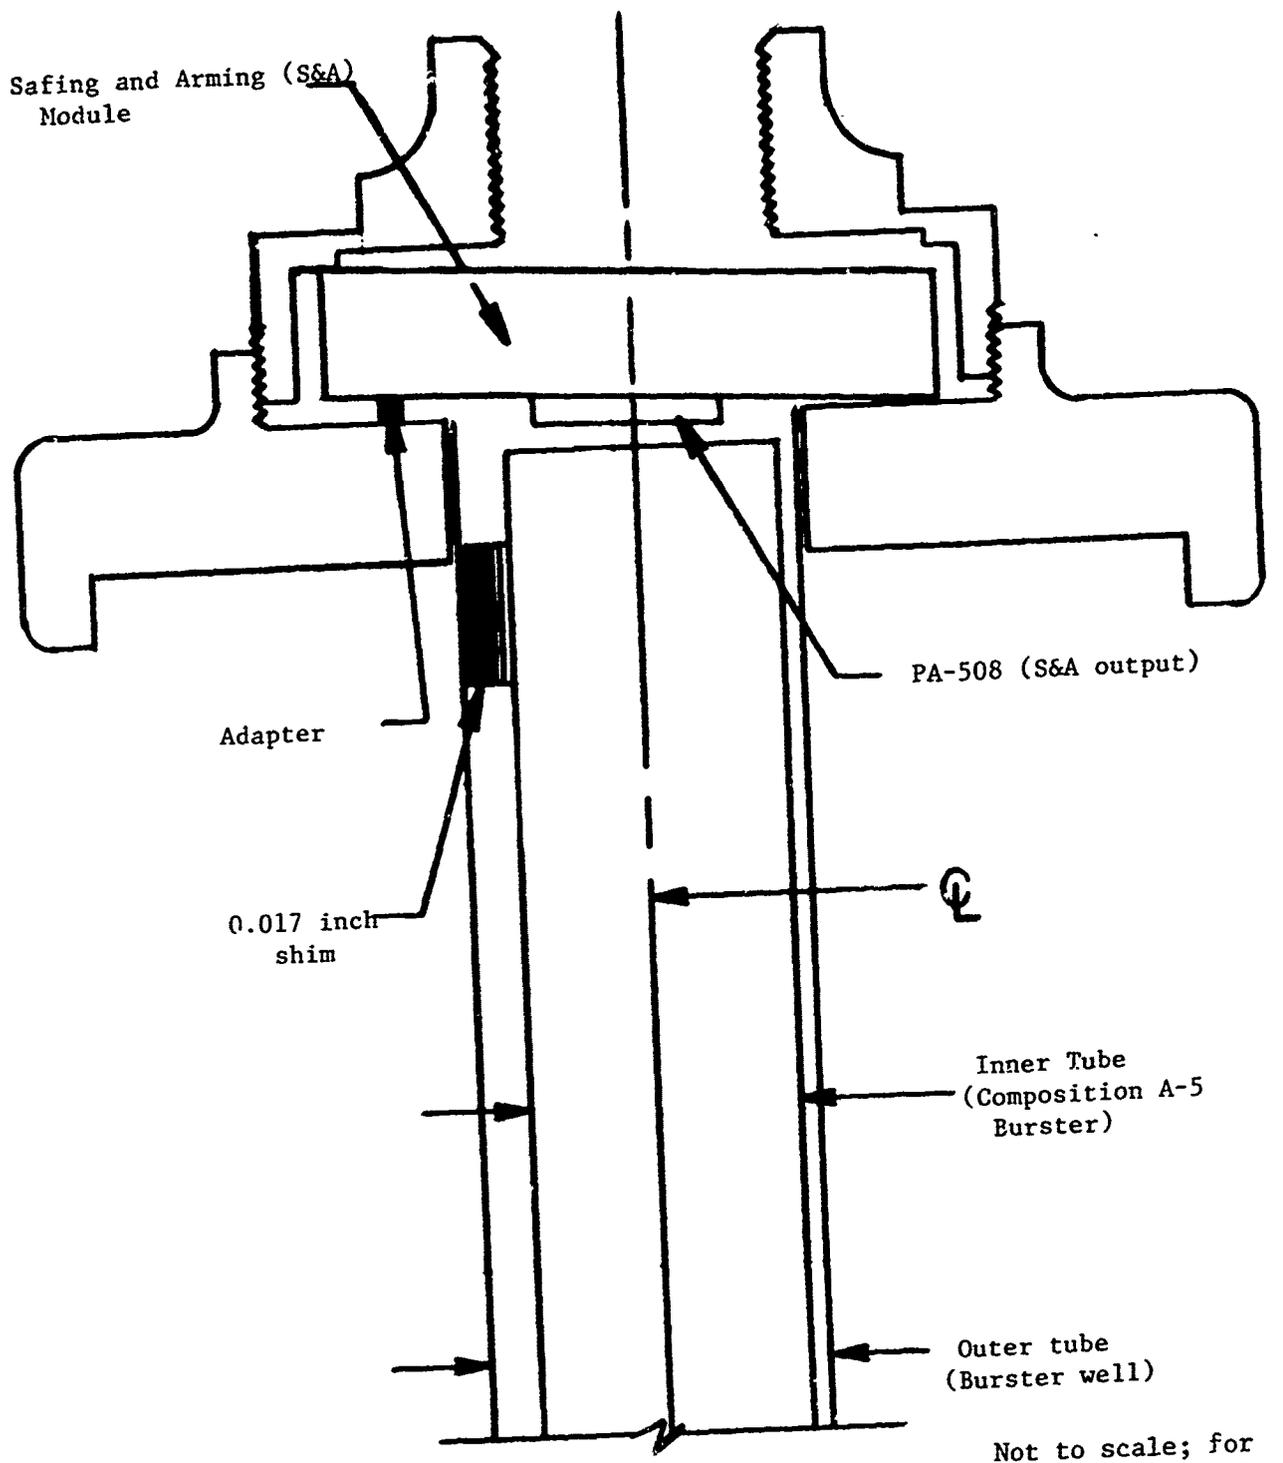
The unit used for the cocked S&A test yielded an output hole dimension of 0.525 in. by 0.496 in., measured 90 deg apart. An adapter was fabricated to ensure that the S&A remained in a tilted position. The gap between burster and the S&A lead was set at a maximum by placing a 0.017-in. shim. the felt disc was also removed from the burster in order to provide a vertical gap. This configuration is illustrated in figure 8. The S&A functioned the burster high order (fig. 9). The S&A output hole was measured to be 0.460 in. by 0.430 in., 90 deg apart. This damage was similar to the DPG recovered units. This penalty test clearly indicates that the S&A used in the M825A1 failures provided sufficient output to function the burster.

Safing and Arming (S&A)  
Module

PA-508 (S&A output)

Adapter

0.017 inch  
shim

Inner Tube  
(Composition A-5  
Burster)

Outer tube  
(Burster well)
