Technical Report HL-93-7
August 1993

Scour Protection for Dam No. 2, Arkansas River, Arkansas

Hydraulic Model Investigation

*by John E. Hite, Jr.
Hydraulics Laboratory*

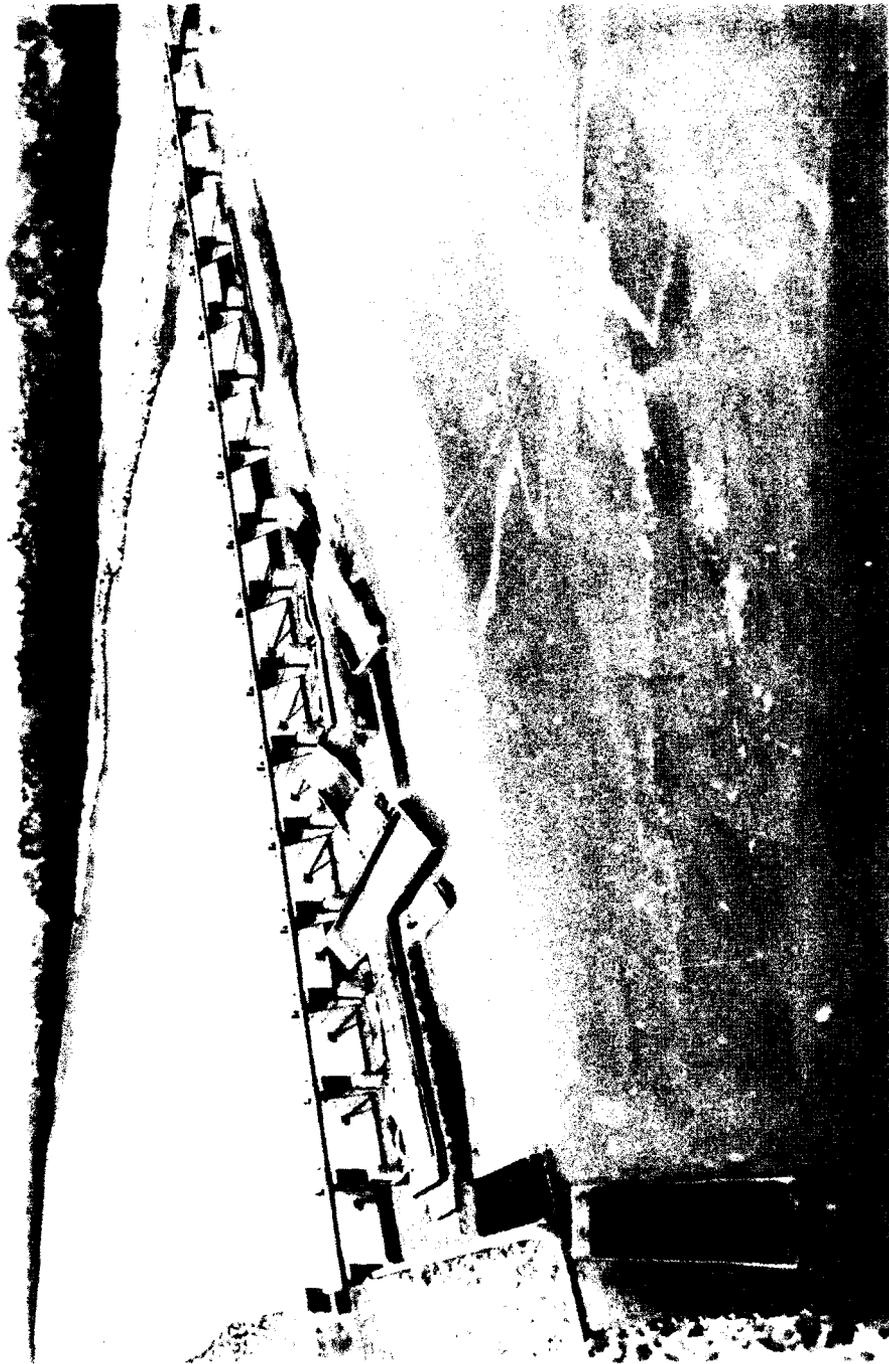
In December 1982, 38 barges broke loose from their moorings upstream of Dam No. 2. Sixteen barges drifted into the dam and ten barges subsequently sank against the spillway. Twelve of the sixteen gates were either partially or completely blocked as depicted in Figure 3. The discharge during this time varied from about 258,000 cfs to about 35,000 cfs. The maximum discharge through the open gates was estimated to be 39,400 cfs per gate, and because of the blockage, the upper pool was about 7 ft higher than for normal operation. The sunken barges, in addition to blocking flow, caused extreme turbulence and velocities both upstream and downstream from the dam. Extensive damage to the scour protection was caused by this extreme turbulence. The upstream scour protection

stone and the concrete scour slab were destroyed from pier 3 to pier 10, a distance of about 480 ft. The stone protection downstream from the stilling basin was extensively damaged or completely destroyed in bay 7 and between piers 9 and 15. The remainder of the downstream stone protection received slight to moderate damage. The gates and the concrete portions of the structure also were damaged. Repairs were completed in July 1983 to ensure safe normal operating conditions at the project.

Figure 3. Artist's conception of barge accident

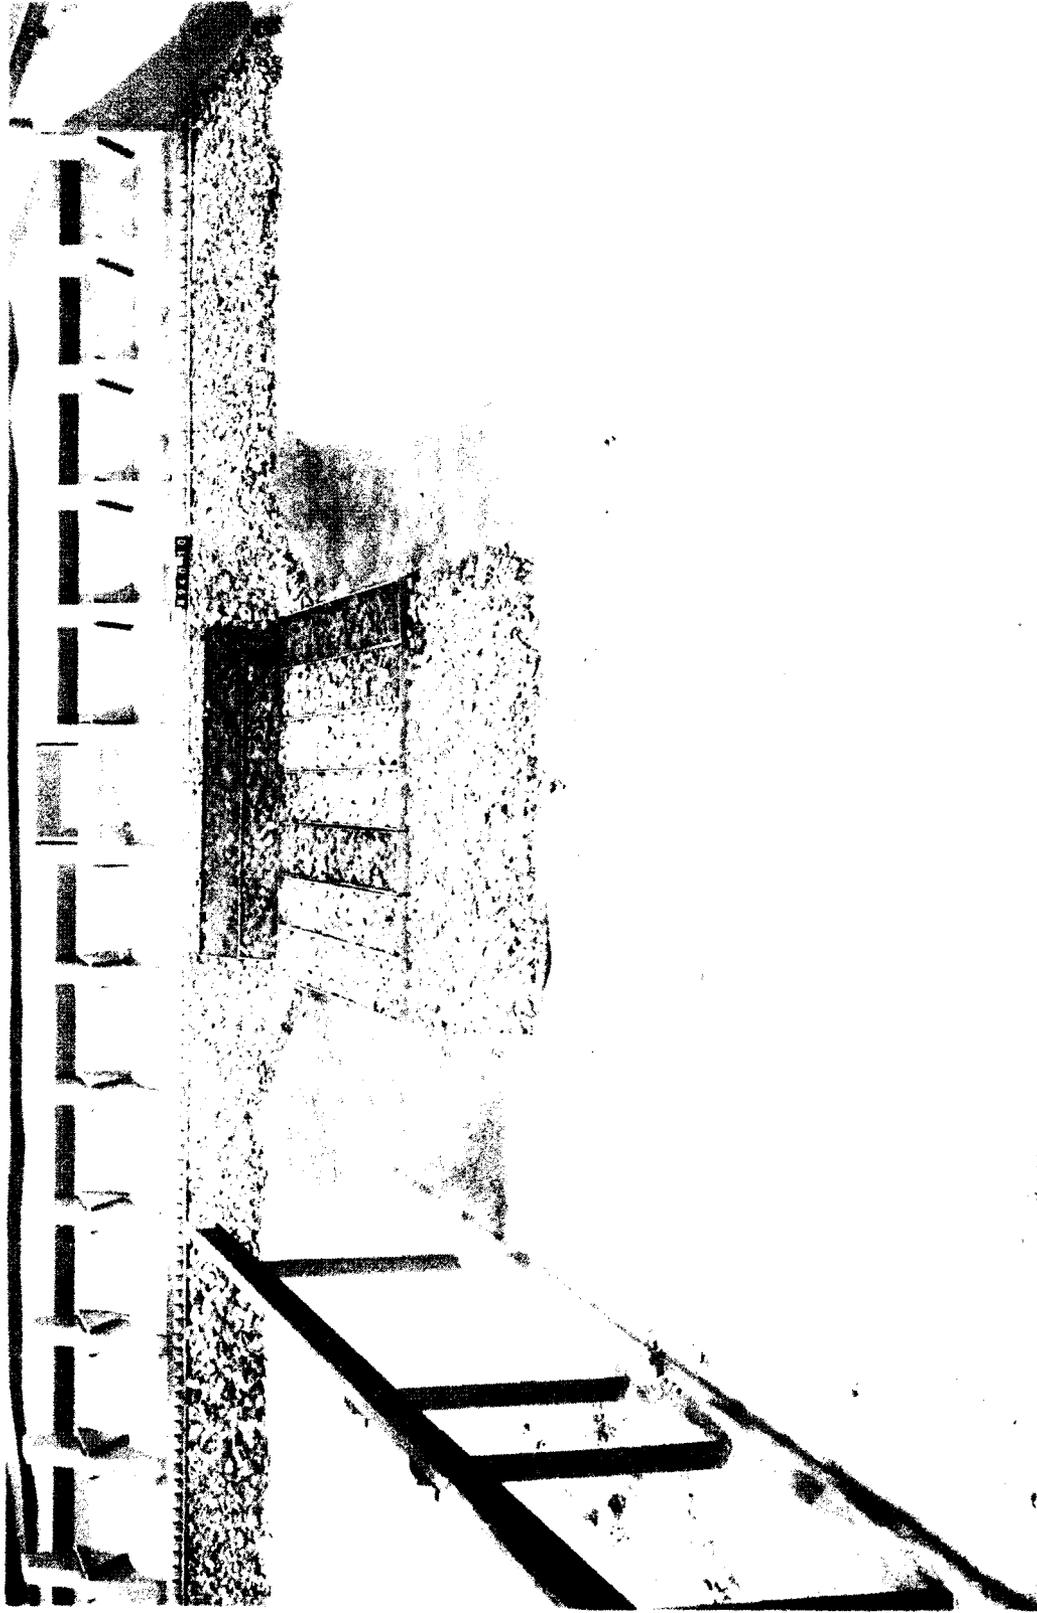
Photo 6. Type 3 scour protection design

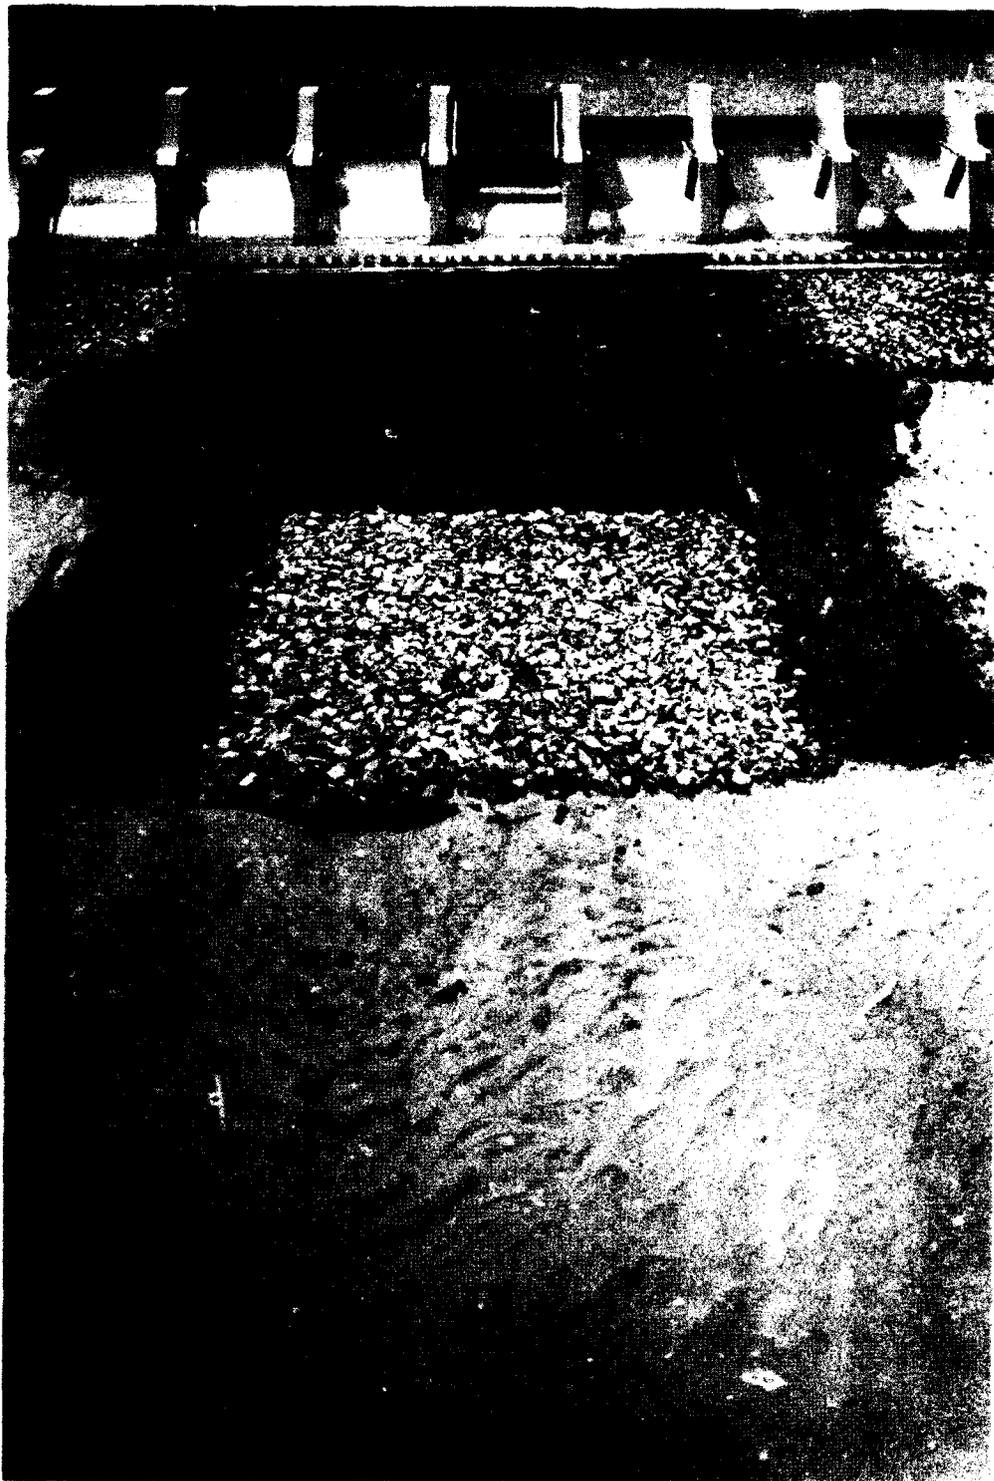
Photo 7. Type 4 scour protection design

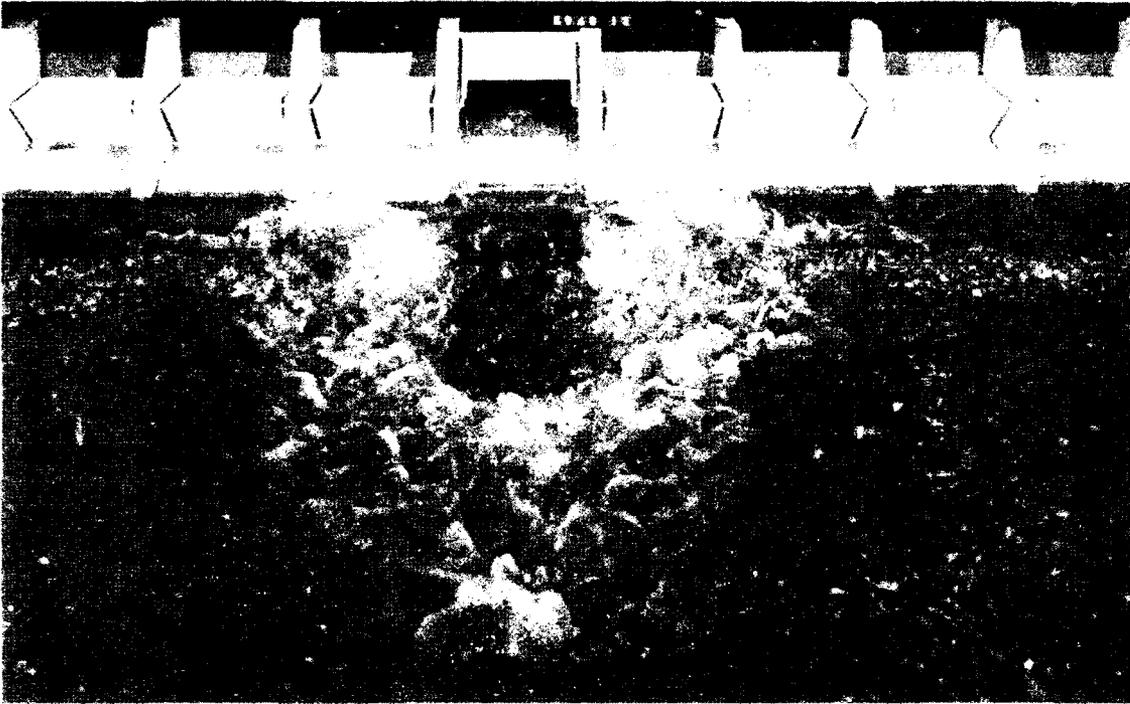
Photo 8. Flow conditions with type 4 scour protection design, normal upper pool, gate 6 fully open, tailwater el 118

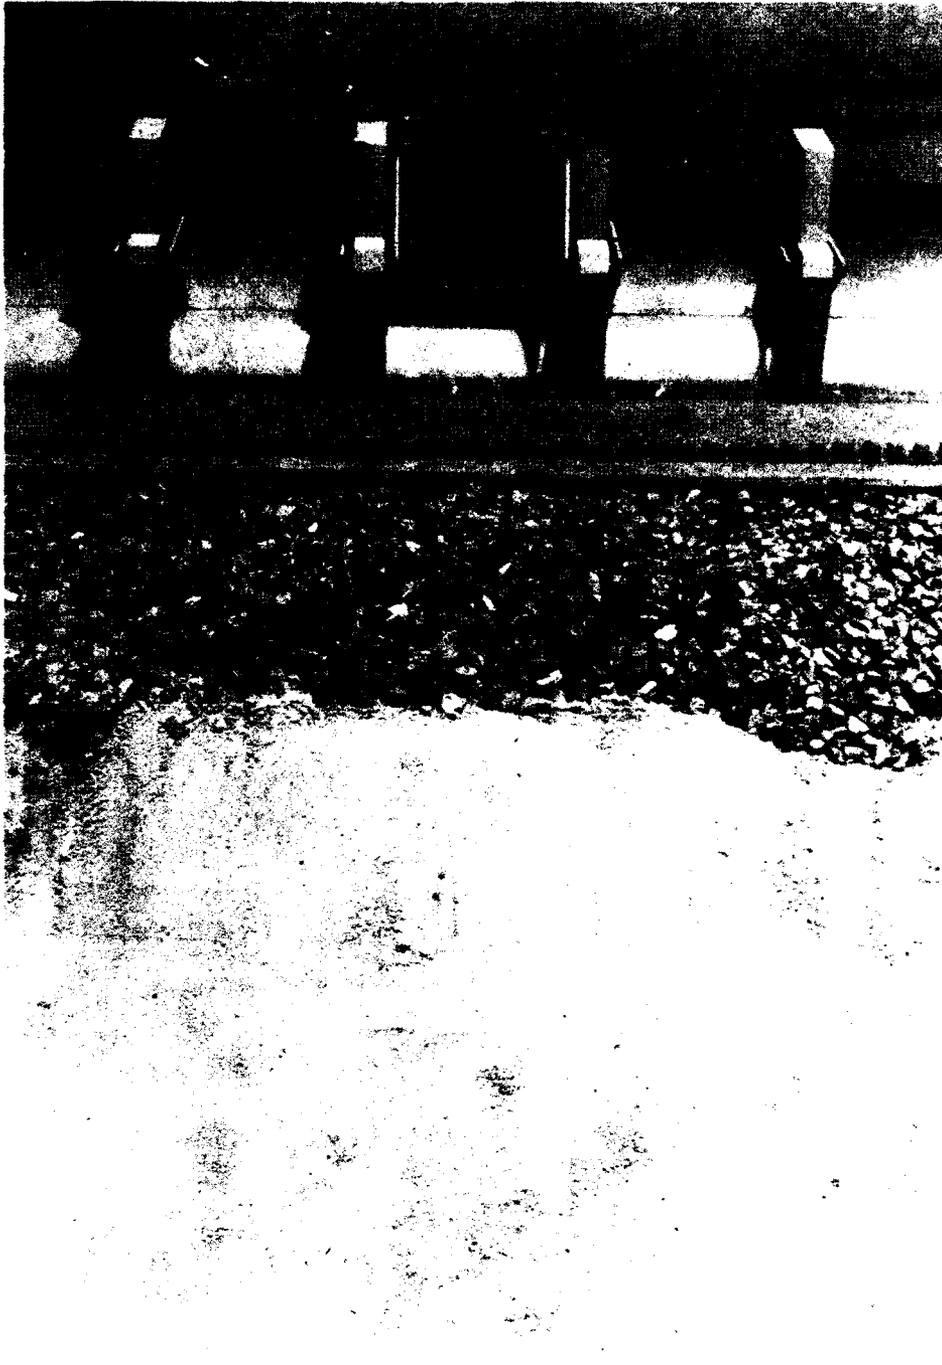
Photo 9. Type 5 scour protection design

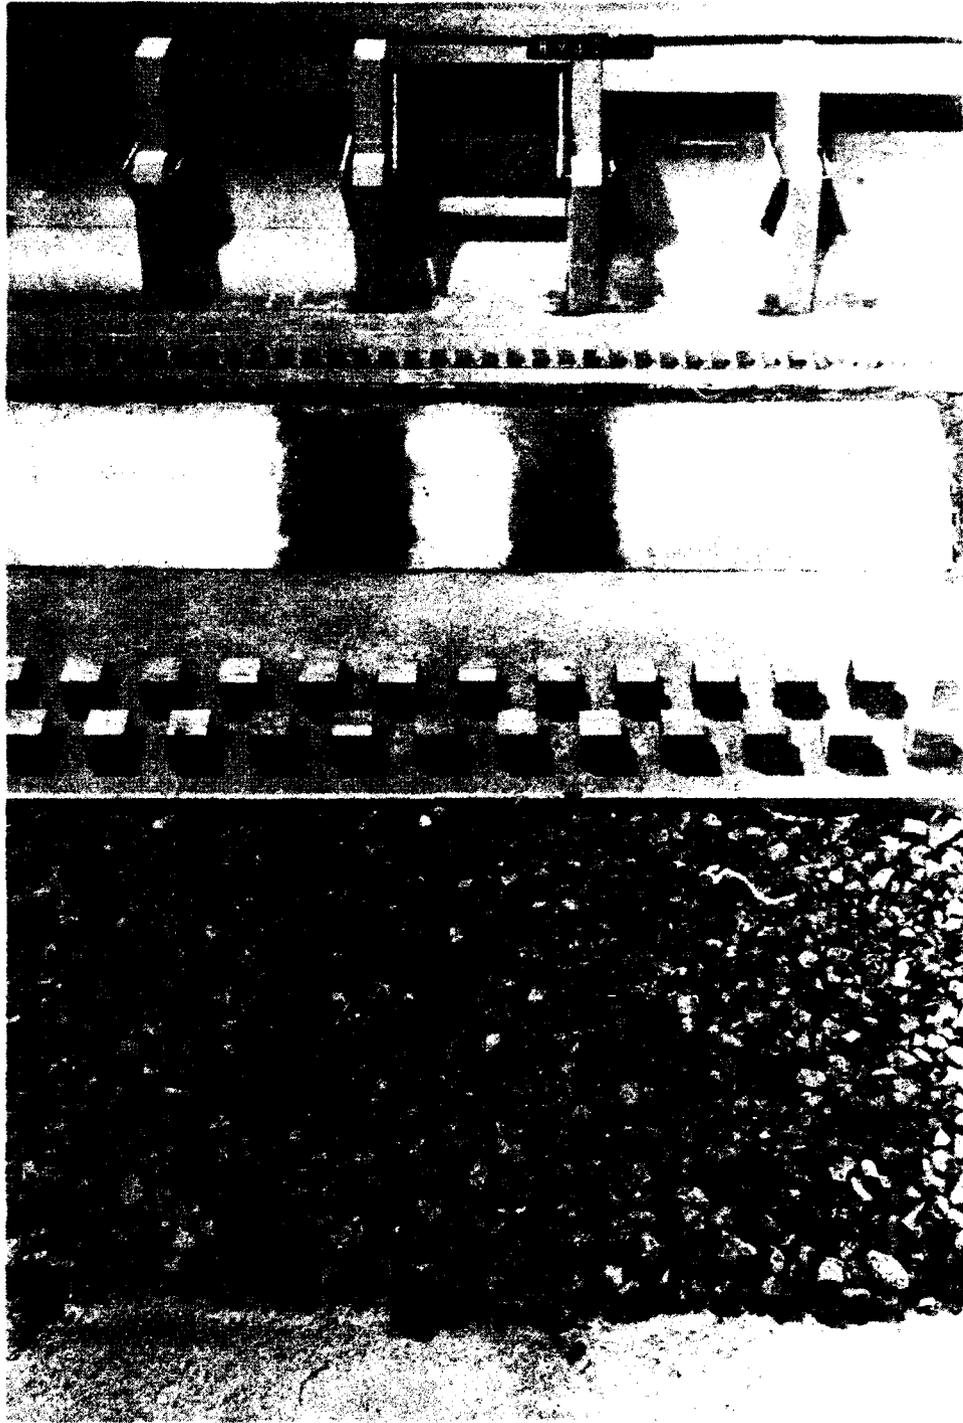
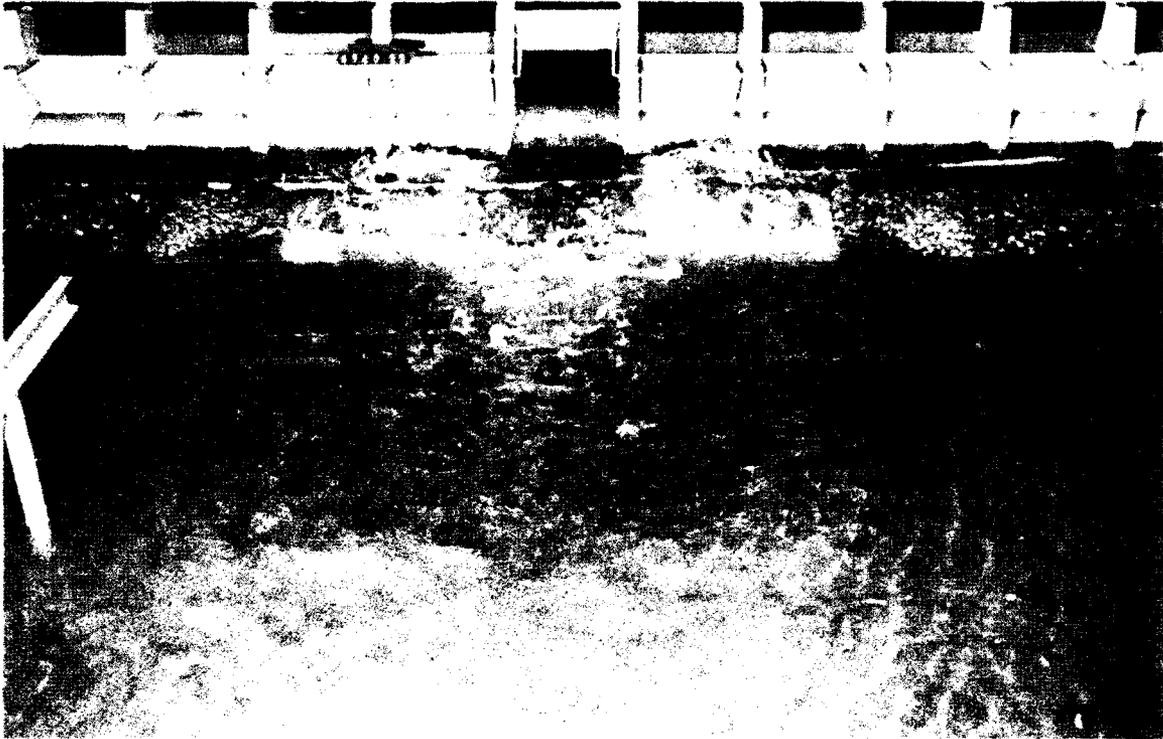
Photo 10. Type 6 scour protection design (Continued)

b. Flow conditions with one gate fully open normal upper pool, tailwater
el 113

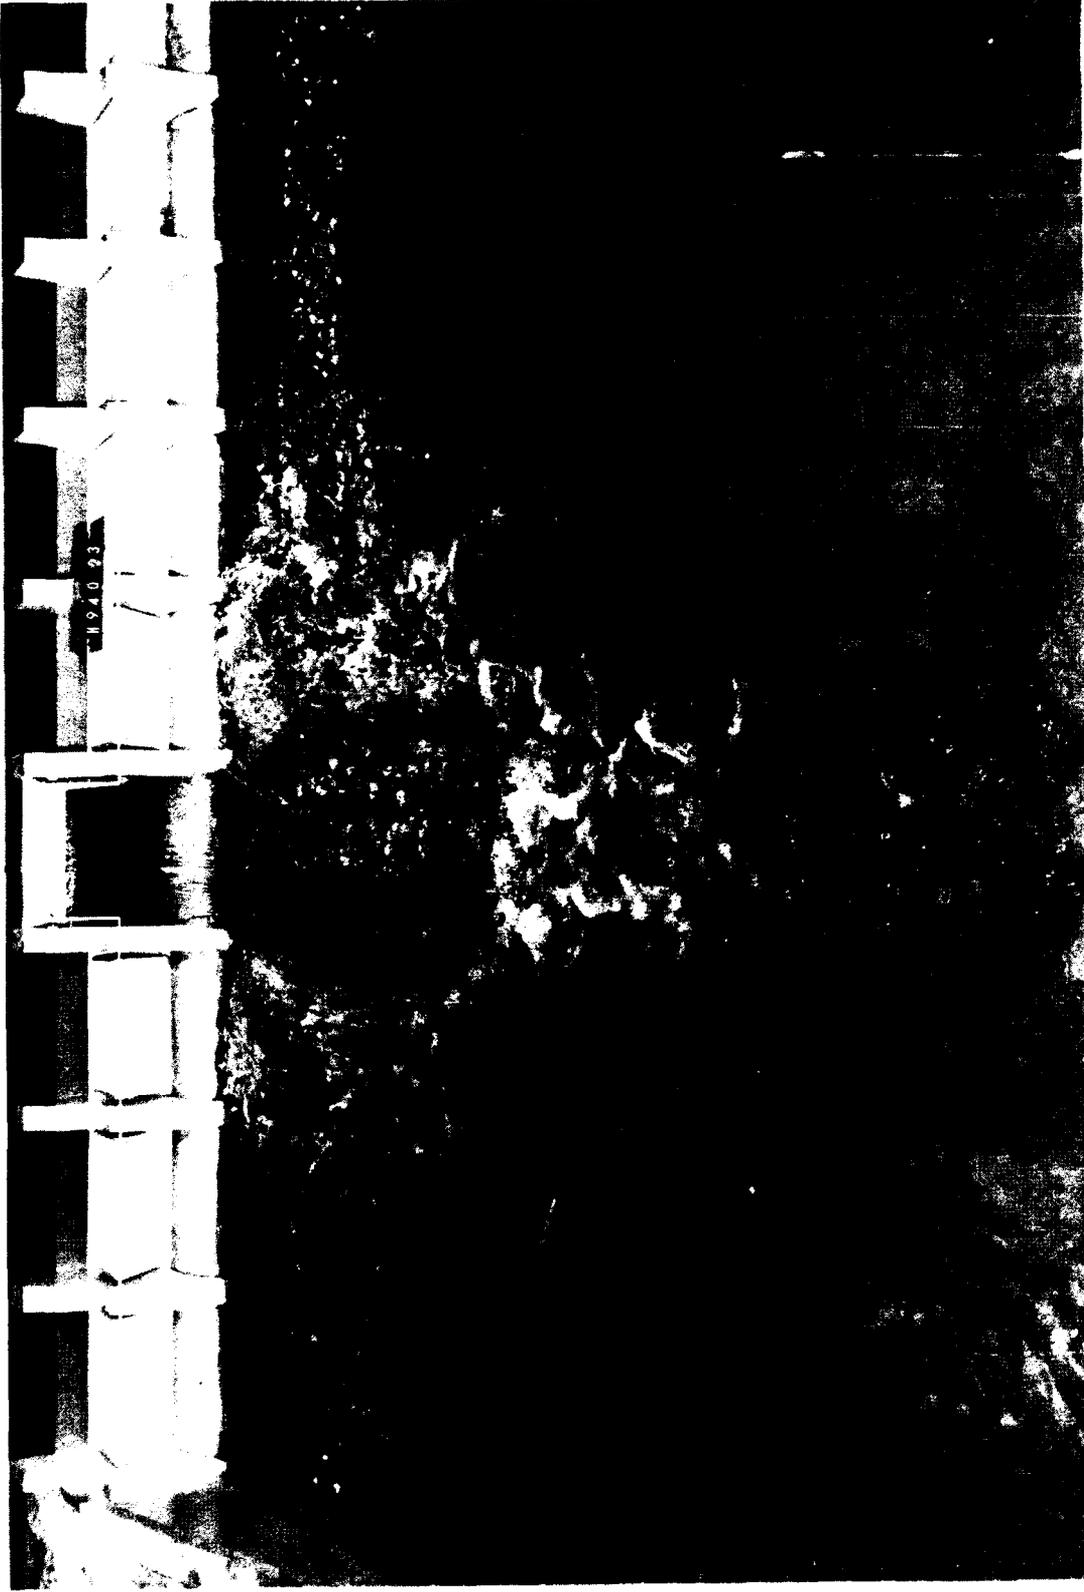
Photo 11. Flow conditions with the type 7 scour protection design, normal upper pool, one gate fully open, tailwater el 112.9

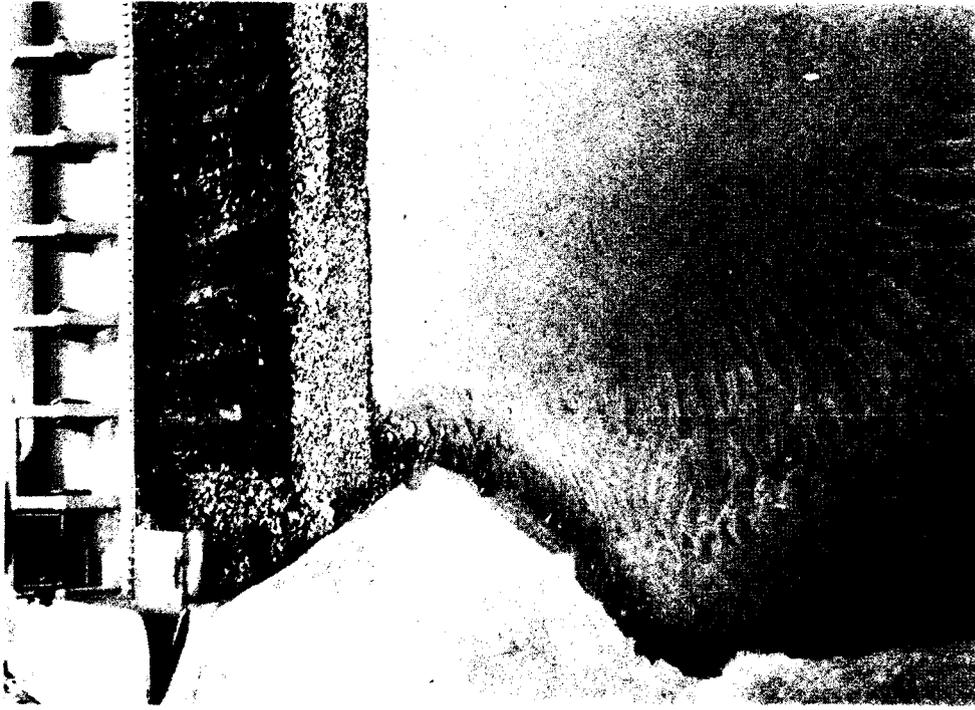
Photo 14. Type 9 scour protection design after 8 hr (prototype) of operation with gate 16 opened fully to the normal pool and tailwater
el 113

The type 9 scour protection design shown in Plate 9 provided adequate protection for single gate operations with minimum tailwater. The design consisted of a 15-ft length of riprap to be placed at the same elevation as the existing end sill and then grouted to form a large mass. Following the grouted riprap were barges 190 ft long by 35 ft wide by 12 ft deep placed on a 1V on 6H downward slope. The barges were filled with riprap and also grouted to form a large and solid mass. The large mass of revetment was necessary to withstand the forces caused by the hydraulic jump. A 50-ft length of Riprap No. 7 offset 4.5 ft below the top of the downstream end of the barge was placed downstream from the barge, followed by a 50-ft length of Riprap No. 8. This smaller size riprap helped to reduce the severity of the localized disturbances at the end of the blanket of Riprap No. 7 and transition the flow to the natural river bottom.

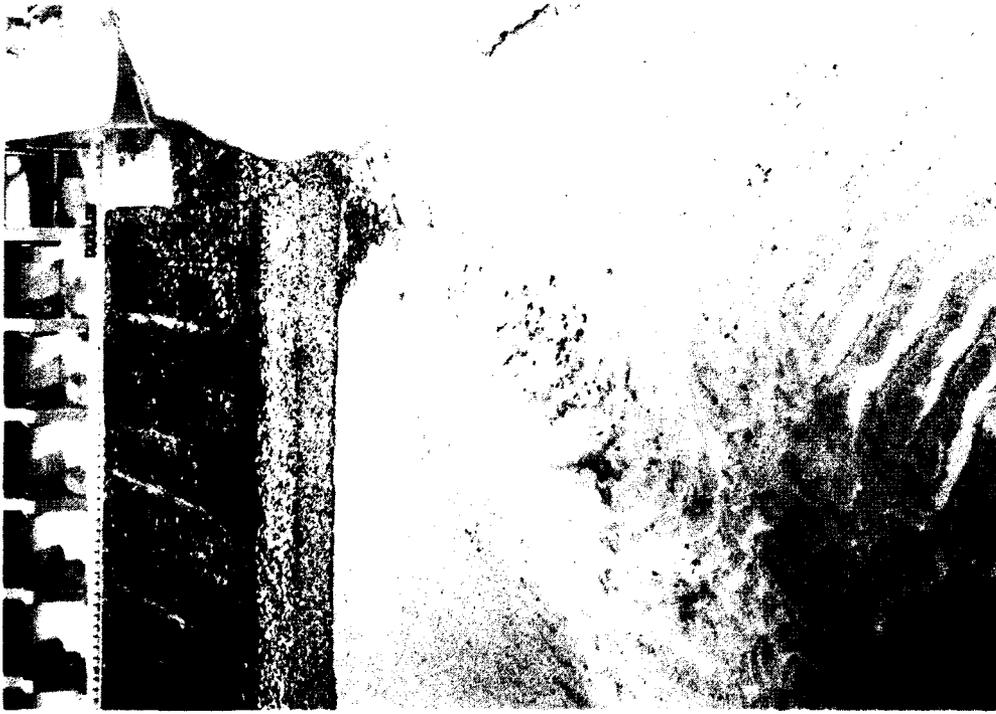
Photo 15. Type 9 scour protection design after 4 hr (prototype) of operation with gate 1 opened fully to the normal upper pool and tailwater el 113

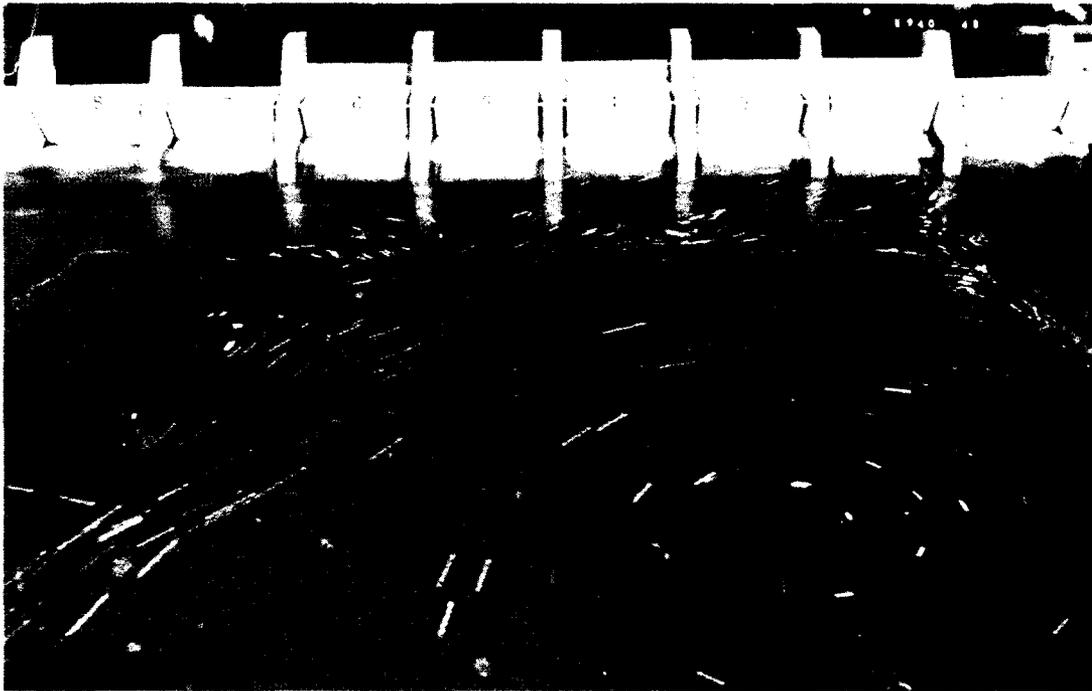
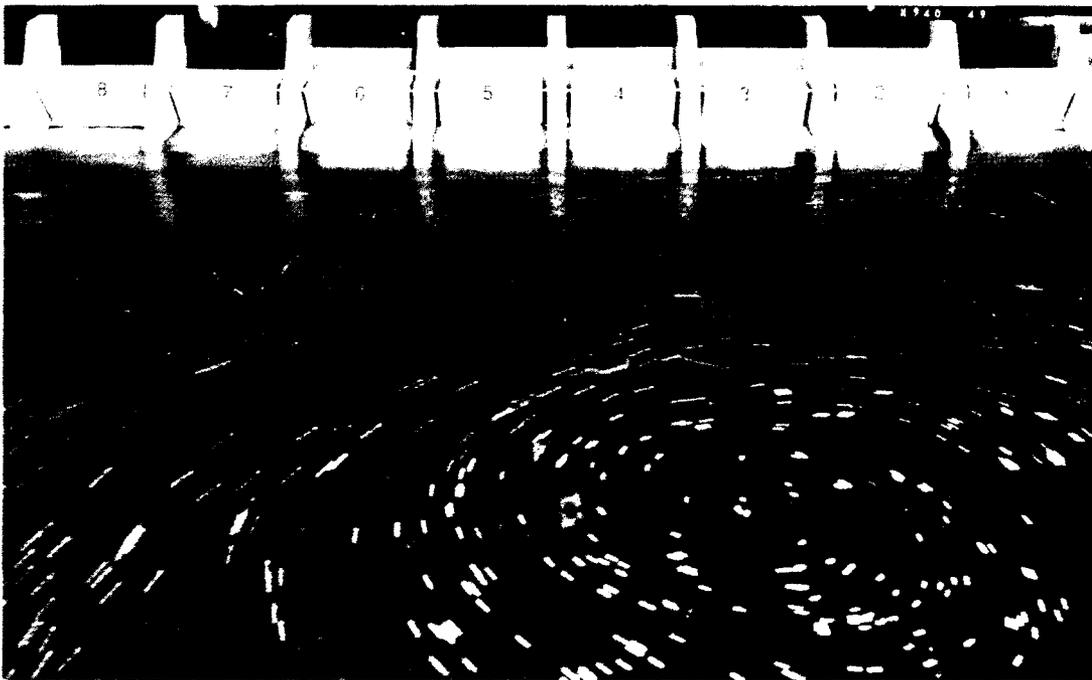
Photo 22 shows flow conditions downstream from gate 4 with a discharge of 50,000 cfs and pool el 162 when gates 2-6 are closed. This condition would exist when barges are being placed in the vicinity of gate 4. No adverse flows were observed and velocities were less than 3.5 fps on the surface. Flow circulation occurred in the working area but was considered slight.

Photo 22. Flow conditions with gates 2-6 closed, a discharge of 50,000 cfs, and pool el 162

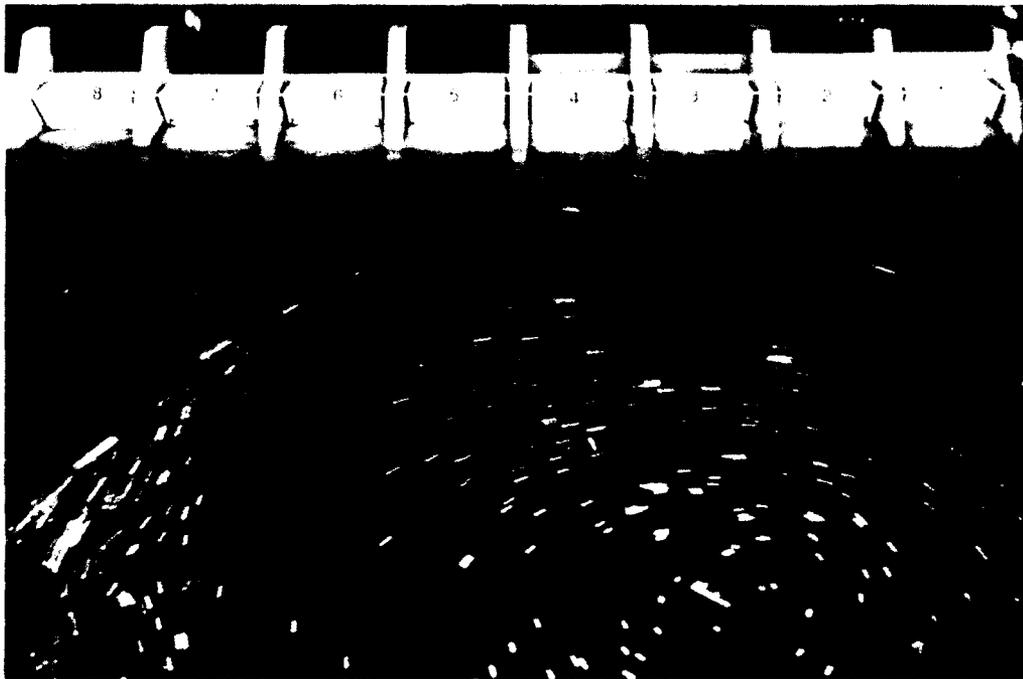
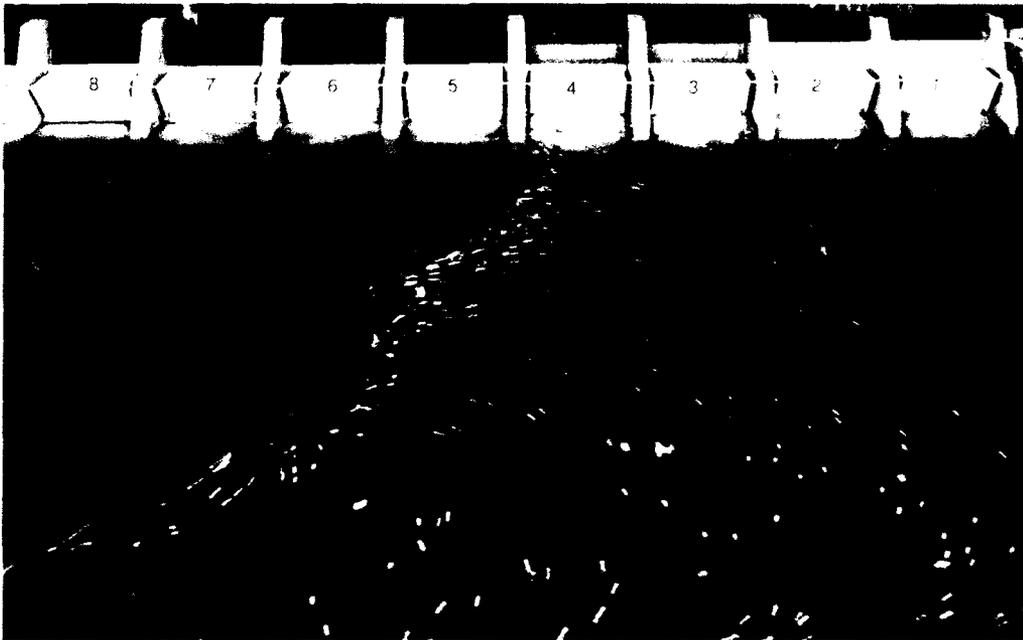
Photo 23 shows flow conditions with gates 1-4 closed for a discharge of 50,000 cfs and pool el 162. These conditions would exist when barges are being placed in the vicinity of gate 2. No adverse flow conditions were observed, flow circulation was minimal, and velocities were less than 3.5 fps. Photos 24 and 25 show flow conditions for a discharge of 15,000 cfs with gates 2-6 and 1-4 closed, respectively. A larger flow circulation pattern was observed with the higher tailwater, but no harmful conditions were observed.

Photo 23. Flow conditions with gates 1-4 closed, discharge of 50,000 cfs, and a pool el of 162

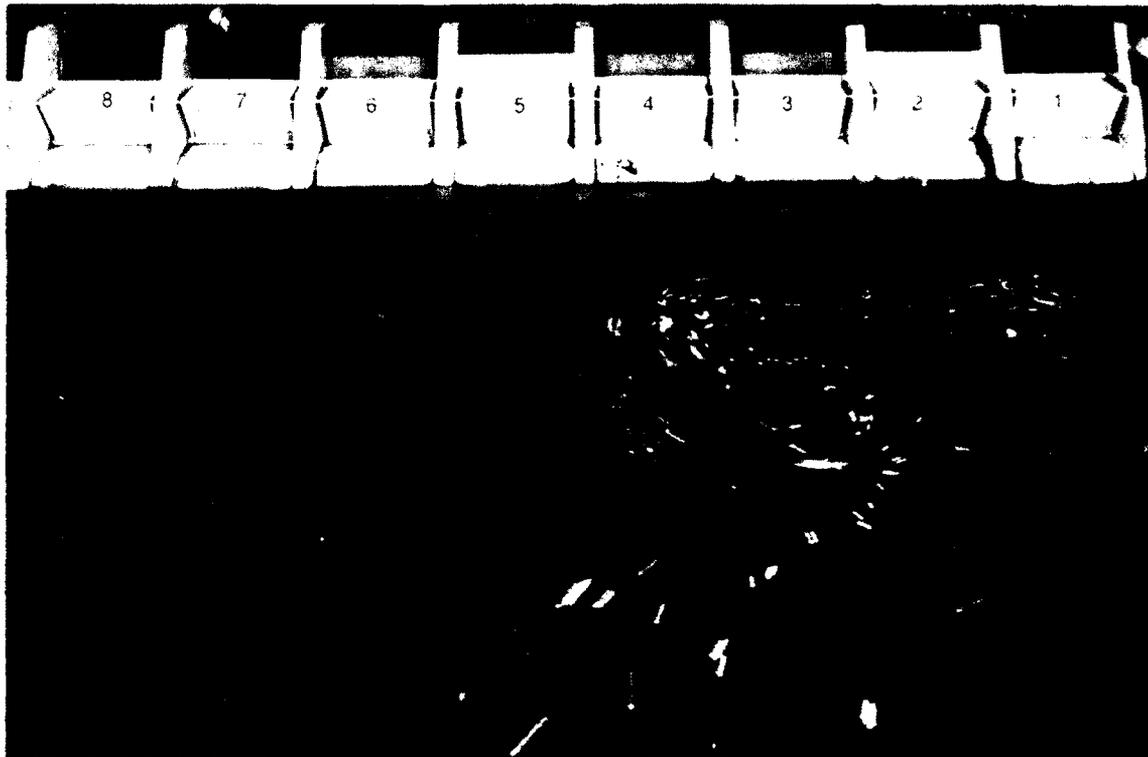
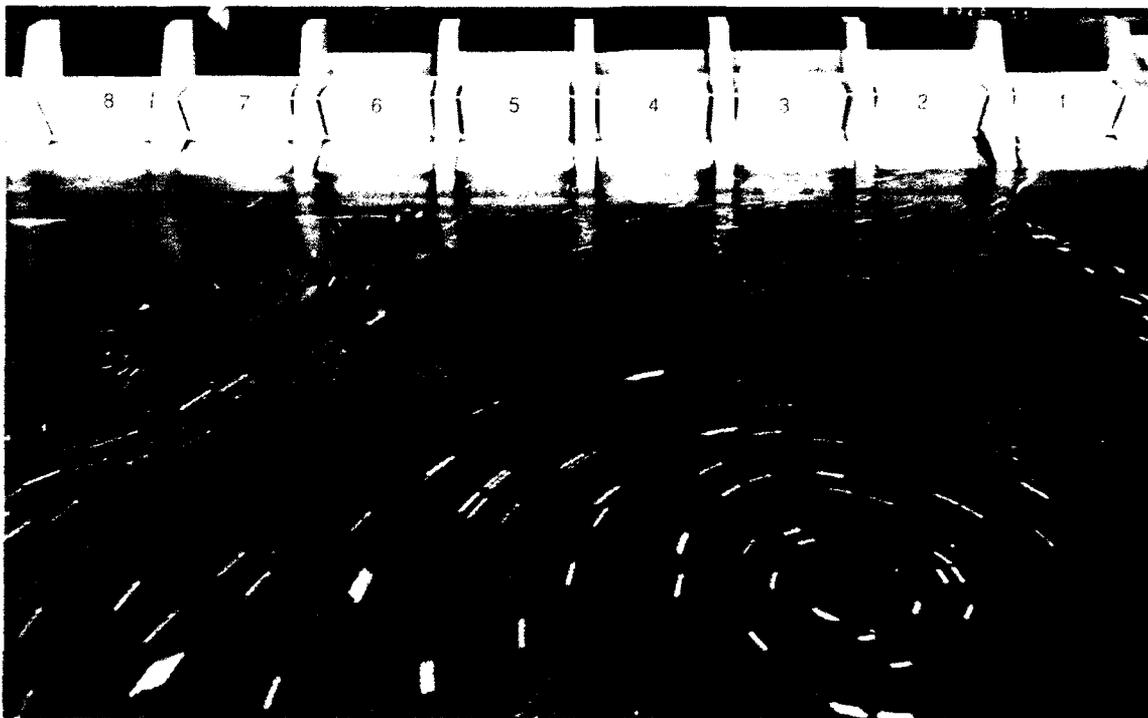
Photo 24. Flow conditions with gates 2-6 closed, a discharge of 15,000 cfs, and pool el 162

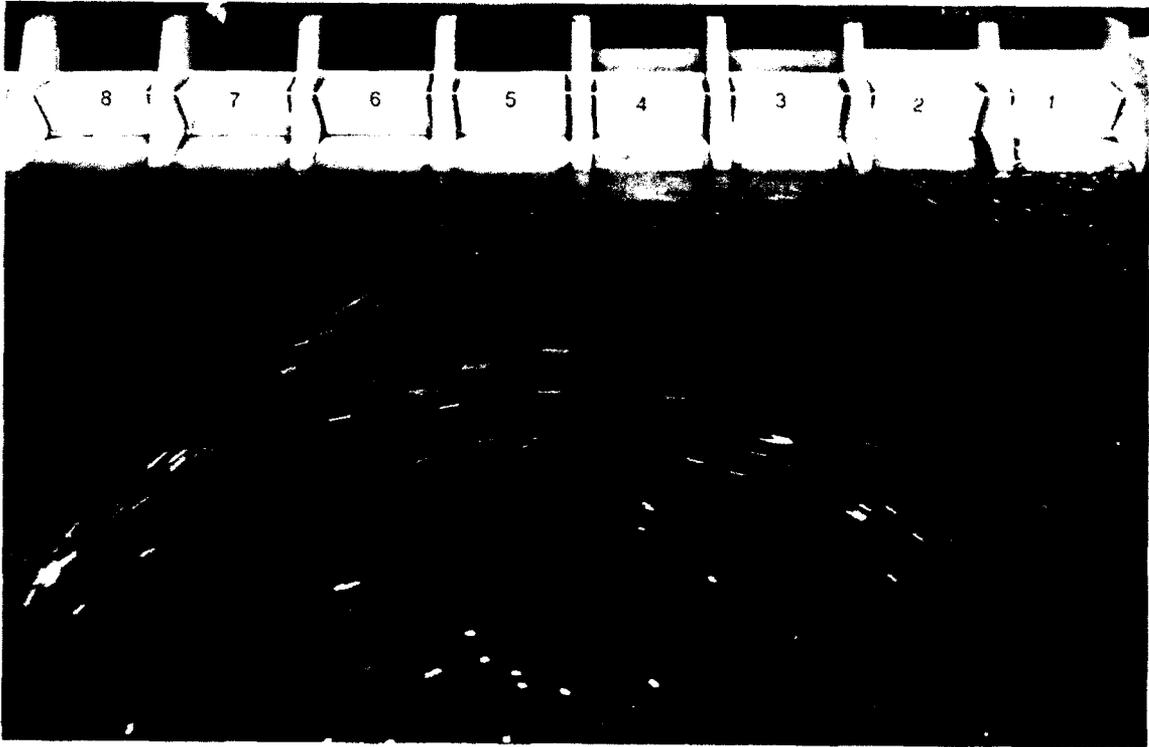
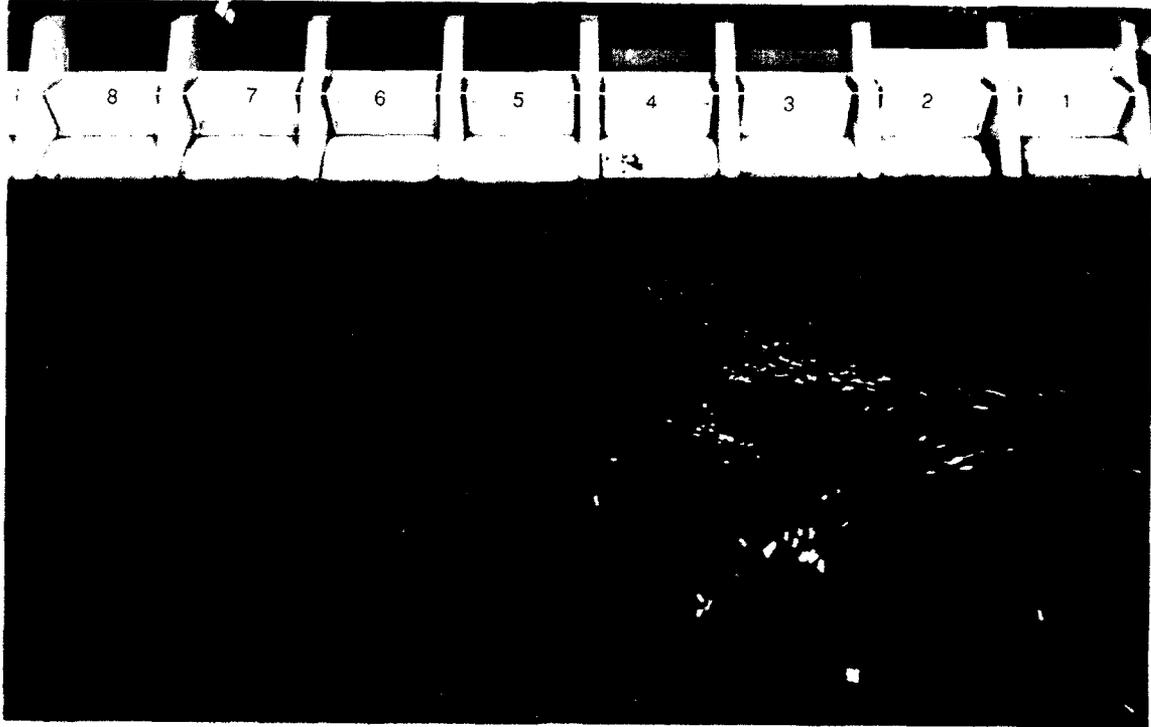
Photo 25. Flow conditions with gates 1-4 closed, discharge of 15,000 cfs, and pool el 162

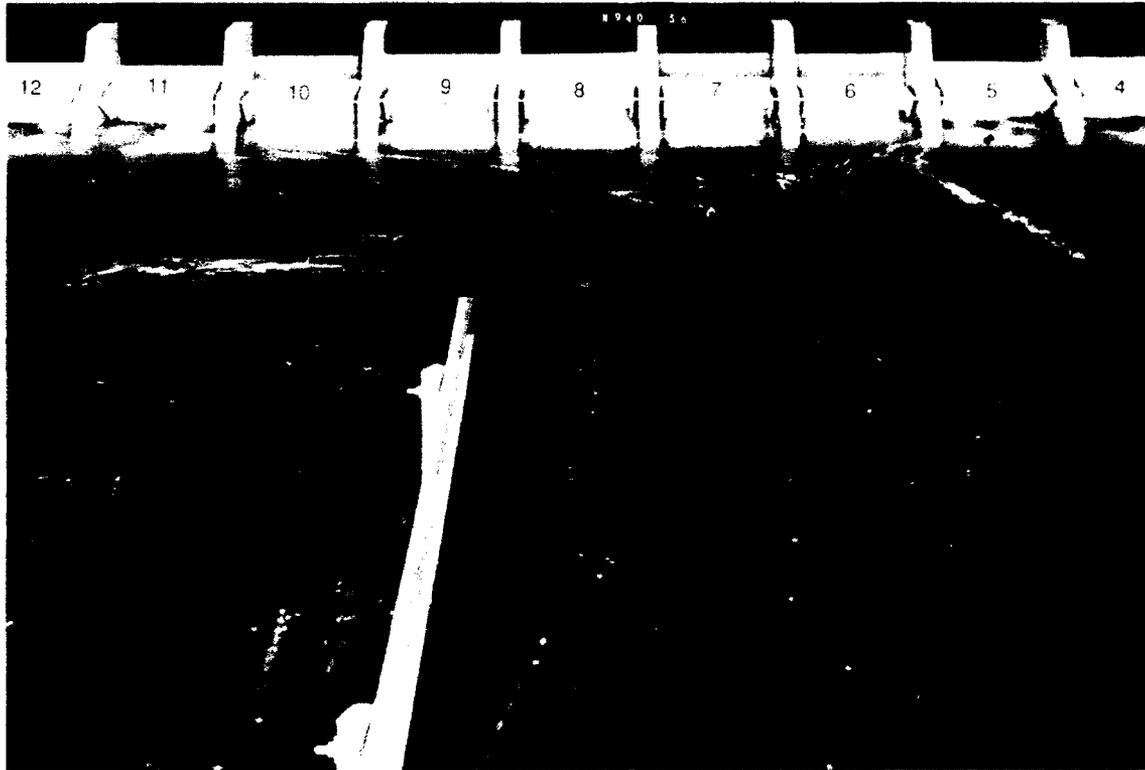
Photo 26. Flow conditions with gates 6-10 closed, discharge of 112,600 cfs, pool el 164, and tailwater el 150
