11. TITLE (Include Security Classification)
ARMY AIRCRAFT FIRE-DETECTION SYSTEMS OPERATION AND RELIABILITY.

**ARMY
AIRCRAFT
FIRE-DETECTION
SYSTEMS
OPERATION
AND RELIABILITY**

This report evaluates the results of a July 1993 study of fire indications on board Army aircraft. Although the focus was the aircraft fire-detection system, other areas involving "potential" fire, such as smoke and sparks, were included and evaluated.

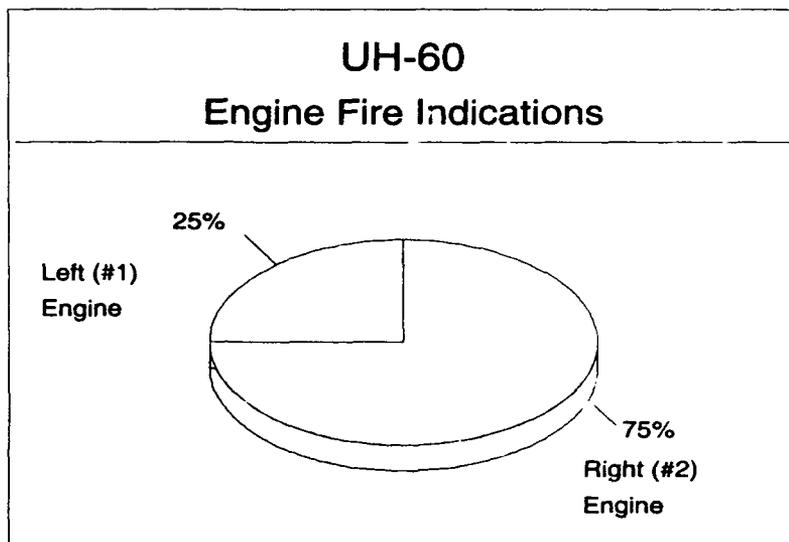
The causes of the fire indications could be broken down as shown in the chart below.

Compass failures accounted for 7 fire indications (8%) during flight and, although seemingly insignificant, in one case the pilot was executing an instrument approach during night IMC. Contending with a primary instrument at such a critical time can increase the crew's workload in several regards. Pilots must isolate the failure, execute the emergency procedure, and, while performing these tasks, fly the aircraft effectively. Weather conditions, illumination, crew rest, and training can adversely impact the crew's effectiveness.

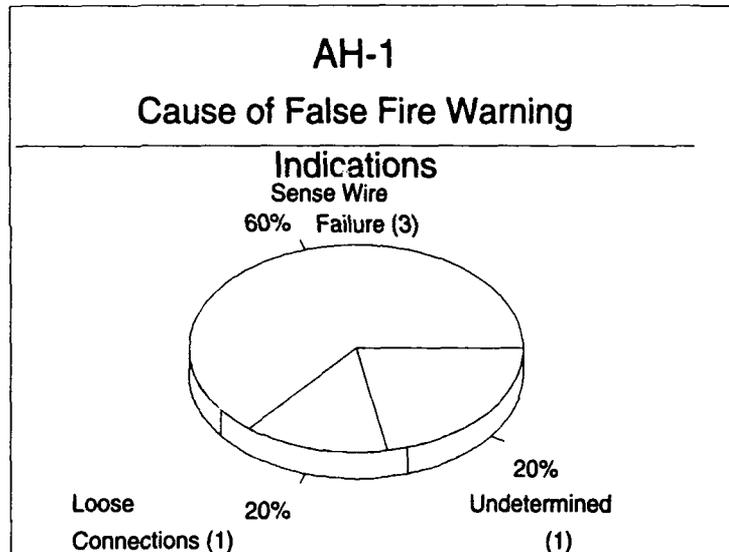
All five activations of the fire-warning systems were false. Of these, 3 (60%) were caused from a wire (fire resistance wire) breakage, 1 (20%) was from a loose cannon plug, and 1 (20%) was undetermined.

Sixteen percent of all fire indications were the result of environmental control unit failures, all of which resulted in smoke in the cockpit. Attack aircraft rely on forced ventilation and their environmental control units. This makes environmental failure events more critical on an AH-1 aircraft than, say, a heater failure on a UH-1, which can be easily vented.

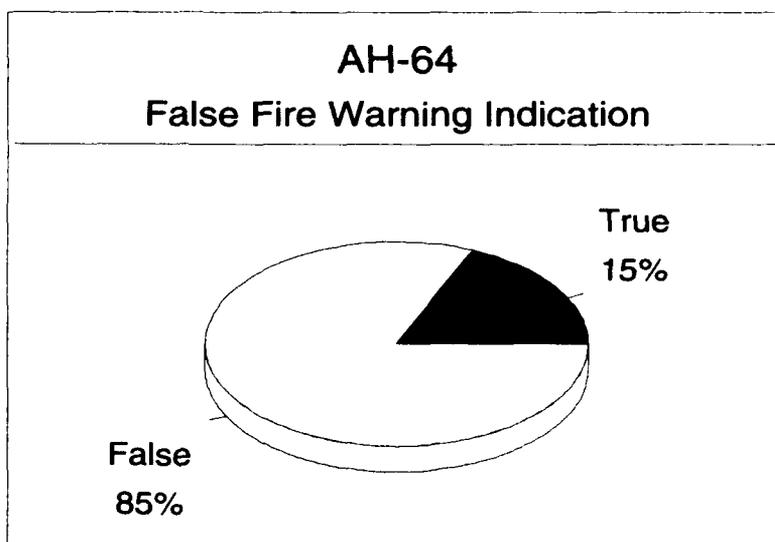
It should be noted that as a result of all 14 fire-warning indications, the Apache crews landed immediately (unlike the UH-1 and the UH-60). This predisposition is most likely related to the severity of fire consequences on board the AH-64.

The study concentrated on three areas: fire-warning activations, shaft-driven-compressor failure, and the environmental control unit (ENCU).

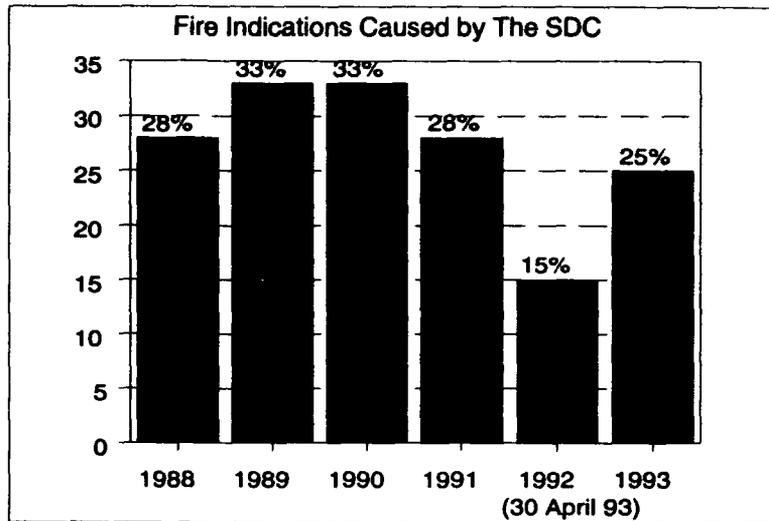
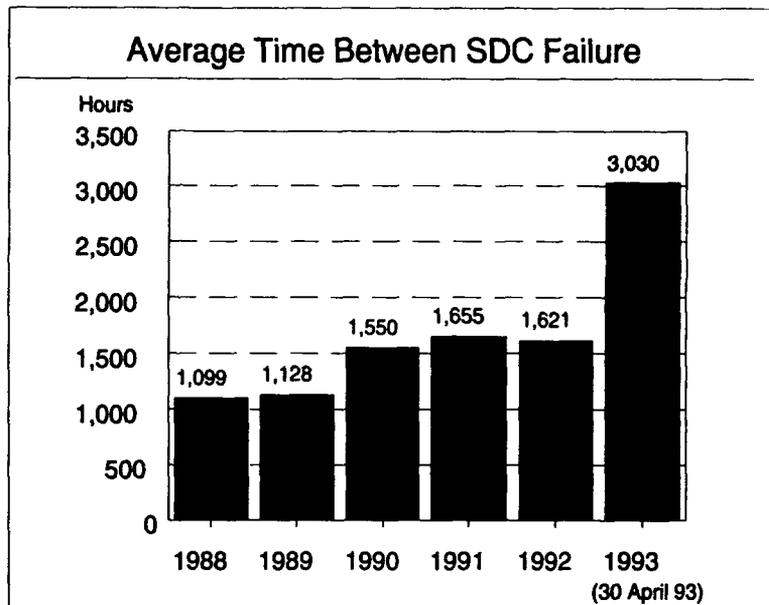
However, the natural question arises as to how SDC failures have been progressing over the last 5 years (fire and nonfire related), and the table to the right breaks that down into the average time between failures of the shaft driven compressor.

As one can see, the mean time between failure has increased almost three fold since 1988 and is attributable to recent modifications. It should be pointed out that according to unconfirmed information, the

The ENCU failures indicate a general leveling over the years with the primary cause of failure stemming from internal turbine cooling fan failure in about 50 percent of the cases. On initial

review of the ENCU, one does not appreciate the criticalness of its failure until the cockpit fills with smoke through the vents. In several cases, pilots had to be evacuated after landing for treatment of smoke inhalation. In three cases the crews were tested for toxic effects of the smoke.

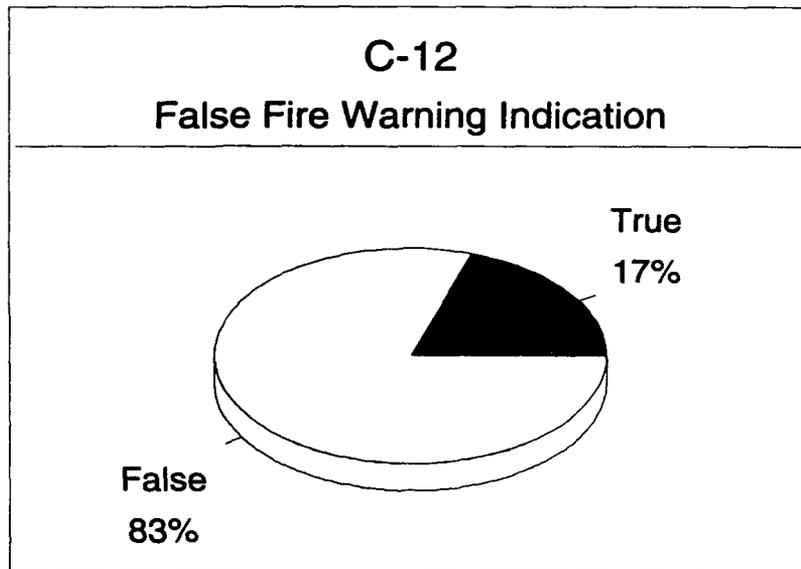
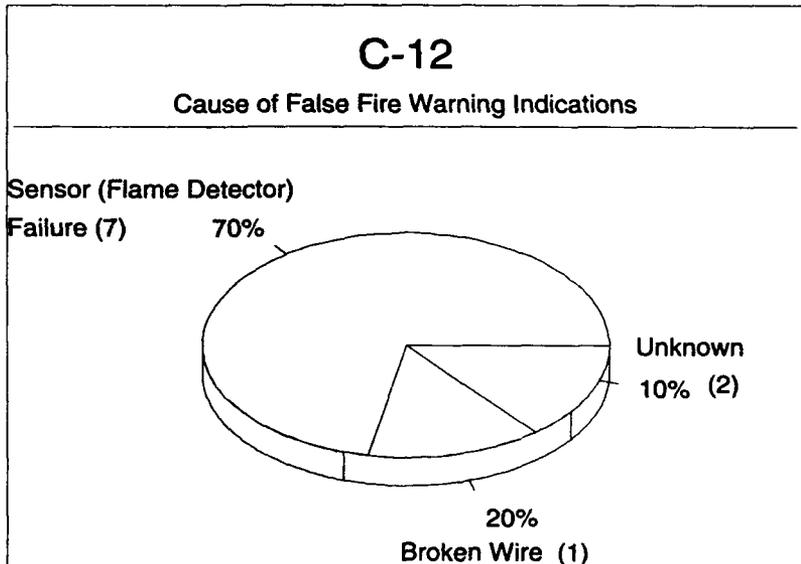
The C-12 has flame detectors made by Pyrotector. Each engine has three. They operate on viewing infrared light from the fire. Of the 12 fire-warning indications, two were true (one oil and the other a burned-out starter generator) while the remaining 10 (83%) were false.

The forward blower motor/fan is a weak link for the Army C-12. Unfortunately, its failure results in smoke and fumes into the cabin and cockpit. It is not considered a critical failure as on the AH-64 and AH-1 in that the C-12 offers a much more stable and thereby manageable platform from which to work.
