NAVY EXPERIMENTAL DIVING UNIT

REPORT NO. 12-93

CONTAMINATED WATER DIVING SYSTEM (CWDS) EVALUATION

DECEMBER 1993

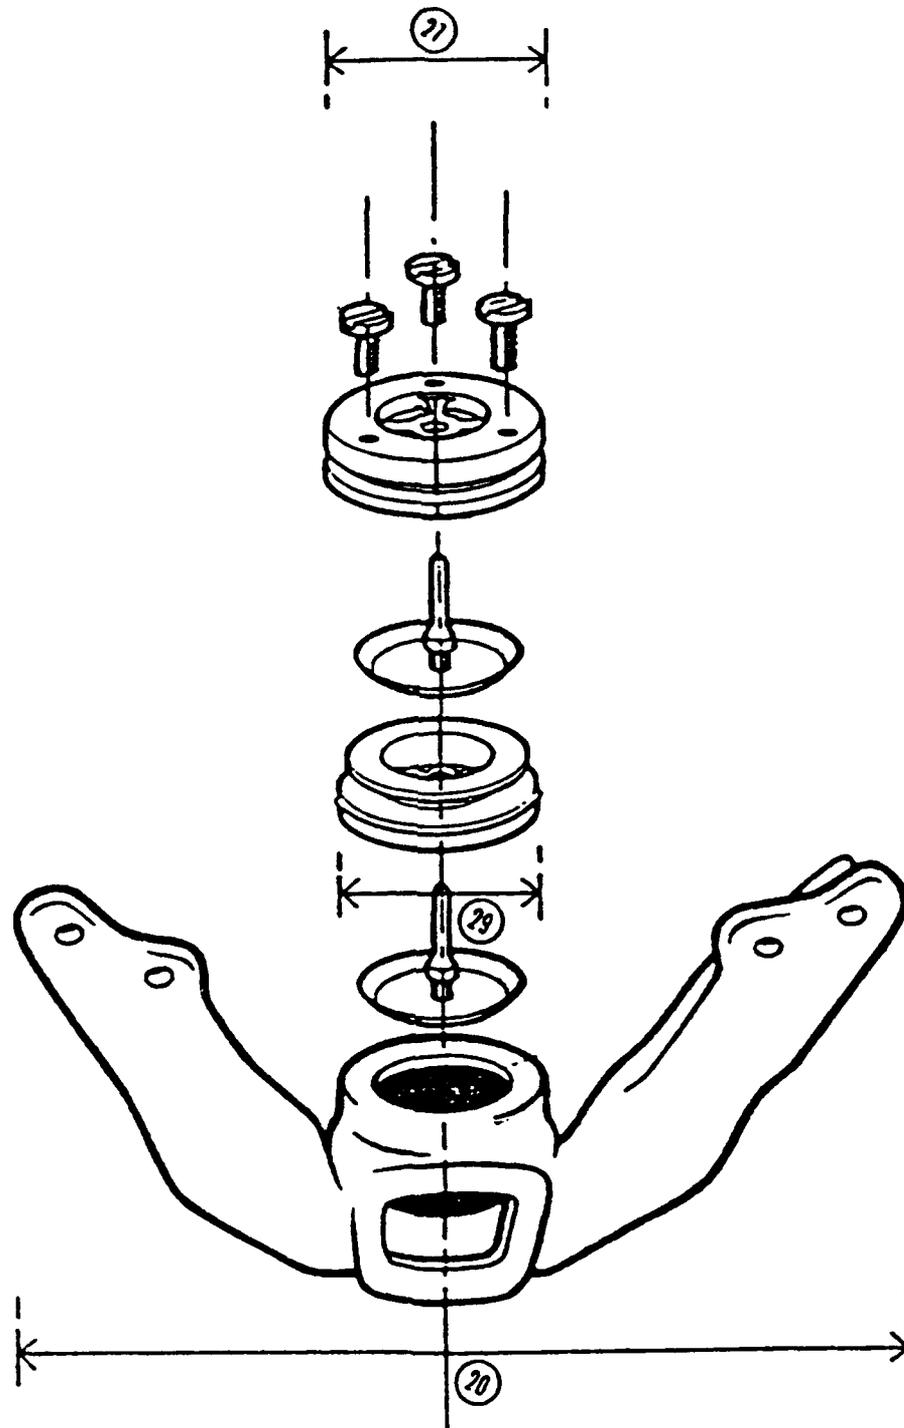
DIAGRAM OF DOUBLE FLAPPER EXHAUST VALVE ASSEMBLY

Initial tests for water aspiration using the contaminated water kits resulted in flooded helmets. Closer examination revealed a problem at the proximal end of some of the exhaust valve housings that had been supplied to NEDU for testing. Specifically, with the contaminated water kit installed, the gas train is diverted approximately 45° by the valve housing immediately after passing through the first exhaust valve. Because some valve seats were improperly centered on the angled housing, the mushroom valve could hang up on one side when it opened, which allowed water outside the valve to enter the helmet. It is important to note that this condition only occurred when the distal exhaust valve in the assembly--which should have prevented water from getting as far as the proximal valve--was wedged open by water-borne debris. Subsequent testing revealed the helmet would still aspirate water at 30.3 msw (99 fsw) and 62.5 LPM RMV. However, the interior of the helmet remained dry throughout three successive tests conducted at 30.3 msw and 40 LPM RMV.
