DOT/FAA/CT-90/10

Fuselage Burnthrough from Large Exterior Fuel Fires

July 1994

Final Report

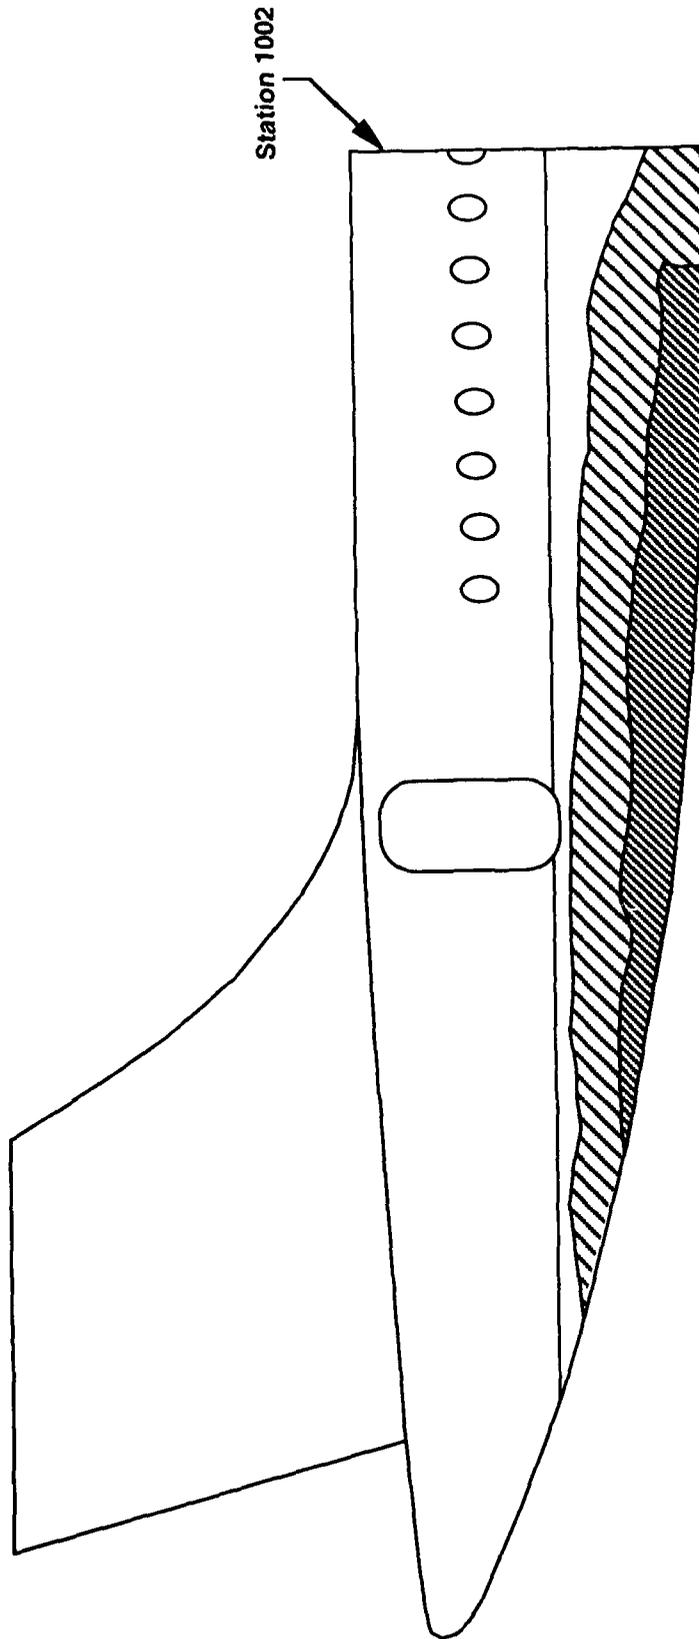
FIGURE D-16. TEST 4 EXTERIOR FIRE DAMAGE, AFT SECTION FUSELAGE PORT SIDE

Paint Burned Off and Some Heat Buckling of Skin Panel

Soot

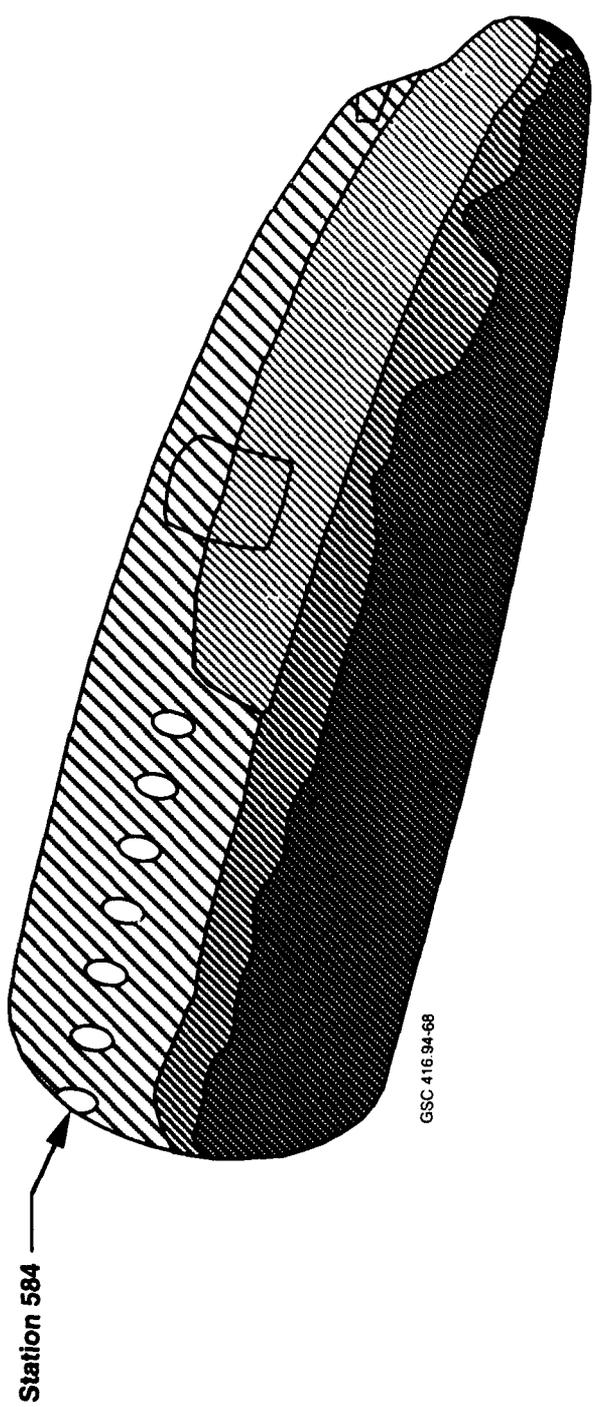
FIGURE E-13. TEST 5 EXTERIOR FIRE DAMAGE, FORWARD SECTION FUSELAGE PORT SIDE

Paint Burned Off and Some Heat

Soot

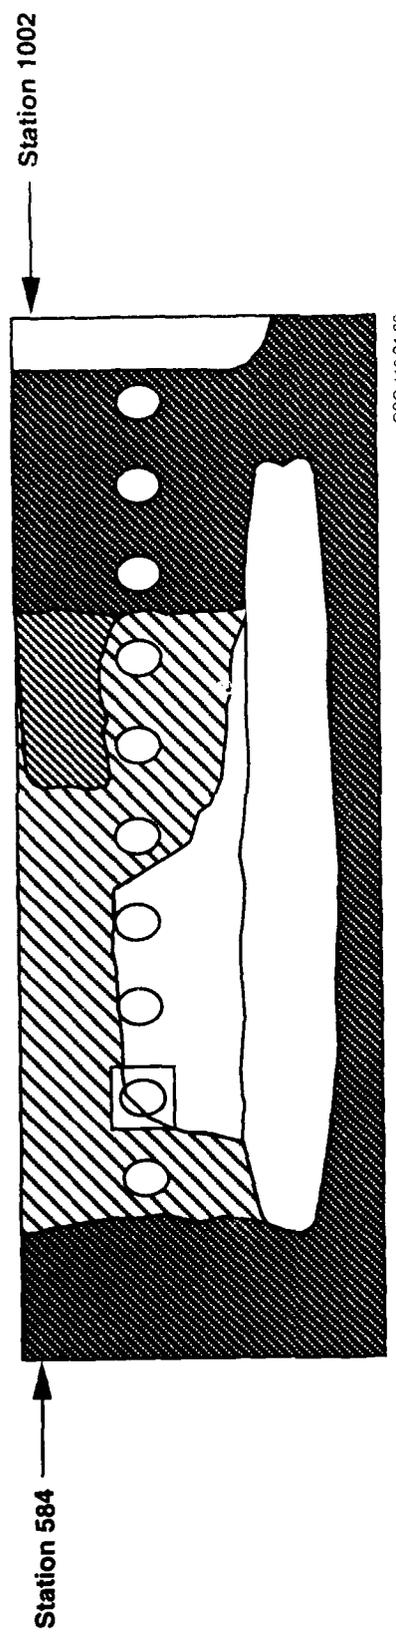
FIGURE F-7. TEST 6 EXTERIOR FIRE DAMAGE, CENTER SECTION FUSELAGE PORT SIDE

▨ Paint Burned Off and Some Heat Buckling of Skin Panel

▧ Soot

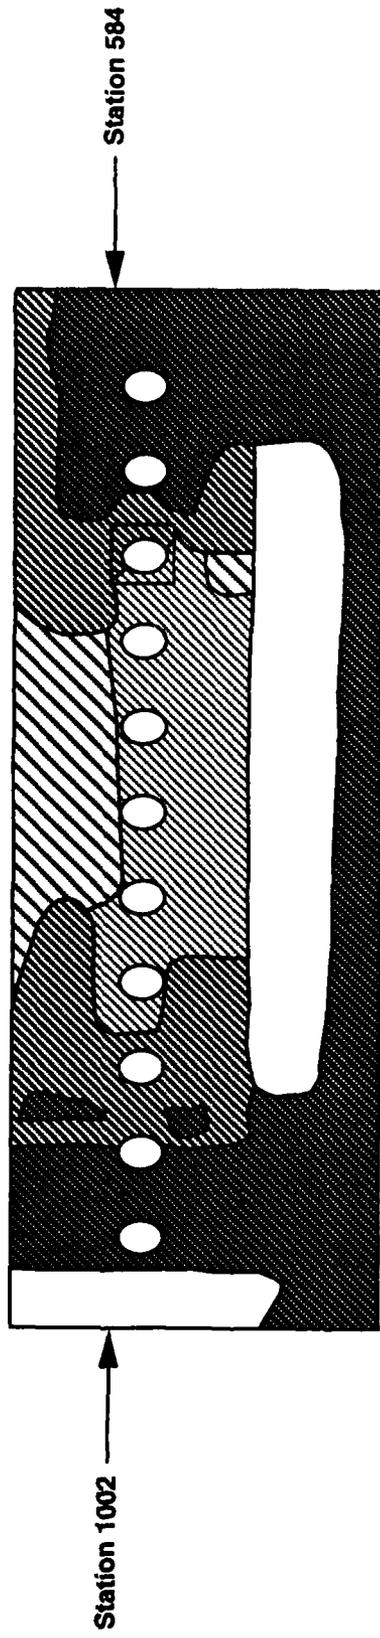
FIGURE F-8. TEST 6 EXTERIOR FIRE DAMAGE, CENTER SECTION FUSELAGE STARBOARD SIDE

Paint Burned Off and Some Heat Buckling of Skin Panel
 -

Soot
