TECHNICAL REPORT ARCCB-TR-94030

FAILURE ANALYSIS OF 120-MM  
MORTAR BUSHINGS AND FIRING PINS

KATHRYN E. NOLL

AUGUST 1994

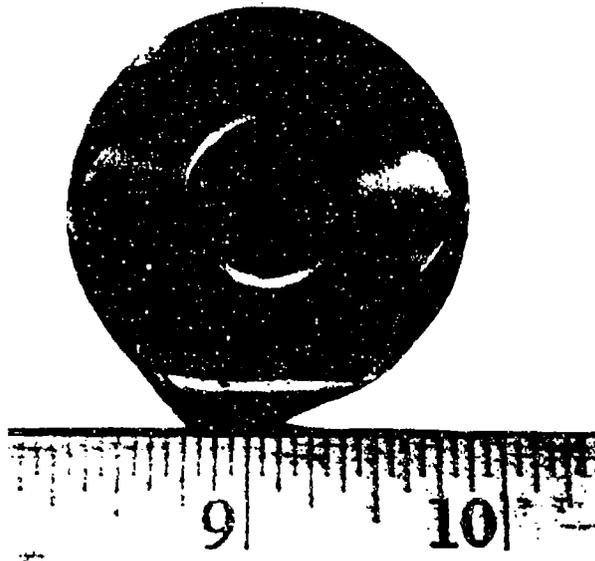
Figure 5. Photograph of bushing assembly, as-received, with Bushing 2 located at the center.

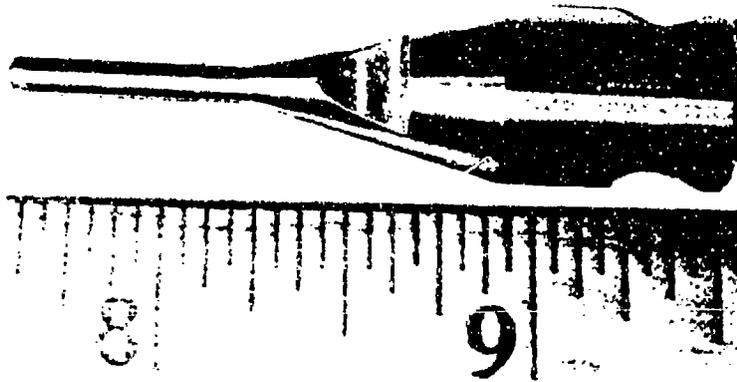
Figure 6. Photograph of Pin 4, as-received.

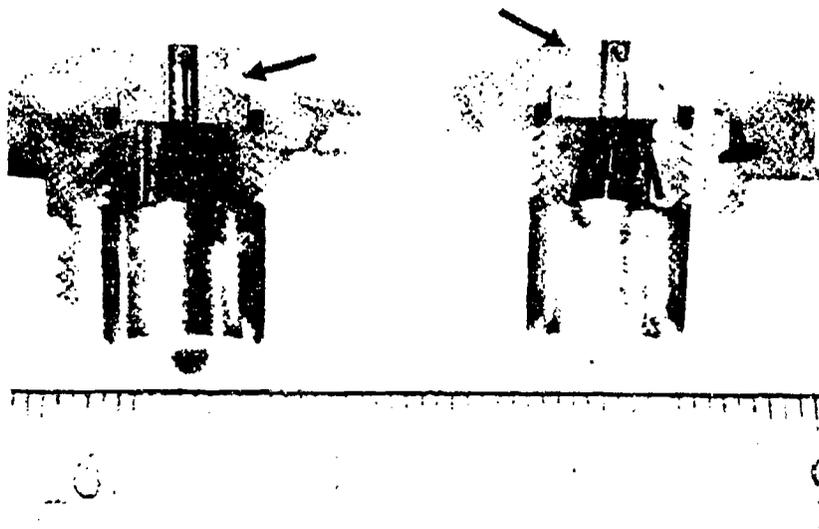
The hole in the U.S.-made bushings (arrows, Figure 9) was cut using wire electrical discharge machining (EDM). The Israeli bushing was cut with a conventional machining operation.

Figure 9. Photograph of bushing assembly, as-received, with Bushing 3 located at the center. Arrows point to the hole machined by wire EDM.
