Technical Report REMR-CS-46
March 1995

Repair, Evaluation, Maintenance, and Rehabilitation Research Program

Repair and Maintenance of Masonry Structures: Case Histories

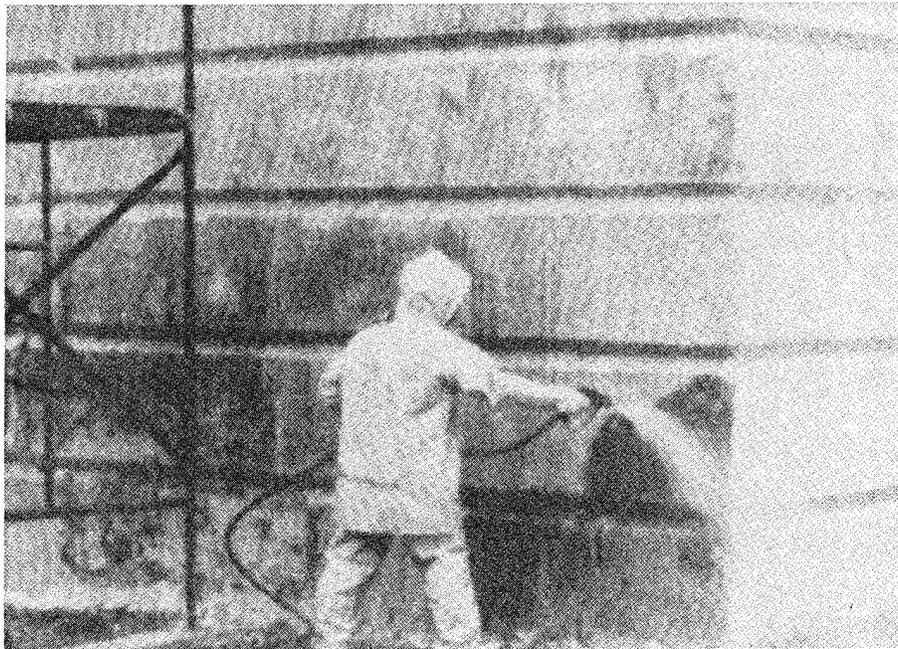
Figure 3. Field test of chemicals on courtyard wall

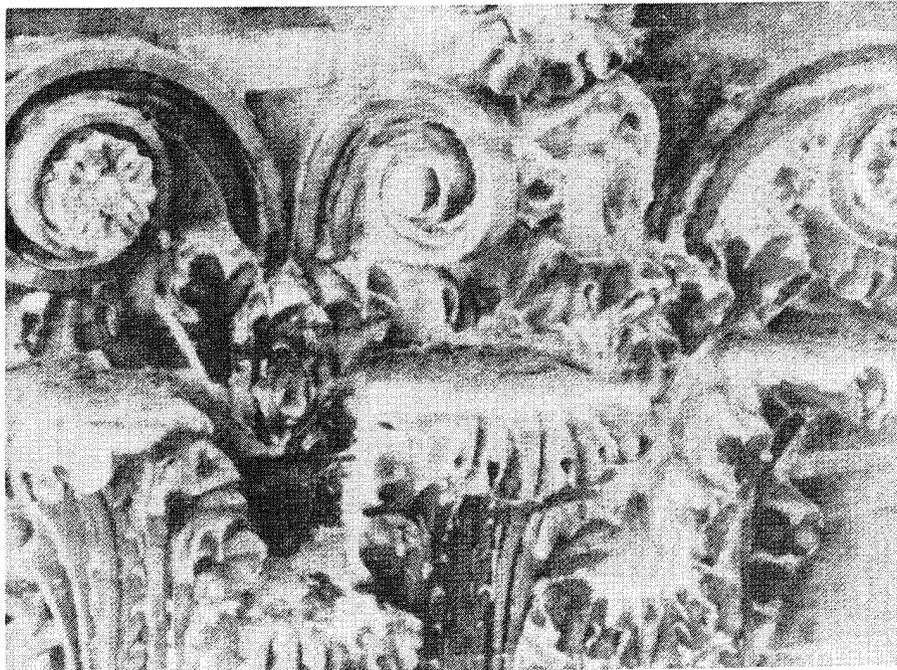
Figure 4. Ornamental detail requiring extra cleaning

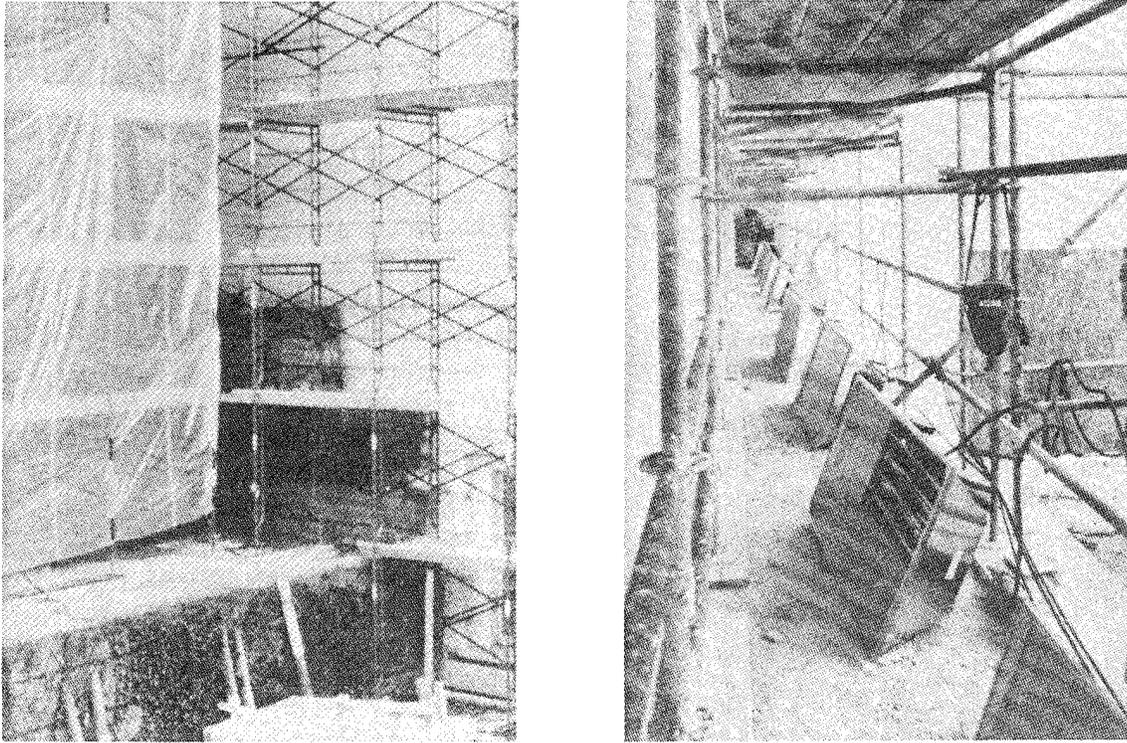
Figure 6. Enclosed scaffolding and heaters

the strengthener was applied, radiant heaters were used near the stone surface at night during the winter. The scaffolding in the area of the work was enclosed with sheets of polyethylene, and the heaters were turned on after the work day was complete, Figure 6. Surface thermometers were installed on the stone and checked each day to make sure that the temperature of the stone was above the minimum 40 °F. The heaters were then disconnected, the polyethylene removed, and the day's work begun.

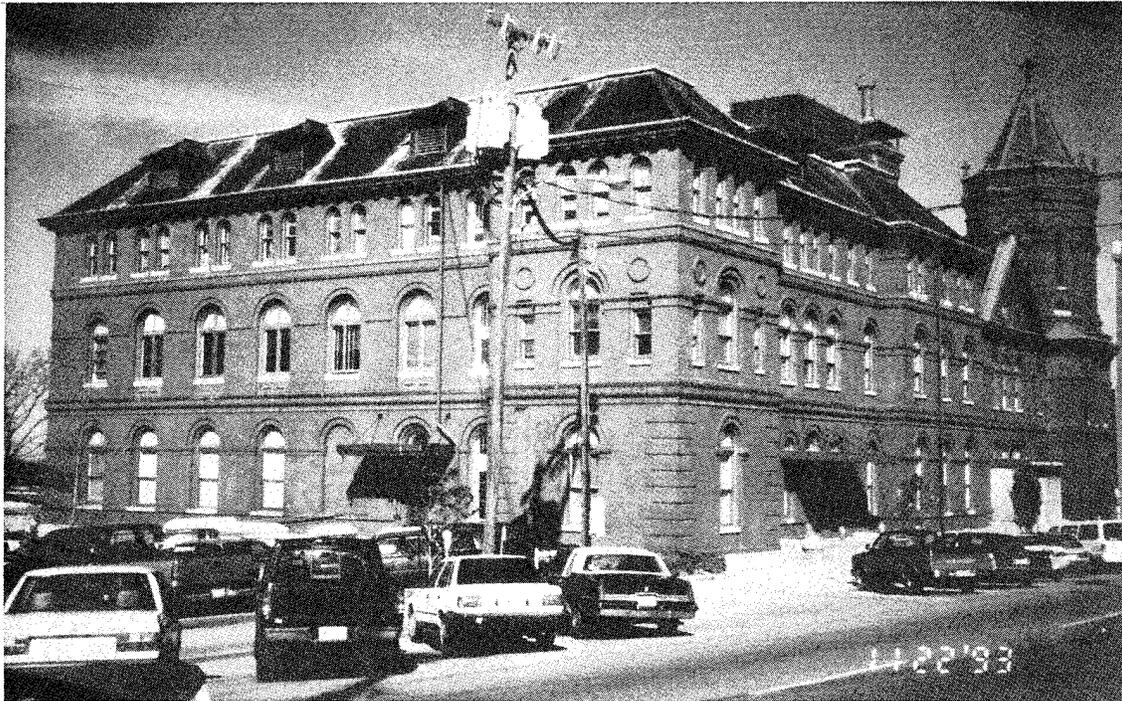
Figure 13. View of cleaned MRC Building

If the above procedure did not clean the surface the first time, it was repeated until the desired result was achieved (Figure 13).

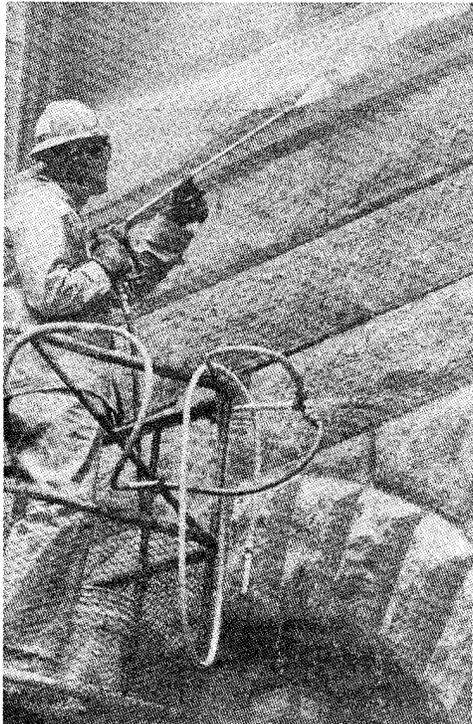
This procedure was used on all the limestone with very good results. Figure 17 shows some of the limestone before and after it had been cleaned. It wasn't until workers began cleaning some of the sandstone sills in Building 108 that there was any problem. The manufacturer of the chemicals used to clean the limestone recommended against using the product with sandstone because it would damage the structure of the stone. A different kind of cleaner was used to clean the sandstone parts of the buildings.

Figure 17. Limestone facade during cleaning

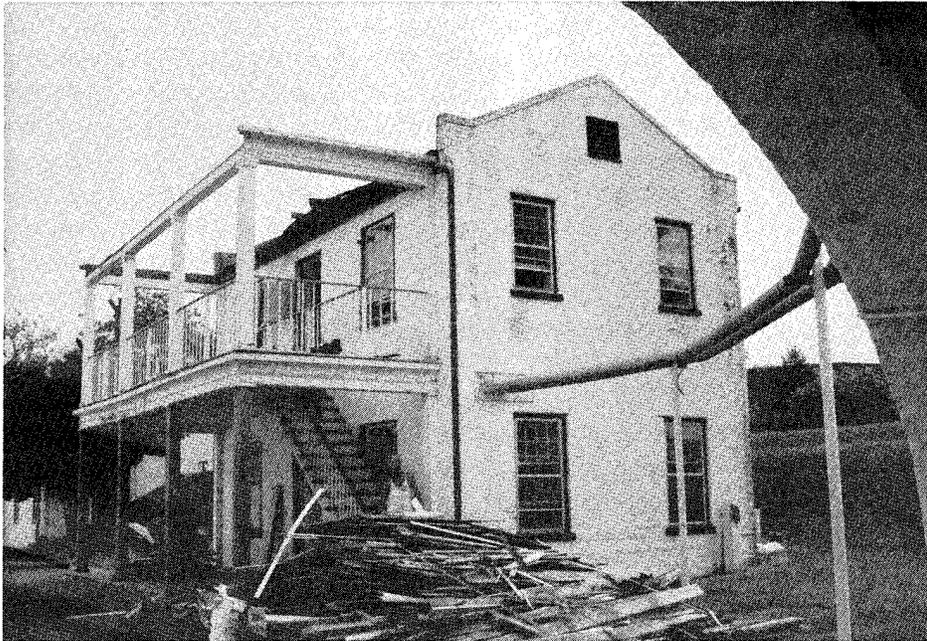
Figure 20. Storehouse showing porch during restoration

The other area of brickwork that had to be renovated was a 1- by 2-ft opening in the end wall of the storehouse that had been cut to allow steam pipes to enter the building (Figure 20.) During the restoration, the steam pipes were removed and the openings closed using the restoration brick and mortar described above.

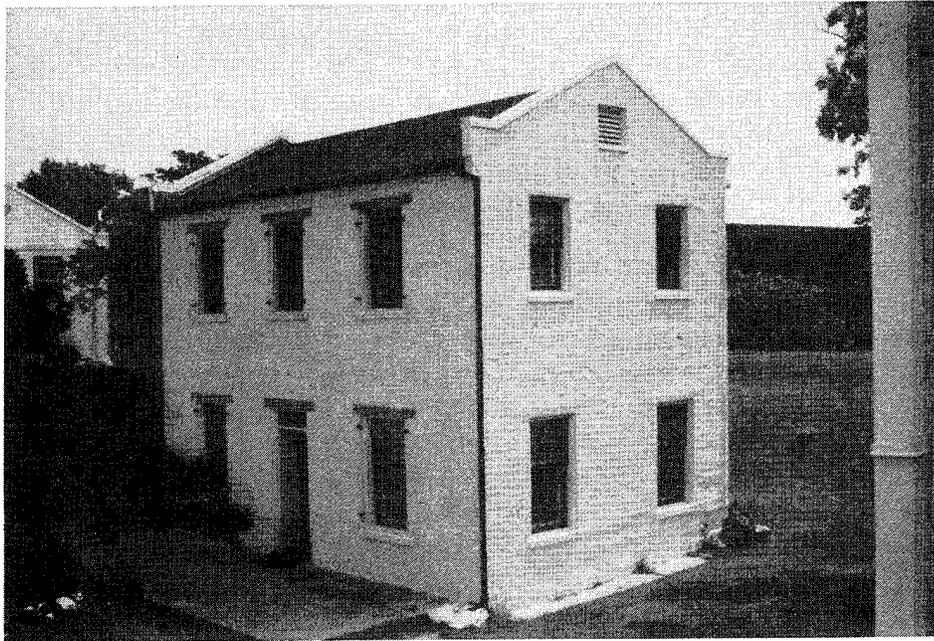
The completed renovation is shown in Figure 21. All renovations are performing well as of this writing. There are no signs of deterioration of the mortar in the joints and the whitewash coat is holding up well. The restoration has returned the building to its appearance in the early 1800's.

Figure 21. Completed restoration of the storehouse

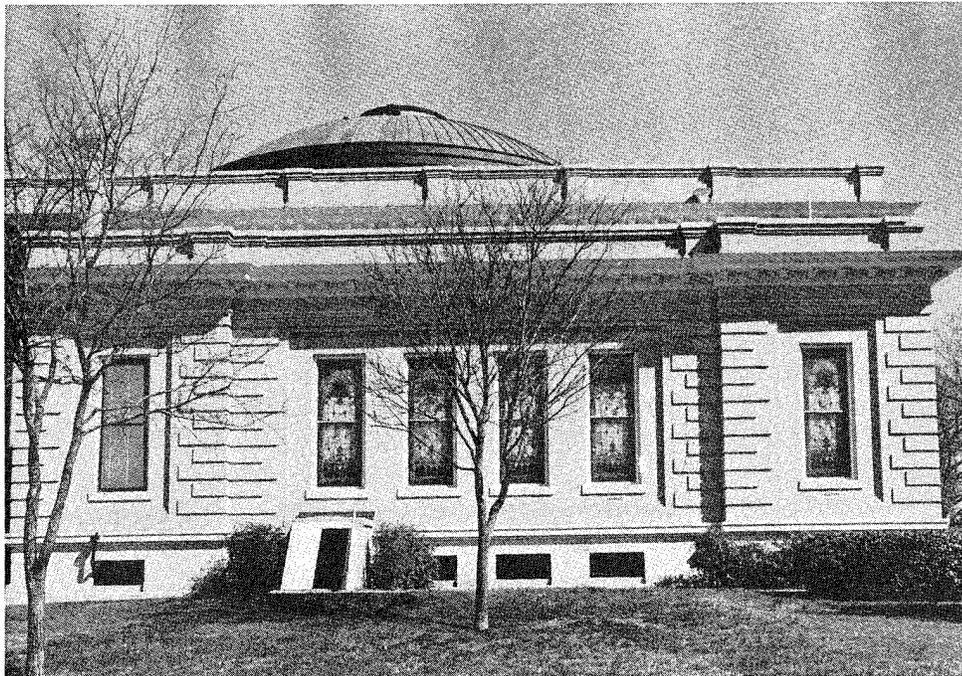
Figure 38. Elevation of the west facade

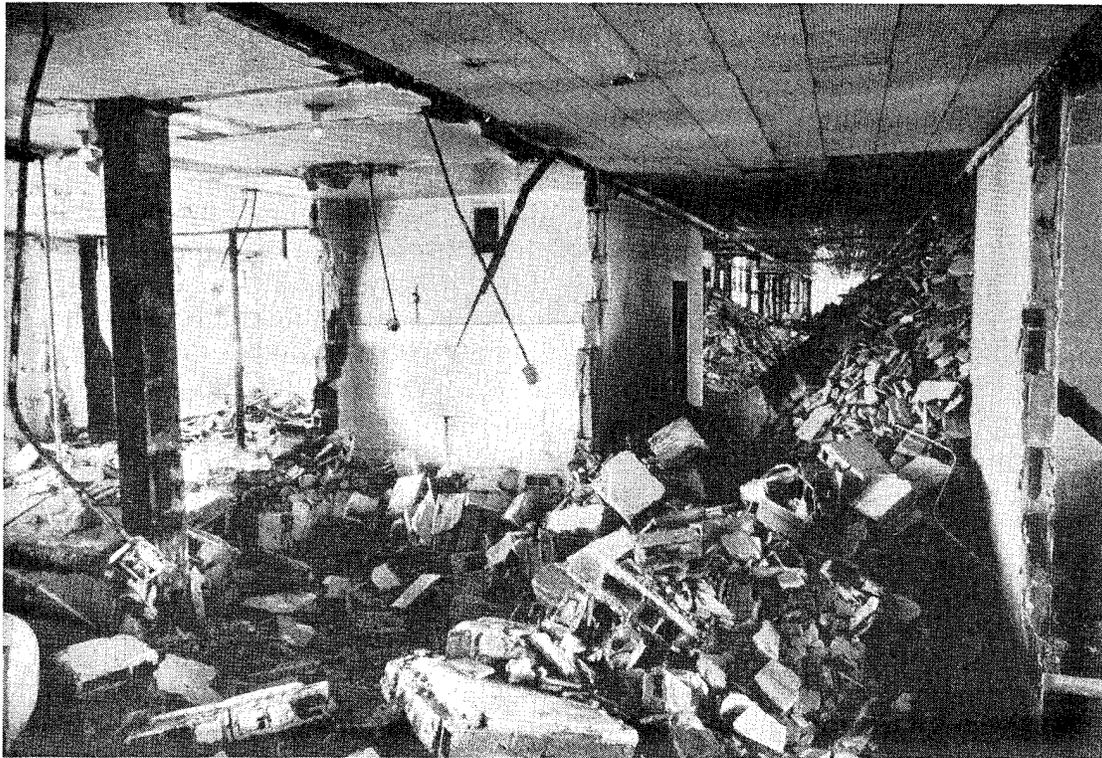
In the initial efforts to renovate the building, many schemes were tried to remodel the existing rooms and corridors for apartment use. It soon became apparent that the existing scheme of rooms would not provide the number of units necessary to financially carry the project. This, coupled with the fact that the interior walls were constructed of hollow clay tile, led to an early decision to demolish all interior walls from the underside of the roof to the basement. Exceptions to this decision were the concrete floors, the exterior walls and the historical rooms. Removal of the hollow clay tile partitions eliminated substantial earthquake hazard, since they will shatter in an

earthquake. Figure 47 shows these tiles during the 1979 renovations. This also reduced the total mass of the building thus lowering the effective earthquake inertia forces.

Figure 47. Clay tile partition rubble from 1979 renovations

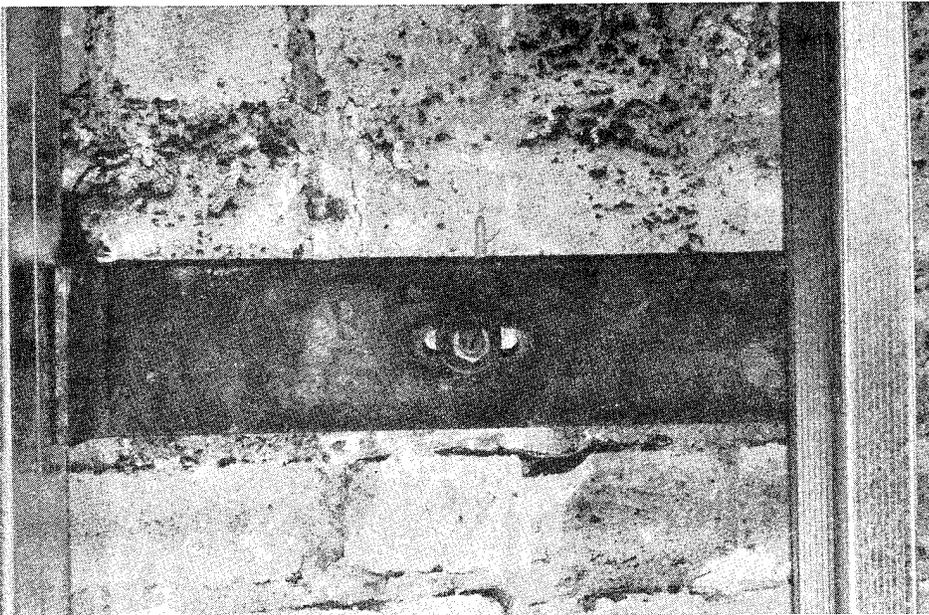
The testing proved that the walls were simply not designed for resistance to the high force levels experienced in an earthquake. However, if the brick wall could be held in place, it could be effective even after suffering major cracking because it will absorb a great deal of energy in crushing of the brick along fracture surfaces during earthquake movement.

Figure 49. Detail of basketing anchor

To effect this type of performance, the decision was made to provide a basketing system to stabilize the brick walls after cracking occurred. The system devised was incorporated into the new wall furring which was applied to the interior of the steel frames of the exterior walls. Figures 48 and 49 show some of the system details. Heavier structural studs were mixed in with the basic stud furring system. These heavy structural studs were spaced to allow wall anchors to be secured at approximately 3 ft on center in both vertical and horizontal directions. The wall anchors were 1/2-in.-diam bolts long enough to extend from the structural studs through the two interior wythes of the exterior wall and into the face brick. The bolts were inserted into the wall through holes drilled into the brick to a depth including partial penetration in the face brick. They were then anchored to the brick with polyester-resin epoxy cartridges.

Tests were conducted to determine the strength of the epoxied bolts in the brick. Prior to the actual use of this system, three anchors were epoxied into brick test panels and were loaded to failure. One failed at 7,500 lbf, and the other two at 9,000 lbf, with all failures occurring in the anchor, not in the brick or in bond between the brick and the anchor. There were 4,900 bolts used in the wall renovation, and 520 of these bolts were subjected to pullout

testing. The anchors were loaded to a magnitude of 1,000 lbf and held at that level for 1 min. Only 34 anchors failed the proof loading.

To complete the anchorage of the wall, the bolts were then attached to plates which spanned between adjacent structural studs. The stud system then provided a positive anchorage detail to the floor framing above and below. Thus, the exterior wall system was reinforced with steel studs having the capacity to brace the walls against out-of-plane forces after failure of the brick. The system was intended to hold the brick in place, reduce the potential falling hazard, and use the crushing of the brick (during an earthquake) for its energy absorbing value.

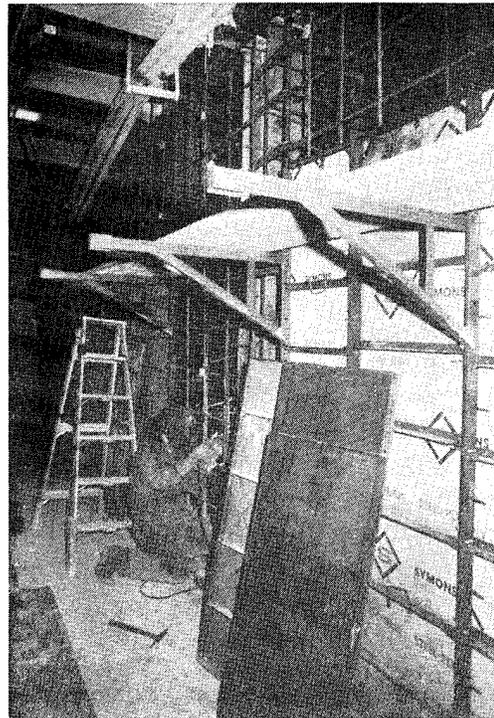
Figure 50. Forming for interior shear walls

Reinforcement of the exterior brick walls was important to the performance of the building in an earthquake, but it was only part of the story. To provide additional strength and ductility to resist major earthquakes, a new system of reinforced concrete shear walls was designed to be added around the stair and elevator shafts (Figure 50). This system, well distributed around the building in the upper stories, was supplemented by additional shear walls from the second floor down to the foundations.

Several functions are served by this system: the needed seismic shear resistance was provided by the new walls, the shafts (stairwell, elevator, etc.) would remain accessible and operable (free of debris that would result from use of a more brittle material), and a 4-hr fire-resistive environment in the shafts was provided.

The new shear wall systems also worked well within the confines of the existing structural framing system. The walls were tied into steel floor beams which served as collectors to deliver diaphragm forces, and into the steel columns, which acted as chord members to resist the tension and compression due to the cantilever action of the wall. Nelson studs were required to be added to the existing structural steel members to develop the forces. The new walls were reinforced for the shear stresses as well as to resist net tension forces at the steel columns to supplement the capacity of the column splices. The most critical aspect of the design of the new shear walls was the overturning effect. Although the interior stresses within a shear wall were readily accommodated, it was necessary to mobilize enough gravity load in the walls to enable them to resist overturning. To accomplish this, the

walls were tied into the load-carrying columns in the upper stories. In the lower stories it became necessary to extend the walls so that they could embrace adjacent columns to create a bigger base and provide stability for each shear wall system to resist overturning effects. In areas where the existing steel columns could not transfer all the uplift into the foundations, additional reinforcing steel was provided, and the new foundations were interconnected with the existing footings to provide a new composite system.

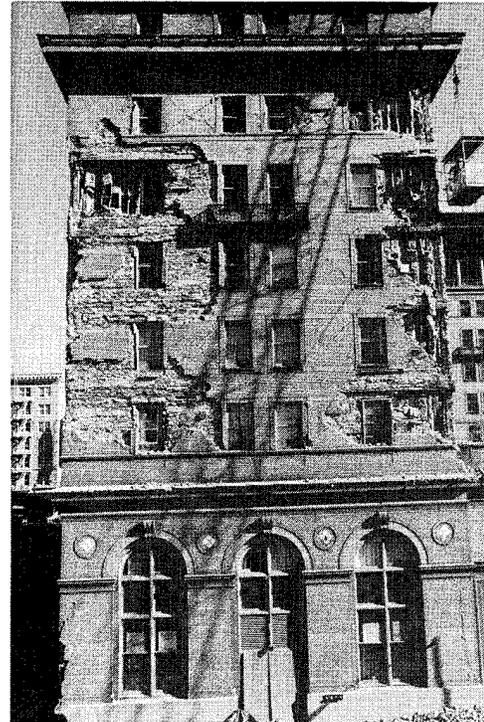
Although the 1989 Loma Prieta earthquake did no damage to the integrity of the structure, there was considerable architectural damage to the exterior brick masonry walls and to a number of apartments. Substantial amounts of brick had fallen to the street from the southwest corner of the building, exposing some of the apartments and the steel framing (Figure 51). With the engineers working to determine the extent of the damage, it was soon learned that the damage was not structural and that except for 30 apartments, the remaining 185 units could continue to be occupied while the repairs to the remaining units were conducted.

The most evident and significant damage sustained by the hotel was the cracking of the exterior brick walls. Although they are not load-bearing walls, the brick walls are the stiffest elements in the building and resisted the main thrust of the earthquake force. The walls are infill brick supported on the structural steel frame, and therefore the damage did not affect the vertical load-carrying capacity of the building. The damage to the brick was manifested as diagonal (X) cracks in the wall piers with virtually no cracking in the horizontal spandrels. Reference to Figure 51 shows this X cracking between bays of windows.

The most severe brick damage took place on the Thirteenth Street end of the Harrison Street wing of the building. There were cracks over 1/2 in. wide, with complex fracturing through the entire thickness of this wall. There were also areas where the face brick had fallen and other areas where it was loose.

Figure 51. Damage to southwest facade after removal of loose brick

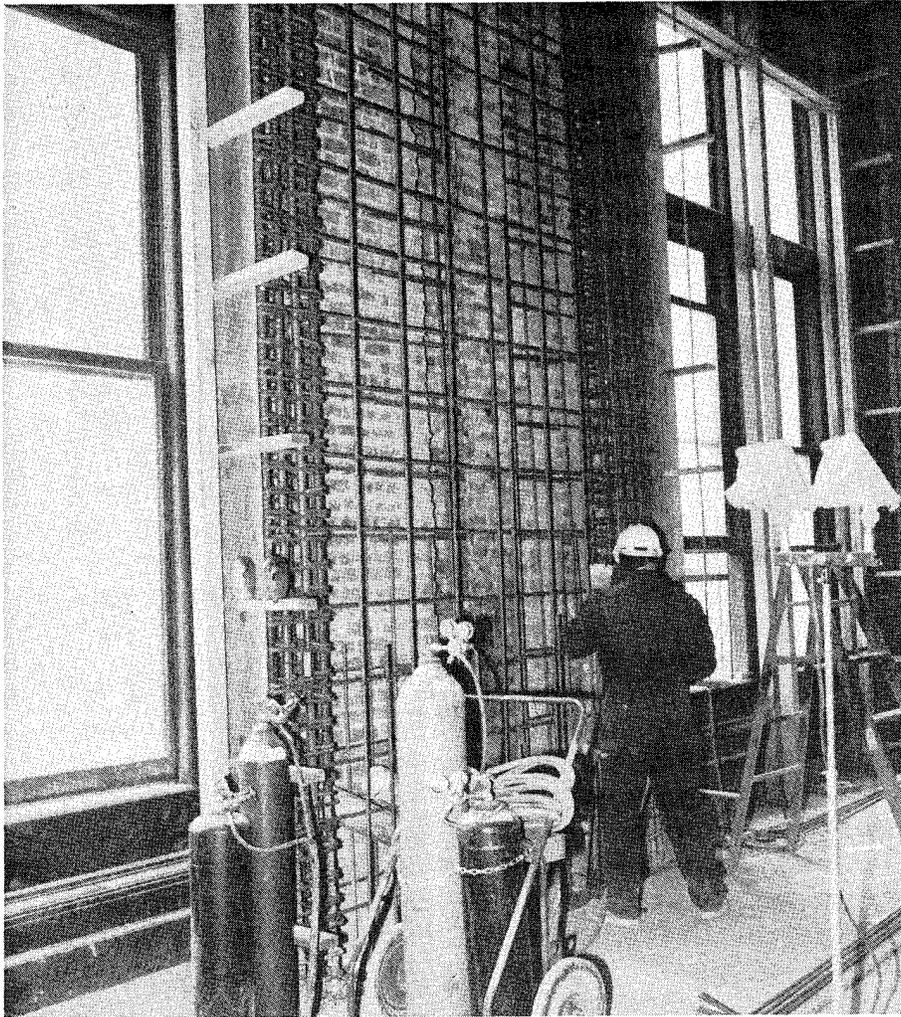
Figure 52. Strengthening of walls behind historical facades

In the first-story historic spaces, the strengthening walls are being located behind the existing historically sensitive wall surfaces to keep the architecture of the space clean (Figure 52). In the upper stories, Figure 53, the additional wall thickness will encroach into the living spaces and the units will be remodeled. Because of the tight spaces in which to work in pouring the new concrete shear walls against the existing brick and the limited amount of work space, the contractor devised an ingenious forming system. Stay-in-place formwork was used and held in place by metal studs that were in turn supported by steel dowels which were carefully placed and epoxied into the facing brick. The studs not only supported the forms but became the method of anchoring the brick to the new concrete walls. The studs were stiffened by wood blocking at each stud and laterally supported by walers. This method allowed for observation of the pour through the formwork and greatly simplified and accelerated the process. The metal studs that remained in place were used as furring for the interior finishes so there were no forms to remove, only the wood blocking and walers.

Where the brick wall was removed, a new reinforced concrete wall was constructed and finished with brick veneer to match the existing brick work. Major new foundation work is required to carry the additional weight of the new concrete walls, and, more importantly, to resist the overturning effects of earthquake forces.

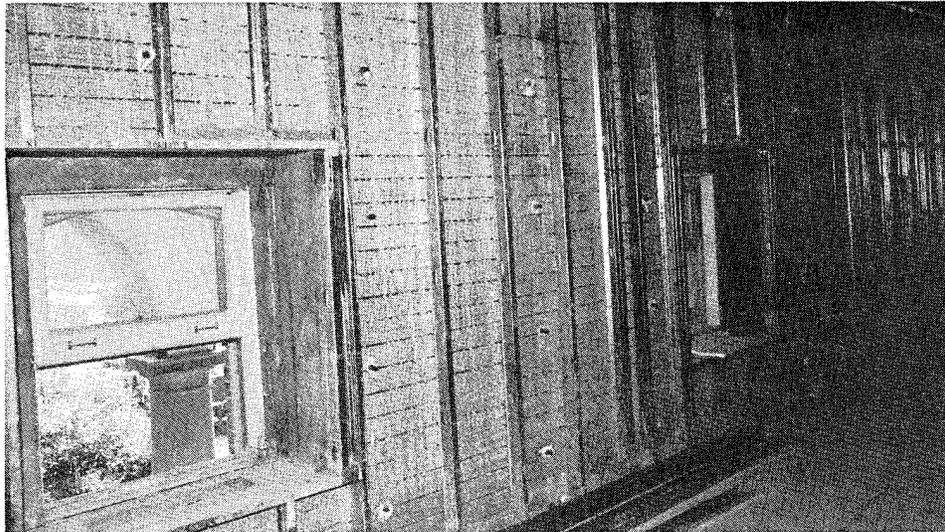
Figure 53. Strengthening of typical upper floor walls
